R3347

SYKE HOUSE FARM – SYKE ROAD, LITTLEBOROUGH,  
OL15 0AH

# REPORT ON STRUCTURE

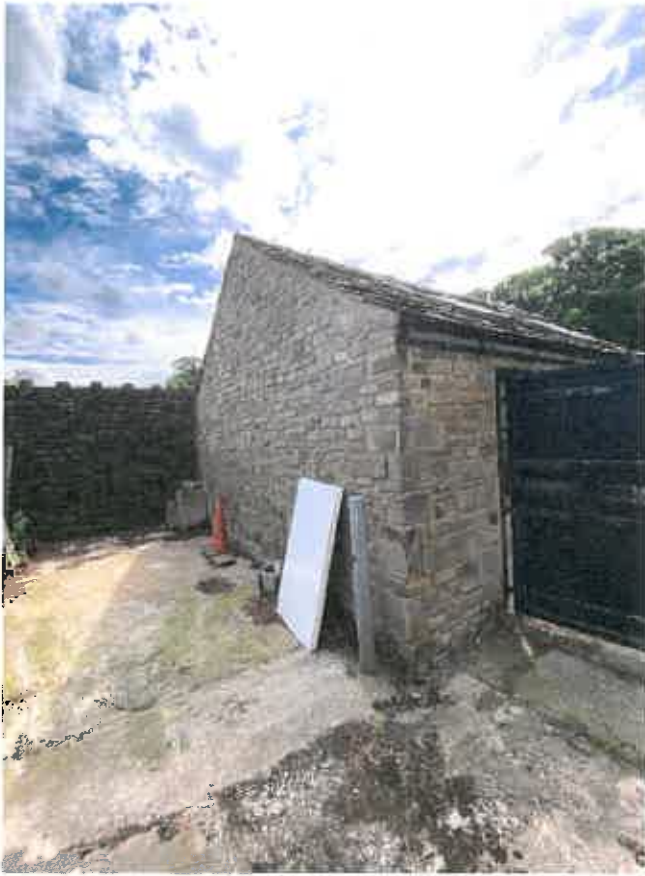
Photograph 1

- 2.01** The Cow Shed is a single storey structure with a gable elevation fronting Syke Road. Photograph 1. The property is built with cavity walls. It has a natural stone facing of a random nature and a blockwork inner leaf.
- 2.02** The roof is duo pitched left to right and has a stone slate flag roof. There are two Velux roof lights in each slope. Photographs 2 & 3.
- 2.03** There are two door openings to the property, one in the forward end of the right-hand side elevation, and one in the rear elevation. Photographs 4 & 5.
- 2.04** The left-hand side elevation abuts an existing boundary wall, photograph 6.
- 2.05** Internally the property is a single area, lined with blockwork walls and with a concrete floor slab.
- 2.06** The roof is vaulted and is supported by a steel ridge beam with timbers spanning from the ridge to the outer leaf. Photograph 7.

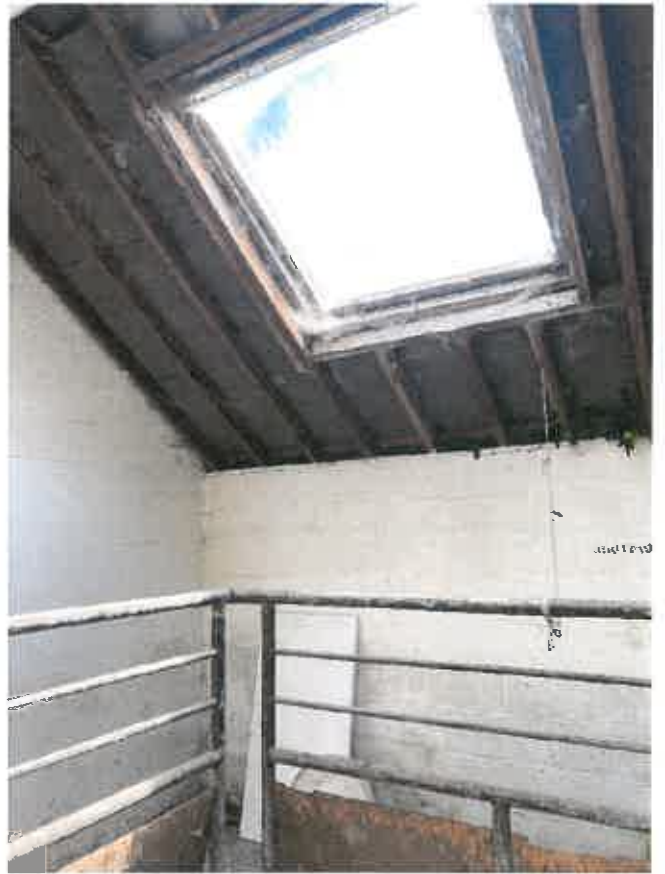
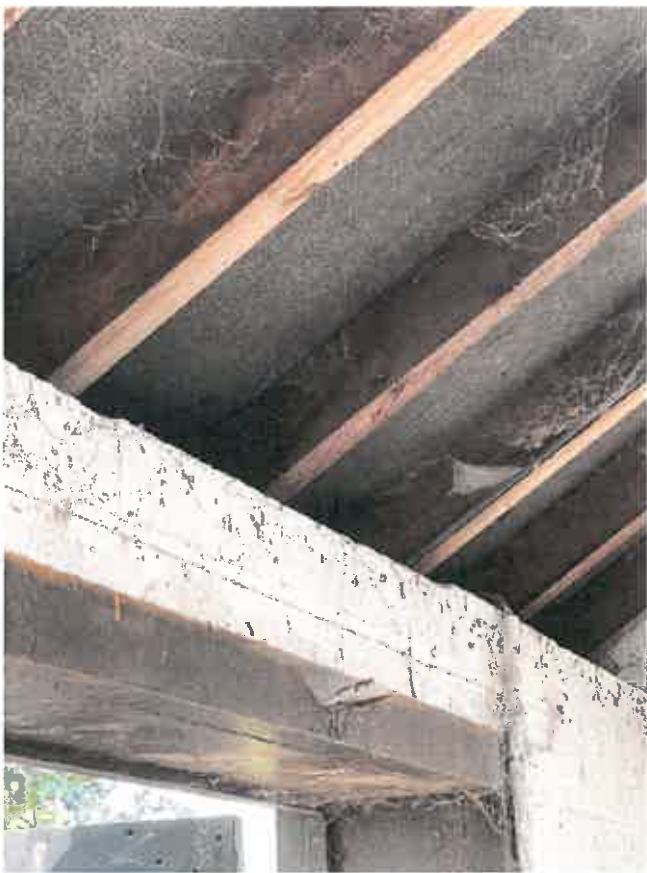
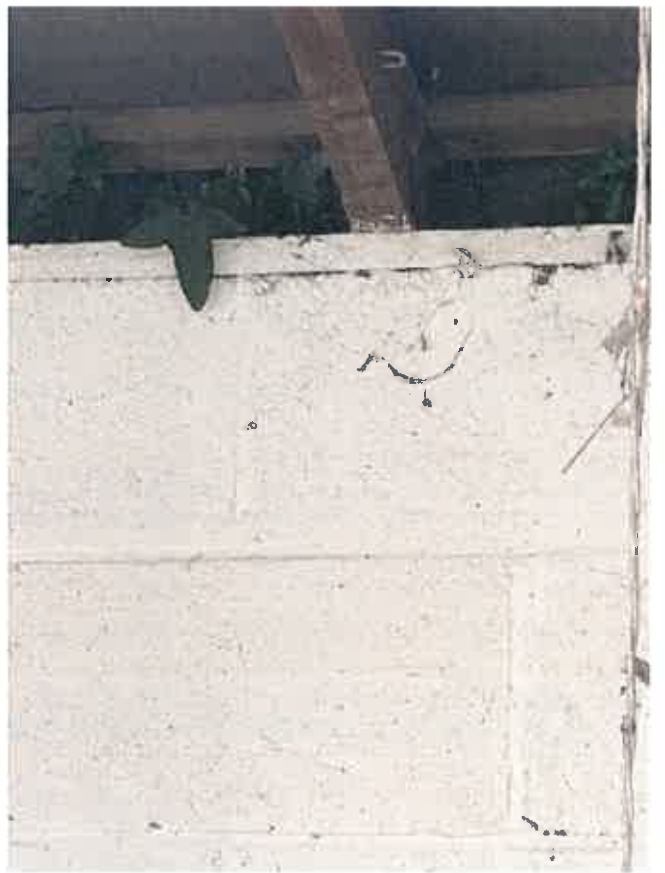
The roof is of simple rafters spanning from a steel ridge to the outer leaf on the front elevation and to the block inner leaf on the rear elevation. Photographs 10, 11 & 12.

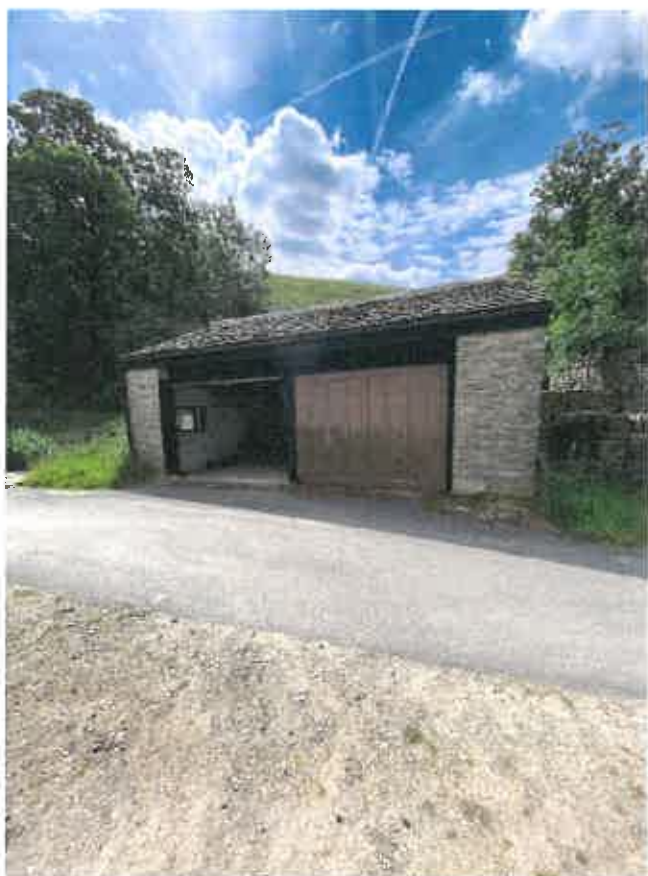
*Photograph 13*

- 2.01** The garage is a two-car garage which fronts Syke Lane. Photograph 13.
- 2.02** The roof is duo pitched front to rear and has a stone slate covering.
- 2.03** The construction of the garage is similar to the Cow Shed. There are random stone outer leaf facings and a blockwork inner leaf. Photographs 14, 15 & 16.
- 2.04** There are openings in the front elevation which comprises of two garage doors. There are single window openings in both the left and right hand gable elevations, photographs 14 & 15.
- 2.05** The rear elevation partially abuts a boundary wall. Photograph 16. The inner blockwork leaf extends higher than this boundary wall. There is no physical access to this area. Photograph 17.

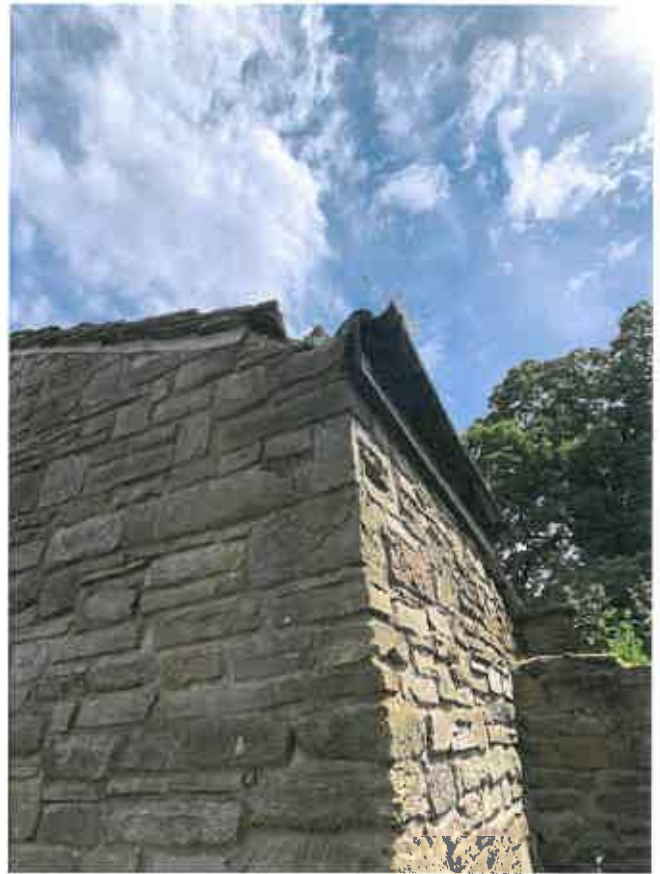
*Photograph 18*

The external walls are of cavity construction. On the three sides which include the two gables and the front, there are stone facings of a random nature. This construction has a short return on the rear right. Photograph 18.

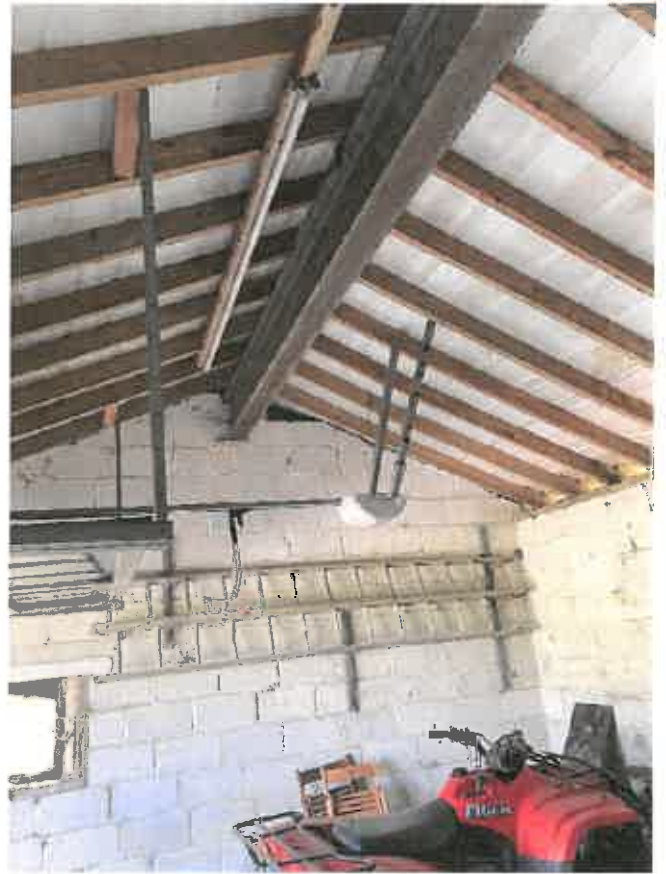
Photograph 26

There is an under-slate felt. Photograph 26.

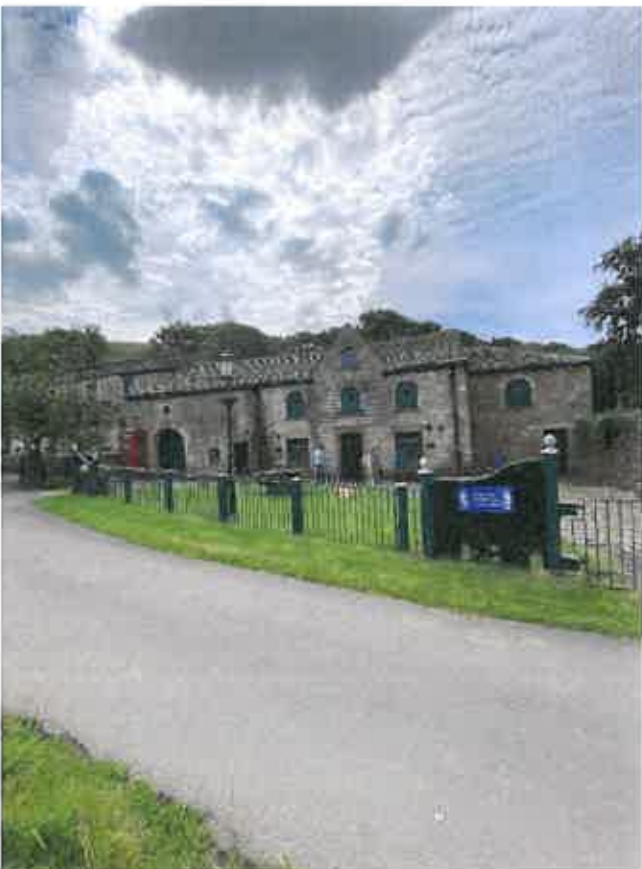
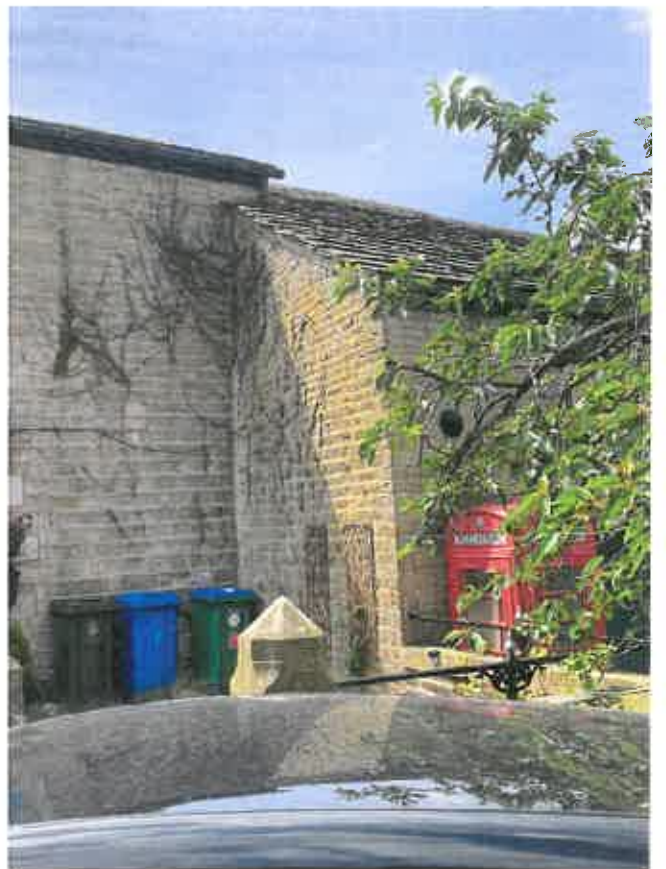
On the left-hand side, the property is partially attached to the farmhouse. Photographs 27 & 28.

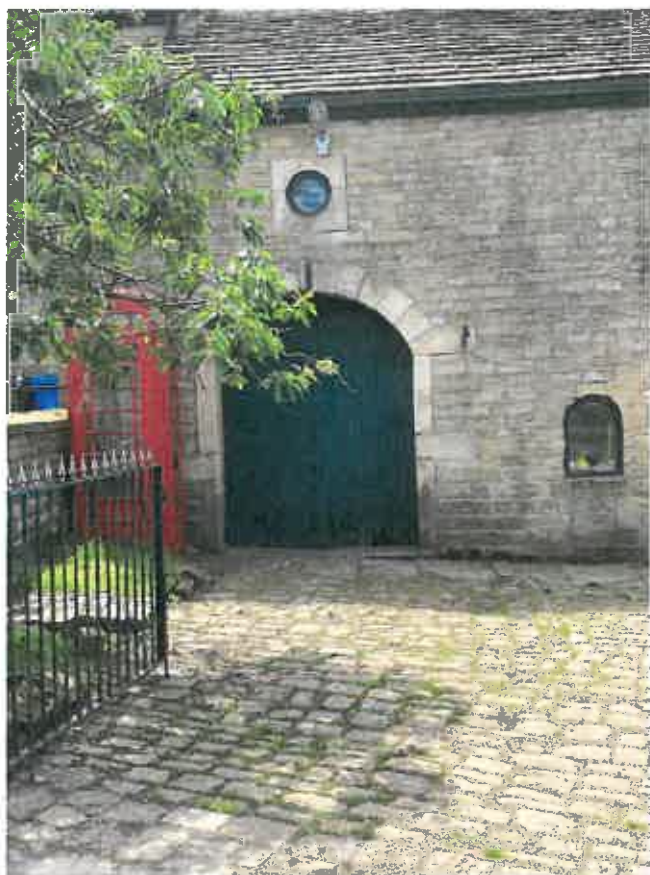
Photograph 29

From the left at ground floor, there is a cart arch set in a coursed stone elevation. Above this is a circular window. Photograph 29. To the right of this is a small arch window with no lintel over and to the right is a door. Photograph 30.

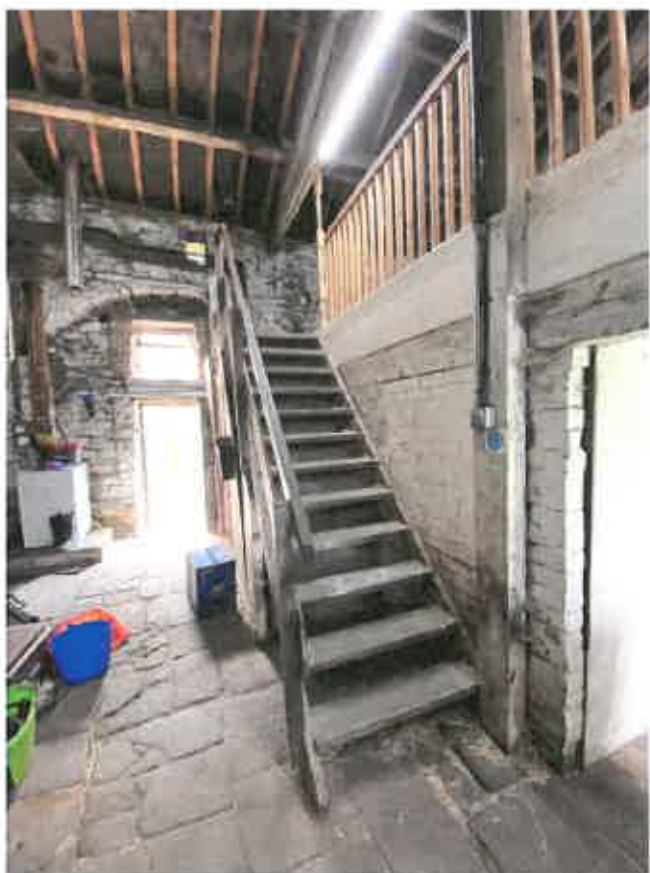
Photograph 31

Immediately to the right of the door is the first of the straight joints. The door on the right leads into a feed store and a tack room at the rear. On the left the cart arch leads into a double height space, in which there is stair access to a hay loft. Photograph 31.

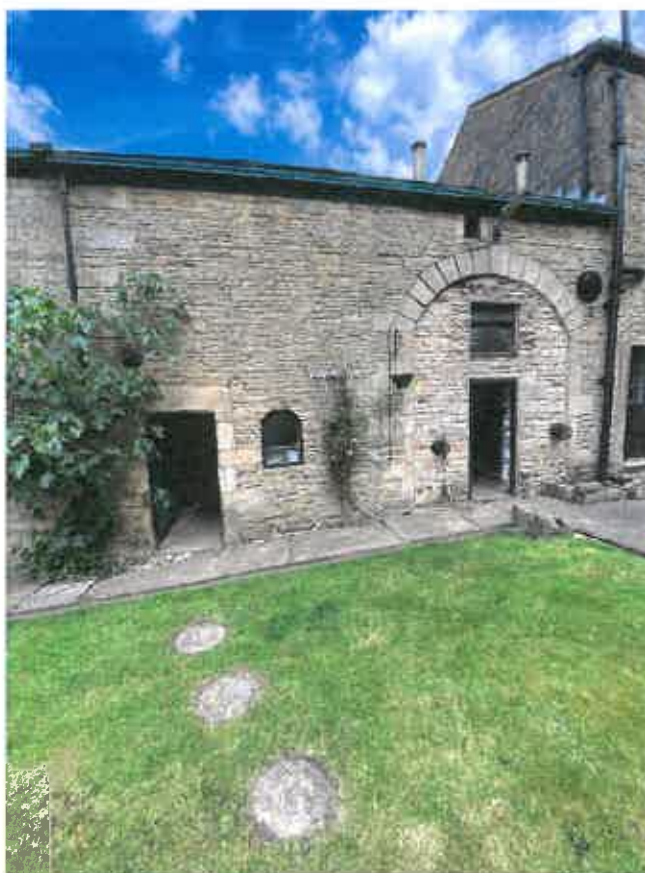
Photograph 32

On the rear elevation of this section. The cart arch has been infilled with a door and a window. To the right of this is a further small arch window and a door mirroring that at the front. Photograph 32. There is a straight joint between this and the next part of the property. There are tie bars and pattresses on the rear elevation of this section. Photographs 33 & 34.

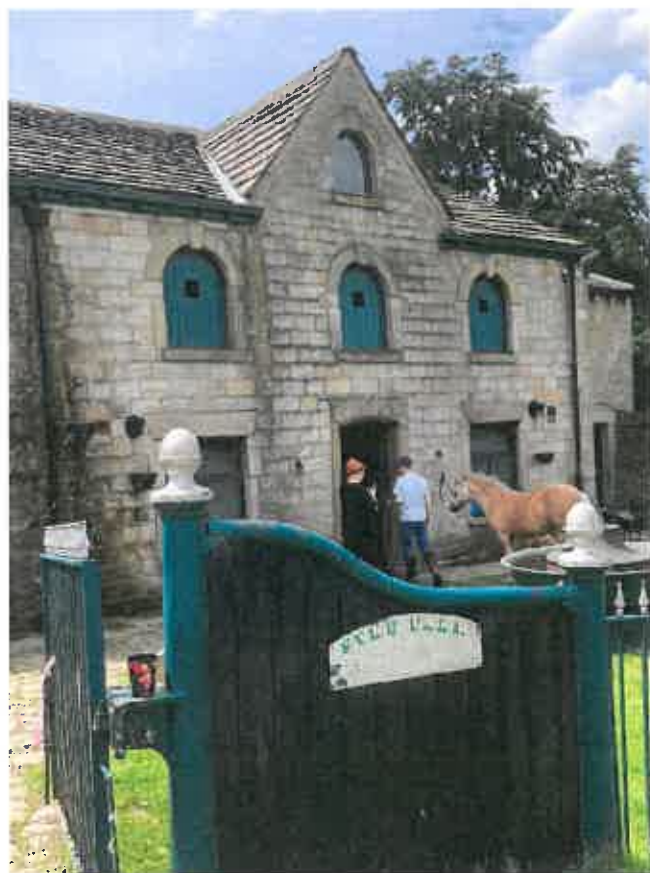
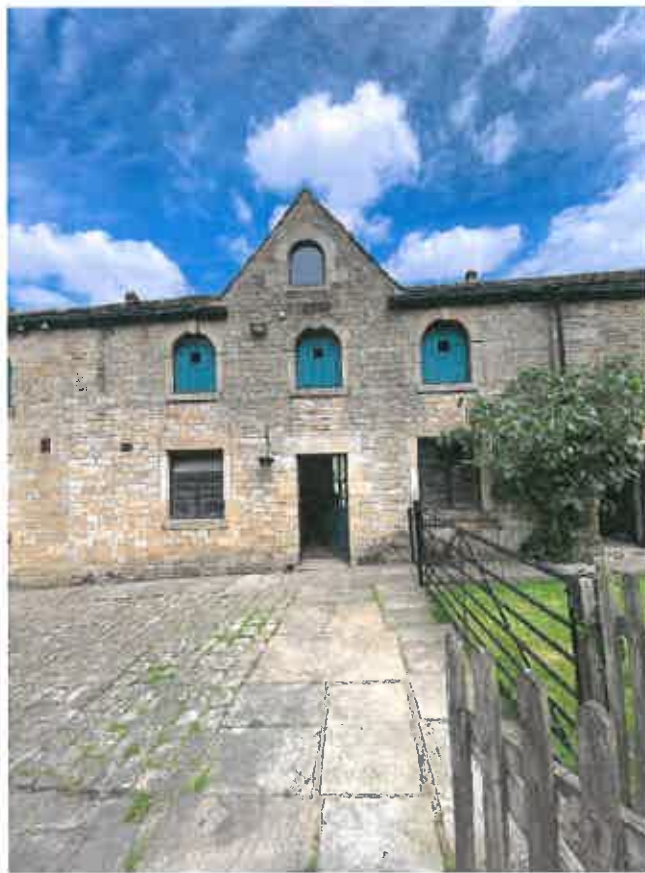
In the central section there are gable pediments to both the front and rear elevations. Photographs 35 & 36. In the front gable pediment, there is a high-level arched window opening and at first floor there are three windows serving a hay loft.

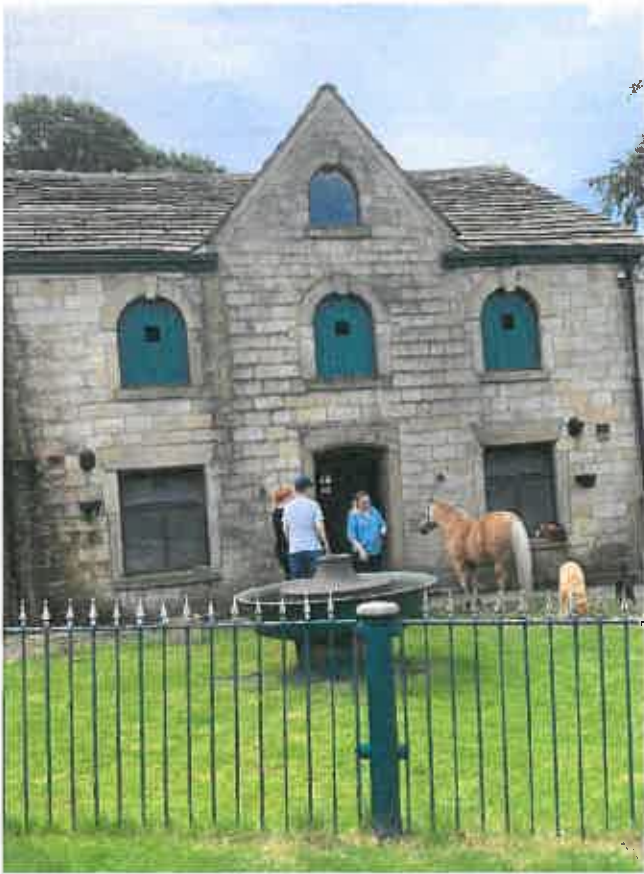
Photograph 37

This elevation is also faced in coursed stone but of a more regular and larger sized stone. Photograph 37.

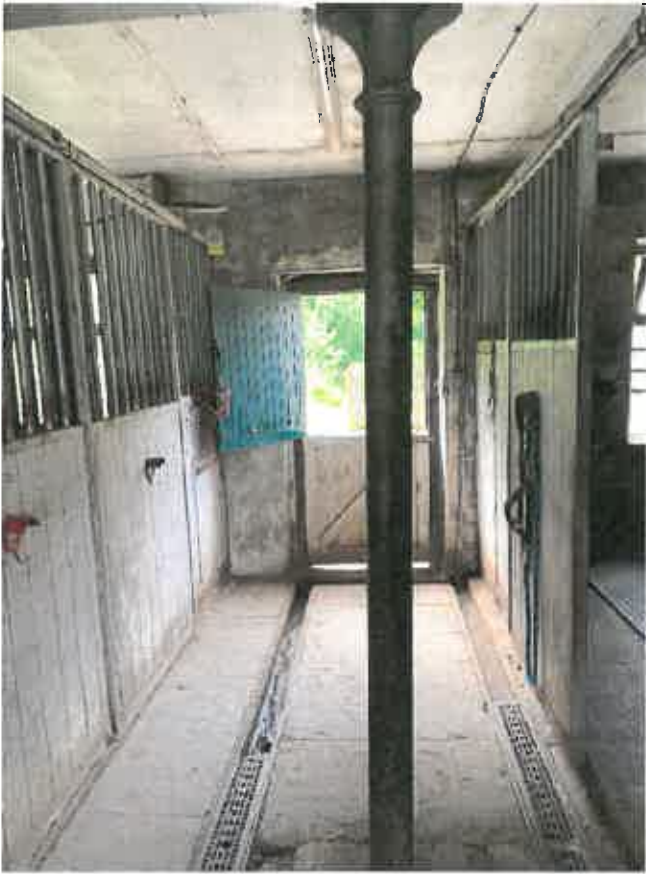
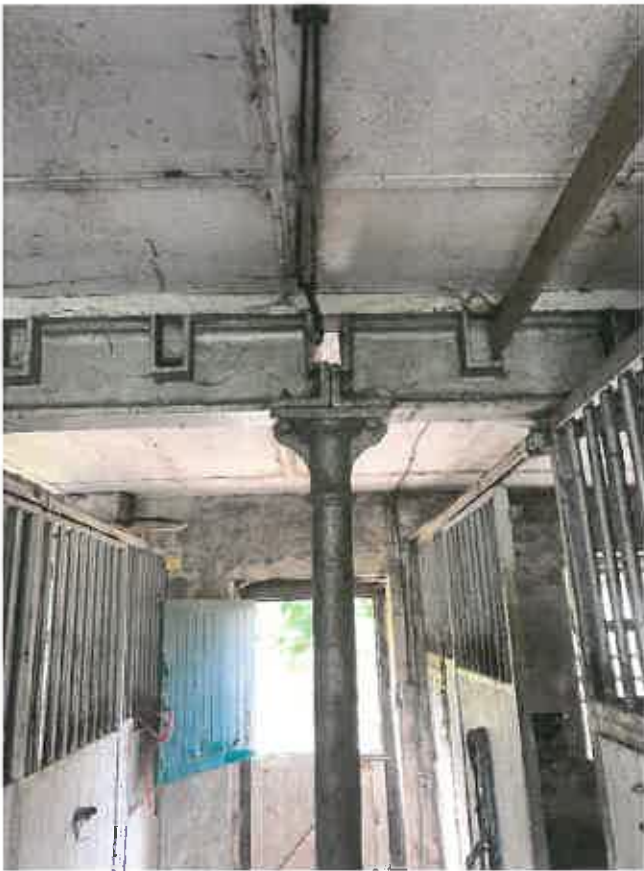
The hay loft is supported by central cast iron columns with substantial wrought iron beams spanning left to right. Timber members span between the beams. Photographs 38 & 39. The rear elevation of this is a mirror image of the front elevation but the stone facings are of a more random size, albeit coursed.

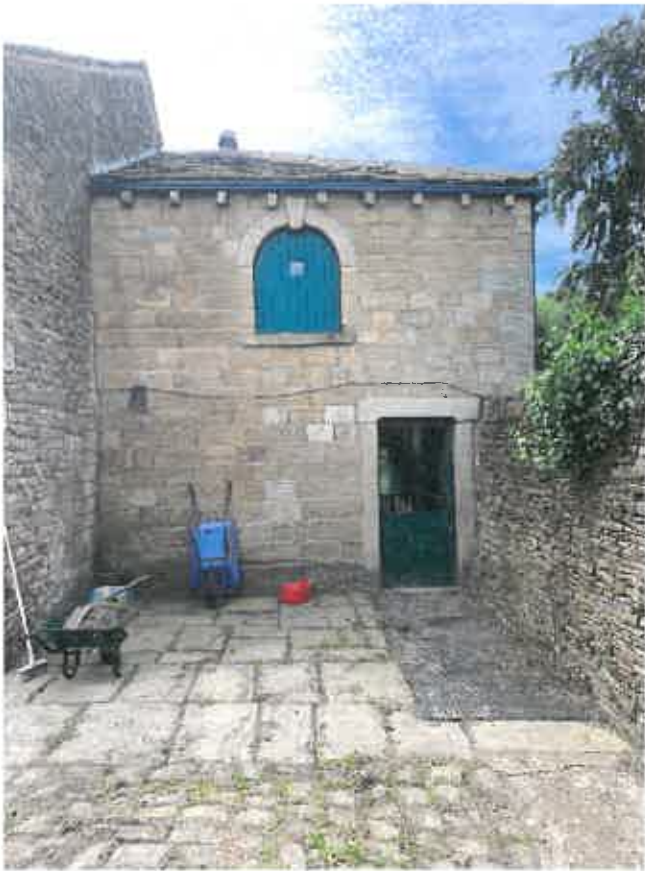
Photograph 40

The front elevation of the right-hand section steps back. Photograph 40. There is a partial gable of the centre section exposed on the left, photograph 41.

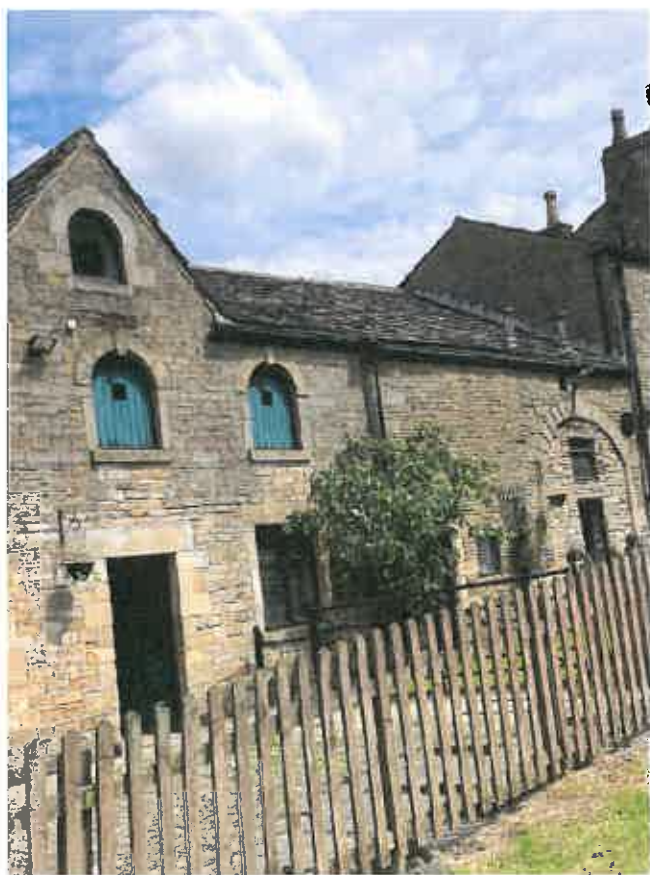
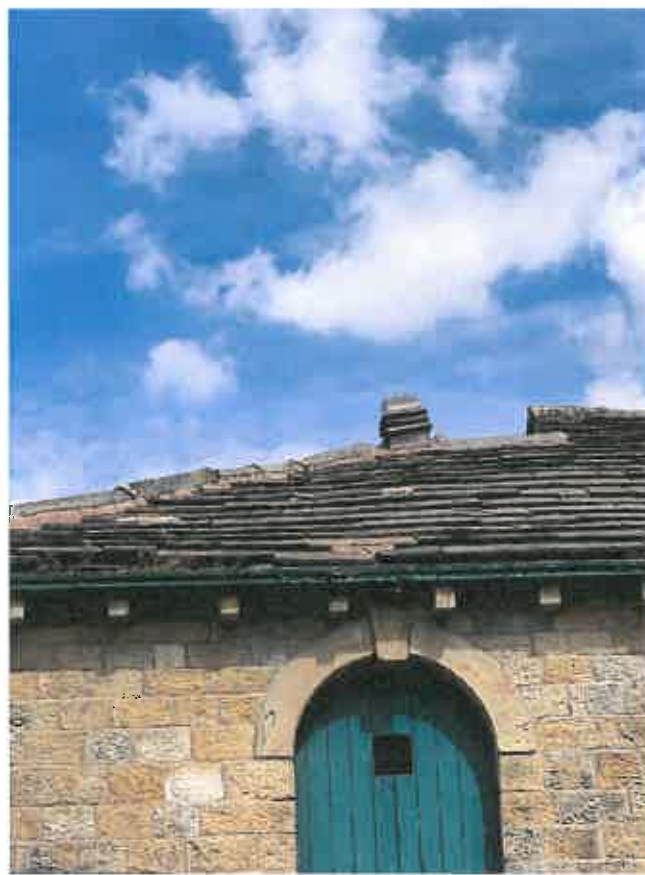
The main roof to both the left-hand side and the central section is duo pitched front to rear and has a stone slate covering. The smaller section on the right-hand end is hipped to the right. Photographs 43 & 44.

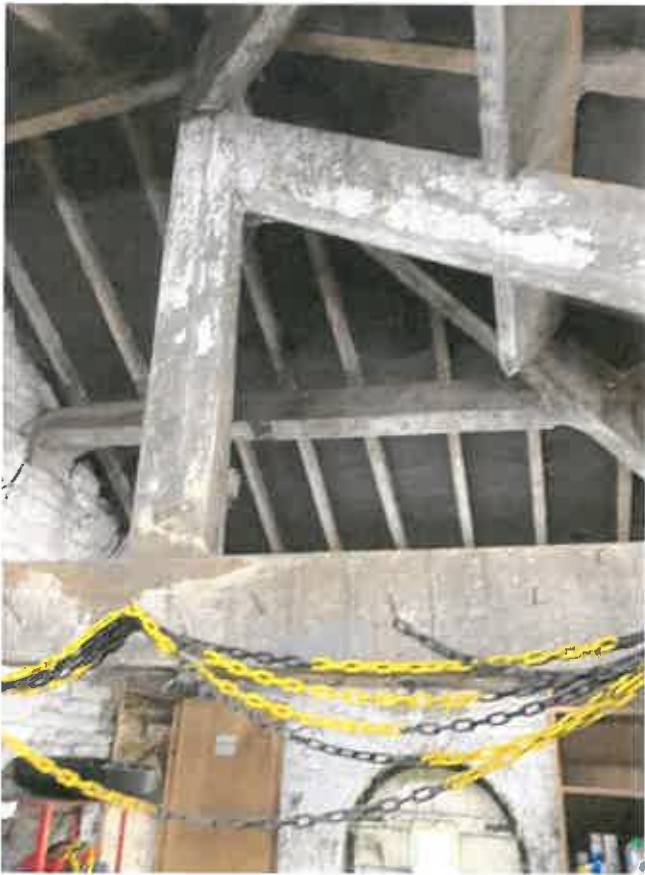
Photograph 61

In the right-hand section, the roof is supported by a mono pitched truss, photographs 61 & 62.

The roof covering has been replaced; we saw no signs of any major issues with this at the time of our survey.

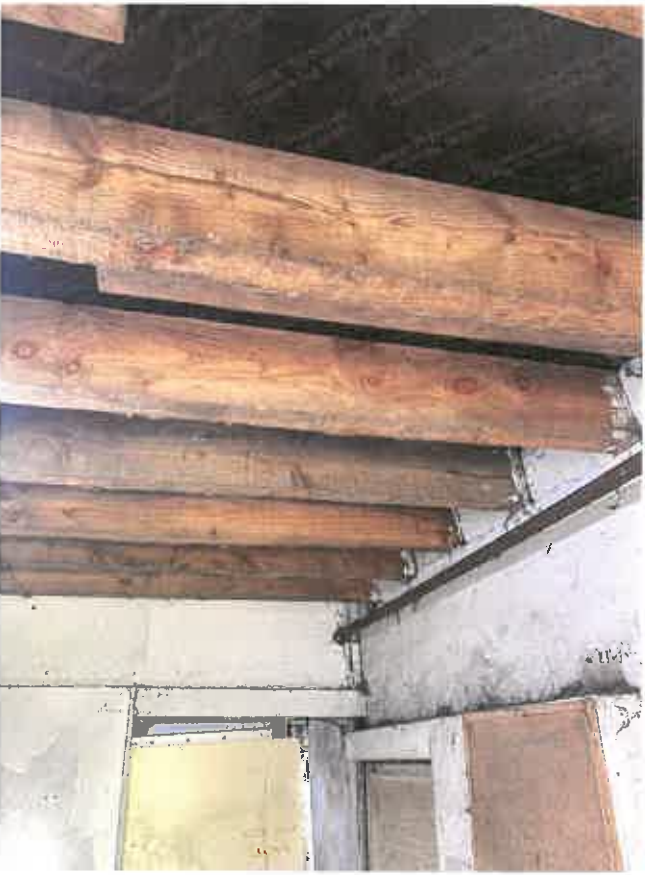
Photograph 63

The hay loft structure is of timber joists, photograph 63.

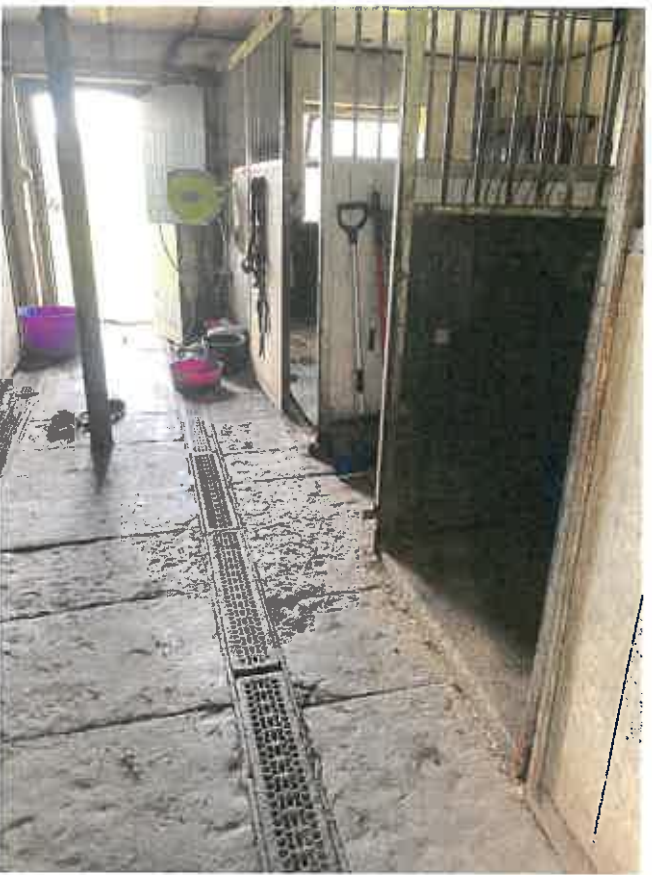
Photograph 64

The ground floor is fit for purpose. Photograph 64.
