# Report regarding the Roofing Works at: The Lower Falinge Development, Rochdale

**Prepared for:** P. Casey & Company Ltd

**Date of Inspection:** Tuesday 12th March 2024

**Reference:** 3749 March 2024

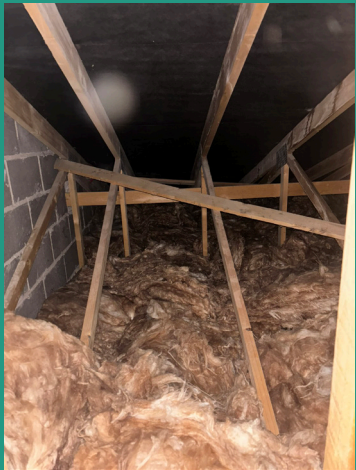
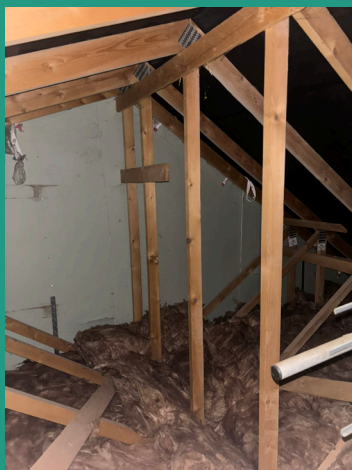
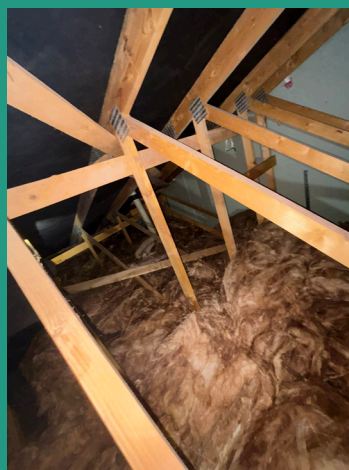
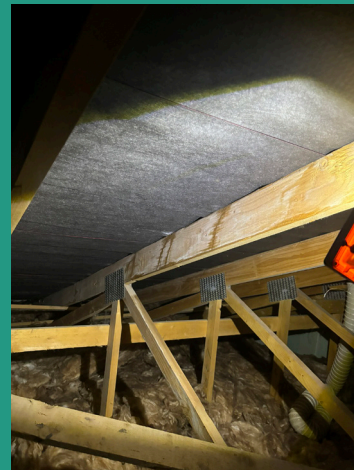
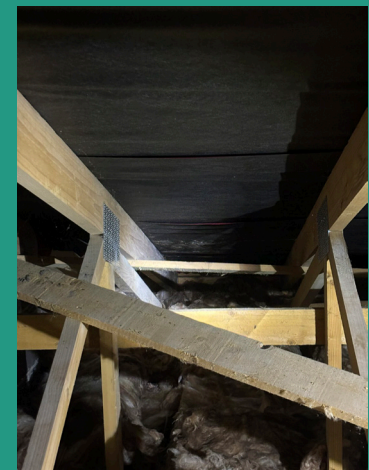
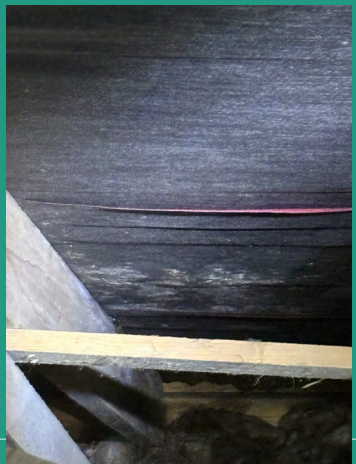
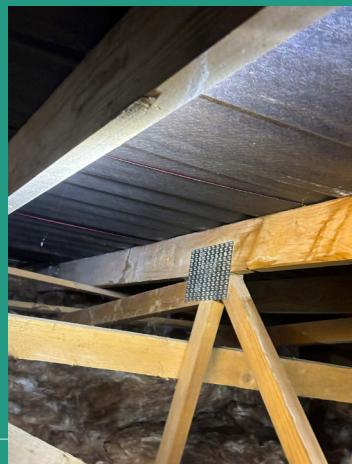
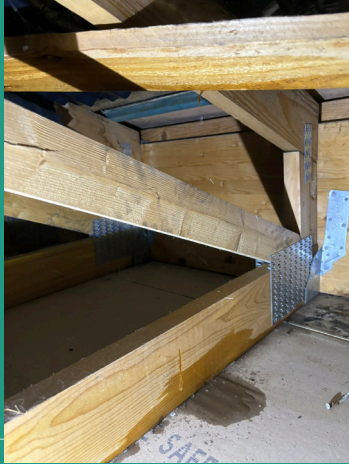
## Typical Loft Access Images

The battens, felt and trusses appear to be in reasonable condition other than the evidence of water ingress.
