| PROJECT | SMP - St Mary's CE Primary School |
| TITLE | Elevation EE - Demolition & Repairs |
| NUMBER | SMP-SEV-XX-XX-DR-A-03014 |

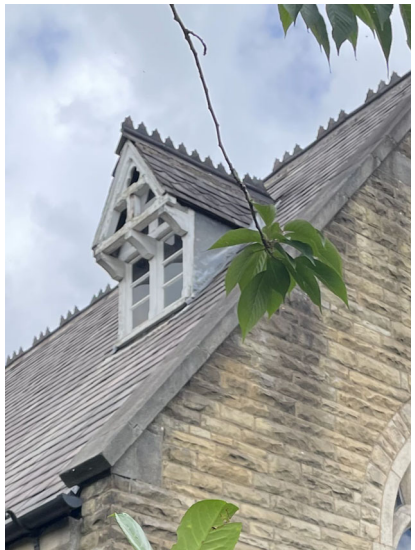
Dormer wood paintwork worn; requires further inspection

Dormer Window: 09 no.  
Splice in new timbers where appropriate. Access to be provided for detailed inspection and methodology agreed. Carefully sand down and repaint in appropriate materials as per the specification. Roofing section per detail F-F in drawing SMP-SEV-XX-XX-DR-A-03105 (Typical Dormer Window)

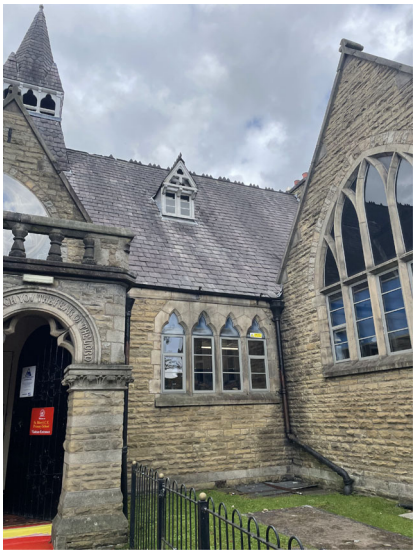
Downpipe rusted; requires sanding down & repainting

Rainwater Goods: 18 no.  
Down-pipe to be removed and replaced with cast-iron rainwater goods allowing for increased diameter (8 inch) to mitigate increased rainfall. Existing cast-iron hoppers to be retained & refurbished where possible. Guttering per detail B-B in drawing SMP-SEV-XX-XX-DR-A-03100 (Typical External Gutter)
