Touchstones Art Gallery, Rochdale  
Alterations and Repairs to Roof Zone 2

Heritage, Design and Access Statement

For Rochdale Development Agency

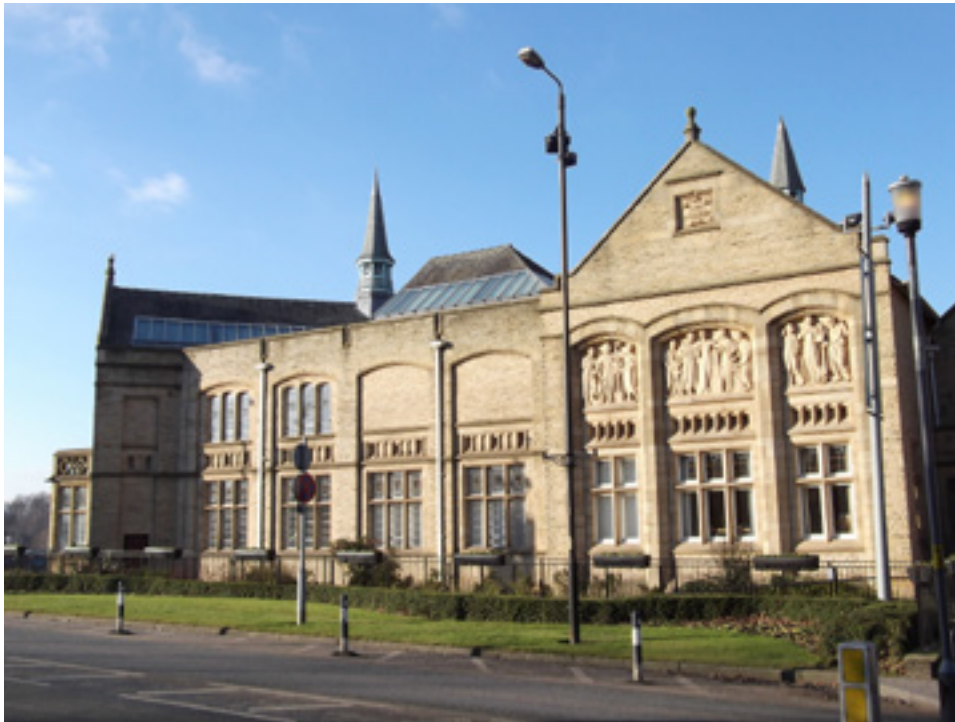
The roof comprises a series of steeply pitched roofs, incorporating a series of gable ends, eaves, rooflights, and fleche ventilators, in keeping with Victorian Gothic and municipal design aesthetics. The variation in height and pitch of different roof sections reflects the building's original internal zoning, which is legible from the exterior. These features break up the mass of the roof and lend it rhythm and architectural character, contributing positively to the building's elevation from The Esplanade [Plates 1.3.1 and 1.3.2].
