Project:
 37 Rochdale Road
 Project Address:
 37 Rochdale Road
 Middleton
 Manchester
 M24 2PT

Drawing Name: Existing (As Found)
Drawing Number: A102
Drawing Date: 07/04/25
Author: B.Rashid. CG.Morrison

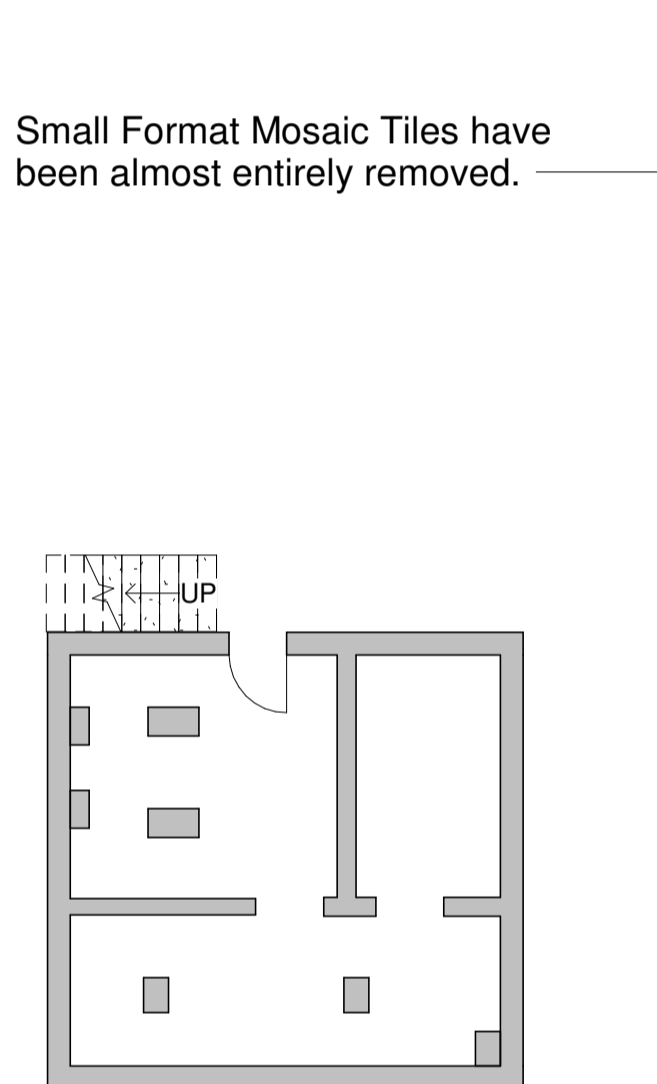
Existing (As Found) Basement
 1 : 100

Small Format Mosaic Tiles have been almost entirely removed.

The structural integrity of the bay window beam requires assessment by a Structural Engineer, including an inspection for rot and potential structural deficiencies.
