## CCTV Inspection Report

**Crimble hall Rochdale OL11 4AD**

**29/07/2025**

# MCC Solutions

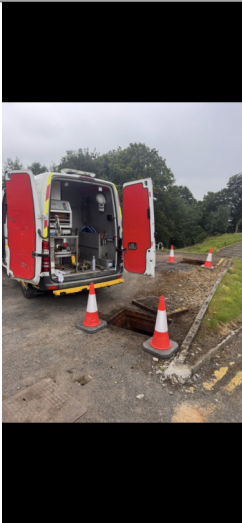
| Job Number<br><b>Crimble Hall</b> | Surveyed by (Operator)<br><b>B McCabe</b> | Base Unit<br><b>DPQFOHMAE5</b> | Date<br><b>29/07/2025</b> |
|---|---|---|---|
| <p><b>Manhole / Access Point: MH 02 Location</b></p> | | <p><b>Manhole / Access Point: MH 02 Internal</b></p> | |

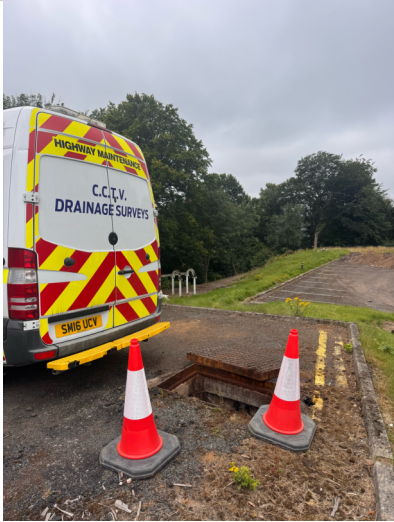
| Job Number<br><b>Crimble Hall</b> | Surveyed by (Operator)<br><b>B McCabe</b> | Base Unit<br><b>DPQFOHMAE5</b> | Date<br><b>29/07/2025</b> |
|---|---|---|---|
| <p><b>Manhole / Access Point: MH 03 Location</b></p> | | <p><b>Manhole / Access Point: MH 03 Internal</b></p> | |

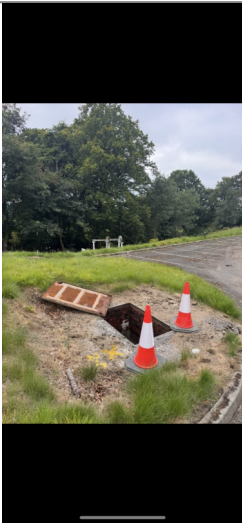
| Job Number<br><b>Crimble Hall</b> | Surveyed by (Operator)<br><b>B McCabe</b> | Base Unit<br><b>DPQFOHMAE5</b> | Date<br><b>29/07/2025</b> |
|---|---|---|---|
| <p><b>Manhole / Access Point: PUMP STATION Location</b></p> | | <p><b>Manhole / Access Point: PUMP STATION Internal</b></p> | |

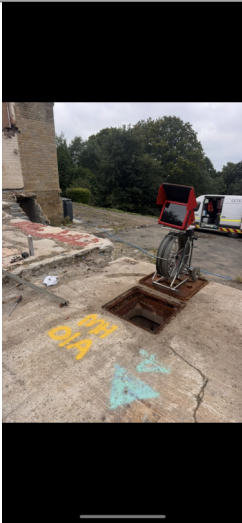
| Job Number<br><b>Crimble Hall</b> | Surveyed by (Operator)<br><b>B McCabe</b> | Base Unit<br><b>DPQFOHMAE5</b> | Date<br><b>29/07/2025</b> |
|---|---|---|---|
| <p><b>Manhole / Access Point: MH01A Location</b></p> | | <p><b>Manhole / Access Point: MH 01 Internal</b></p> | |

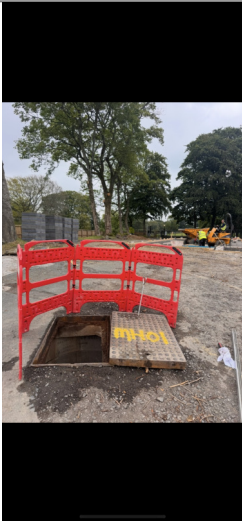
| Job Number<br><b>Crimble Hall</b> | Surveyed by (Operator)<br><b>B McCabe</b> | Base Unit<br><b>DPQFOHMAE5</b> | Date<br><b>29/07/2025</b> |
|---|---|---|---|
| <p><b>Manhole / Access Point: MH 01 Location</b></p> | | <p><b>Other Site Photos: The line from the pump station</b></p> | |

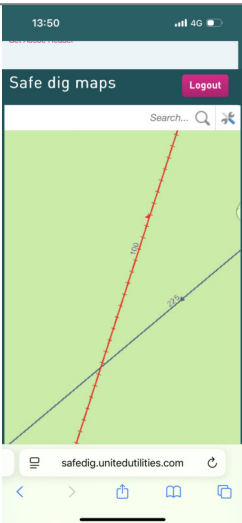
| Job Number<br><b>Crimble Hall</b> | Surveyed by (Operator)<br><b>B McCabe</b> | Base Unit<br><b>DPQFOHMAE5</b> | Date<br><b>29/07/2025</b> |
|---|---|---|---|
| <p><b>Other Site Photos: Line from the pump station</b></p> | | <p><b>Other Site Photos: Line drops into the UU manhole on bury rd</b></p> | |

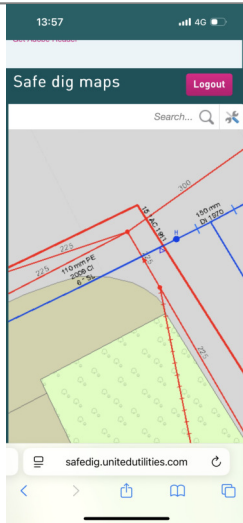
**Other Site Photos:** The location of the manhole the pumpstation joins into

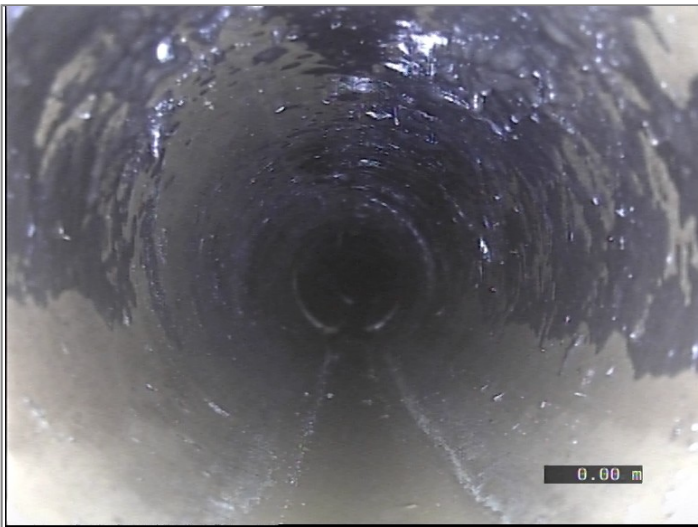
| Job Number<br>Crimble Hall | Surveyed by (Operator)<br>B McCabe | Base Unit<br>DPQFOHMAE5 | Date<br>29/07/2025 |
|---|---|---|---|
| <p>Start node type, manhole, reference MH 02</p> | | <p>Water level 5% height/diameter</p> | |

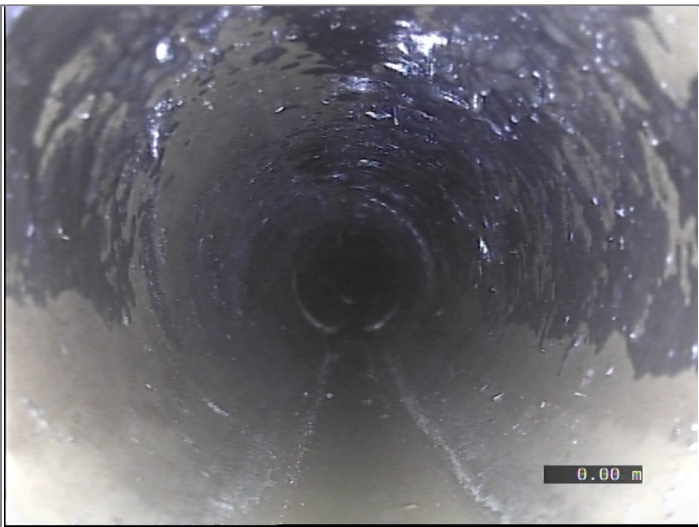
| Position | Code | Description | Photo | Type/Grade |
|---|---|---|---|---|
| 0.00 | WL | Water level 5% height/diameter | 12725691 | Comment / 0 |

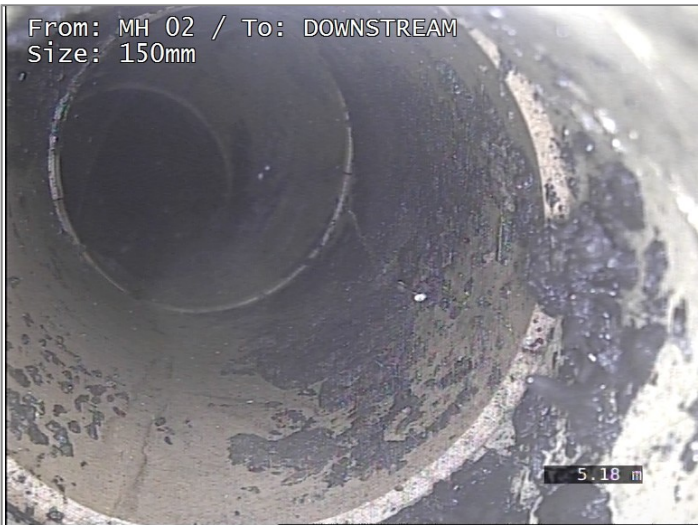
| Position | Code | Description | Photo | Type/Grade |
|---|---|---|---|---|
| 5.18 | JN | Junction at 10 o'clock, diameter 100mm | 12725721 | Comment / 0 |

| Job Number<br><b>Crimble Hall</b> | Surveyed by (Operator)<br><b>B McCabe</b> | Base Unit<br><b>DPQFOHMAE5</b> | Date<br><b>29/07/2025</b> |
|---|---|---|---|
| <div> <div> From: MH 02 / To: DOWNSTREAM<br/>Size: 150mm </div> <div>Junction at 10 o'clock, diameter 100mm</div> </div> <div> <div> From: MH 02 / To: DOWNSTREAM<br/>Size: 150mm </div> <div>Cracks multiple from 5 to 11 o'clock, at joint</div> </div> | | | |

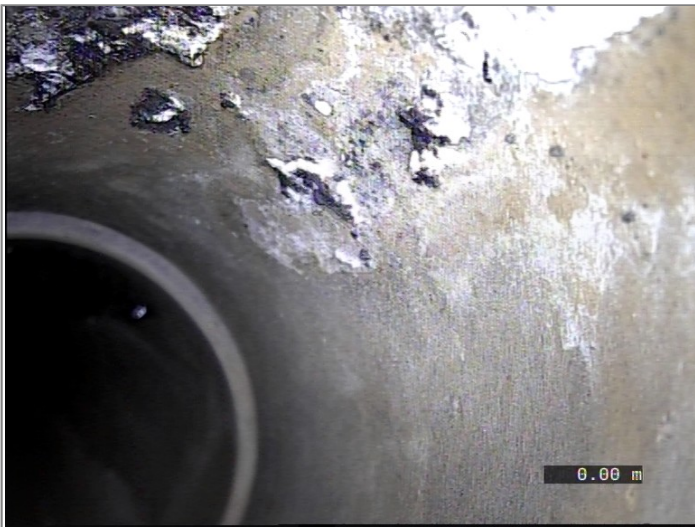
| Job Number<br>Crimble Hall | Surveyed by (Operator)<br>B McCabe | Base Unit<br>DPQFOHMAE5 | Date<br>29/07/2025 |
|---|---|---|---|
| <p>Start node type, manhole, reference MH 03</p> | | | |

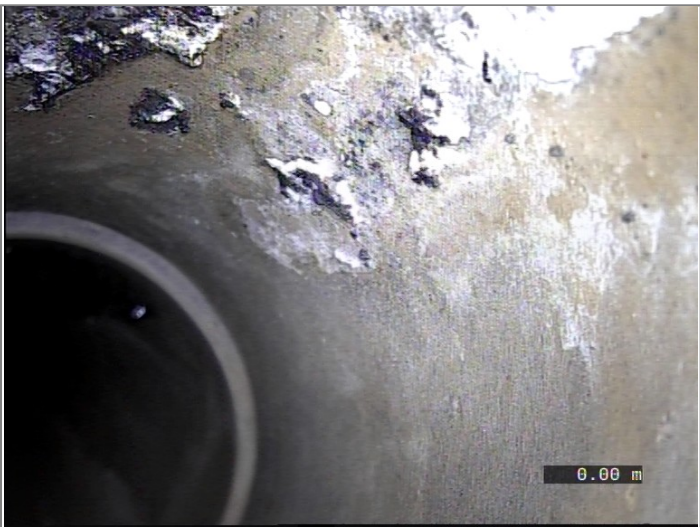
| Job Number<br>Crimble Hall | Surveyed by (Operator)<br>B McCabe | Base Unit<br>DPQFOHMAE5 | Date<br>29/07/2025 |
|---|---|---|---|
| <p>Water level 5% height/diameter</p> | | | |

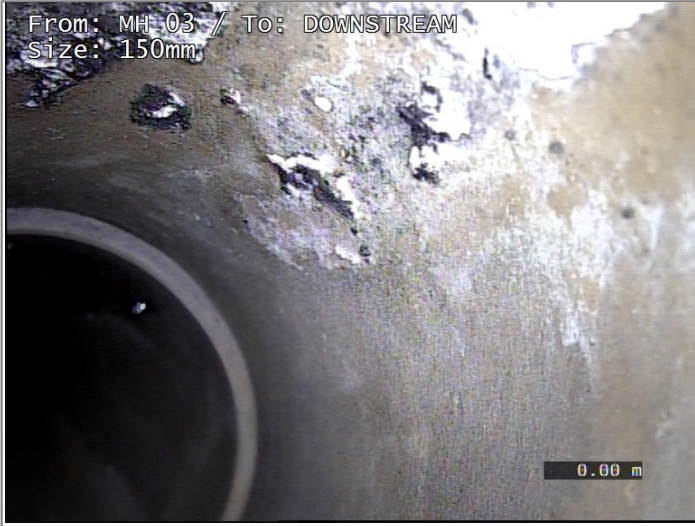
| Job Number<br>Crimble Hall | Surveyed by (Operator)<br>B McCabe | Base Unit<br>DPQFOHMAE5 | Date<br>29/07/2025 |
|---|---|---|---|
| <p>Line of drain/sewer deviates left</p> | | | |

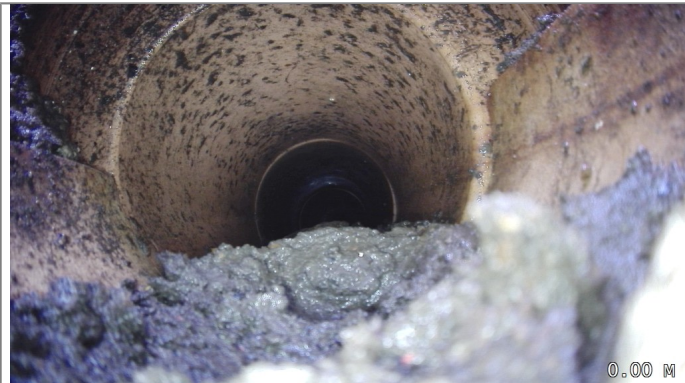
| Job Number<br>Crimble Hall | Surveyed by (Operator)<br>B McCabe | Base Unit<br>DPQFOHMAE5 | Date<br>29/07/2025 |
|---|---|---|---|
| <p>0.00 M</p> <p>Start node type, manhole, reference MH01A</p> | | <p>0.00 M</p> <p>Water level 5% height/diameter</p> | |

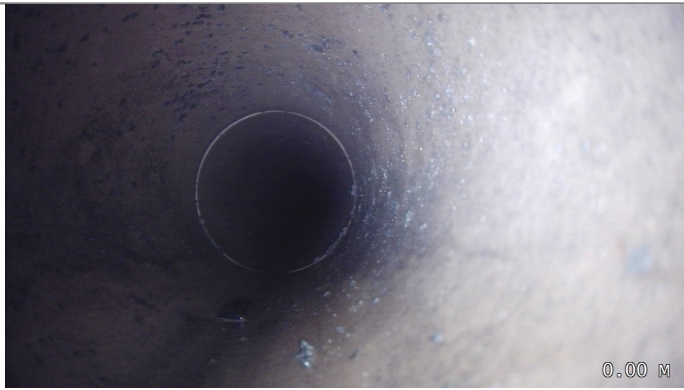
| Job Number<br>Crimble Hall | Surveyed by (Operator)<br>B McCabe | Base Unit<br>DPQFOHMAE5 | Date<br>29/07/2025 |
|---|---|---|---|
| <p>0.00 M</p> <p>Start node type, manhole, reference MH 01</p> | | <p>0.00 M</p> <p>Water level 5% height/diameter</p> | |

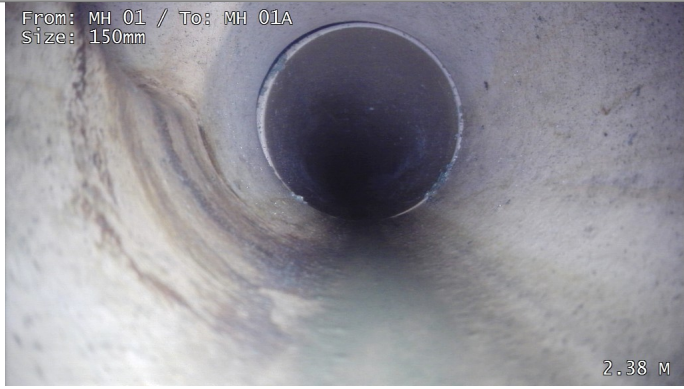
| Job Number<br>Crimble Hall | Surveyed by (Operator)<br>B McCabe | Base Unit<br>DPQFOHMAE5 | Date<br>29/07/2025 |
|---|---|---|---|
| <p>From: MH 01 / To: MH 01A<br/>Size: 150mm</p> <p>2.38 M</p> <p>Junction at 9 o'clock, diameter 100mm</p> | | <p>From: MH 01 / To: MH 01A<br/>Size: 150mm</p> <p>6.50 M</p> <p>Crack circumferential from 1 to 11 o'clock</p> | |

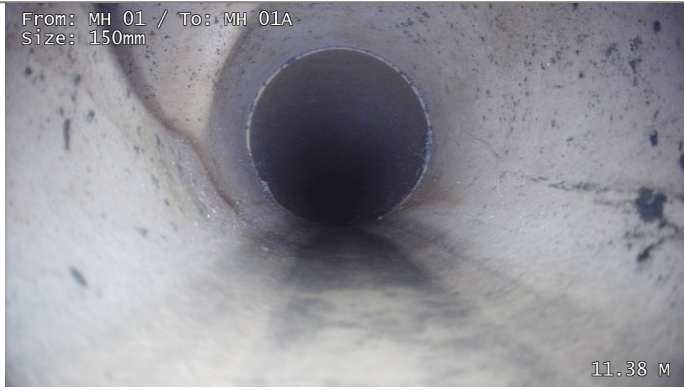
| Job Number<br>Crimble Hall | Surveyed by (Operator)<br>B McCabe | Base Unit<br>DPQFOHMAE5 | Date<br>29/07/2025 |
|---|---|---|---|
| <p>From: MH 01 / To: MH 01A<br/>Size: 150mm</p> <p>11.38 M</p> <p>Junction at 9 o'clock, diameter 100mm</p> | | <p>From: MH 01 / To: MH 01A<br/>Size: 150mm</p> <p>14.62 M</p> <p>Junction at 6 o'clock, diameter 150mm</p> | |

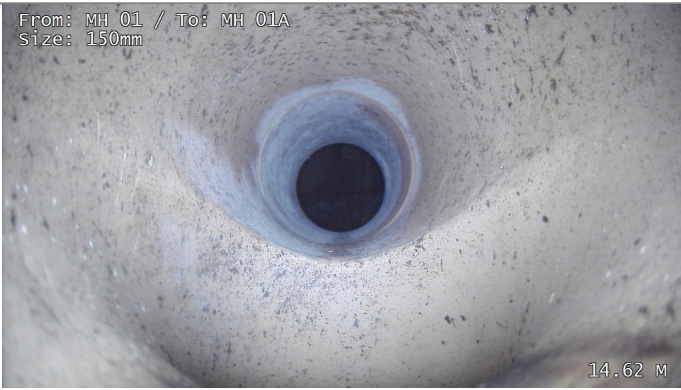
| Job Number<br><b>Crimble Hall</b> | Surveyed by (Operator)<br><b>B McCabe</b> | Base Unit<br><b>DPQFOHMAE5</b> | Date<br><b>29/07/2025</b> |
|---|---|---|---|
| <p>From: MH 01 / To: MH 01A<br/>Size: 150mm</p> <p>14.62 M</p> <p>DROPSHAFT INTO MH 01A</p> | | <p>From: MH 01 / To: MH 01A<br/>Size: 150mm</p> <p>14.62 M</p> <p>Finish node type, manhole, reference MH 01A</p> | |
