| PROJECT | SMP - St Mary's CE Primary School |
| TITLE | Elevation DD - Demolition & Repairs |
| NUMBER | SMP-SEV-XX-XX-DR-A-03013 |

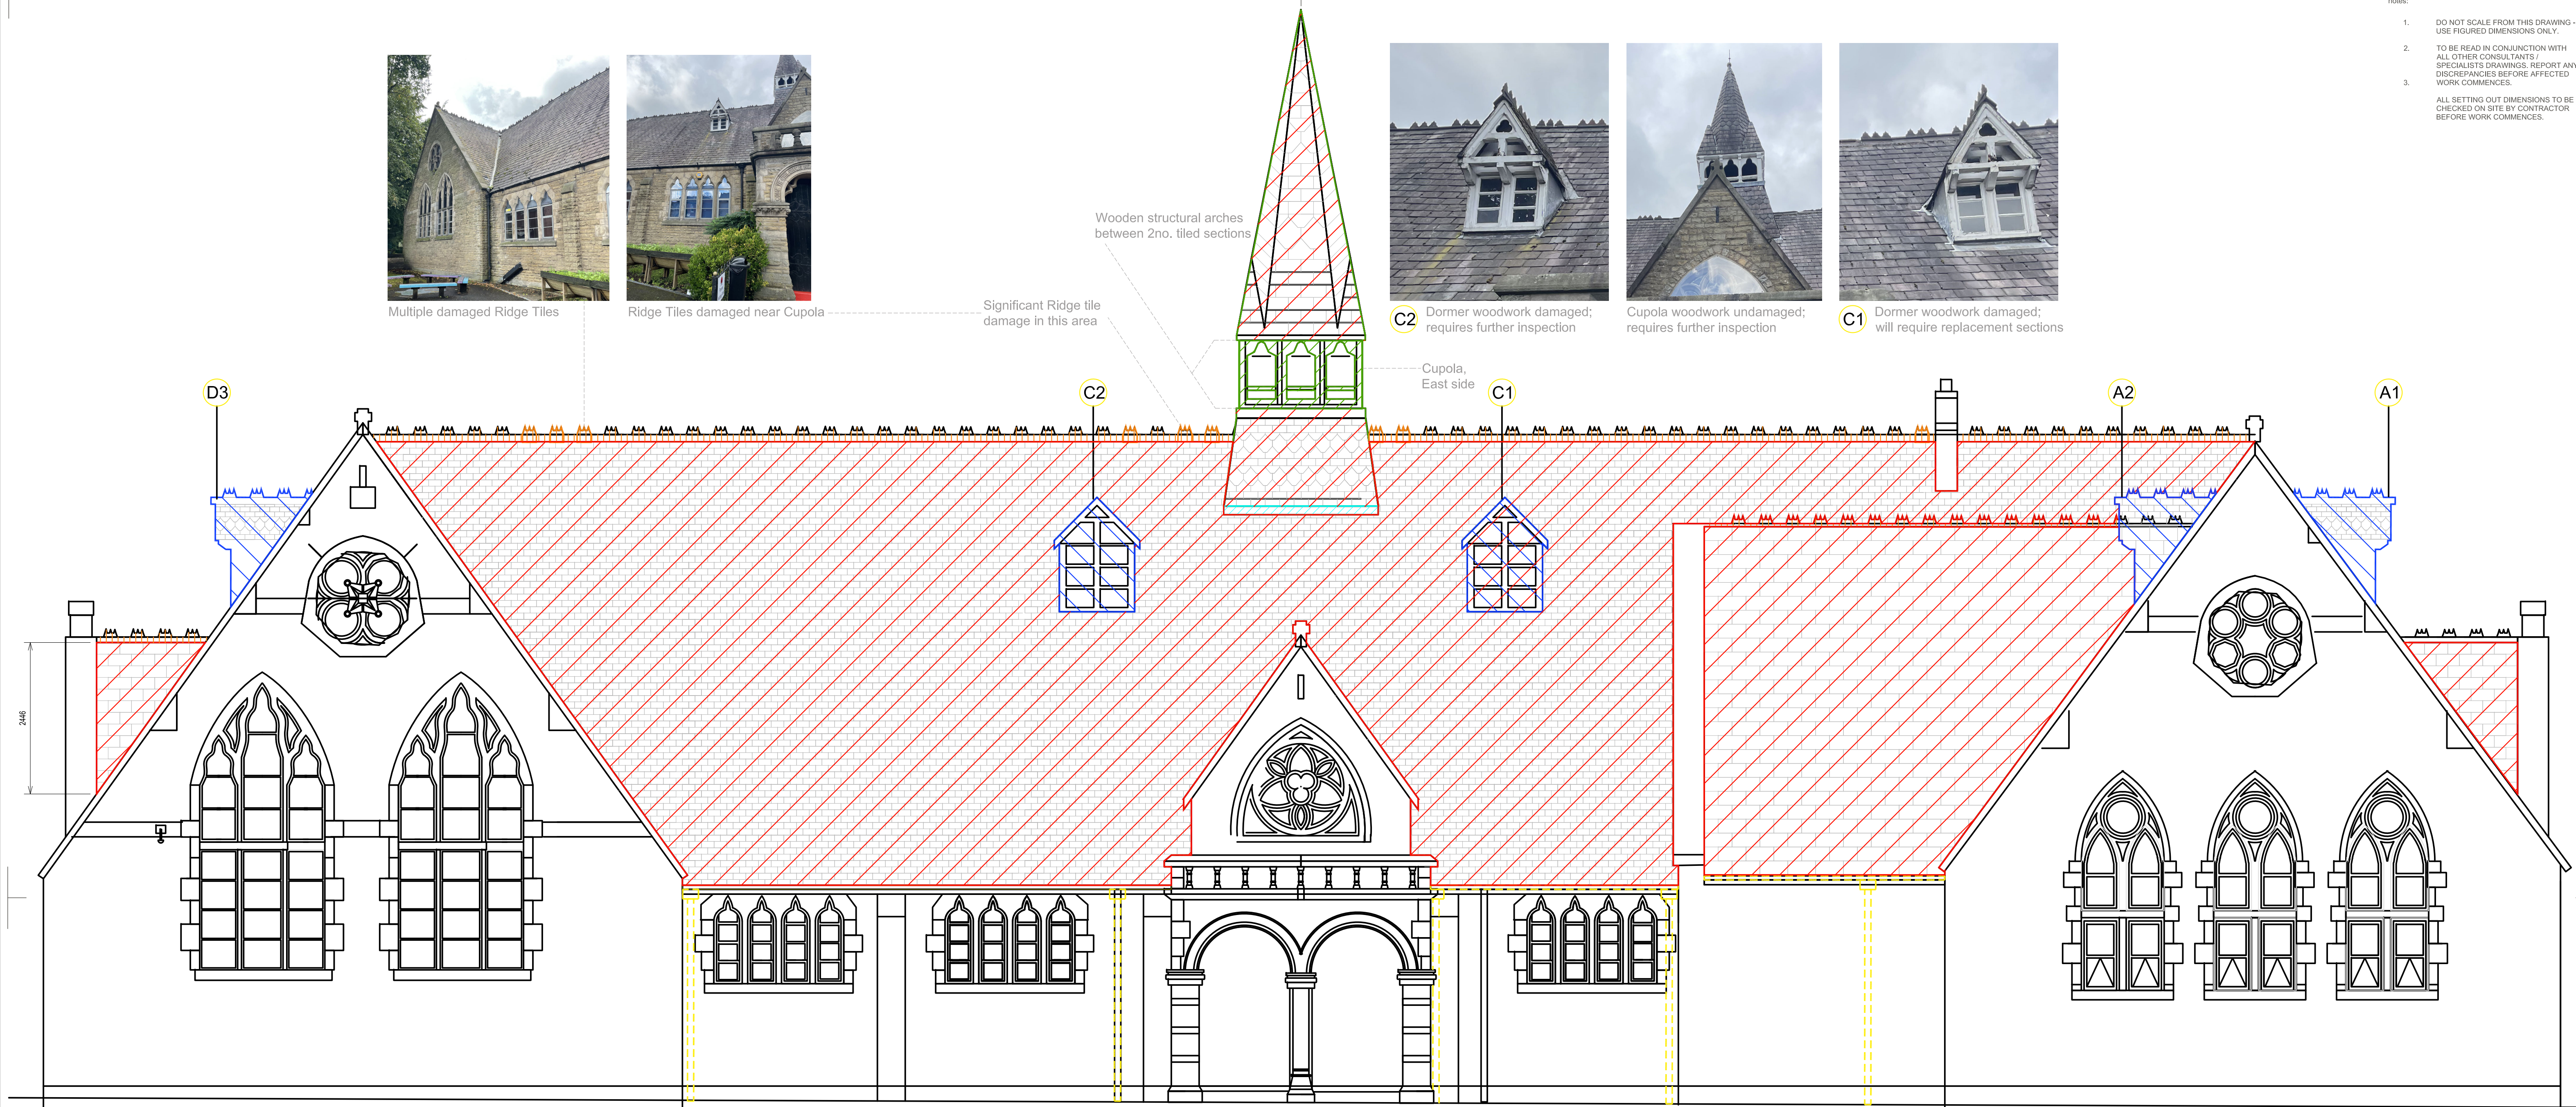
Elevation DD

Multiple damaged Ridge Tiles

Ridge Tiles damaged near Cupola

Significant Ridge tile damage in this area

C2 Dormer wooden damaged; requires further inspection

Cupola, East side  
Cupola wooden undamaged; requires further inspection

C1 Dormer wooden damaged; will require replacement sections

Dormer Window: 09 no.  
Splice in new timbers where appropriate. Access to be provided for detailed inspection and methodology agreed. Carefully sand down and repaint in appropriate materials as per the specification. Roofing section per detail F-F in drawing SMP-SEV-XX-XX-DR-A-03105 (Typical Dormer Window)

Decorative Ridge Tiles: 105 Lm  
Ridge tiles to be removed and set aside with salvaged tiles for re-use. Replace damaged tiles as per the existing style. Ridge ventilation provided with new linear vent. Ridge venting per detail F-F in drawing SMP-SEV-XX-XX-DR-A-03105 (Typical Dormer Window)
