# TIMBER DORMER SCHEDULE

Client: Rochdale Borough Council  
Project: St Mary's CE Primary School  
Reference: SMP-SEV-ZZ-XX-RP-A-04001  
Date: August | 2024

| DOCUMENT TITLE | TIMBER DORMER SCHEDULE |

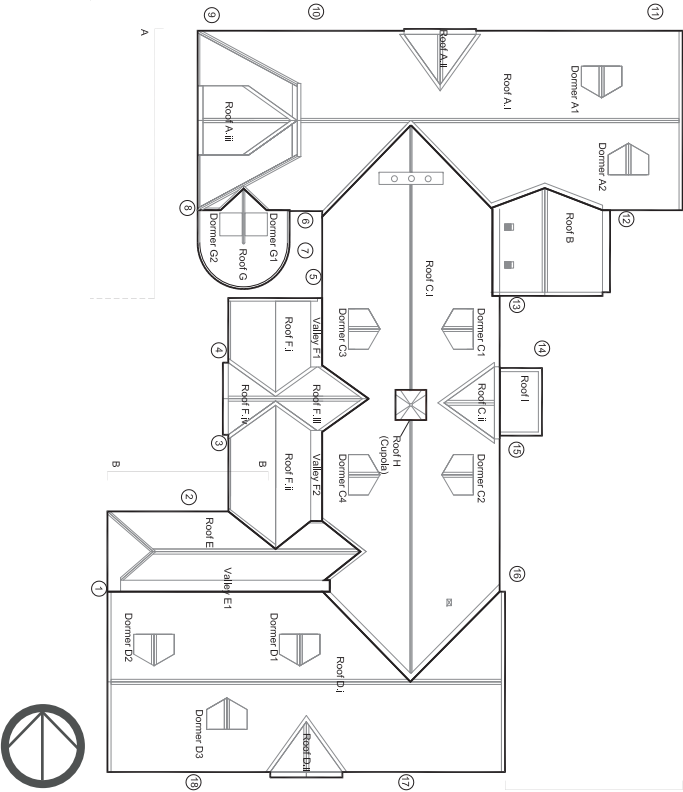
| Reference/ Element | Location | Proposals |
|---|---|---|
| | Dormer D3<br>Roof Di | Dormer has been removed in order to be repaired off site in the workshop.<br><br>All areas highlighted in red are rotten and need to be replaced. Splice repairs to each section with materials to match the existing.<br><br>All paintwork to be carefully sanded back and repainted as per the restoration specification. |

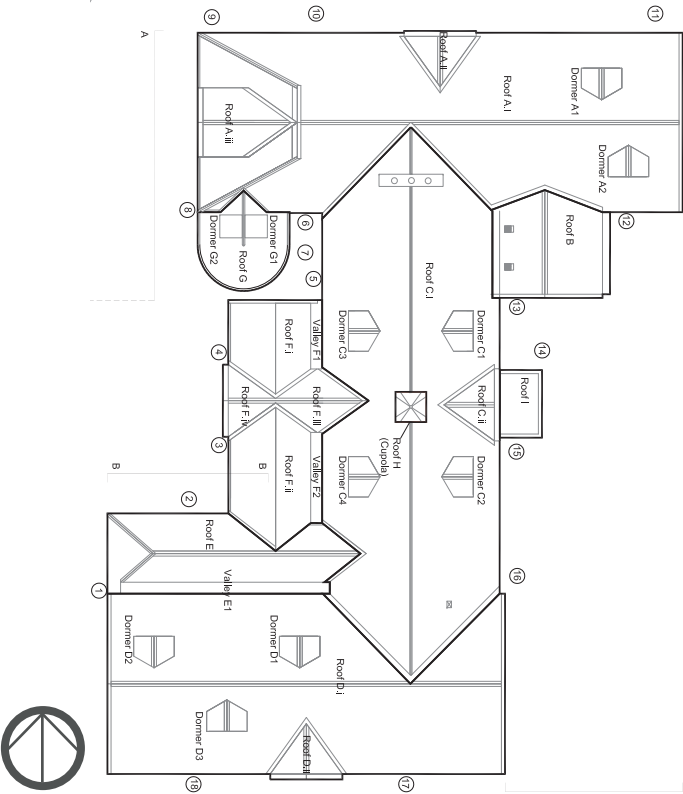
| Reference/ Element | Location | Proposals |
|---|---|---|
| | Dormer C2<br>Roof Ci | Full replacement required. |

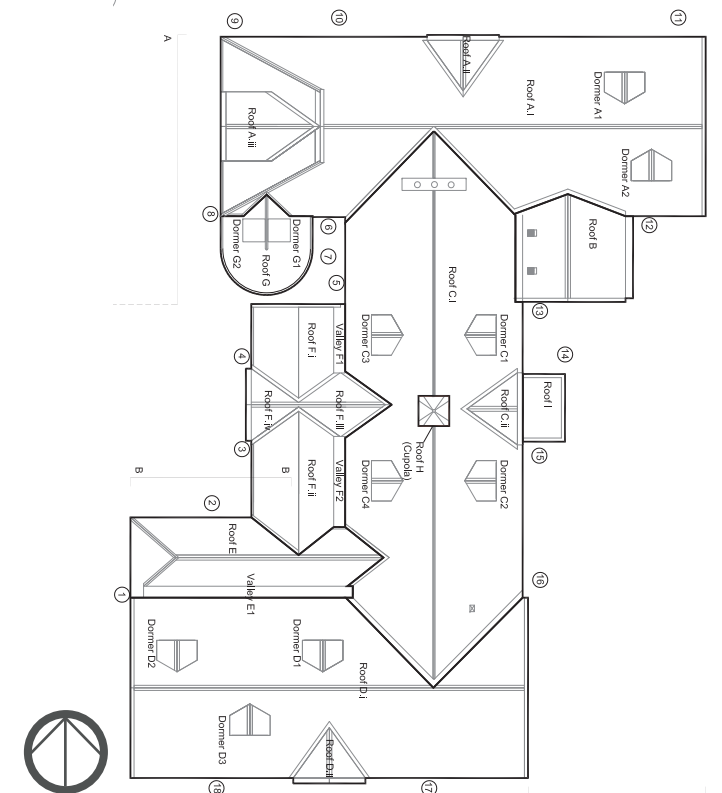
| Reference/ Element | Location | Proposals |
|---|---|---|
| | Dormer C4<br>Roof Ci | <p>All areas highlighted in red are rotten and need to be replaced. Splice repairs to each section with materials to match the existing.</p> <p>All paintwork to be carefully sanded back and repainted as per the restoration specification.</p> |

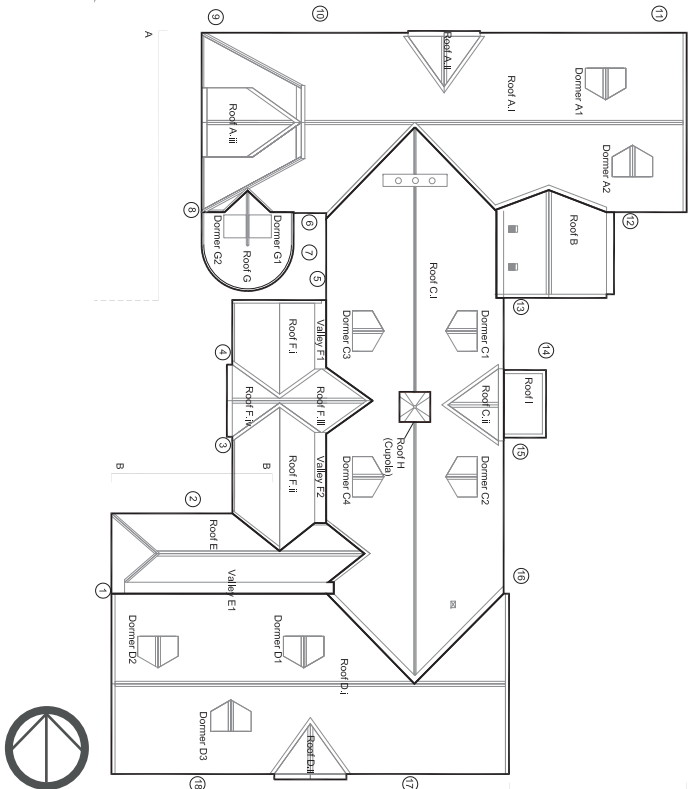
| Reference/ Element | | Location | Proposals |
|---|---|---|---|
| | | Dormer<br>G2<br>Roof G | Full replacement required. |

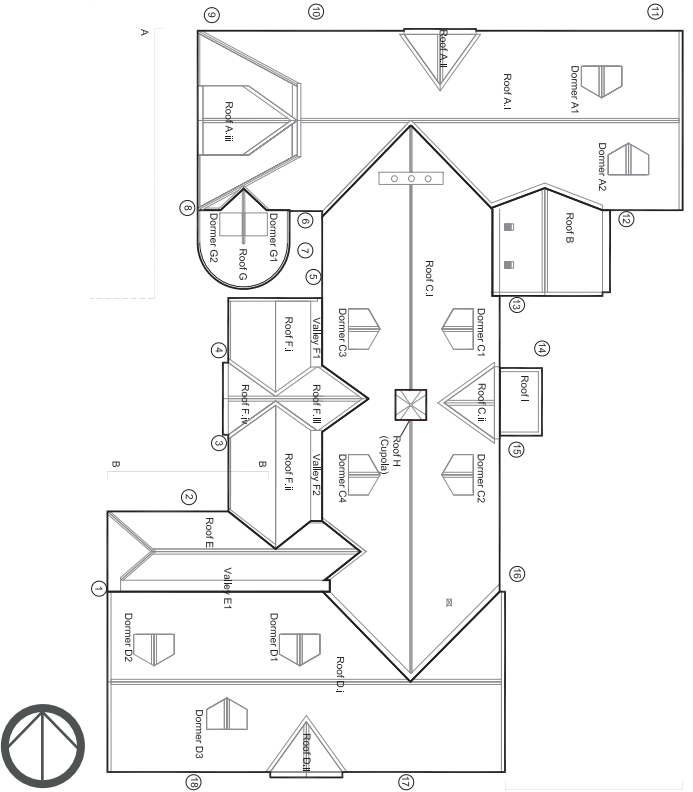
Lead roof looks to be on good condition and does not require renewal. All wraps to timber ends should be in lead.

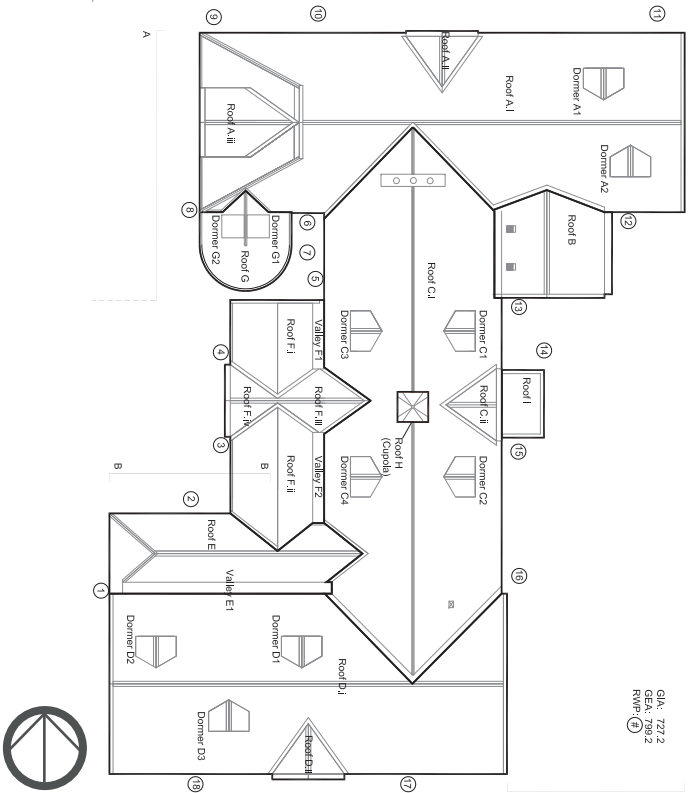
| Reference/ Element | Location | Proposals |
|---|---|---|
| <br><br><br> | Cupola<br>East<br>Flank | <p>All areas highlighted in red are rotten and need to be replaced. Splice repairs to each section with materials to match the existing.</p> <p>All paintwork to be carefully sanded back and repainted as per the restoration specification.</p> |

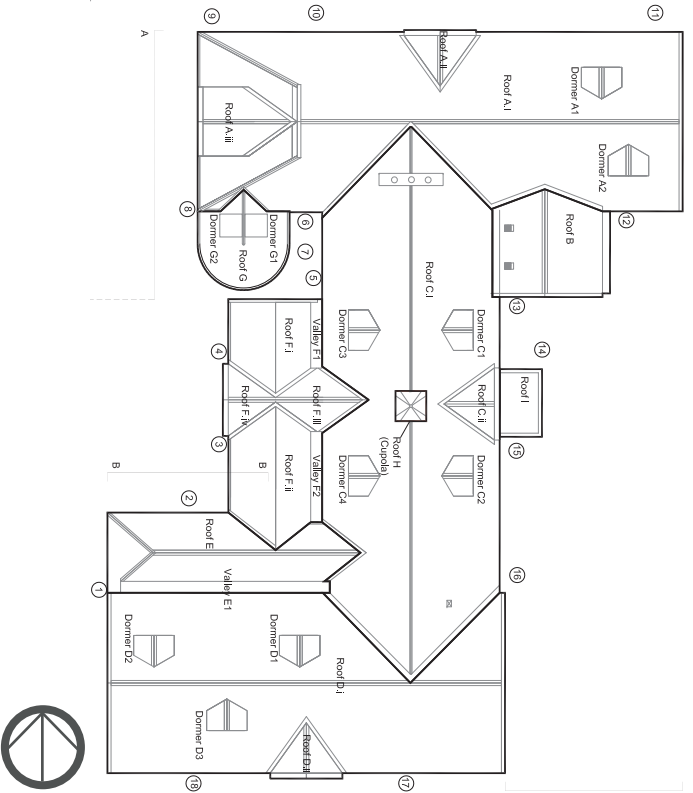
| Reference/ Element | Location | Proposals |
|---|---|---|
| | Cupola<br>West Flank | <p>All areas highlighted in red are rotten and need to be replaced. Splice repairs to each section with materials to match the existing.</p> <p>The area in yellow is an existing splice detail however the joint to the old and new is not flush and requires sanding to exactly match to stop water tracking into the joint.</p> <p>All paintwork to be carefully sanded back and repainted as per the restoration specification.</p> |
