## STRUCTURAL ENGINEER'S REPORT

37 Rochdale Road  
Middleton  
M24 2PT

Contract No: 12489  
Dated: October 2024

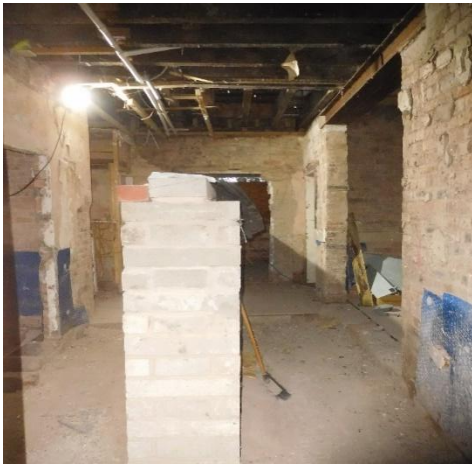
4.2.1 Alterations had commenced to the ground floor layout. At the time of our inspection a blockwork wall had been constructed through the length of the hallway and into the rear room; the wall was built to a height of approximately 1500mm above floor level; circulation gaps had been left at each end. The floor in the hallway was overlaid with board so the nature and condition of the floor could not be seen.

Front end of dividing wall in hallway

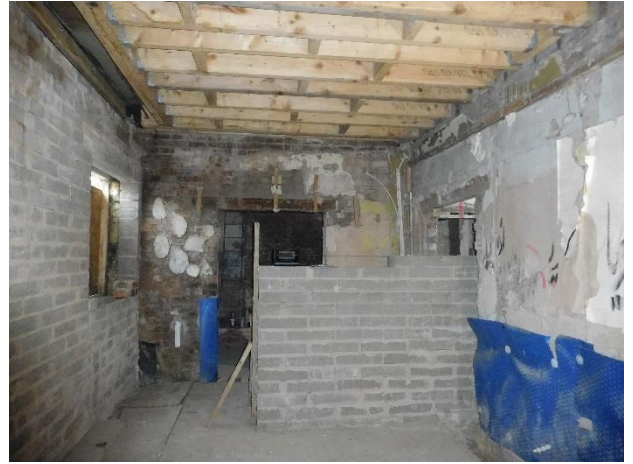
Rear end of dividing wall in rear room

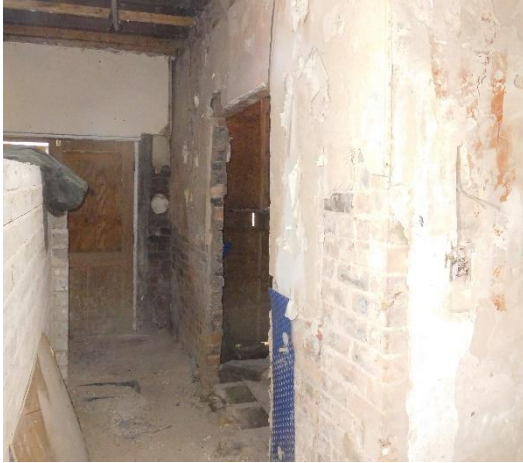
4.2.3 The doorway into the front lefthand room had been extended to form a wide opening from the hallway; a softwood lintel had been installed above this opening. The bay window in the front elevation had been dismantled. A number of the bricks were stored on the floor but these did not appear to be sufficient for the extent of masonry taken down. A timber bressummer beam spanned over the bay window opening supporting the floor above; it was not possible to confirm the condition of the bearing ends of the beam.

Opening into front lefthand room

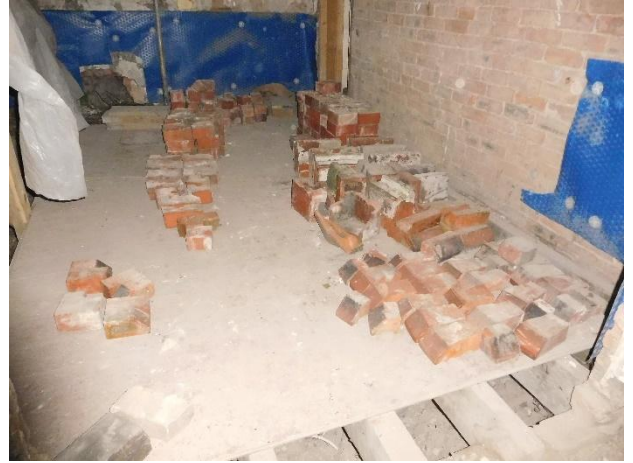
Masonry from bay window stored on floor

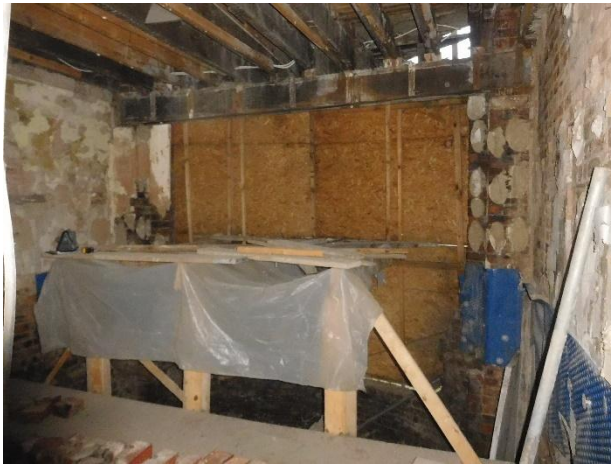
4.2.4 The floor in this room had been removed over the front portion of the room; the joists spanned from side to side and it could be seen that a number of the floor joists towards the front of the room were suffering from wet rot at their bearing ends. The exposed over-site visible where the floor had been removed did not show any clear evidence of disturbance.

Front elevation where bay has been dismantled

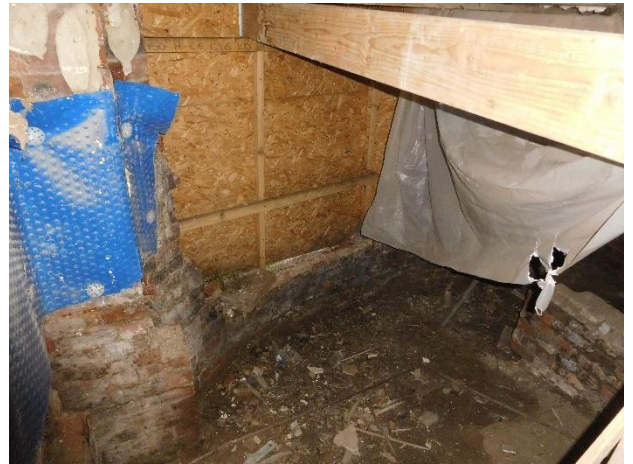
Undisturbed over-site

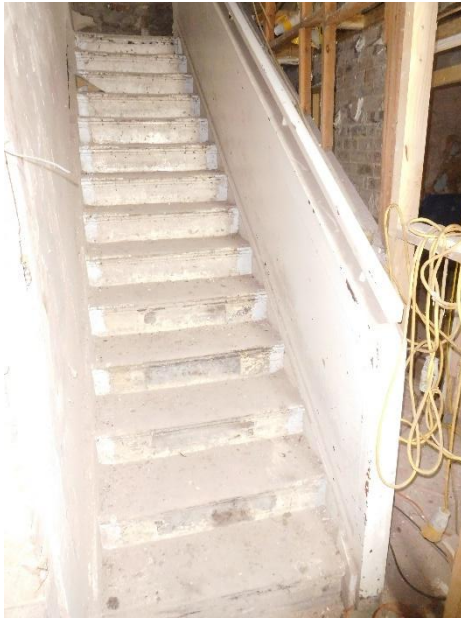
The stair was located to the rear of the front lefthand reception room. The stairs rose up to second floor level and would have also extended down to basement level. The stair appeared utilitarian but the evidence of where the carpet had run up the centre of the stair is indicative of the stairs being original. The balustrade was boarded over but may contain some hidden original features. The stairs appeared to generally be in a reasonable condition with just a few treads suffering from deterioration which will require their replacement.

Stair from ground up to half landing

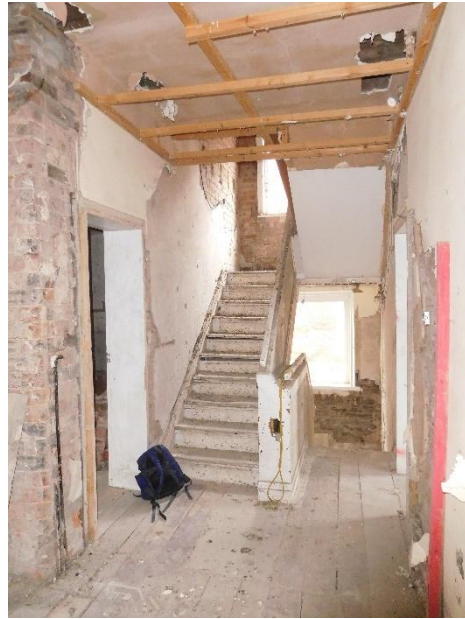
Stair from first floor up to next half landing

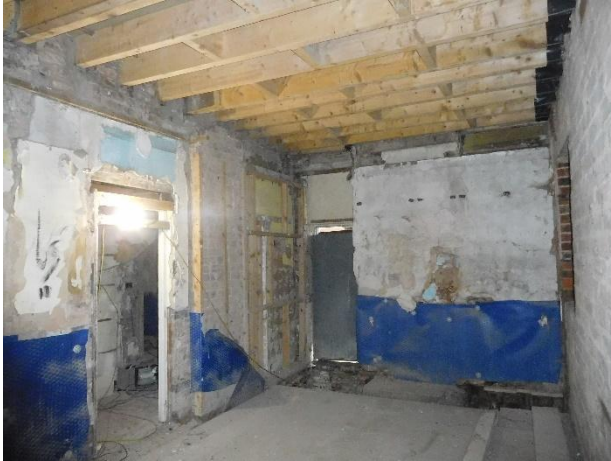
4.2.9 The rear lefthand room extended across approximately two thirds of the rear elevation. The floor had been removed at the lefthand end of the room leaving the concrete hearth visible; it could be seen that this was supported on props and a permanent support will be required. The rear wall of this room had been rebuilt as a cavity wall using concrete blockwork; the wall comprised a 210mm inner leaf , a 140mm cavity and a 95mm outer leaf.

Lefthand end of room

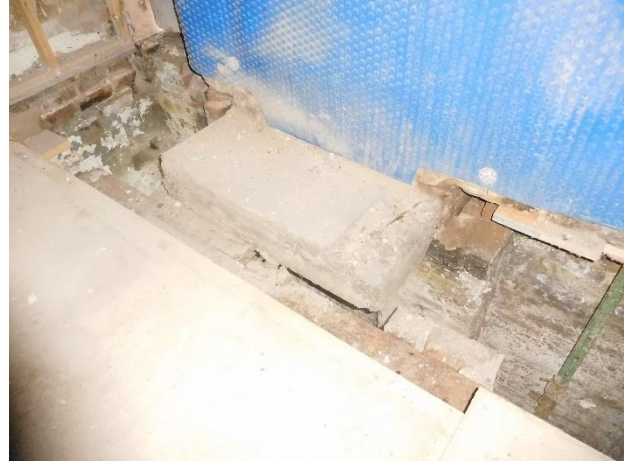
Open floor exposing hearth

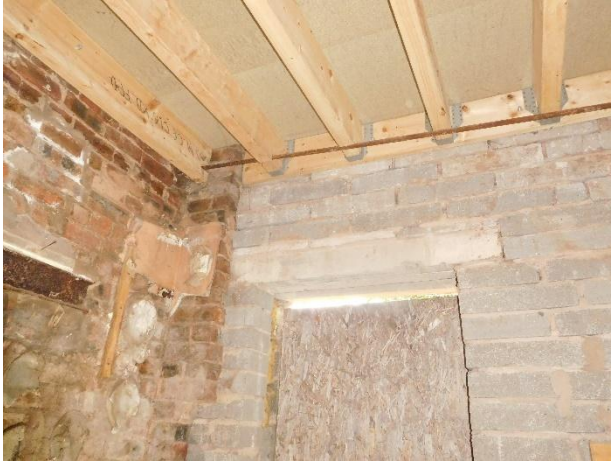
The division wall between the two rear rooms was the original brick construction. A short return of the original rear wall remained with the substantial portion of the rear wall having been reconstructed in blockwork.

Junction of original dividing wall and new rear wall

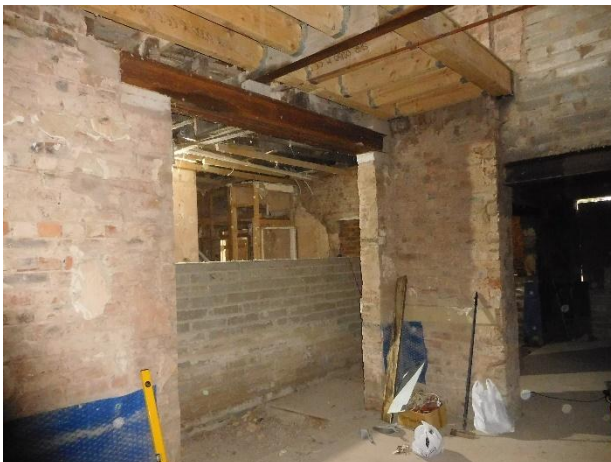
Opening in wall between hallway and front righthand room

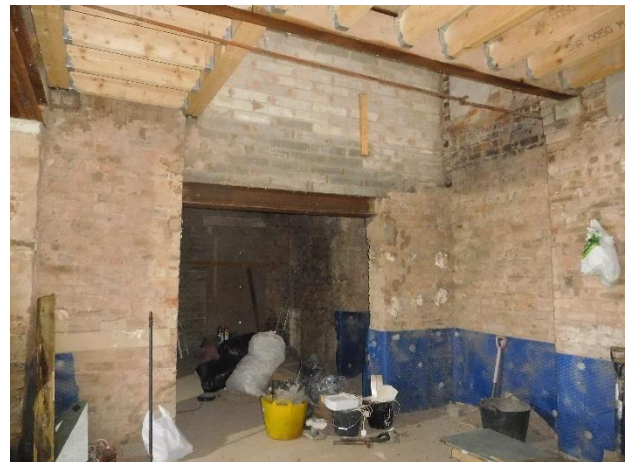
Opening between righthand rooms

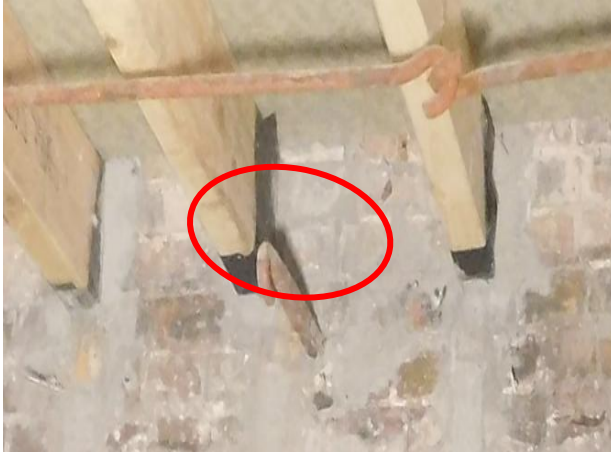
An opening had been formed within the floor above which is understood will accommodate a new staircase. A tie rod spans across this opening which will impinge on the proposed stair. Adjacent to the front elevation further tie rods spanned from side to side. A hook also protruded from the front elevation which would have been within the depth of the original floor construction (the new floor level having been raised); this corresponded with an external patress plate indicating that there had previously been a front to rear tie rod.

Hook connected to pattern plate

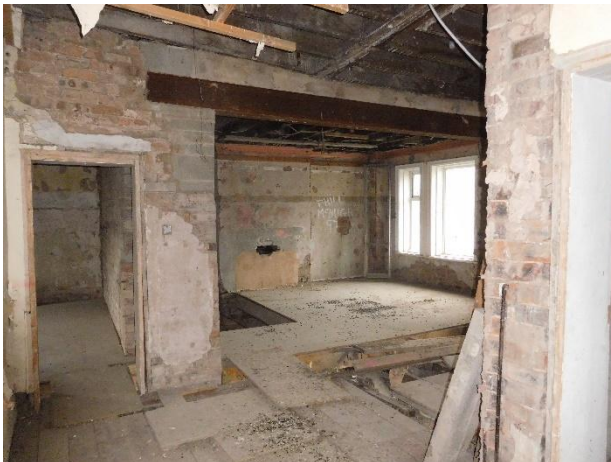
4.3.1 At first floor, significant areas of floor boarding were missing especially to the front righthand room and the area above the ground floor hallway; the lack of safe guardrails meant that our inspection had to proceed with great caution and some restrictions to access.

View from stairs towards front righthand corner

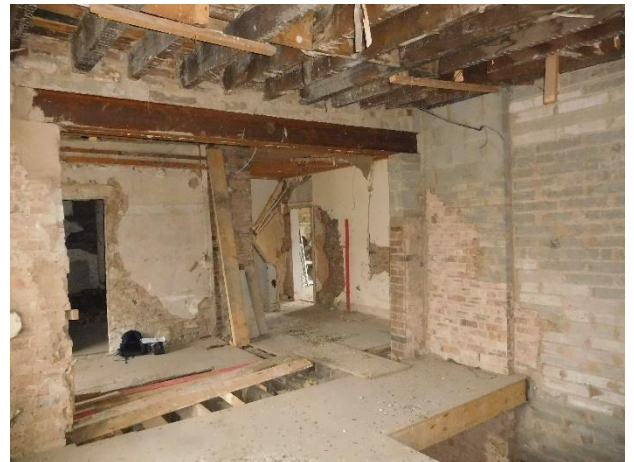
View from front righthand corner towards stairs

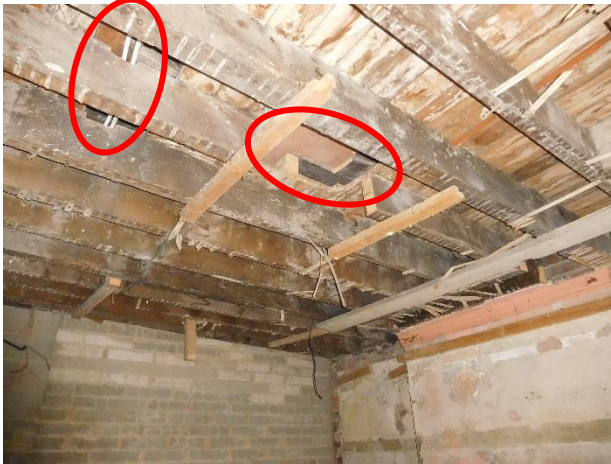
Various holes could be seen in the underside of the floor above but the majority of these had been covered with plywood sheeting. A view of the underside of the second floor adjacent to the chimney breast in the front righthand room revealed that a timber trimmer beam which would have supported the floor joists had been cut through.

Holes in floor above

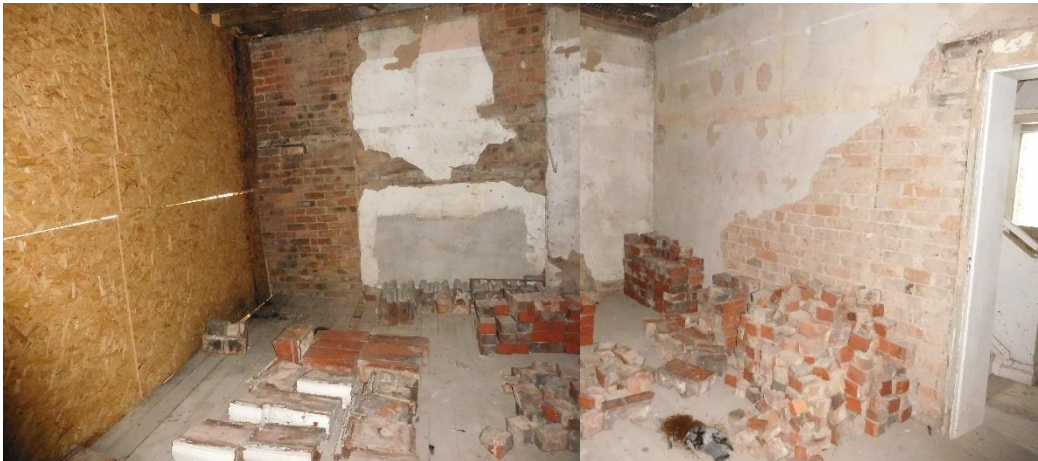
As at ground floor level, the front elevation of the front lefthand room was boarded over due to the bay having been dismantled. The masonry of the bay was stored on the floor of the room; the load has not be calculated but appears to be heavy for a domestic floor.

View towards left in front lefthand room

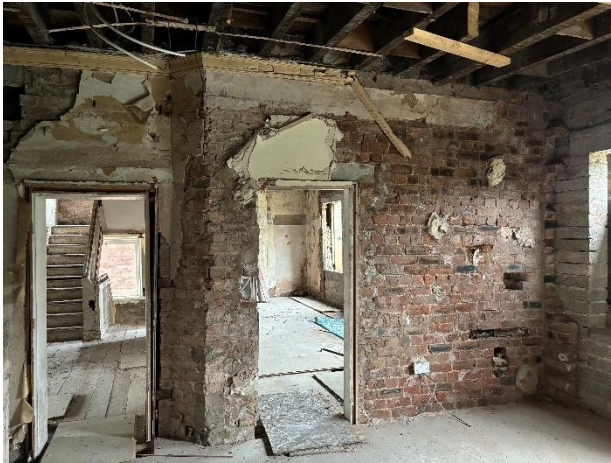
In the rear righthand room the rear wall had been rebuilt in blockwork; this appeared to be block laid on its side providing a 215mm inner leaf to the wall. The junction with the internal division wall with the rear wall indicated the external wall having been moved outwards by approximately 100mm relative to the brickwork of the original rear wall.

View towards stairwell from rear righthand room

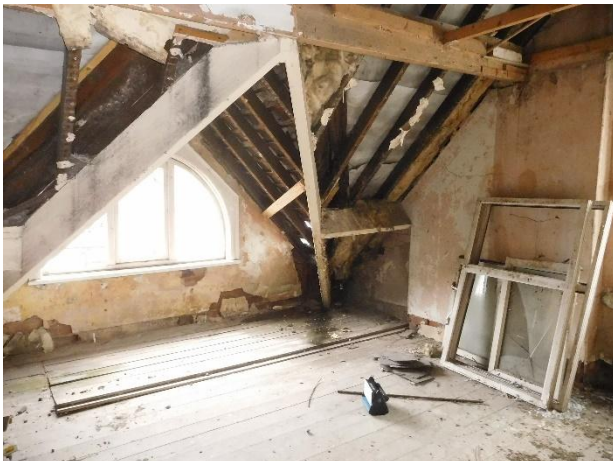
The roof structure was generally exposed in this room. Modern roofing materials indicated that some work had been undertaken relatively recently but the quality of this could not be determined from our visual inspection. The lefthand timber valley member for the dormer above the bay window showed indications of wet rot at its foot and also in the vicinity of the purlin.

View into front lefthand corner

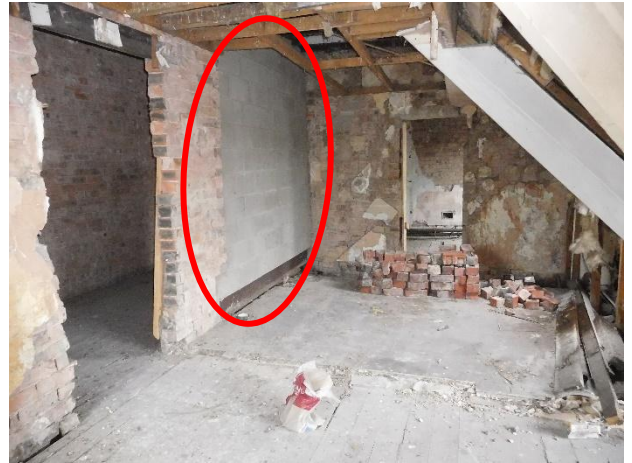
The rear wall of the front lefthand room had a roughly formed doorway out to the stairwell; cracking was noted in the brickwork above this doorway. The righthand end of the wall had been reconstructed in blockwork built on a steel beam

Blockwork wall built on steel beam

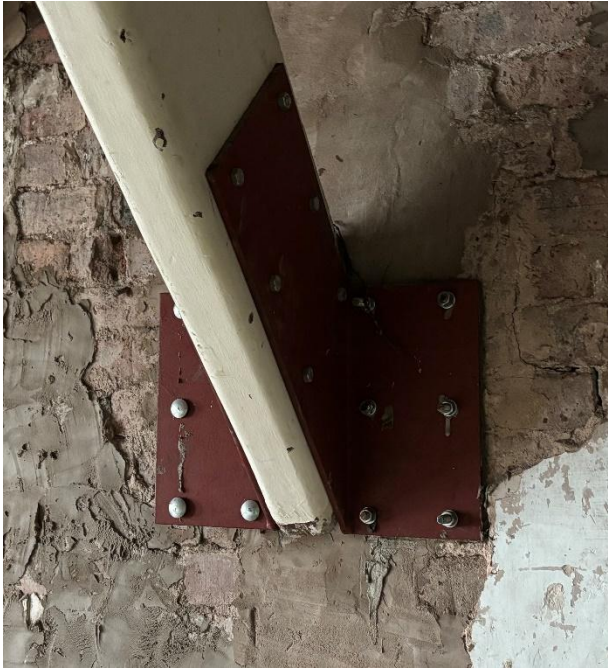
bracket but this was not to sufficient depth. There was no indication of the anchors having pulled out of the wall however, it is anticipated that the anchors have not been designed to for the bending stresses to which they will be subjected by the gap between the wall and the bracket. The adequacy of the support detail at the top end of the valley was not clearly visible.

Valley bracket connection to wall

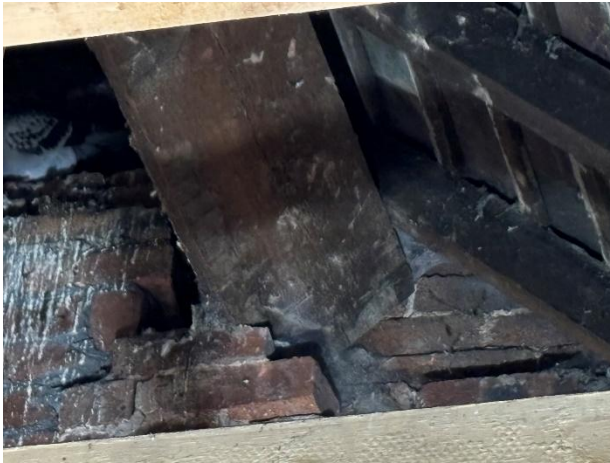
The upper purlin which extended from the front gable back to the valley member was very poorly supported with its bottom corner resting on a brick at its front end. The lower purlin also appeared to be supported on its corner but in this location to be resting on a short length of timber. Neither of the purlins were built in leaving them both prone to rotation.

Upper purlin bearing into front gable

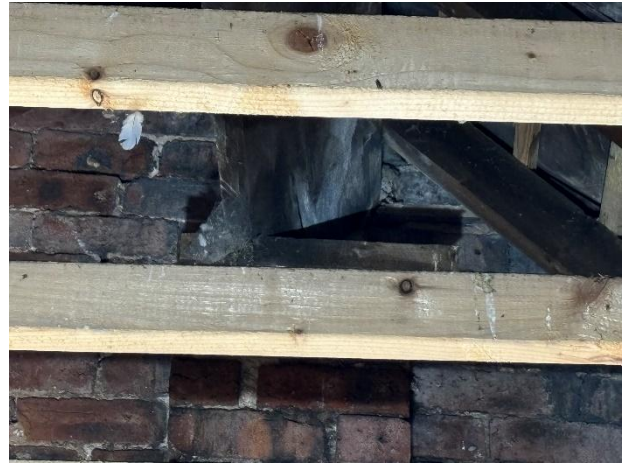
Lower purlin bearing into front gable

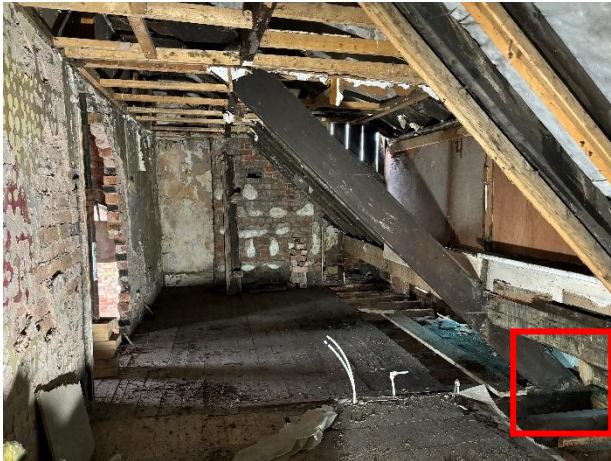
4.4.17 Areas of water ingress were noted particularly along the rear eaves and to the sides of the dormer window. To the righthand side of the dormer the connection between the principal rafter and floor beam was suffering from wet rot.

Rear lefthand room

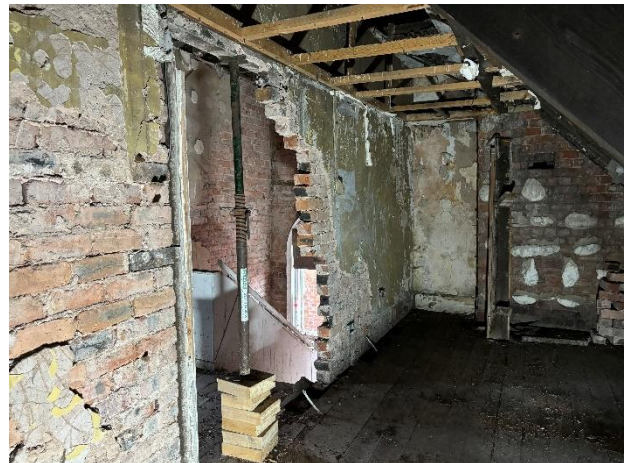
Opening between rear room and stairwell

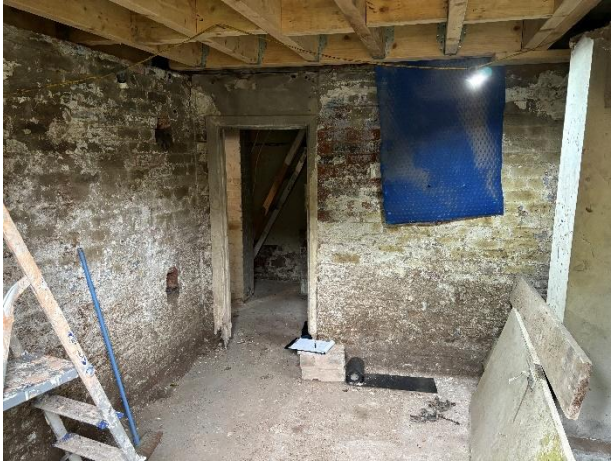
- 4.6 The basement extended beneath the rear half of the house and was accessed via a door in the rear wall, the former stair having been removed. The space comprised two rear rooms and a front room which extended across the full width of the basement; this was located beneath the stairwell. A blockwork wall had been constructed to the righthand side of the basement; this extended the full depth of the basement and was located approximately 1m away from the party wall.
- 4.7 In the rear lefthand room temporary support was noted to the hearth above which was mentioned in the photographs in 4.2.11 of this report. There were no significant defects noted to the walls of this room. It was noted that the floor above had been replaced with new timber.

View towards front in rear lefthand room

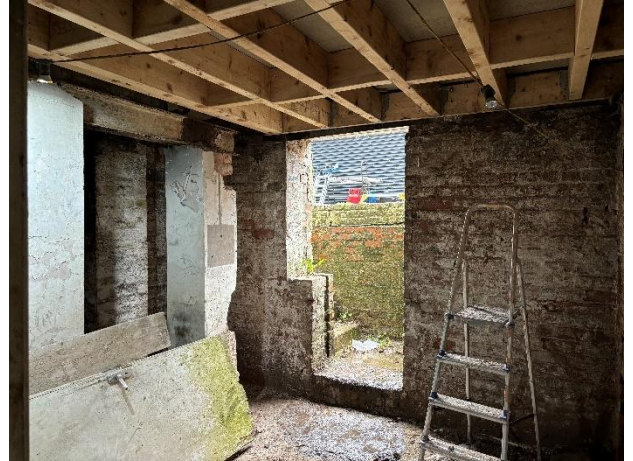
View towards rear in rear lefthand room

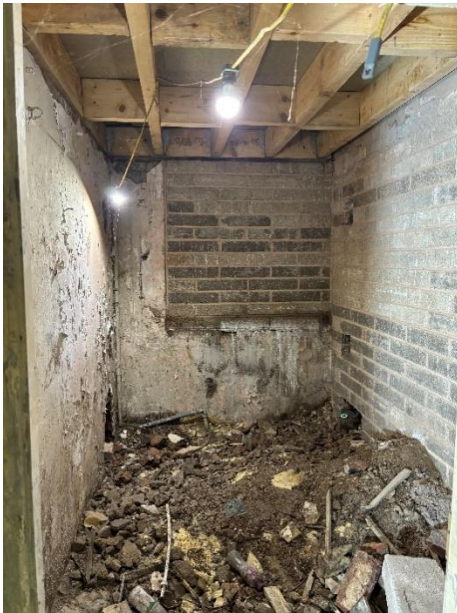
The rear wall of the righthand room appeared to comprise plastered brickwork at low level with a blockwork infill above; the straight joint to the lefthand side of this was indicative of this having previously been a window opening. This room was reduced in width due to the blockwork wall to the right. There was considerable debris on the floor of this room some of which exhibited evidence of fungal growth. Viewing through a hole in the blockwork wall revealed the void between this wall and the party wall to contain a substantial quantity of building debris.

View towards rear in rear righthand room

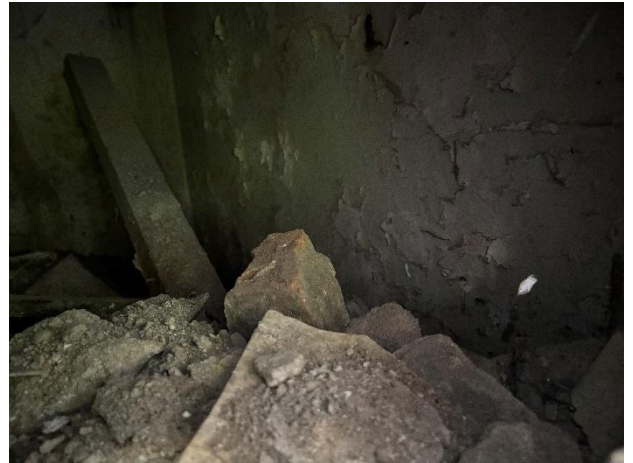
View into void behind block wall

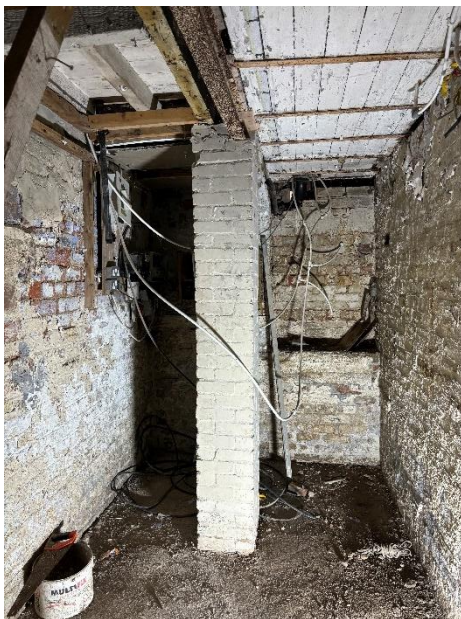
The room beneath the stairwell included two brickwork piers supporting a steel beam which trimmed the former stair opening. The floor over this room was unusual in that it comprised timber boards spanning from side to side supported on steel straps.

View towards left below stairwell

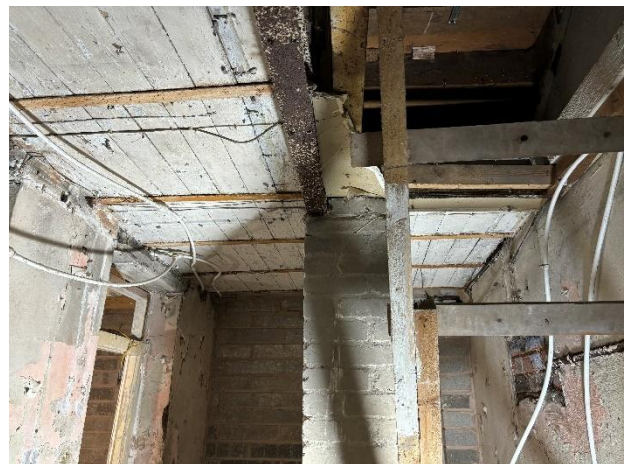
View towards right below stairwell
