# 1 CASTLE HILL CRESCENT, ROCHDALE, OL11 4HZ.

## Preliminary Roost Assessment update and Nocturnal Bat Survey Report

*January 2026*

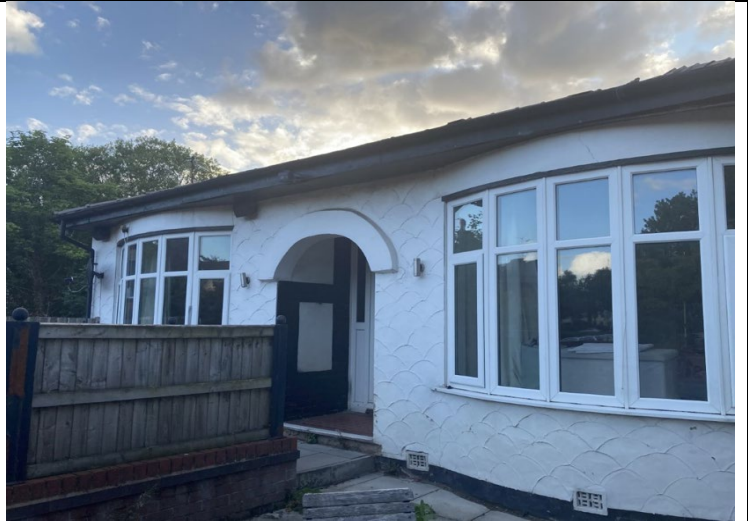
| <p>Photograph 1- Southern elevation of the building.</p> | |

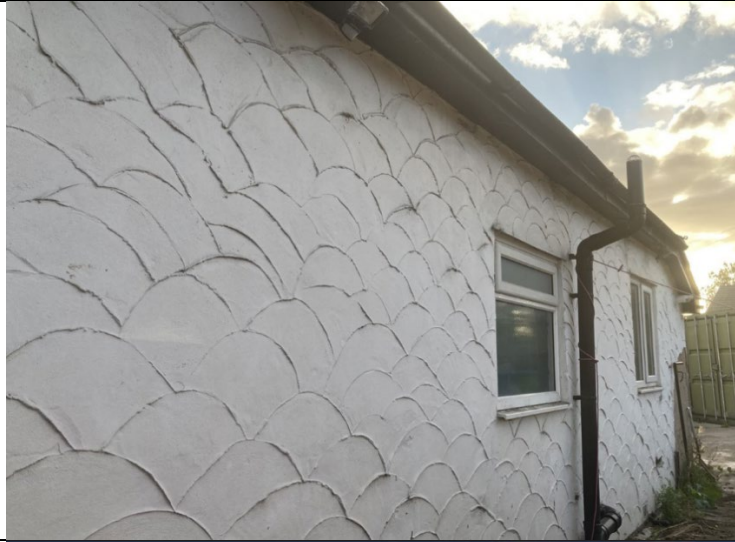
Photograph 4- Eastern elevation showing the render finish.

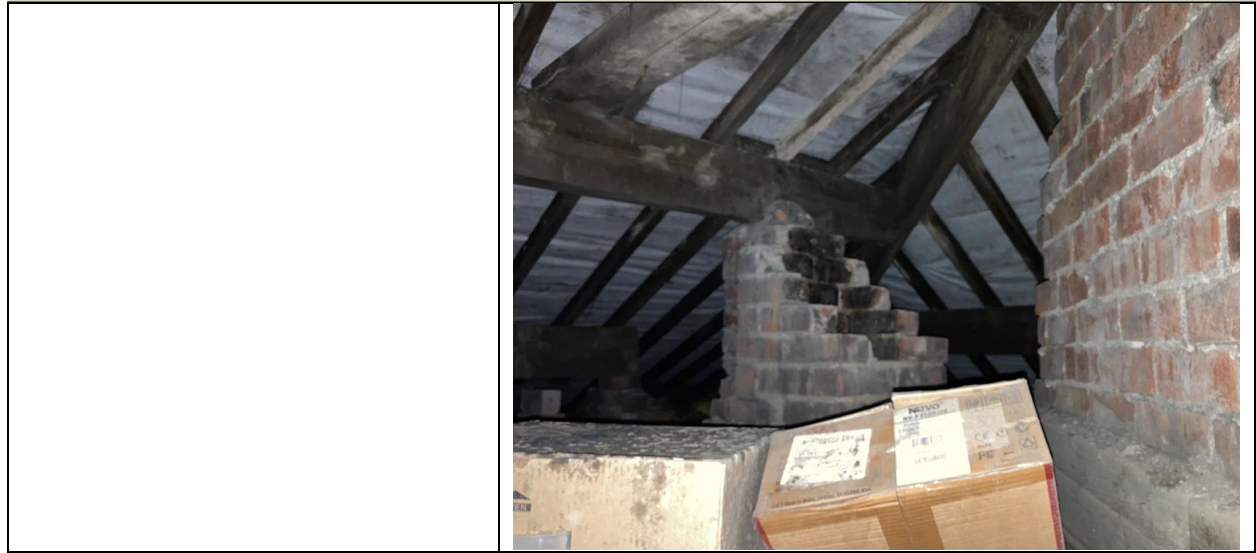
Figure 3.1- PRF features building plan.

3.1.4. The building was found to contain multiple features which afforded suitable PRF's for bats, both internally and externally, it was of a rendered blockwork construction with a slate roof and interlocking ridge tile system, the internal loft void was constructed from wooden roof trusses with a bitumen felt liner (see plan 3.3 below for PRF feature plan).

3.1.5. There were several areas of failed and rotten fascia and soffit boards on the northeast elevation of the building which afforded access into the soffit box area void. These measured roughly 0.5m to 1m long with an opening on the vertical face of around 30mm extending up to 150mm, no evidence of bat access was observed such as urine staining, droppings or smooth edges often created by access over time, these features were rated as low value.

3.1.6. Multiple sections of damaged and missing ridge and hip tiles were observed at the union with the slate roof covering on the northwestern and southern roof elevations. These offered crevice dwelling species access between the slate roof covering and the felt liner.

Yellow dots lifted and slipped tiles and slates  
Orange dots damaged fascia and soffit  
Green stars areas of damaged felt liner

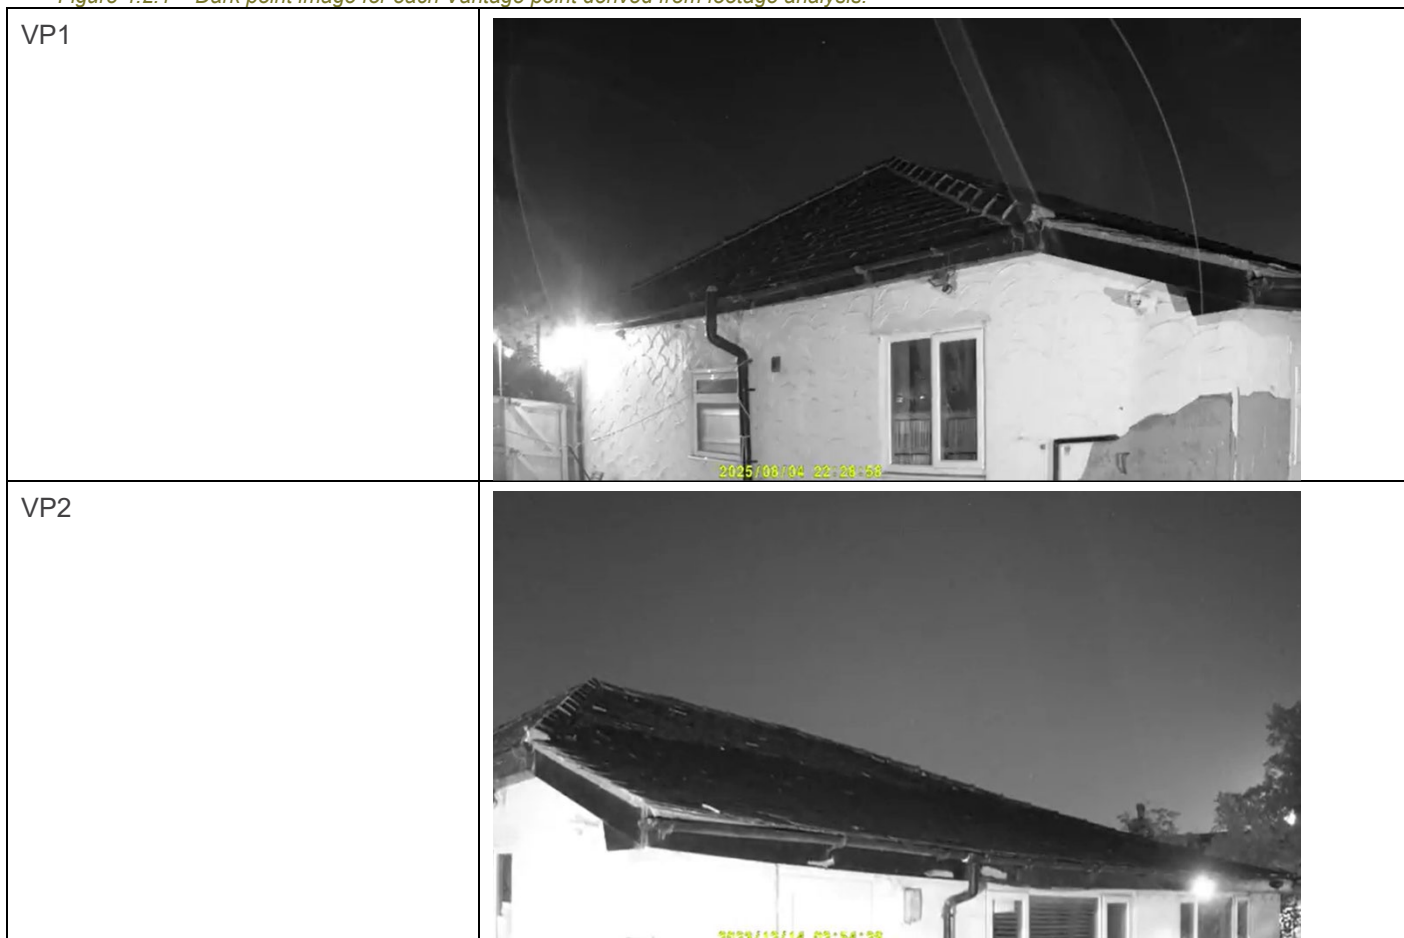
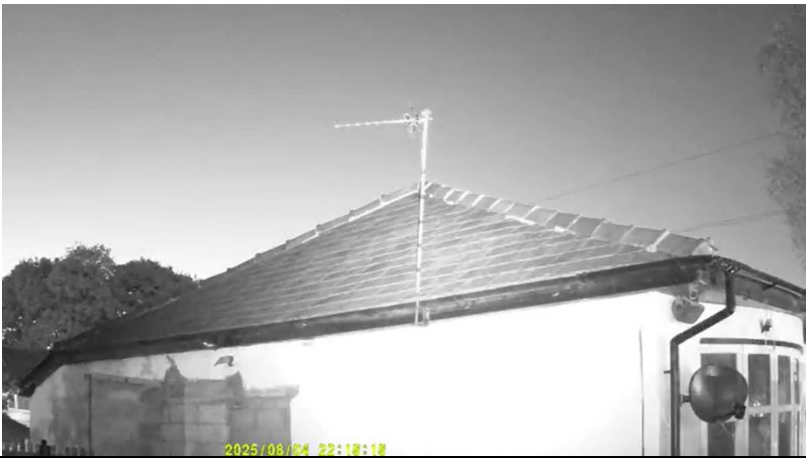
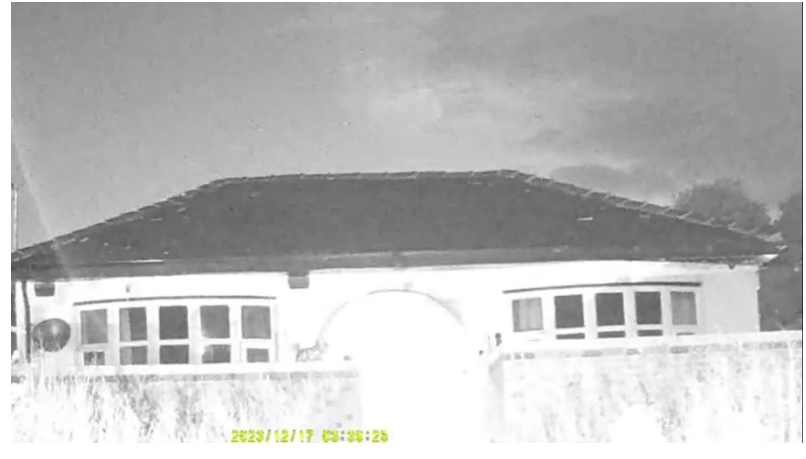
*Figure 4.2.1 – Dark point image for each Vantage point derived from footage analysis.*

- 4.1.2. The first bat was recorded at 21: 32 (approximately 32 minutes after sunset) by VP1. It was a common pipistrelle commuting north to south over the site. Common pipistrelle formed three of the four acoustic records, mostly observed within the proximity of VP1 and VP2 to the north and west of the building.

- 4.1.6. The subsequent camera footage review was undertaken by qualified ecologists and utilised tracking technology supplied by Wildlife imaging systems to provide additional assistance to determine trajectory and orientation of foraging, commuting and any potential emergence events. Please see Figures 4.2.1.

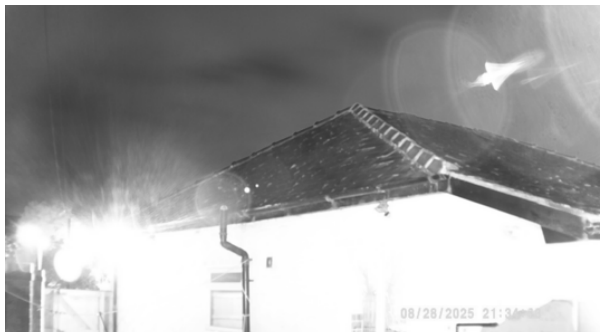
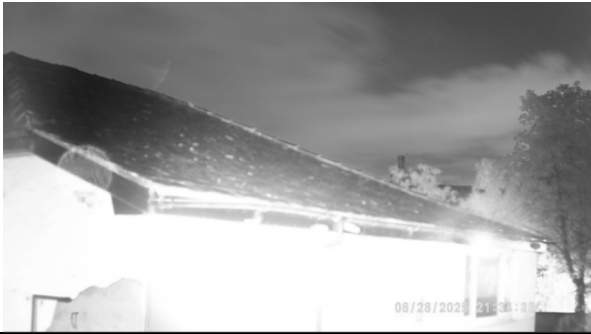
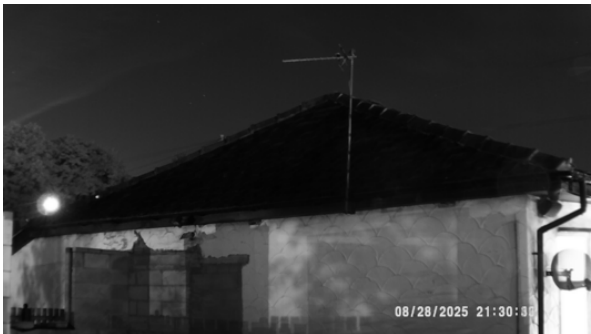
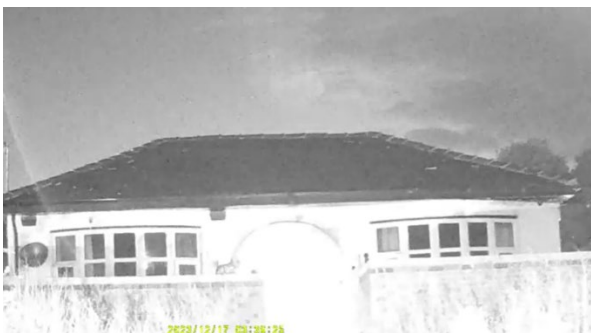
*Figure 4.2.2. – Dark point image for each Vantage point derived from footage analysis.*

- 4.2.1. Bat activity was recorded at very low levels throughout the survey, with only common pipistrelle heard. A total of two bat passes only, were recorded over the duration of the survey.
- 4.2.2. The first bat was recorded at 20:42 (approximately 35 minutes after sunset) by VP2, it was a common pipistrelle. Common pipistrelle formed the other acoustic record, and both were recorded as heard not seen.
- 4.2.3. The static detector to the west of the building recorded four calls, all common pipistrelle, again associated with the roadside tree cover to the west.
- 4.2.4. No bats were recorded emerging from the residential building.
