# Historic Building Record

## Level 3

# Parkfield House,

Manchester Old Road, Middleton, M24 3EB

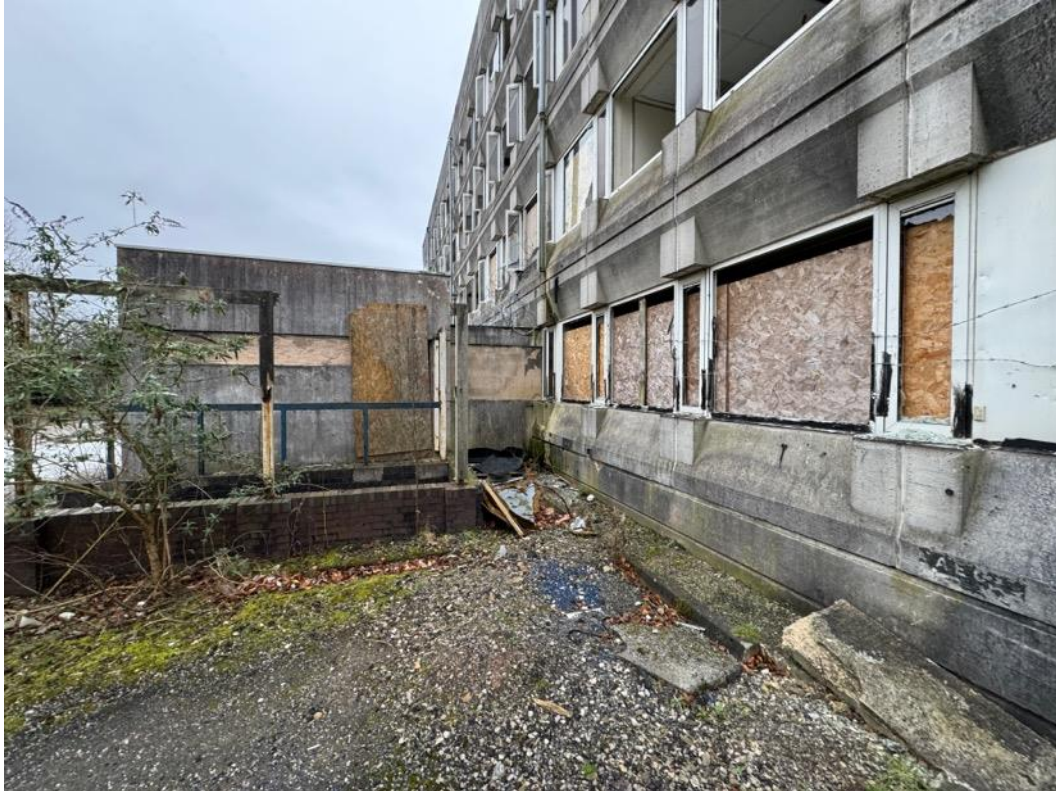
*Image 20 – Closer view of northwest corner, showing connection of extension to main building.*

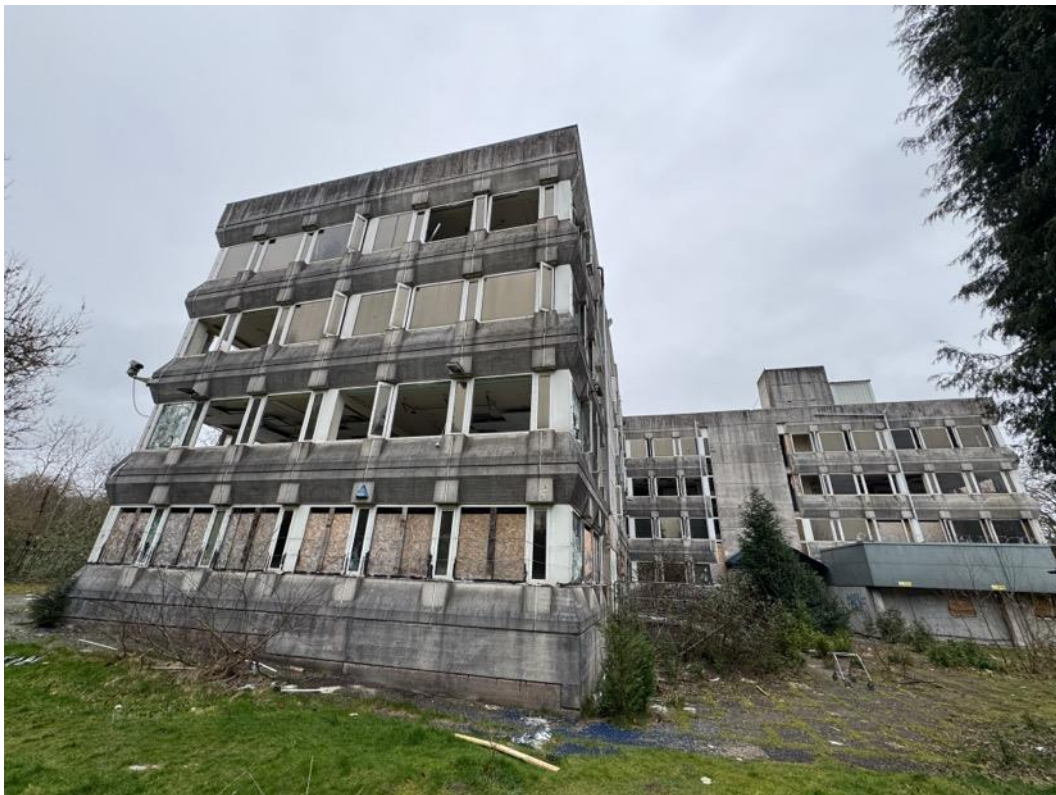
*Image 21 – Overall view of west elevation, access restricted by mature trees and site boundary.*

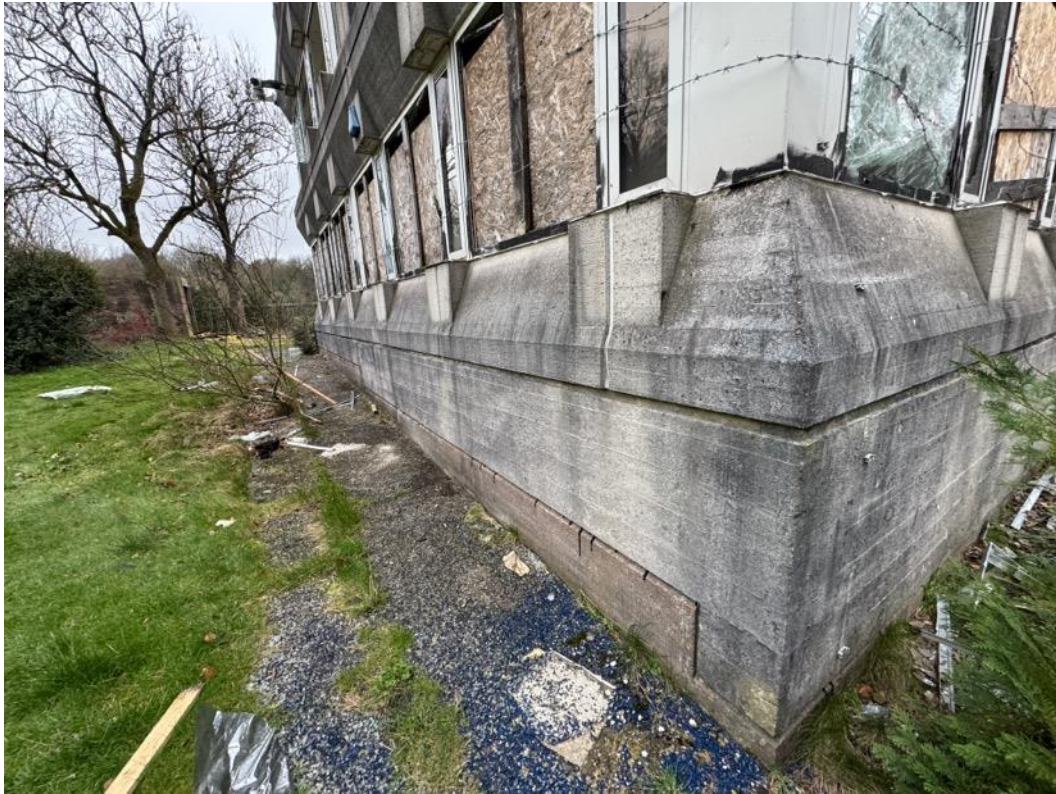
*Image 22 – Closer view of west elevation, with some wood grain imprints to pre-cast concrete panels.*

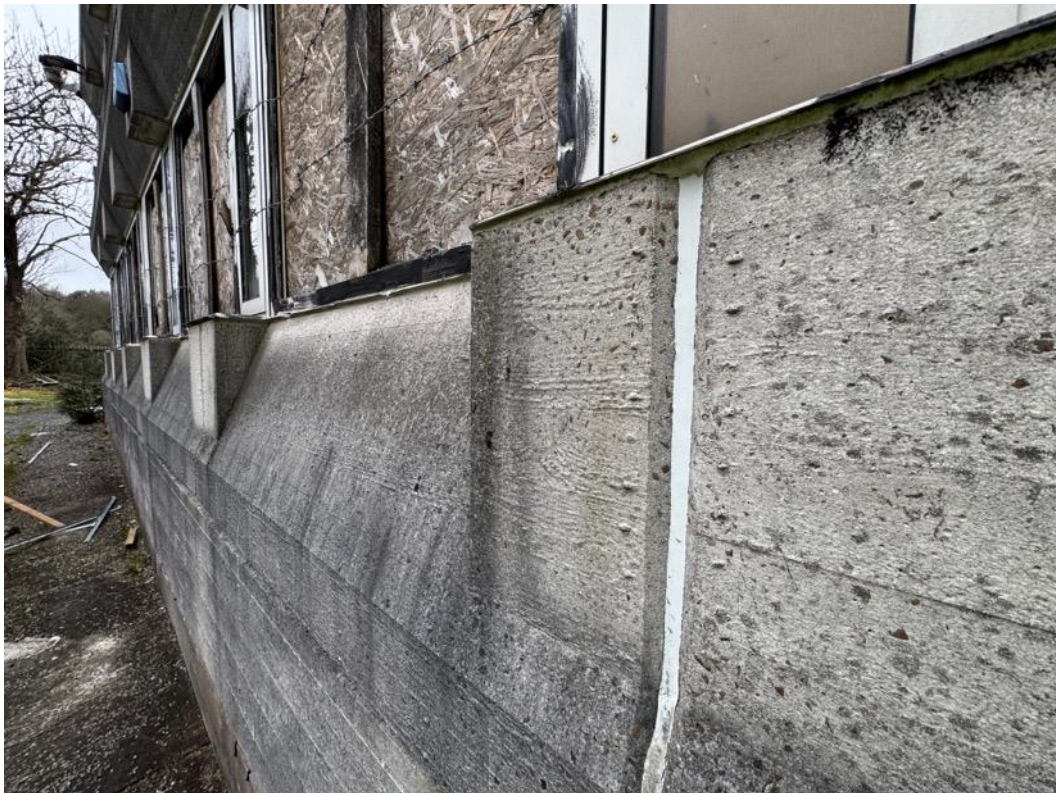
*Image 23 – Close-up view of wood grain detail to pre-cast concrete panels, a design feature of the original Brutalist style.*

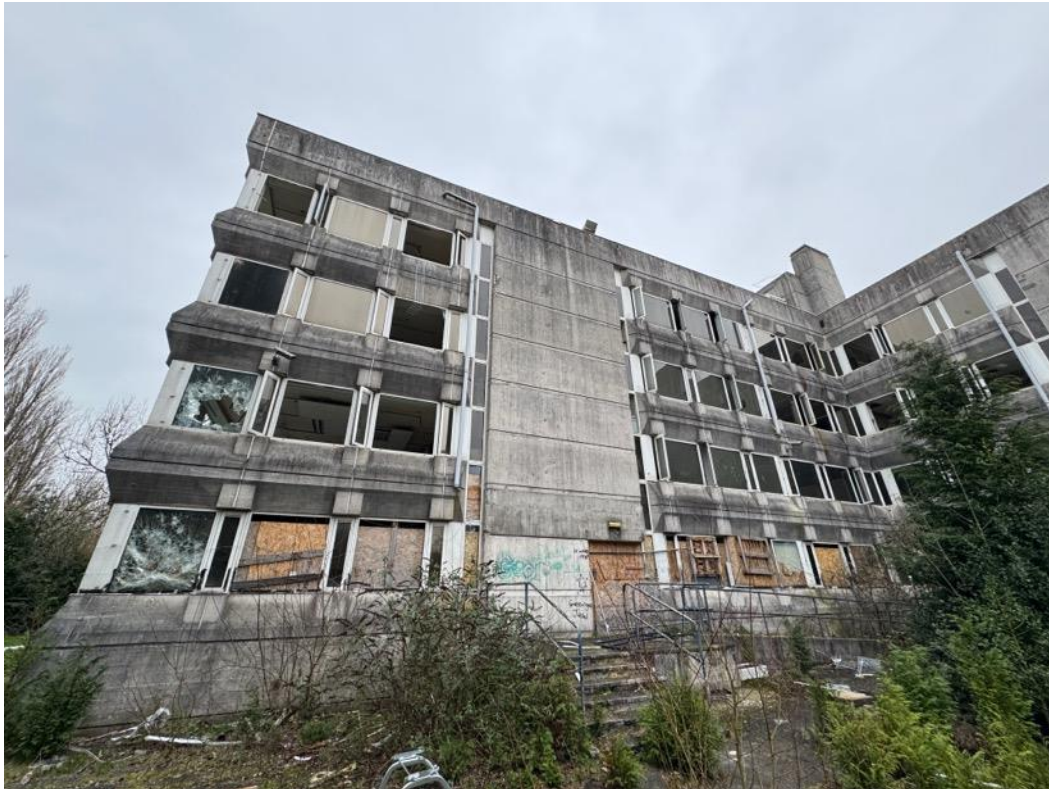
*Image 24 – Overall view of south elevation left hand side. Photo taken from inner courtyard, access restricted by vegetation growth.*

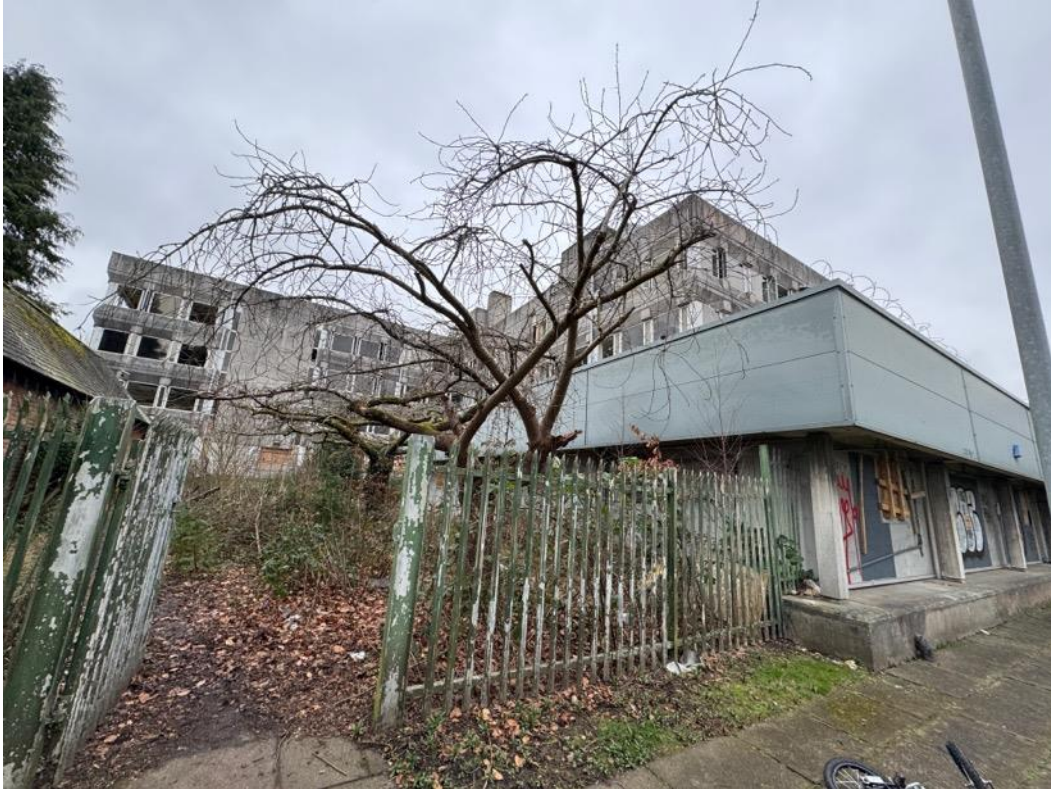
*Image 32 – View of southwest corner of ground floor extension, with steel palisade fencing to inner courtyard area.*

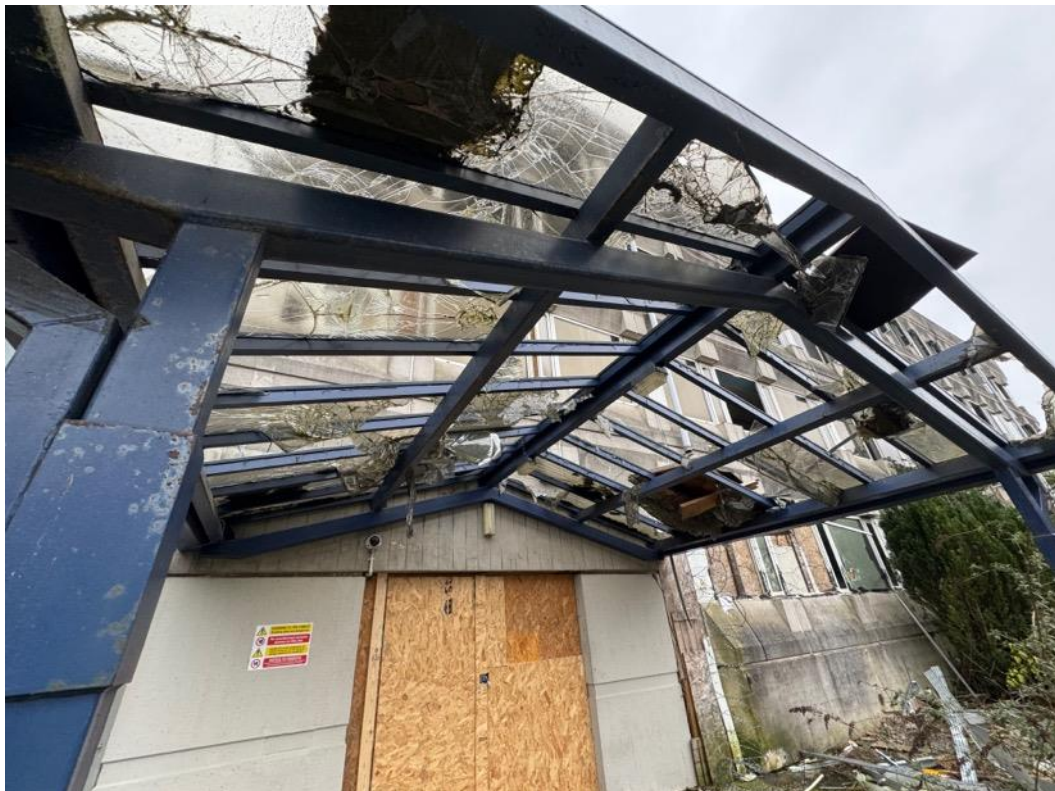
*Image 39 – Closer view of glass canopy to main entrance, heavily vandalised. Original concrete block canopy lost at some stage.*

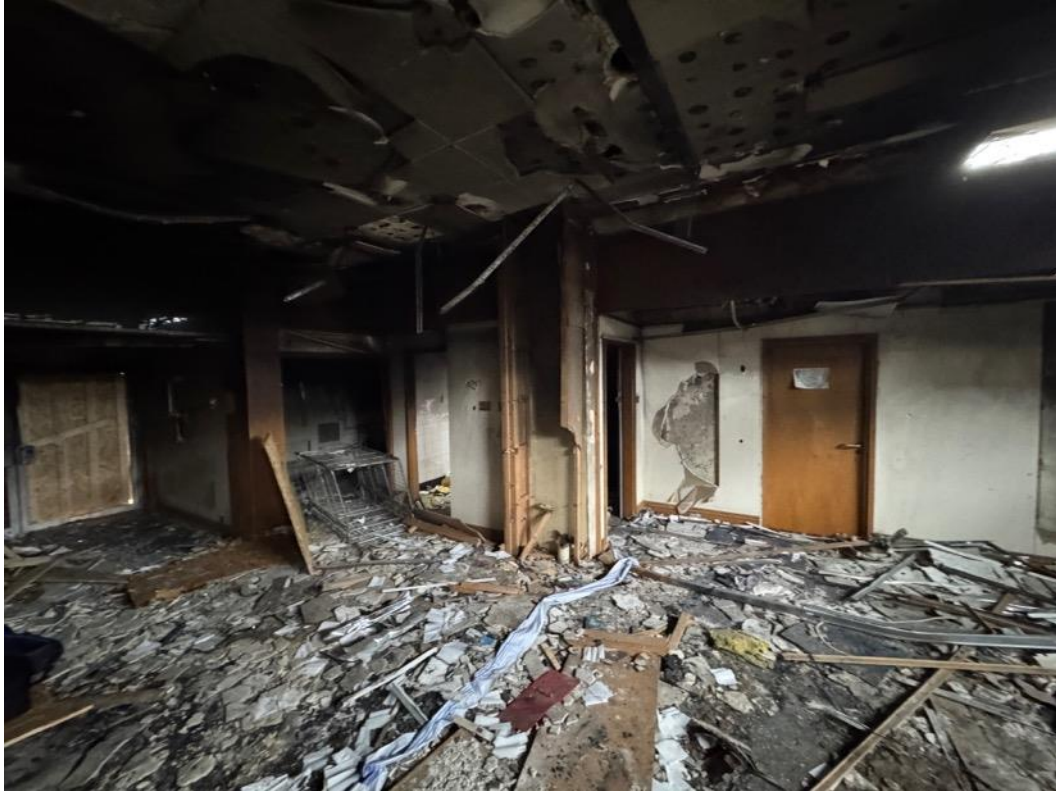
*Image 42 – Internal view of entrance hall looking south toward toilet block.*

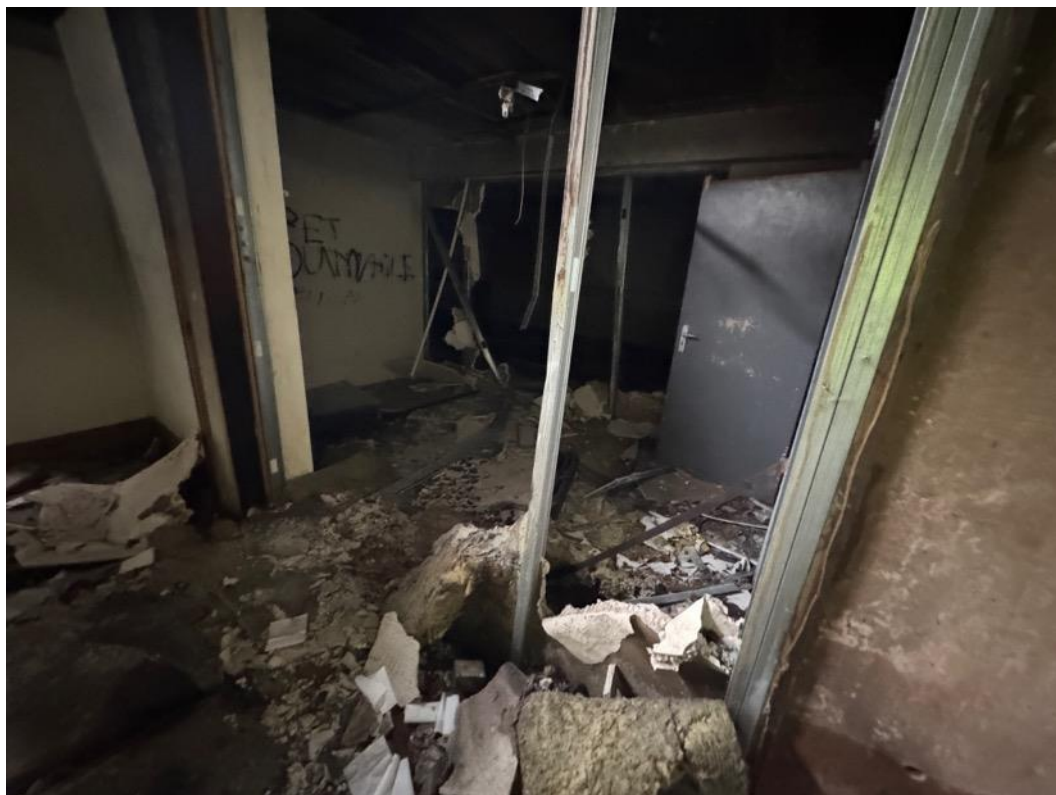
*Image 44 – View of west wall of entrance hall. Wall finish largely collapsed onto floor, but some concrete panels visible.*

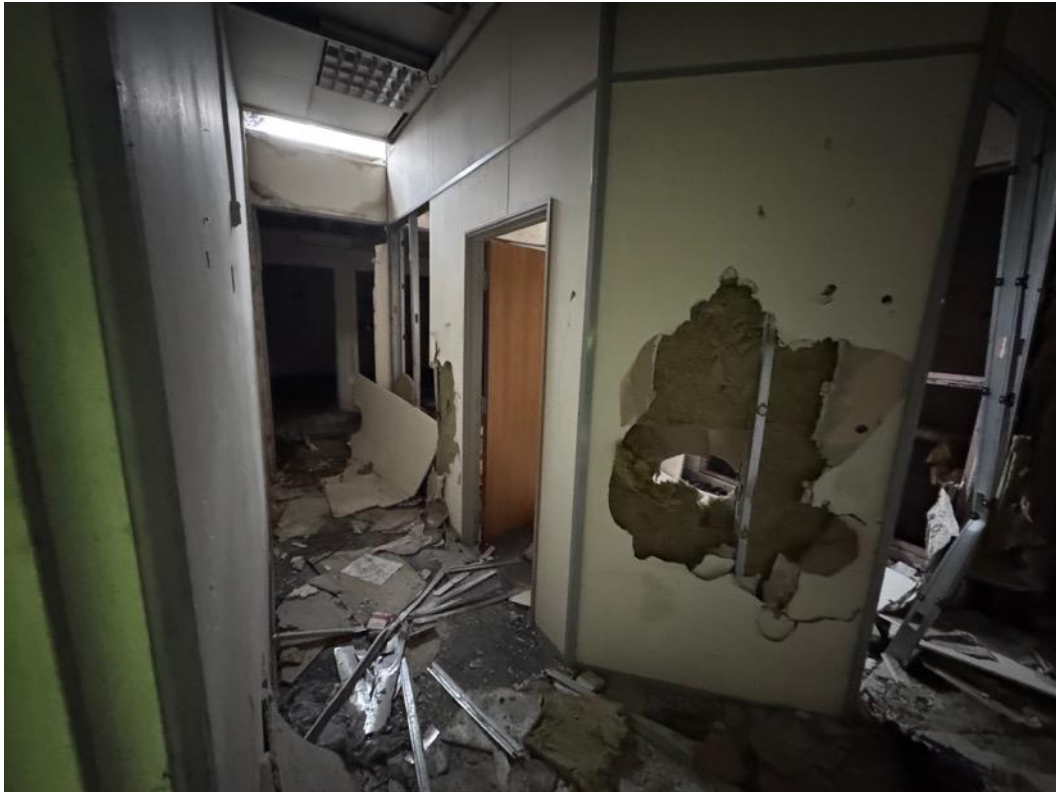
*Image 45 – Internal view through ruined partition walls in extension to west side.*

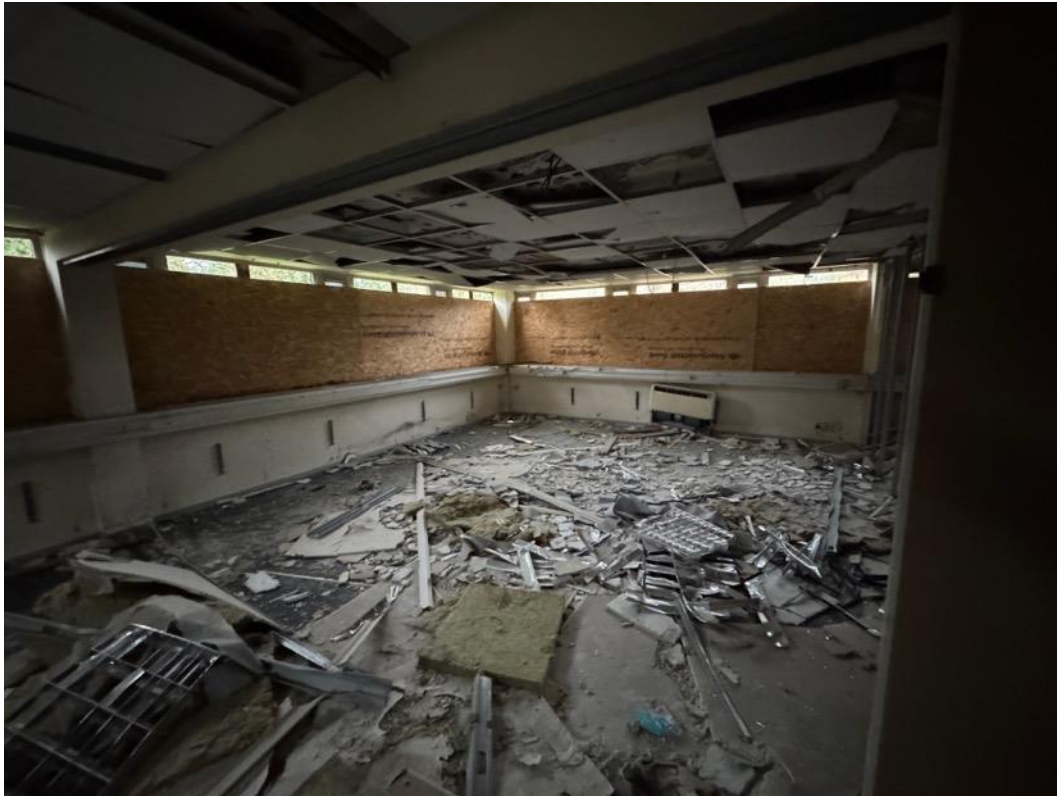
*Image 55 – Office space to ground floor. Internal glazing missing and walls destroyed.*

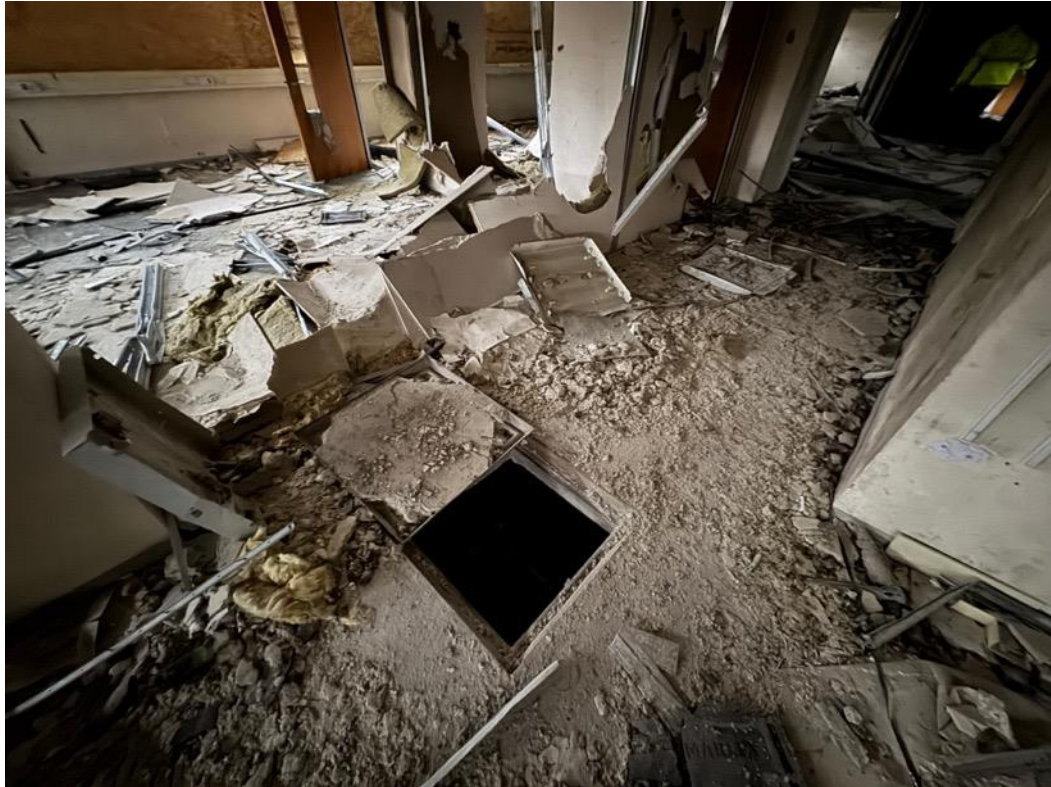
*Image 58 – View to length of northern side of the ground floor, heavy piles of debris made access difficult.*

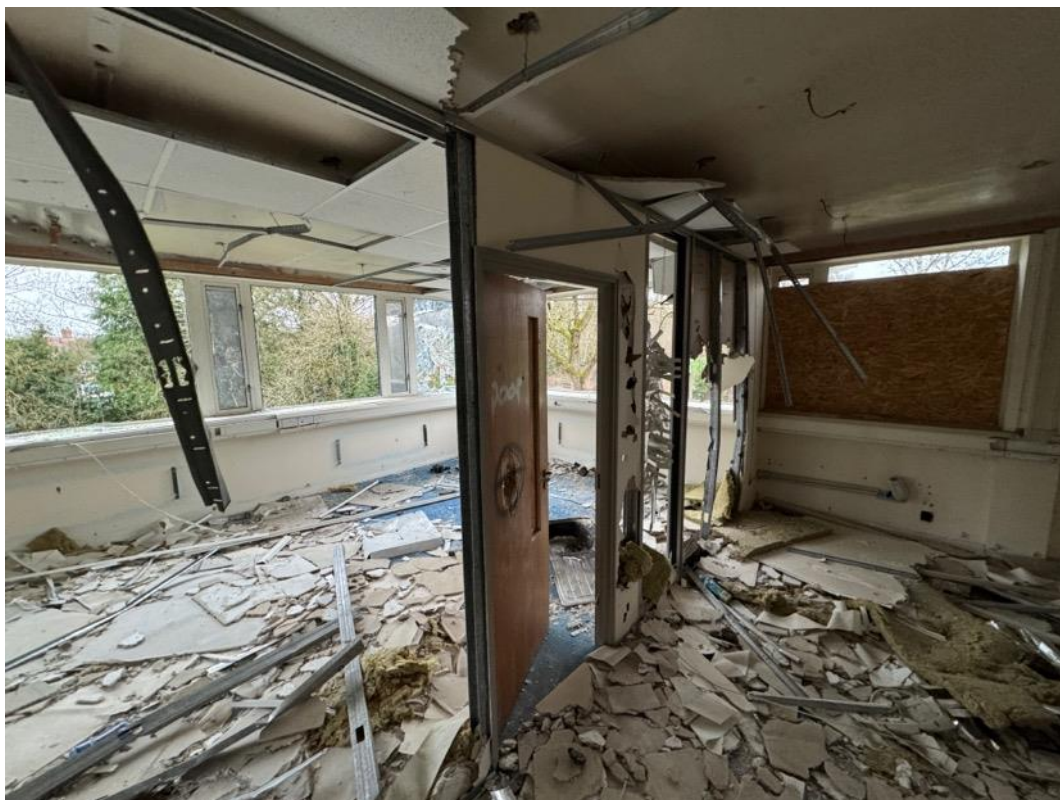
*Image 64 – View of west end of first floor. Suspended tile ceiling remains in part.*

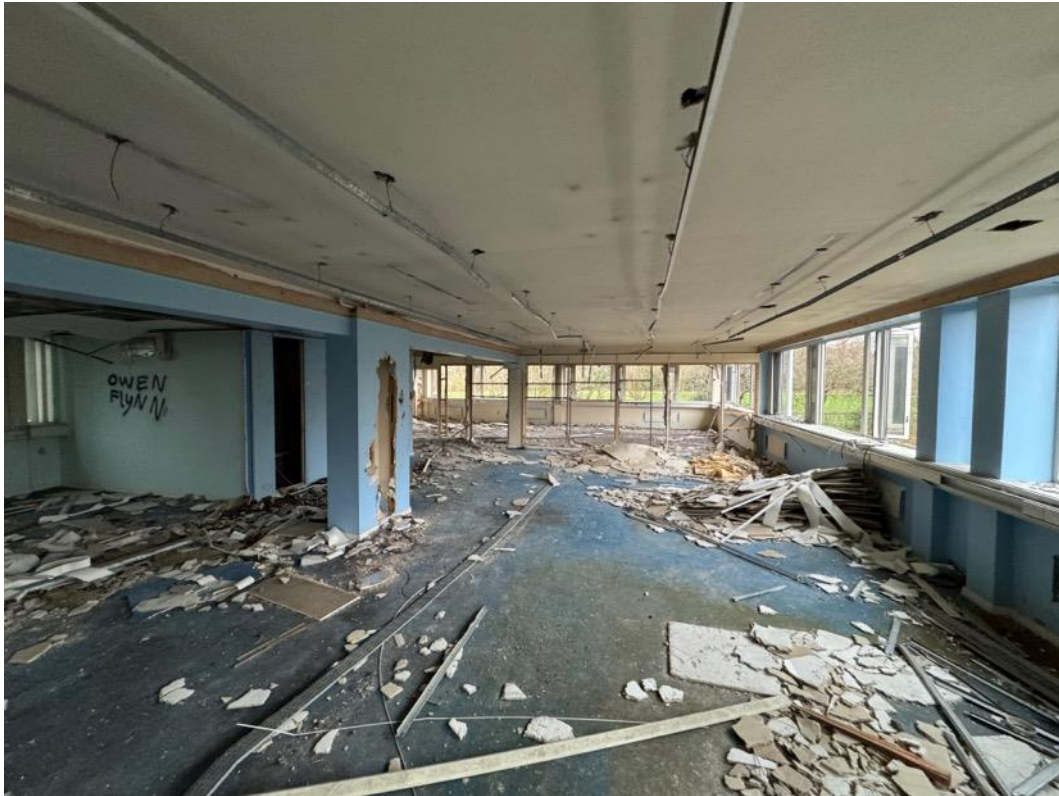
*Image 71 – View to central corridor space, first floor. All partitions heavily damaged.*

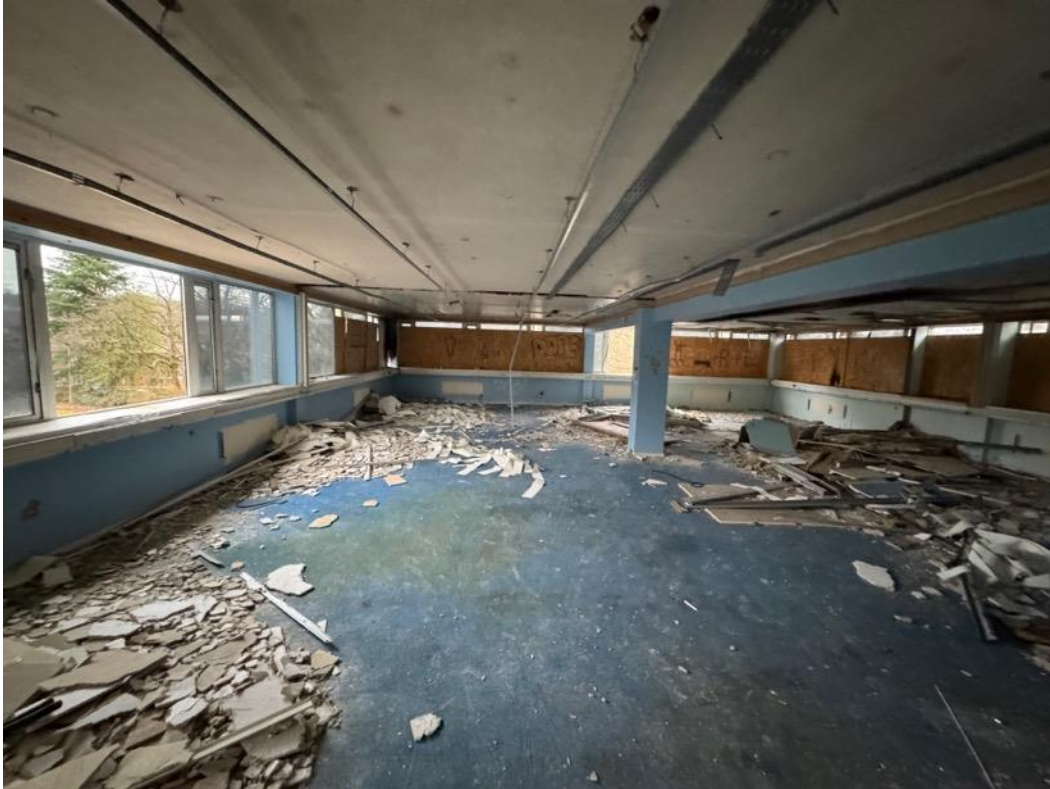
*Image 75 – First floor view of southwest corner. Windows boarded above ground floor flat roof.*

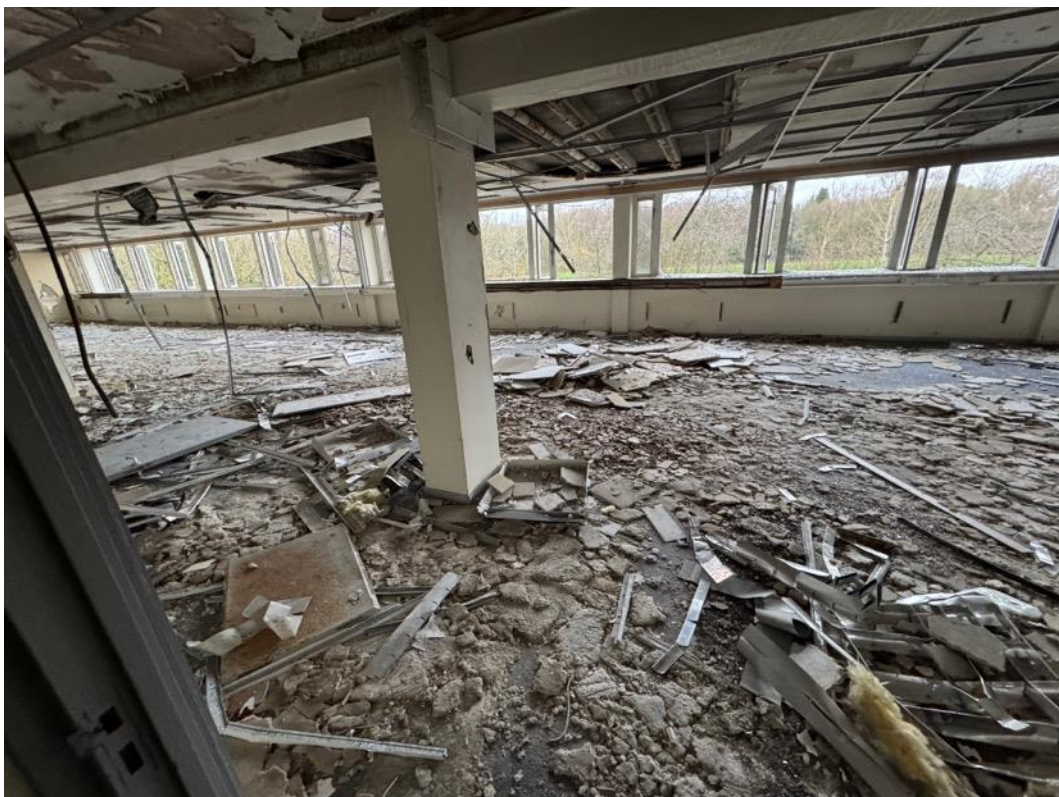
*Image 89 – Second floor view looking north.*

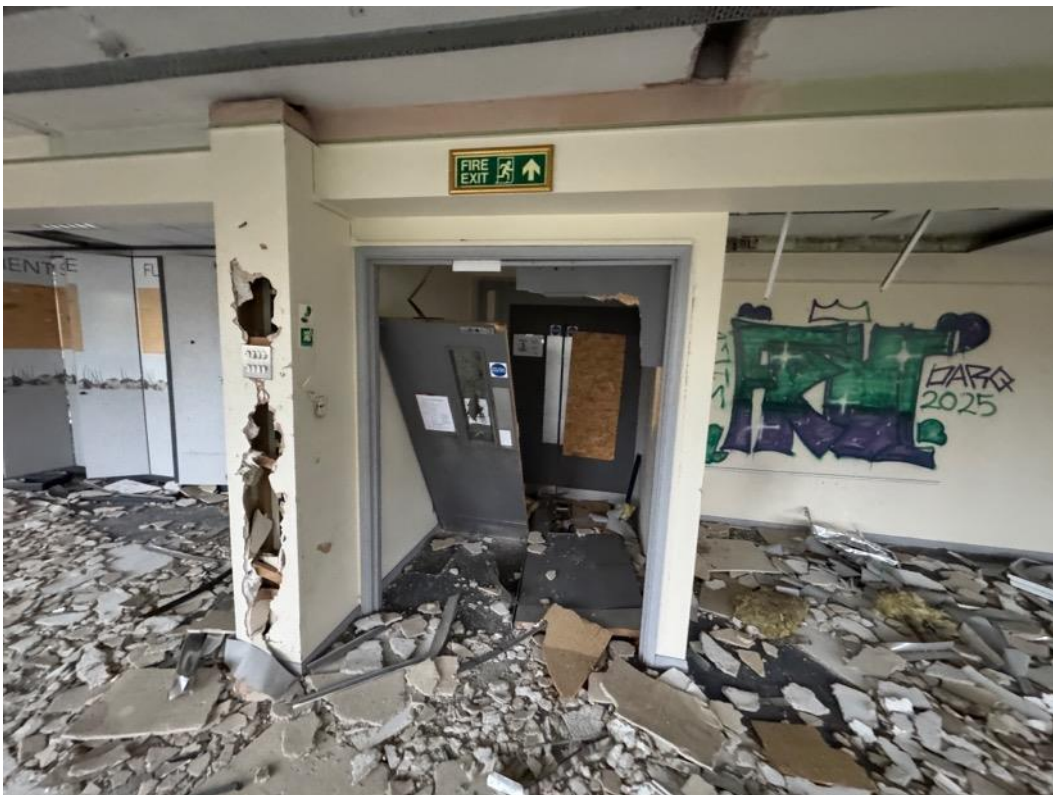
*Image 93 – View of southern stairwell, second floor. Doors sealed shut preventing access.*

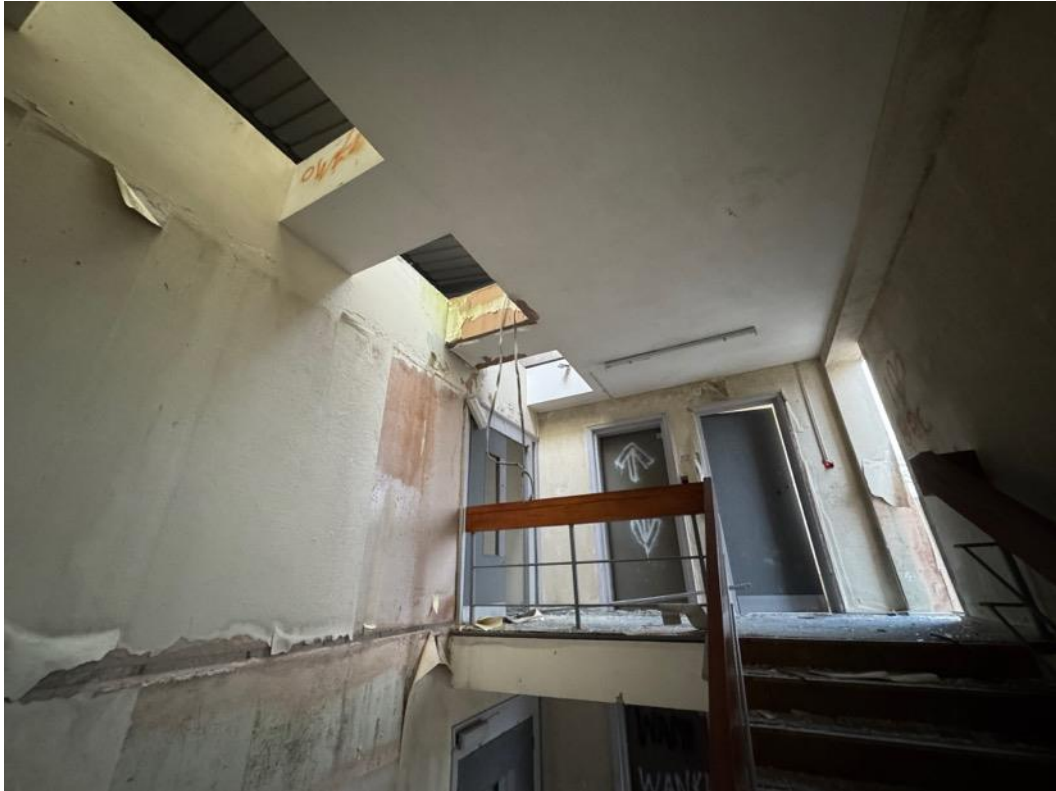
*Image 100 – Southern stairwell third floor level, showing skylights and lift doors. Door to right is for a small store cupboard.*
