# KHAN & THOMPSON LTD

External Boundary Wall-  
Crescent Nurseries,  
Crescent Hall, Edmund Street,  
Rochdale, OL12 6QG

Khan & Thompson Ltd  
Structural Engineers  
Initial Business Centre,  
Wilson Park,  
Manchester,  
M40 8WN

22<sup>nd</sup> February, 2026

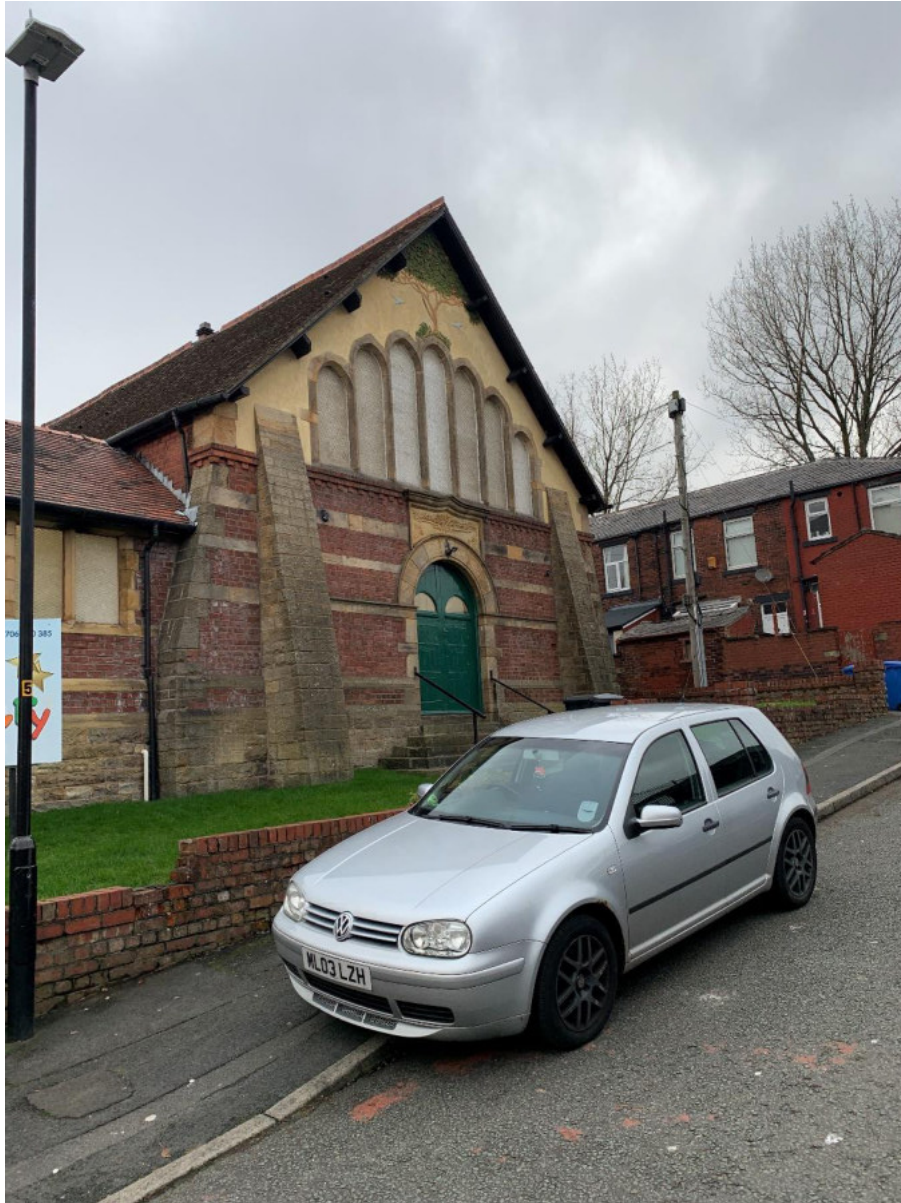
*Front Elevation*

- The brickwork below the 2 top capping courses have severely deteriorated which is self-evident and can be clearly seen by the photographs.
- The brick faces have spalled across a large and consistent area of the front visible wall. This is very unsightly and does not benefit at all the appearance or heritage of the Church or this area.

- The factors that may have contributed to the above-
  - This is typical of the continuous process over many years of constant wet brickwork and freezing temperatures causing the wet brickwork to freeze. Once frozen the bricks will then expand, crack, loosen and spall onto the footway.

- The brickwork and wall is in very poor condition.
- Typical or standard remedial repairs available for this type of wall are-
  - Re-pointing
  - Break out remove and replace the damaged bricks with new bricks
  - Excavate behind the wall and construct a suitable drainage system
  - Core drill Weepholes through the wall.
