## **SCHEDULE OF CONDITION FOR:**

**Drake Street  
Rochdale  
OL16 1PJ**

**Survey Date: 17<sup>th</sup> March 2026**

**For: Great Places Housing Group**

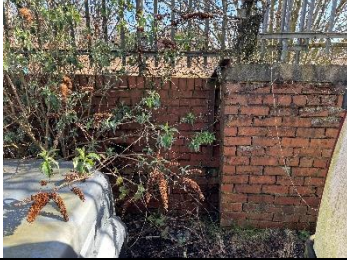
| 7 | Speedwell Garage Ltd, 210-216 Drake Street, Rochdale, OL16 1UP | Boundary wall positioned to the West of the site, facing from the external site perimeter | | Solid masonry wall observed (16 brick courses high). Buddleia growth/ displacement of brick courses, cracked/ spalled bricks, missing/ defective pointing, finished brick on edge course, steel palisade railings affixed to wall. |

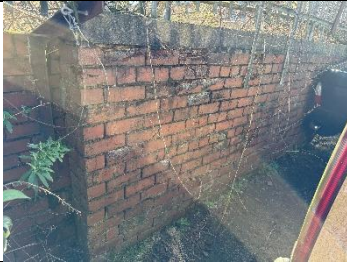
| 8 | Speedwell Garage Ltd, 210-216 Drake Street, Rochdale, OL16 1UP | Boundary wall positioned to the West of the site, facing from the external site perimeter | | Solid masonry wall observed (approx. 18 brick courses high). Buddleia growth, cracked/ spalled bricks, missing/ defective pointing, finished with concrete coping, steel palisade railings affixed to wall. |

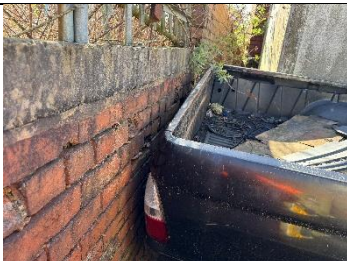
| 9 | Speedwell Garage Ltd, 210-216 Drake Street, Rochdale, OL16 1UP | Boundary wall positioned to the West of the site, facing from the external site perimeter | | Solid masonry wall observed (approx. 18 brick courses high). Buddleia growth, cracked/ spalled bricks, missing/ defective pointing, finished with concrete coping, steel palisade railings affixed to wall. |

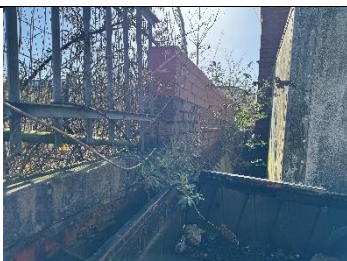
| 10 | Speedwell Garage Ltd, 210-216 Drake Street, Rochdale, OL16 1UP | Boundary wall positioned to the West of the site, facing from the external site perimeter | | Solid masonry wall observed (26 brick courses high). Buddleia growth, cracked/ spalled bricks, missing/ defective pointing, upper 4 courses comprise a more recent installation in a stretcher bond arrangement and remains unfinished. |

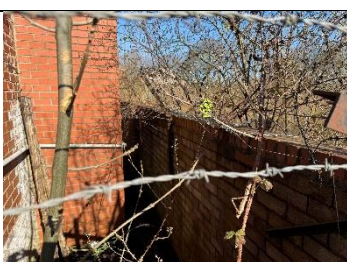
| 11 | Speedwell Garage Ltd, 210-216 Drake Street, Rochdale, OL16 1UP | Boundary wall positioned to the West of the site, facing from the external site perimeter | | Stretcher bond masonry wall observed (20 brick courses high). Limited vegetation to this section, pointing generally appears intact. Finished with brick on edge course and barbed wiring affixed to proprietary brackets. |

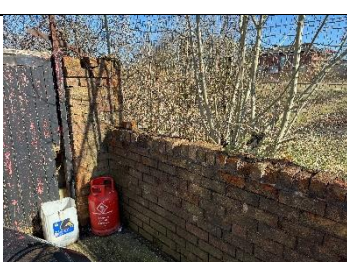
| 12 | Speedwell Garage Ltd, 210-216 Drake Street, Rochdale, OL16 1UP | Boundary wall positioned to the West of the site, facing from the external site perimeter | | Solid masonry wall (12 brick courses high). Appears to have suffered sustained impact damage overtime. Finished with brick on edge course, cracked/ spalled bricks, missing pointing, brick on edge variously spalled. Vegetation to several areas. |

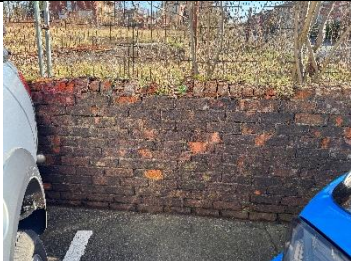
| 15 | Speedwell Garage Ltd, 210-216 Drake Street, Rochdale, OL16 1UP | Boundary wall positioned to the West of the site, facing from the external site perimeter | | Solid masonry wall (12 brick courses high). Appears to have suffered sustained impact damage overtime. Finished with brick on edge course, cracked/spalled bricks, missing pointing, brick on edge variously spalled. Vegetation to several areas. |

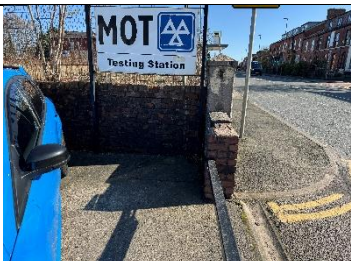
| 17 | Speedwell Garage Ltd, 210-216 Drake Street, Rochdale, OL16 1UP | Boundary wall positioned to the West of the site, facing from the external site perimeter | | Solid masonry wall (12 brick courses high). Appears to have suffered sustained impact damage overtime. Finished with brick on edge course, cracked/spalled bricks, missing pointing, brick on edge variously spalled. Vegetation to several areas. |

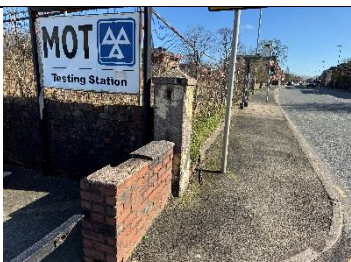
| 18 | Drake Street, Rochdale, OL16 1PJ | Boundary wall positioned to the West of the site, facing from the external site perimeter | | Solid masonry wall (9 brick courses high). Localised spalling to brickwork, missing pointing, missing concrete coping stone. Abuts stone pier to Southwest corner of the site. Adhesive/paint residue to pier. 4-way pier cap installed. |

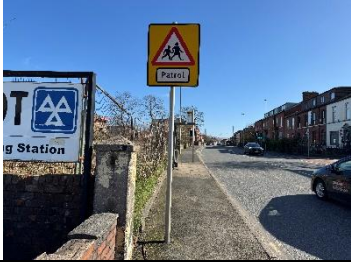
| 19 | Drake Street,<br>Rochdale, OL16 1PJ | Boundary wall positioned to the West of the site, facing from the external site perimeter | | Heras fencing along boundary of site. Road sign in good condition and showing no damage to pole. Overgrown vegetation along site perimeter above low-level stone upstand to pavement edge, stone pier/tarmac pavement. |

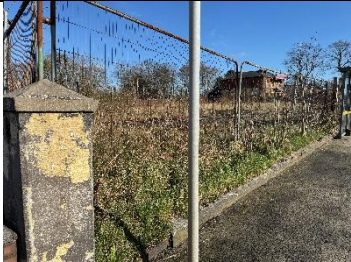
| 20 | Drake Street,<br>Rochdale, OL16 1PJ | Boundary wall positioned to the South of the site, facing from the external site perimeter | | Heras fencing along boundary of site. Overgrown vegetation along site perimeter above low-level stone upstand to pavement edge, stone pier with 4-way cap/ tarmac pavement. |

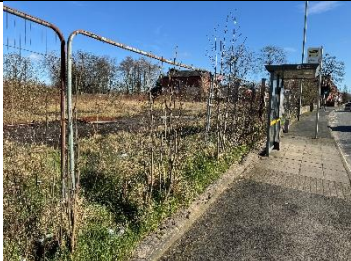
| 21 | Drake Street,<br>Rochdale, OL16 1PJ | Boundary wall positioned to the South of the site, facing from the external site perimeter | | Heras fencing along boundary of site. Overgrown vegetation along site perimeter above low-level stone upstand to pavement edge/ tarmac pavement. |

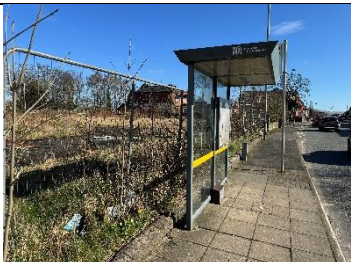
| 22 | Drake Street,<br>Rochdale, OL16 1PJ | Boundary wall positioned to the South of the site, facing from the external site perimeter | | Heras fencing along boundary of site. Overgrown vegetation along site perimeter above low-level stone upstand to pavement edge/ tarmac pavement. Bus stop is in good condition. |

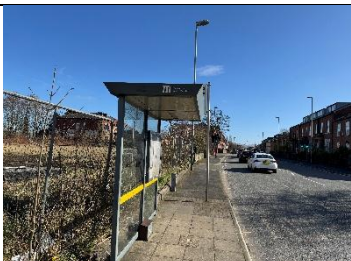
| 23 | Drake Street,<br>Rochdale, OL16 1PJ | Boundary wall positioned to the South of the site, facing from the external site perimeter | | Heras fencing along boundary of site. Overgrown vegetation along site perimeter above low-level stone upstand to pavement edge/ tarmac pavement. Bus stop is in good condition. |

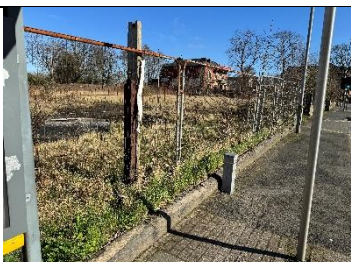
| 24 | Drake Street,<br>Rochdale, OL16 1PJ | Boundary wall positioned to the South of the site, facing from the external site perimeter | | Heras fencing along boundary of site. Overgrown vegetation along site perimeter above low-level stone upstand to pavement edge/ tarmac pavement. |

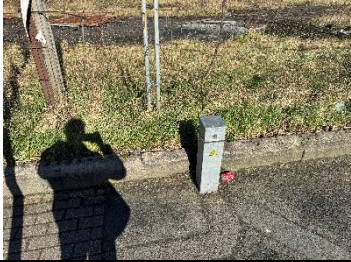
| 25 | Drake Street,<br>Rochdale, OL16 1PJ | Boundary wall positioned to the South of the site, facing from the external site perimeter | | Heras fencing along boundary of site. Overgrown vegetation along site perimeter above low-level stone upstand to pavement edge/ tarmac pavement. Electrical box adjacent to site curtilage. |

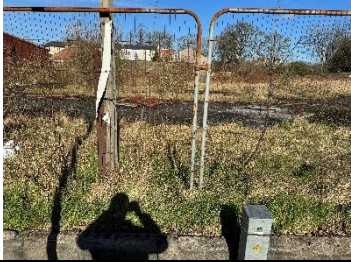
| 26 | Drake Street,<br>Rochdale, OL16 1PJ | Boundary wall positioned to the South of the site, facing from the external site perimeter | | Heras fencing along boundary of site. Overgrown vegetation along site perimeter above low-level stone upstand to pavement edge/ tarmac pavement. Electrical box adjacent to site curtilage. |

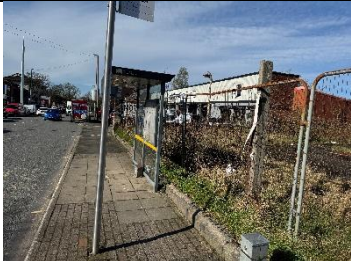
| 27 | Drake Street,<br>Rochdale, OL16 1PJ | Boundary wall positioned to the South of the site, facing from the external site perimeter | | Heras fencing along boundary of site. Overgrown vegetation along site perimeter above low-level stone upstand to pavement edge/ tarmac pavement. Bus stop in good condition. |

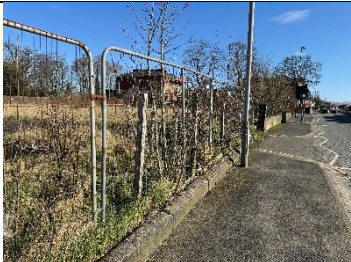
| 28 | Drake Street,<br>Rochdale, OL16 1PJ | Boundary wall positioned to the South of the site, facing from the external site perimeter | | Heras fencing along boundary of site. Overgrown vegetation along site perimeter above low-level stone upstand to pavement edge/ tarmac pavement. |

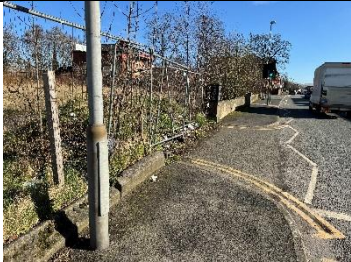
| 29 | Drake Street,<br>Rochdale, OL16 1PJ | Boundary wall positioned to the South of the site, facing from the external site perimeter | | Heras fencing along boundary of site. Overgrown vegetation along site perimeter above low-level stone upstand to pavement edge, stone pier with 4-way cap/ tarmac pavement. Site entrance blocked with spoil heap. |

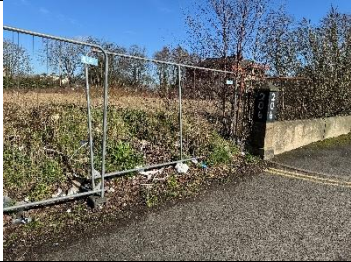
| 30 | Drake Street,<br>Rochdale, OL16 1PJ | Boundary wall positioned to the South of the site, facing from the external site perimeter | | Heras fencing along boundary of site. Overgrown vegetation along site perimeter above low-level stone upstand to pavement edge, stone pier with 4-way cap/ tarmac pavement. Site entrance blocked with spoil heap. |

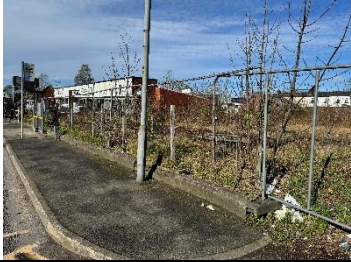
| 31 | Drake Street,<br>Rochdale, OL16 1PJ | Boundary wall<br>positioned to the<br>South of the site,<br>facing from the<br>external site perimeter | | Heras fencing along boundary<br>of site. Overgrown vegetation<br>along site perimeter above low-<br>level stone upstand to<br>pavement edge/ tarmac<br>pavement. |

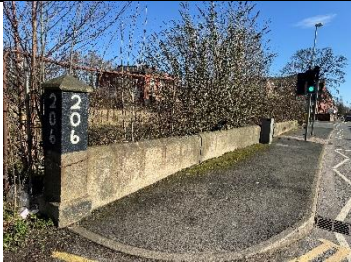
| 32 | Drake Street,<br>Rochdale, OL16 1PJ | Boundary wall<br>positioned to the<br>South of the site,<br>facing from the<br>external site perimeter | | Heras fencing along boundary<br>of site. Overgrown vegetation<br>along site perimeter above low-<br>level stone upstand to<br>pavement edge/ tarmac<br>pavement. stone pier with 4-<br>way cap, painted. |

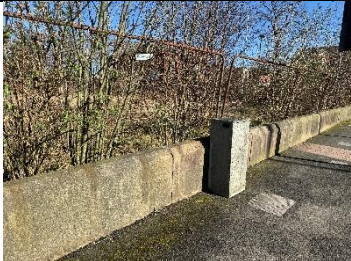
| 33 | Drake Street,<br>Rochdale, OL16 1PJ | Boundary wall<br>positioned to the<br>South of the site,<br>facing from the<br>external site perimeter | | Heras fencing along boundary<br>of site. Overgrown vegetation<br>along perimeter. Electrical box<br>in good condition adjacent to<br>site curtilage. Slight staining and<br>surface deposits/ patina to<br>stone walling. |

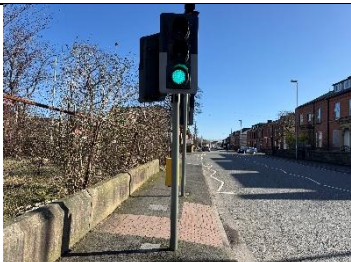
| 34 | Drake Street,<br>Rochdale, OL16 1PJ | Boundary wall<br>positioned to the<br>South of the site,<br>facing from the<br>external site perimeter | | Heras fencing along boundary<br>of site. Overgrown vegetation<br>along perimeter. Traffic light in<br>good condition and positioned<br>adjacent to pedestrian crossing.<br>tarmacadam pavement/ pre<br>cast concrete pavours<br>demarcating crossing point. |

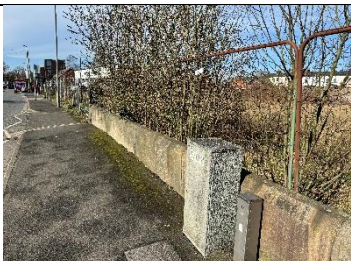
| 35 | Drake Street,<br>Rochdale, OL16 1PJ | Boundary wall<br>positioned to the<br>South of the site,<br>facing from the<br>external site perimeter | | Heras fencing along boundary<br>of site. Overgrown vegetation<br>along perimeter. Electrical box<br>in good condition adjacent to<br>site curtilage. Slight staining and<br>surface deposits/ patina to<br>stone walling. |

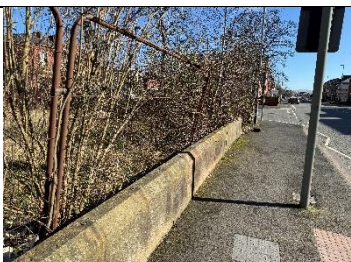
| 36 | Drake Street,<br>Rochdale, OL16 1PJ | Boundary wall<br>positioned to the<br>South of the site,<br>facing from the<br>external site perimeter | | Heras fencing along boundary<br>of site. Overgrown vegetation<br>along perimeter. Slight staining<br>and surface deposits/ patina to<br>stone walling. |

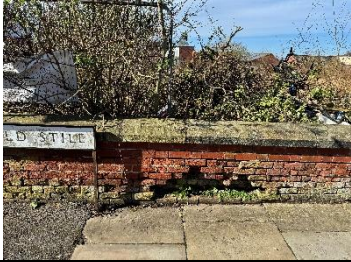
| 43 | Broadfield Stile, Rochdale, OL16 1PJ | Boundary wall positioned to the East of the site, facing from the external site perimeter | | Solid masonry wall. Cracked bricks, spalling, missing pointing and damaged in various areas throughout length of the wall. Stone copings installed appear generally intact. Missing brick work at base of wall. Road name signage corroded. |

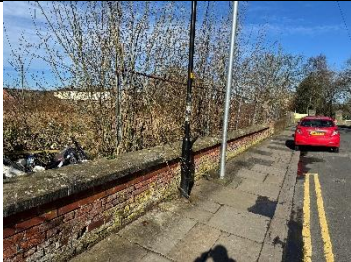
| 44 | Broadfield Stile, Rochdale, OL16 1PJ | Boundary wall positioned to the East of the site, facing from the external site perimeter | | Solid masonry wall. Cracked bricks, spalling, missing pointing and damaged in various areas throughout length of the wall. Stone copings installed appear generally intact. Telephone pole and street lighting installed |

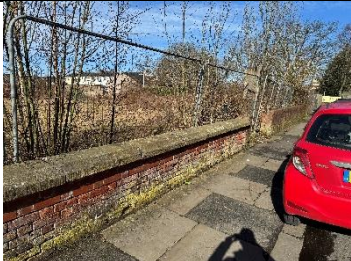
| 45 | Broadfield Stile, Rochdale, OL16 1PJ | Boundary wall positioned to the East of the site, facing from the external site perimeter | | Heras fencing along boundary of site. Solid masonry wall. Cracked bricks, spalling, missing pointing and damaged in various areas throughout length of the wall. Stone copings installed appear generally intact. |

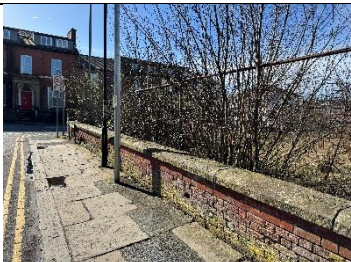
| 46 | Broadfield Stile, Rochdale, OL16 1PJ | Boundary wall positioned to the East of the site, facing from the external site perimeter | | Heras fencing along boundary of site. Solid masonry wall. Cracked bricks, spalling, missing pointing and damaged in various areas throughout length of the wall. Stone copings installed appear generally intact. |

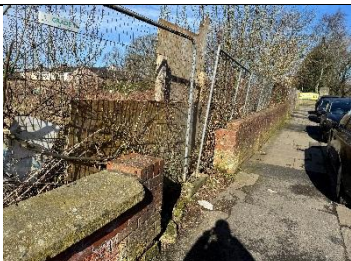
| 47 | Broadfield Stile, Rochdale, OL16 1PJ | Boundary wall positioned to the East of the site, facing from the external site perimeter | | Heras fencing along boundary of site. Solid masonry wall. Cracked bricks, spalling, missing pointing and damaged in various areas throughout length of the wall. Site entrance blocked by plywood, Heras fencing and vegetation. |

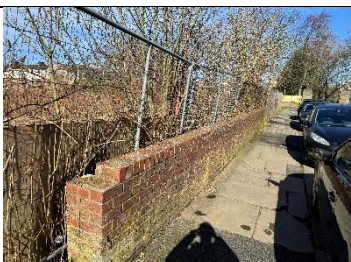
| 48 | Broadfield Stile, Rochdale, OL16 1PJ | Boundary wall positioned to the East of the site, facing from the external site perimeter | | Heras fencing along boundary of site. Solid masonry wall with brick on edge finish. General water staining and minor vegetation at low level. Site entrance blocked by plywood, Heras fencing and vegetation. Missing brick on edge locally. |

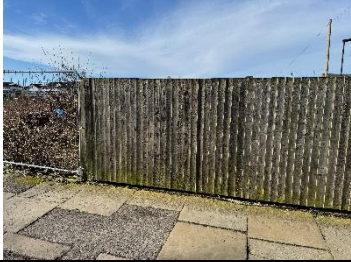
| 55 | Broadfield Stile,<br>Rochdale, OL16 1PJ | Boundary wall<br>positioned to the East<br>of the site, facing from<br>the external site<br>perimeter | | Timber featheredge fence to<br>boundary. Vegetation behind<br>fence. General weathering and<br>discoloration to boards. Fence<br>line slightly out of plumb.<br>Cracked and uneven pavements<br>to pavement. |

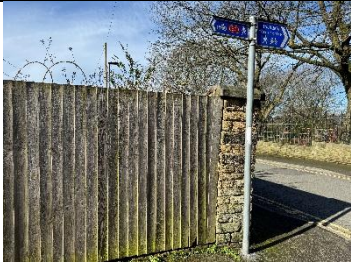
| 56 | Broadfield Stile,<br>Rochdale, OL16 1PJ | Boundary wall<br>positioned to the East<br>of the site, facing from<br>the external site<br>perimeter | | Timber featheredge fence to<br>boundary. Vegetation behind<br>fence. General weathering and<br>discoloration to boards. Fence<br>line slightly out of plumb.<br>Cracked and uneven pavements<br>to pavement. Way finder signage<br>in good condition. |

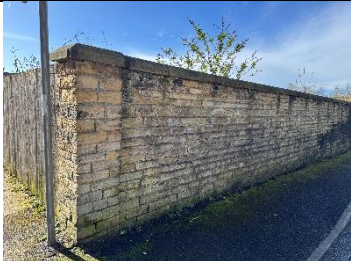
| 57 | St Alban's Street,<br>Rochdale, OL16 1UU | Boundary wall<br>positioned to the<br>North of the site,<br>facing from the<br>external site perimeter | | Solid stone wall with various<br>cracked, missing and friable<br>pointing along its length. Wall is<br>variously stained/ weathered.<br>Coping stones weathered/<br>appear seated and intact. Ivy<br>present and cut back in part.<br>Lean observed to this section. |

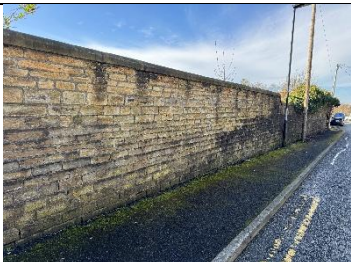
| 58 | St Alban's Street,<br>Rochdale, OL16 1UU | Boundary wall<br>positioned to the<br>North of the site,<br>facing from the<br>external site perimeter | | Solid stone wall with various<br>cracked, missing and friable<br>pointing along its length. Wall is<br>variously stained/ weathered.<br>Coping stones weathered/<br>appear seated and intact. Ivy<br>present and cut back in part.<br>Lean observed to this section. |

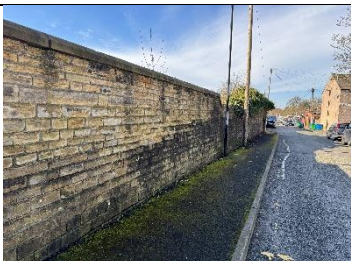
| 59 | St Alban's Street,<br>Rochdale, OL16 1UU | Boundary wall<br>positioned to the<br>North of the site,<br>facing from the<br>external site perimeter | | Solid stone wall with various<br>cracked, missing and friable<br>pointing along its length. Wall is<br>variously stained/ weathered.<br>Coping stones weathered/<br>appear seated and intact. Ivy<br>present and cut back in part.<br>Lean observed to this section. |

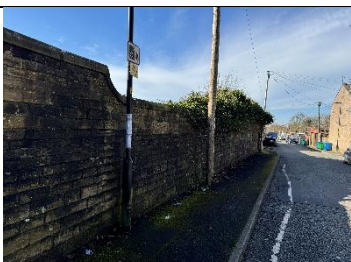
| 60 | St Alban's Street,<br>Rochdale, OL16 1UU | Boundary wall<br>positioned to the<br>North of the site,<br>facing from the<br>external site perimeter | | Solid stone wall with various<br>cracked, missing and friable<br>pointing along its length. Wall is<br>variously stained/ weathered.<br>Coping stones weathered/<br>appear seated and intact. Lamp<br>post stained to lower part.<br>telephone pole present. |

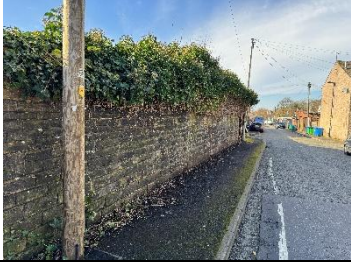
| 61 | St Alban's Street,<br>Rochdale, OL16 1UU | Boundary wall positioned to the North of the site, facing from the external site perimeter | | Solid stone wall with various cracked, missing and friable pointing along its length. Wall is variously stained/ weathered. Coping stones weathered/ appear seated and intact. Ivy present and cut back in part. |

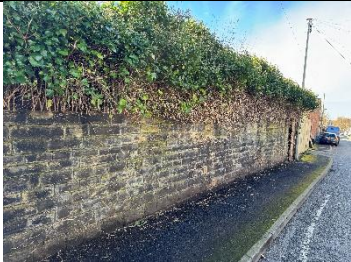
| 62 | St Alban's Street,<br>Rochdale, OL16 1UU | Boundary wall positioned to the North of the site, facing from the external site perimeter | | Solid stone wall with various cracked, missing and friable pointing along its length. Wall is variously stained/ weathered. Coping stones weathered/ appear seated and intact. Ivy present and cut back in part. |

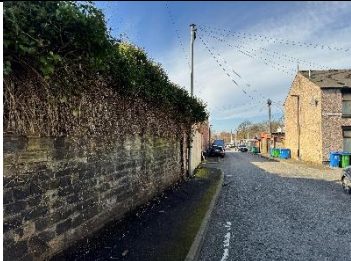
| 63 | St Alban's Street,<br>Rochdale, OL16 1UU | Boundary wall positioned to the North of the site, facing from the external site perimeter | | Solid stone wall with various cracked, missing and friable pointing along its length. Wall is variously stained/ weathered. Coping stones weathered/ appear seated and intact. Ivy present and cut back in part. |

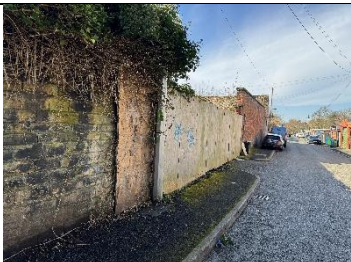
| 64 | St Alban's Street,<br>Rochdale, OL16 1UU | Boundary wall positioned to the North of the site, facing from the external site perimeter | | Plywood panels blocking entrance to the site. Vegetation behind plywood panels and ivy located at the top of the panels. Delamination noted to some localised areas indicating hoarding is approaching the end of its useful life. |

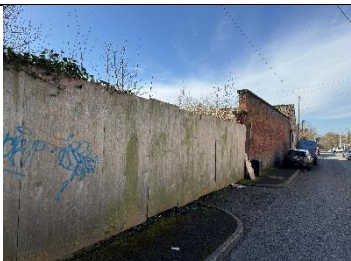
| 65 | St Alban's Street,<br>Rochdale, OL16 1UU | Boundary wall positioned to the North of the site, facing from the external site perimeter | | Plywood panels blocking entrance to the site. Vegetation behind plywood panels and ivy located at the top of the panels. Delamination noted to some localised areas indicating hoarding is approaching the end of its useful life. |

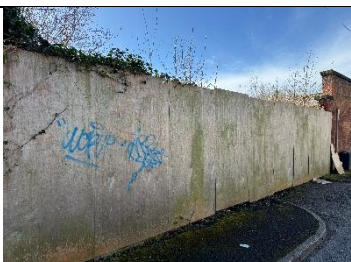
| 66 | St Alban's Street,<br>Rochdale, OL16 1UU | Boundary wall positioned to the North of the site, facing from the external site perimeter | | Plywood panels blocking entrance to the site. Vegetation behind plywood panels and ivy located at the top of the panels. Delamination noted to some localised areas indicating hoarding is approaching the end of its useful life. |

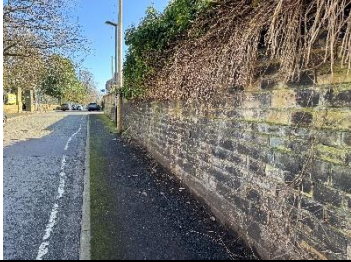
| 73 | St Alban's Street,<br>Rochdale, OL16 1UU | Boundary wall<br>positioned to the<br>North of the site,<br>facing from the<br>external site perimeter | | Solid stone wall with various cracked, missing and friable pointing along its length. Wall is variously stained/ weathered. Coping stones weathered/ appear seated and intact. telephone pole present. Ivy growth present/ cut back. |

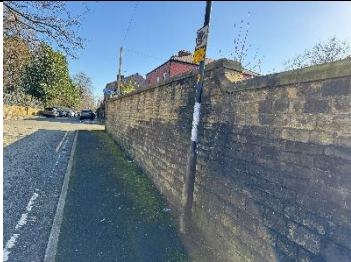
| 74 | St Alban's Street,<br>Rochdale, OL16 1UU | Boundary wall<br>positioned to the<br>North of the site,<br>facing from the<br>external site perimeter | | Solid stone wall with various cracked, missing and friable pointing along its length. Wall is variously stained/ weathered. Coping stones weathered/ appear seated and intact. Lamp post in good condition, staining to lower part. |

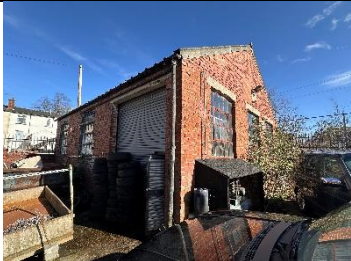
| 75 | Speedwell Garage<br>Ltd, 210-216 Drake<br>Street, Rochdale,<br>OL16 1UP | Boundary structure<br>positioned to the West<br>of the site, facing from<br>the external site<br>perimeter | | Overview of the masonry structure from within Speedwell Garage. Corrugated concrete roof covering and concrete rainwater goods; suspected asbestos. Various impact damage. Lintels over windows are cracked/ spalled. |

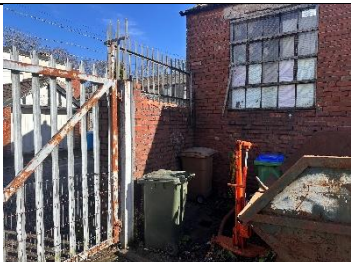
| 76 | Speedwell Garage<br>Ltd, 210-216 Drake<br>Street, Rochdale,<br>OL16 1UP | Boundary structure<br>positioned to the West<br>of the site, facing from<br>the external site<br>perimeter | | Overview of the masonry structure from within Speedwell Garage. Corrugated concrete roof covering and concrete rainwater goods; suspected asbestos. Various impact damage. Lintel over window is cracked/ spalled. |

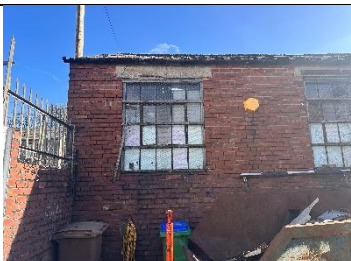
| 77 | Speedwell Garage<br>Ltd, 210-216 Drake<br>Street, Rochdale,<br>OL16 1UP | Boundary structure<br>positioned to the West<br>of the site, facing from<br>the external site<br>perimeter | | Overview of the masonry structure from within Speedwell Garage. Corrugated concrete roof covering and concrete rainwater goods; suspected asbestos. Various impact damage. Lintel over window is cracked/ spalled. |

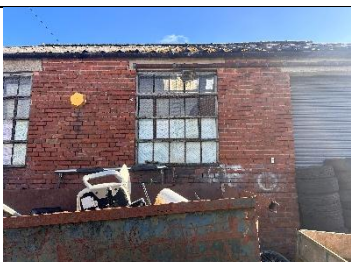
| 78 | Speedwell Garage<br>Ltd, 210-216 Drake<br>Street, Rochdale,<br>OL16 1UP | Boundary structure<br>positioned to the West<br>of the site, facing from<br>the external site<br>perimeter | | Overview of the masonry structure from within Speedwell Garage. Corrugated concrete roof covering and concrete rainwater goods; suspected asbestos. Various impact damage. |

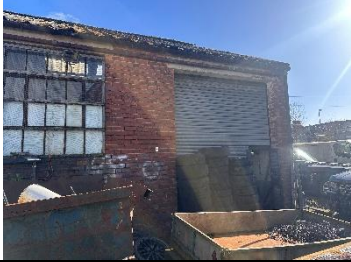
| 79 | Speedwell Garage Ltd, 210-216 Drake Street, Rochdale, OL16 1UP | Boundary structure positioned to the West of the site, facing from the external site perimeter | | Cracked and blown lintel above garage door/ impact damage. Solid masonry structure situated within Speedwell Garage and close to the boundary. Suspected asbestos roof and rainwater goods. |

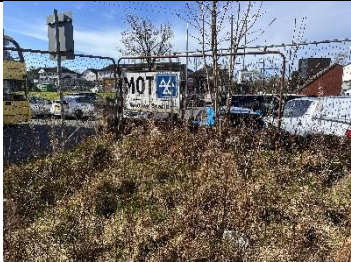
| 80 | Speedwell Garage Ltd, 210-216 Drake Street, Rochdale, OL16 1UP | Boundary wall positioned to the West of the site, facing from within the site curtilage | | Solid masonry wall finished with brick on edge course, cracked/spalled bricks, missing pointing, brick on edge variously spalled. Vegetation to several areas. Heras fencing installed to secure site. Self-seeded saplings/ vegetation. |

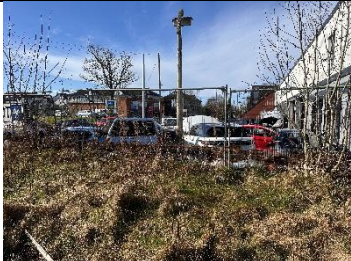
| 81 | Speedwell Garage Ltd, 210-216 Drake Street, Rochdale, OL16 1UP | Boundary wall positioned to the West of the site, facing from within the site curtilage | | Solid masonry wall finished with brick on edge course, cracked/spalled bricks, missing pointing, brick on edge variously spalled. Vegetation to several areas. Heras fencing installed to secure site. Self-seeded saplings/ vegetation. |

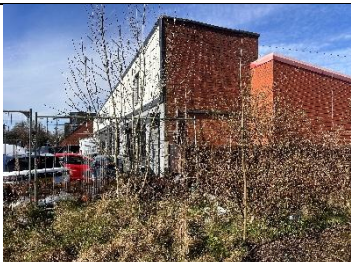
| 82 | Speedwell Garage Ltd, 210-216 Drake Street, Rochdale, OL16 1UP | Boundary wall positioned to the West of the site, facing from within the site curtilage | | Solid masonry wall. Minor vegetative growth to the length of the wall. Brick on edge finish. Missing/ loose pointing. Some localised spalling/ brick decay. Limited observations due to vegetative growth within the site. |

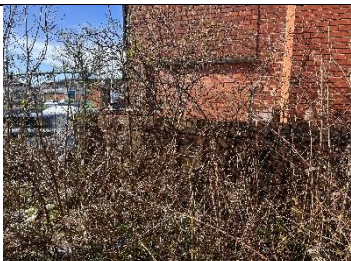
| 83 | Speedwell Garage Ltd, 210-216 Drake Street, Rochdale, OL16 1UP | Boundary wall positioned to the West of the site, facing from within the site curtilage | | Solid masonry wall. Minor vegetative growth to the length of the wall. Brick on edge finish. Missing/ loose pointing. Some localised spalling/ brick decay. Limited observations due to vegetative growth within the site. |

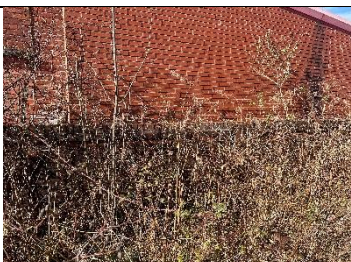
| 84 | Speedwell Garage Ltd, 210-216 Drake Street, Rochdale, OL16 1UP | Boundary wall positioned to the West of the site, facing from within the site curtilage | | Solid masonry wall. Minor vegetative growth to the length of the wall. Brick on edge finish. Missing/ loose pointing. Some localised spalling/ brick decay. Limited observations due to vegetative growth within the site. |

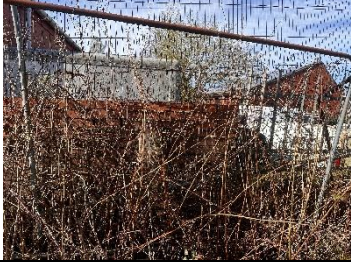
| 91 | Speedwell Garage Ltd, 210-216 Drake Street, Rochdale, OL16 1UP | Boundary wall positioned to the West of the site, facing from within the site curtilage | | Solid masonry wall. Minor vegetative growth to the length of the wall. unfinished stretcher bond. Poorly pointed, missing/ loose pointing. Buddleia growth to some localised areas. Limited observations due to vegetative growth within the site. |

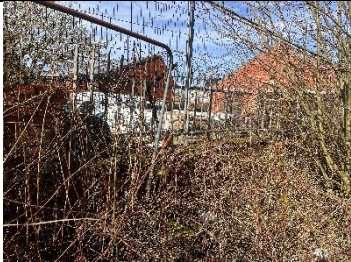
| 92 | Speedwell Garage Ltd, 210-216 Drake Street, Rochdale, OL16 1UP | Boundary wall positioned to the West of the site, facing from within the site curtilage | | Solid masonry wall. Minor vegetative growth to the length of the wall. Brick on edge finish. Various spalling, brick decay and missing/ loose pointing. Buddleia growth to some localised areas. Various stained. Palisade installed. |

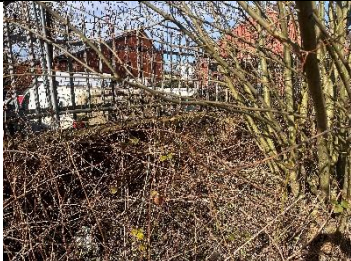
| 93 | Speedwell Garage Ltd, 210-216 Drake Street, Rochdale, OL16 1UP | Boundary wall positioned to the West of the site, facing from within the site curtilage | | Solid masonry wall. Minor vegetative growth to the length of the wall. Brick on edge finish. Various spalling, brick decay and missing/ loose pointing. Buddleia growth to some localised areas. Various stained. Palisade installed. |

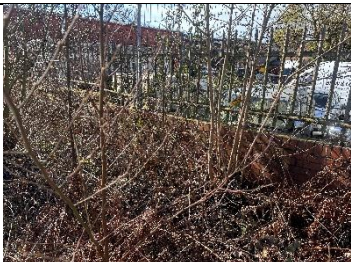
| 94 | Speedwell Garage Ltd, 210-216 Drake Street, Rochdale, OL16 1UP | Boundary wall positioned to the West of the site, facing from within the site curtilage | | Solid masonry wall. Minor vegetative growth to the length of the wall. Brick on edge finish. Various spalling, brick decay and missing/ loose pointing. Buddleia growth to some localised areas. Various stained. Palisade installed. |

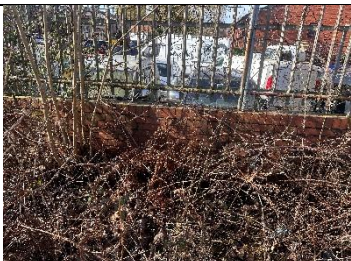
| 95 | Speedwell Garage Ltd, 210-216 Drake Street, Rochdale, OL16 1UP | Boundary wall positioned to the West of the site, facing from within the site curtilage | | Solid masonry wall. Minor vegetative growth to the length of the wall. Brick on edge finish. Various spalling, brick decay and missing/ loose pointing. Buddleia growth to some localised areas. Various stained. Palisade installed. |

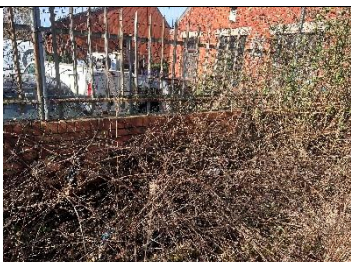
| 96 | Speedwell Garage Ltd, 210-216 Drake Street, Rochdale, OL16 1UP | Boundary wall positioned to the West of the site, facing from within the site curtilage | | Solid masonry wall. Minor vegetative growth to the length of the wall. Brick on edge finish. Various spalling, brick decay and missing/ loose pointing. Buddleia growth to some localised areas. Various stained. Palisade installed. |

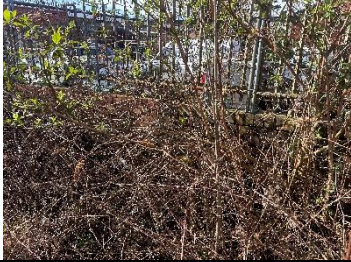
| 97 | Speedwell Garage Ltd, 210-216 Drake Street, Rochdale, OL16 1UP | Boundary wall positioned to the West of the site, facing from within the site curtilage | | Solid masonry wall. Minor vegetative growth to the length of the wall. Brick on edge finish. Various spalling, brick decay and missing/ loose pointing. Buddleia growth to some localised areas. Variously stained. Palisade installed. |

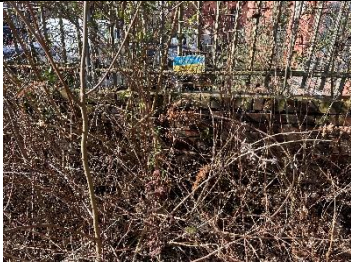
| 98 | Speedwell Garage Ltd, 210-216 Drake Street, Rochdale, OL16 1UP | Boundary wall positioned to the West of the site, facing from within the site curtilage | | Solid masonry wall. Minor vegetative growth to the length of the wall. Brick on edge finish. Various spalling, brick decay and missing/ loose pointing. Buddleia growth to some localised areas. Variously stained. Palisade installed. |

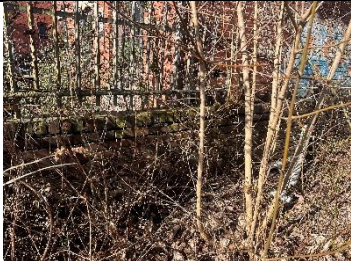
| 99 | Speedwell Garage Ltd, 210-216 Drake Street, Rochdale, OL16 1UP | Boundary wall positioned to the West of the site, facing from within the site curtilage | | Solid masonry wall. Minor vegetative growth to the length of the wall. Brick on edge finish. Various spalling, brick decay and missing/ loose pointing. Buddleia growth to some localised areas. Variously stained. Palisade installed. |

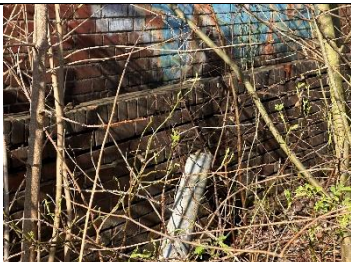
| 100 | Speedwell Garage Ltd, 210-216 Drake Street, Rochdale, OL16 1UP | Boundary wall positioned to the West of the site, facing from within the site curtilage | | Solid masonry wall. Minor vegetative growth to the length of the wall. Brick on edge finish. Various spalling, brick decay and missing/ loose pointing. Buddleia growth to some localised areas. Variously stained. |

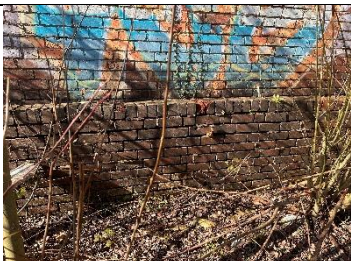
| 101 | Speedwell Garage Ltd, 210-216 Drake Street, Rochdale, OL16 1UP | Boundary wall positioned to the West of the site, facing from within the site curtilage | | Solid masonry wall. Minor vegetative growth to the length of the wall. Brick on edge finish. Various spalling, brick decay and missing/ loose pointing. Buddleia growth to some localised areas. Variously stained. |

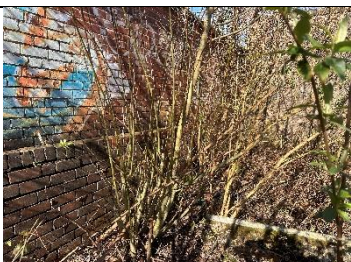
| 102 | Speedwell Garage Ltd, 210-216 Drake Street, Rochdale, OL16 1UP | Boundary wall positioned to the West of the site, facing from within the site curtilage | | Solid masonry wall. Minor vegetative growth to the length of the wall. Brick on edge finish. Various spalling, brick decay and missing/ loose pointing. Buddleia growth to some localised areas. Variously stained. |

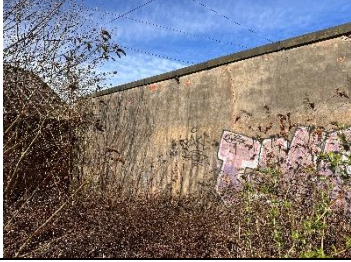
| 109 | St Alban's Street,<br>Rochdale, OL16 1UU | Boundary wall<br>positioned to the<br>North of the site,<br>facing from within the<br>site curtilage | | Solid masonry wall. Sand/<br>cement render installed;<br>variously weathered cracked<br>and missing. Coping stones<br>weathered/ generally appear<br>intact/ seated atop the wall.<br>Missing pointing/ spalling of<br>brickwork. Graffiti present. |

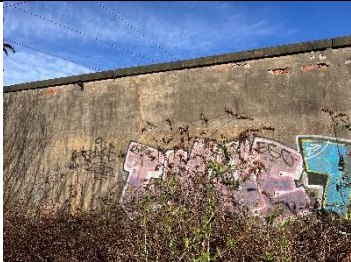
| 110 | St Alban's Street,<br>Rochdale, OL16 1UU | Boundary wall<br>positioned to the<br>North of the site,<br>facing from within the<br>site curtilage | | Solid masonry wall. Sand/<br>cement render installed;<br>variously weathered cracked<br>and missing. Coping stones<br>weathered/ generally appear<br>intact/ seated atop the wall.<br>Missing pointing/ spalling of<br>brickwork. Graffiti present. |

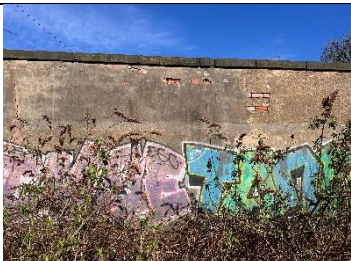
| 111 | St Alban's Street,<br>Rochdale, OL16 1UU | Boundary wall<br>positioned to the<br>North of the site,<br>facing from within the<br>site curtilage | | Solid masonry wall. Sand/<br>cement render installed;<br>variously weathered cracked<br>and missing. Coping stones<br>weathered/ generally appear<br>intact/ seated atop the wall.<br>Missing pointing/ spalling of<br>brickwork. Graffiti present. |

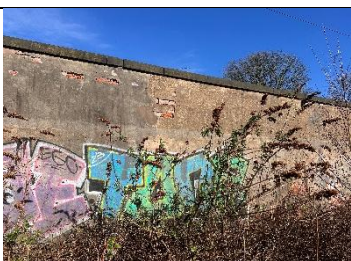
| 112 | St Alban's Street,<br>Rochdale, OL16 1UU | Boundary wall<br>positioned to the<br>North of the site,<br>facing from within the<br>site curtilage | | Solid masonry wall. Sand/<br>cement render installed;<br>variously weathered cracked<br>and missing. Coping stones<br>weathered/ generally appear<br>intact/ seated atop the wall.<br>Missing pointing/ spalling of<br>brickwork. Graffiti present. |

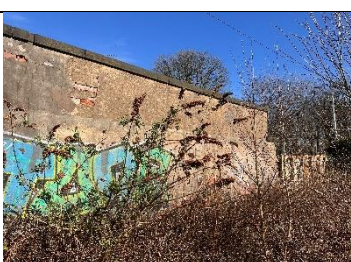
| 113 | St Alban's Street,<br>Rochdale, OL16 1UU | Boundary wall<br>positioned to the<br>North of the site,<br>facing from within the<br>site curtilage | | Solid masonry wall. Sand/<br>cement render installed;<br>variously weathered cracked<br>and missing. Coping stones<br>weathered/ generally appear<br>intact/ seated atop the wall.<br>Missing pointing/ spalling of<br>brickwork. Graffiti present. |

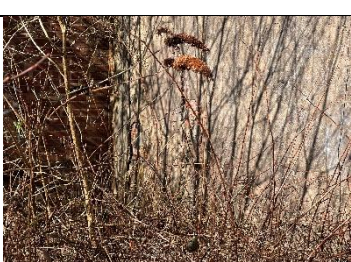
| 114 | St Alban's Street,<br>Rochdale, OL16 1UU | Boundary wall<br>positioned to the<br>North of the site,<br>facing from within the<br>site curtilage | | Solid masonry wall. Cracked<br>Solid masonry wall. Sand/<br>cement render installed;<br>variously weathered cracked<br>and missing. Coping stones<br>weathered/ generally appear<br>intact/ seated atop the wall.<br>Missing pointing/ spalling of<br>brickwork. |

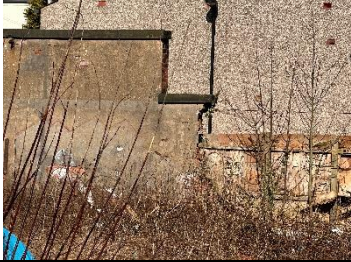
| 121 | St Alban's Street,<br>Rochdale, OL16 1UU | Boundary wall<br>positioned to the<br>North of the site,<br>facing from within the<br>site curtilage | | Solid masonry wall poorly terminated. Several cracked and defective bricks. Sand/ cement render installed; variously weathered cracked and missing. Coping stones weathered/ generally appear intact/ seated atop the wall. |

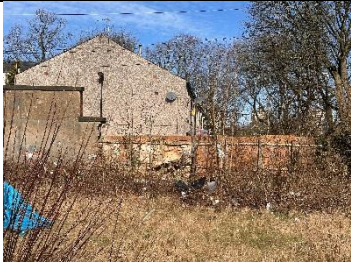
| 122 | St Alban's Street,<br>Rochdale, OL16 1UU | Boundary wall<br>positioned to the<br>North of the site,<br>facing from within the<br>site curtilage | | Timber post and ply hoarded section of the site; suspected temporary structure to secure site perimeter. Debris/ general rubbish to site boundary. Plywood delaminated to several boards and is likely approaching the end of its useful life. |

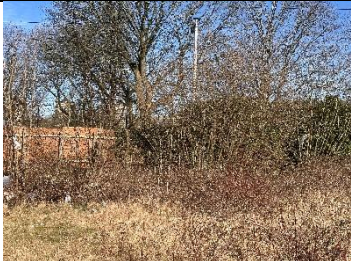
| 123 | St Alban's Street,<br>Rochdale, OL16 1UU | Boundary wall<br>positioned to the<br>North of the site,<br>facing from within the<br>site curtilage | | Timber post and ply hoarded section of the site; limited observation due to vegetative growth. Suspected temporary structure to secure site perimeter. Debris/ general rubbish to site boundary. |

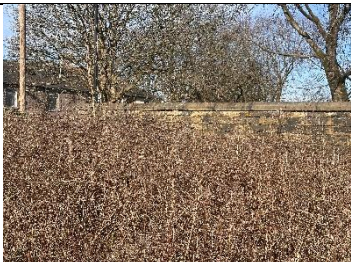
| 124 | St Alban's Street,<br>Rochdale, OL16 1UU | Boundary wall<br>positioned to the<br>North of the site,<br>facing from within the<br>site curtilage | | Angular coursed stone wall. Surface patina. Stone copings appear intact. Limited observation of lower section due to vegetative growth. Pointing generally appears intact to this section. Some spalling noted to lighter areas. |

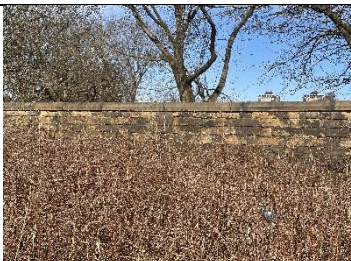
| 125 | St Alban's Street,<br>Rochdale, OL16 1UU | Boundary wall<br>positioned to the<br>North of the site,<br>facing from within the<br>site curtilage | | Angular coursed stone wall. Surface patina. Stone copings appear intact. Limited observation of lower section due to vegetative growth. Pointing generally appears intact to this section. Some spalling noted to lighter areas. |

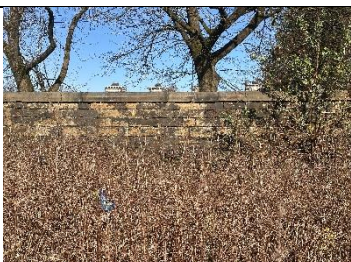
| 126 | St Alban's Street,<br>Rochdale, OL16 1UU | Boundary wall<br>positioned to the<br>North of the site,<br>facing from within the<br>site curtilage | | Angular coursed stone wall. Surface patina. Stone copings appear intact. Limited observation of lower section due to vegetative growth. Pointing generally appears intact to this section. Some spalling noted to lighter areas. |

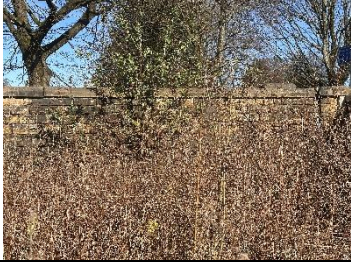
| 127 | St Alban's Street,<br>Rochdale, OL16 1UU | Boundary wall<br>positioned to the<br>North of the site,<br>facing from within the<br>site curtilage | | Limited observations of angular<br>coursed stone wall due to<br>vegetative growth obstructing<br>view. Surface patina/ buddleia<br>growth observed. Stone copings<br>appear intact. |

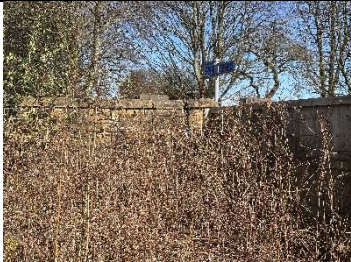
| 128 | St Alban's Street,<br>Rochdale, OL16 1UU | Boundary wall<br>positioned to the<br>North of the site,<br>facing from within the<br>site curtilage | | Timber post and feather edge<br>board generally appears intact;<br>limited observations due to<br>vegetative growth to site.<br>Missing pointing to angular<br>coursed stone wall/ surface<br>patina/ buddleia growth. Stone<br>coping appear intact. |

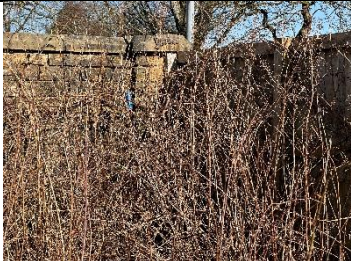
| 129 | St Alban's Street,<br>Rochdale, OL16 1UU | Boundary wall<br>positioned to the<br>North of the site,<br>facing from within the<br>site curtilage | | Timber post and feather edge<br>board generally appears intact;<br>limited observations due to<br>vegetative growth to site.<br>Missing pointing to angular<br>coursed stone wall/ surface<br>patina/ buddleia growth. Stone<br>coping appear intact. |

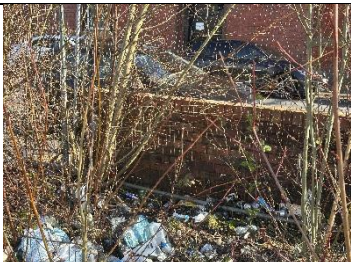
| 130 | Broadfield Stile,<br>Rochdale, OL16 1PJ | Boundary wall<br>positioned to the East<br>of the site, facing from<br>within the site<br>curtilage | | Heras fencing installed behind<br>masonry wall within the site.<br>Self-seeded and vegetative<br>growth intertwined within<br>Heras. Debris along site<br>boundary. Minor defects to<br>brickwork/ pointing. Brick on<br>edge finish; some missing. |

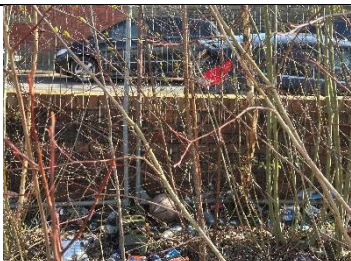
| 131 | Broadfield Stile,<br>Rochdale, OL16 1PJ | Boundary wall<br>positioned to the East<br>of the site, facing from<br>within the site<br>curtilage | | Heras fencing installed behind<br>masonry wall within the site.<br>Self-seeded and vegetative<br>growth intertwined within<br>Heras. Debris along site<br>boundary. Minor defects to<br>brickwork/ pointing. Brick on<br>edge finish; some missing. |

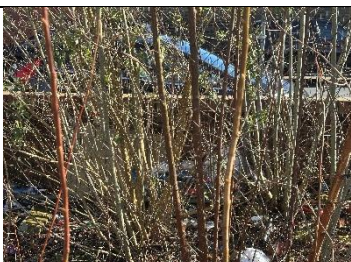
| 132 | Broadfield Stile,<br>Rochdale, OL16 1PJ | Boundary wall<br>positioned to the East<br>of the site, facing from<br>within the site<br>curtilage | | Heras fencing installed behind<br>masonry wall within the site.<br>Self-seeded and vegetative<br>growth intertwined within<br>Heras. Debris along site<br>boundary. Minor defects to<br>brickwork/ pointing. Brick on<br>edge finish; some missing. |

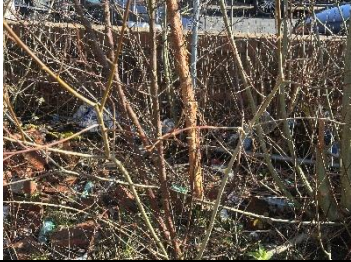
| 133 | Broadfield Stile, Rochdale, OL16 1PJ | Boundary wall positioned to the East of the site, facing from within the site curtilage | | Heras fencing installed behind masonry wall within the site. Self-seeded and vegetative growth intertwined within Heras. Debris along site boundary. Minor defects to brickwork/ pointing. Brick on edge finish; some missing. |

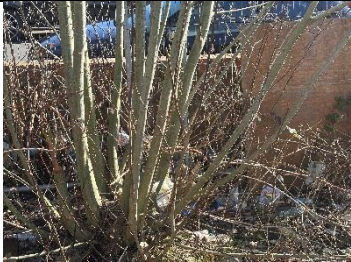
| 134 | Broadfield Stile, Rochdale, OL16 1PJ | Boundary wall positioned to the East of the site, facing from within the site curtilage | | Heras fencing installed behind masonry wall within the site. Self-seeded and vegetative growth intertwined within Heras. Debris along site boundary. Minor defects to brickwork/ pointing. Brick on edge finish; some missing. |

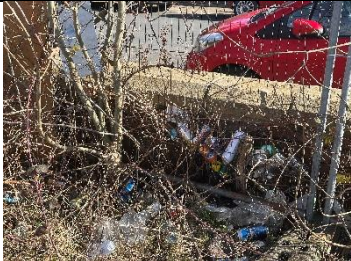
| 135 | Broadfield Stile, Rochdale, OL16 1PJ | Boundary wall positioned to the East of the site, facing from within the site curtilage | | Heras fencing installed behind masonry wall within the site. Self-seeded and vegetative growth intertwined within Heras. Debris along site boundary. Minor defects to brickwork/ stone copings installed and generally intact. |

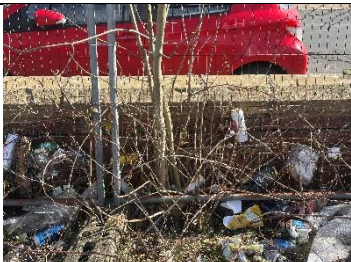
| 136 | Broadfield Stile, Rochdale, OL16 1PJ | Boundary wall positioned to the East of the site, facing from within the site curtilage | | Heras fencing installed behind masonry wall within the site. Self-seeded and vegetative growth intertwined within Heras. Debris along site boundary. Minor defects to brickwork/ stone copings installed and generally intact. |

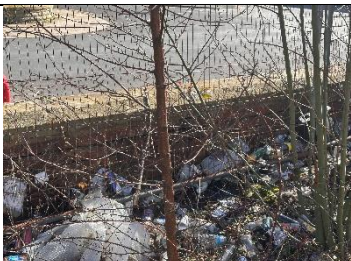
| 137 | Broadfield Stile, Rochdale, OL16 1PJ | Boundary wall positioned to the East of the site, facing from within the site curtilage | | Heras fencing installed behind masonry wall within the site. Self-seeded and vegetative growth intertwined within Heras. Debris along site boundary. Minor defects to brickwork/ stone copings installed and generally intact. |

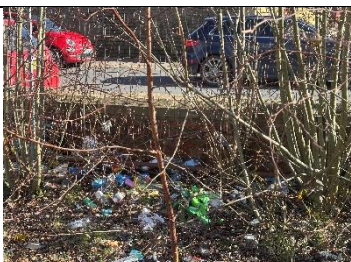
| 138 | Broadfield Stile, Rochdale, OL16 1PJ | Boundary wall positioned to the East of the site, facing from within the site curtilage | | Heras fencing installed behind masonry wall within the site. Self-seeded and vegetative growth intertwined within Heras. Debris along site boundary. Minor defects to brickwork/ stone copings installed and generally intact. |

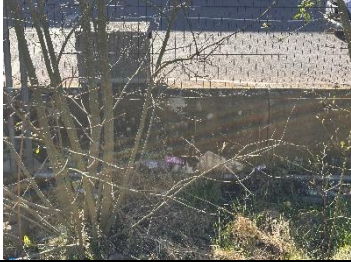
| 145 | Drake Street,<br>Rochdale, OL16 1PJ | Boundary wall<br>positioned to the<br>South of the site,<br>facing from within the<br>site curtilage | | Heras fencing installed behind<br>stone boundary within the site.<br>Self-seeded and vegetative<br>growth intertwined within<br>Heras. Debris along site<br>boundary. Limited observations<br>of wall. Surface patina/ limited<br>defects observed. |

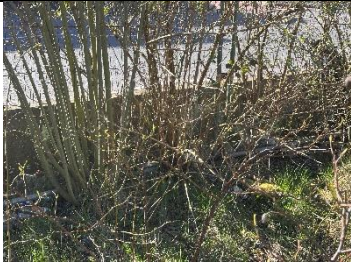
| 146 | Drake Street,<br>Rochdale, OL16 1PJ | Boundary wall<br>positioned to the<br>South of the site,<br>facing from within the<br>site curtilage | | Heras fencing installed behind<br>stone boundary within the site.<br>Self-seeded and vegetative<br>growth intertwined within<br>Heras. Debris along site<br>boundary. Limited observations<br>of wall. Surface patina/ limited<br>defects observed. |

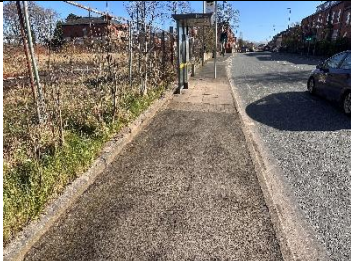
| 147 | Drake Street,<br>Rochdale, OL16 1PJ | Hardstanding to the<br>South of the site,<br>facing from the<br>external site perimeter | | Tarmacadam pedestrian<br>pavement, general condition is<br>sound; no potholing or<br>otherwise observed. Some<br>patch repairs noted. Minor<br>vegetative build up along site<br>boundary. Kerb edging in place<br>and intact. |

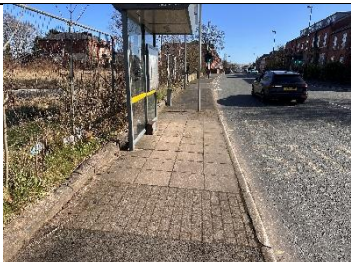
| 148 | Drake Street,<br>Rochdale, OL16 1PJ | Boundary wall<br>positioned to the<br>South of the site,<br>facing from the<br>external site perimeter | | Bus shelter positioned adjacent<br>to the site boundary; steel/<br>glazed partition with overhead<br>canopy; no obvious defects<br>observed. hardstanding<br>comprises block paving and<br>precast concrete paviours;<br>some minor unevenness noted. |

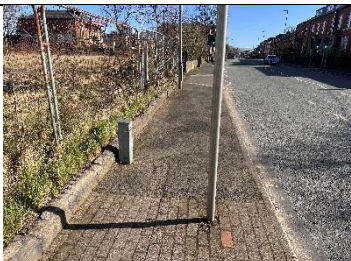
| 149 | Drake Street,<br>Rochdale, OL16 1PJ | Boundary wall<br>positioned to the<br>South of the site,<br>facing from the<br>external site perimeter | | Tarmacadam pedestrian<br>pavement, general condition is<br>sound; no potholing or<br>otherwise observed. Some<br>patch repairs noted. Minor<br>vegetative build up along site<br>boundary. Kerb edging in place<br>and intact. |

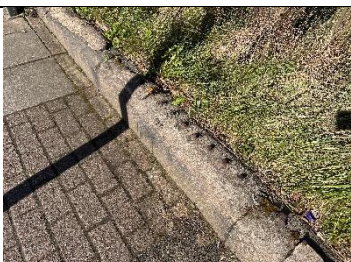
| 150 | Drake Street,<br>Rochdale, OL16 1PJ | Boundary wall<br>positioned to the<br>South of the site,<br>facing from the<br>external site perimeter | | Cuts ends of suspected former<br>wrought iron railings integrated<br>within the stone upstand. Cut<br>ends corroded and flaunching<br>installed to other areas has<br>failed to this location;<br>therefore, cut ends are<br>exposed. Minor vegetation. |

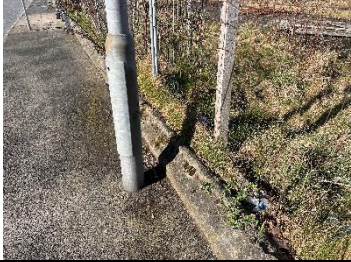
| 151 | Drake Street,<br>Rochdale, OL16 1PJ | Boundary wall<br>positioned to the<br>South of the site,<br>facing from the<br>external site perimeter | | Galvanized steel street lighting<br>positioned to the South of the site.<br>Stone upstand to this<br>location has failed likely due to<br>former corrosion/ expansion of<br>wrought iron railings and now<br>weathered. Minor vegetation<br>present to this area. |

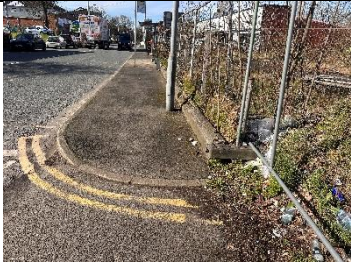
| 152 | Drake Street,<br>Rochdale, OL16 1PJ | Boundary wall<br>positioned to the<br>South of the site,<br>facing from the<br>external site perimeter | | Left side of the existing site<br>entrance to Drake Street.<br>Painted double yellow lines and<br>dopped kerb to this location.<br>Some fading of line making<br>observed. vegetation/ debris to<br>tarmacadam hardstanding to<br>site entrance. |

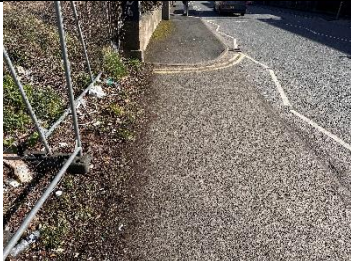
| 153 | Drake Street,<br>Rochdale, OL16 1PJ | Boundary wall<br>positioned to the<br>South of the site,<br>facing from the<br>external site perimeter | | Right side of the existing site<br>entrance to Drake Street.<br>Painted double yellow lines and<br>dopped kerb to this location.<br>Some fading of line making<br>observed. vegetation/ debris to<br>tarmacadam hardstanding to<br>site entrance. |

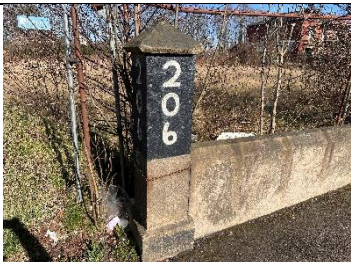
| 154 | Drake Street,<br>Rochdale, OL16 1PJ | Boundary wall<br>positioned to the<br>South of the site,<br>facing from the<br>external site perimeter | | Stone pier to Southwest corner<br>of the site. Painted upper<br>section of pier indicating former<br>site number '206'. 4-way pier<br>cap installed with some impact<br>damage/ spalling to corners.<br>Corrosive staining observed due<br>to chain installed around pier. |

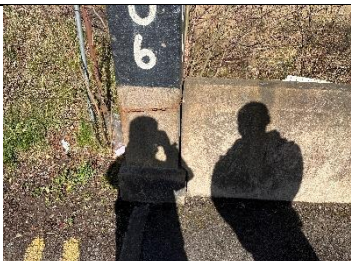
| 155 | Drake Street,<br>Rochdale, OL16 1PJ | Boundary wall<br>positioned to the<br>South of the site,<br>facing from the<br>external site perimeter | | Slight separation noted at<br>vertical junction of stone pier<br>where this abuts stone walling,<br>approximately 10mm. Slight<br>staining and surface deposits/<br>patina to stone. |

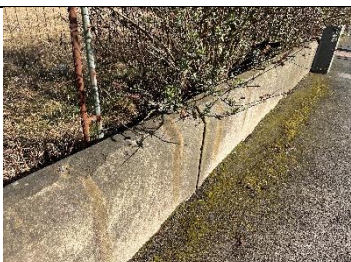
| 156 | Drake Street,<br>Rochdale, OL16 1PJ | Boundary wall<br>positioned to the<br>South of the site,<br>facing from the<br>external site perimeter | | Slight separation/ displacement<br>of the stone walling at the<br>vertical junction where this<br>abuts the adjacent stone<br>section, approximately 5-10mm<br>displacement. Slight staining<br>and surface deposits/ patina to<br>stone. |

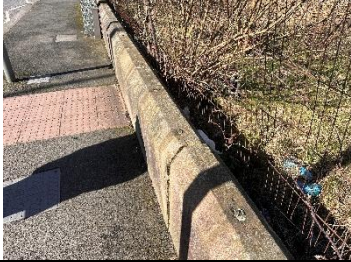
| 157 | Drake Street,<br>Rochdale, OL16 1PJ | Boundary wall positioned to the South of the site, facing from the external site perimeter | | Slight separation/ displacement of the stone walling at the vertical junction where this abuts the adjacent stone section, approximately 10-15mm displacement. Pedestrian crossing to this location with PCC pavements. |

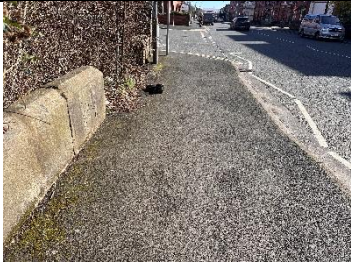
| 158 | Drake Street,<br>Rochdale, OL16 1PJ | Boundary wall positioned to the South of the site, facing from the external site perimeter | | Tarmac pedestrian pavement, general condition is sound; no potholing or otherwise observed. Some patch repairs noted. Minor vegetative build up along site boundary. Kerb edging in place and intact. |

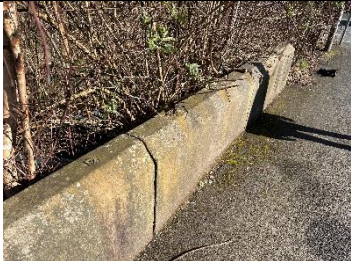
| 159 | Drake Street,<br>Rochdale, OL16 1PJ | Boundary wall positioned to the South of the site, facing from the external site perimeter | | Slight separation/ displacement of the stone walling at the vertical junction where this abuts the adjacent stone section, approximately 5-10mm displacement. Slight staining and surface deposits/ patina to stone. |

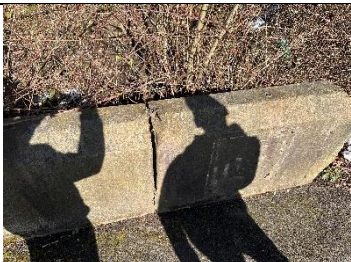
| 160 | Drake Street,<br>Rochdale, OL16 1PJ | Boundary wall positioned to the South of the site, facing from the external site perimeter | | Separation noted at vertical junction where stone walling abuts adjacent section, approximately 20-25mm. Slight staining and surface deposits/ patina to stone. Adhesive residue present from former signage. |

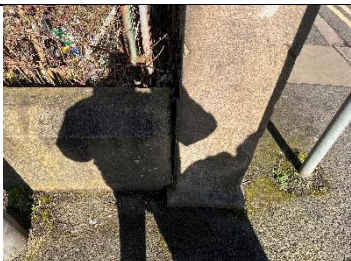
| 161 | Drake Street,<br>Rochdale, OL16 1PJ | Boundary wall positioned to the South of the site, facing from the external site perimeter | | Separation noted at vertical junction of stone pier to Southeast where this abuts stone walling, approximately 10-30mm. Slight staining and surface deposits/ patina to stone. |

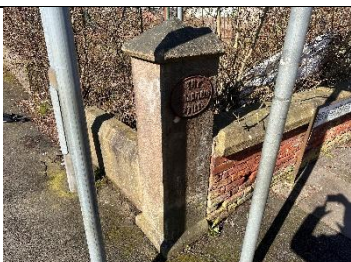
| 162 | Drake Street,<br>Rochdale, OL16 1PJ | Boundary wall positioned to the South of the site, facing from the external site perimeter | | Stone pier to Southeast corner of the site. Graffiti residue to pier. 4-way pier cap installed; minor impact damage to corners/ edges. Road signage installed; corroded/ pitted. Street lighting and signage installed to this location. |
