## **SCHEDULE OF CONDITION FOR:**

**Drake Street  
Rochdale  
OL16 1PJ**

**Survey Date: 17<sup>th</sup> March 2026**

**For: Great Places Housing Group**

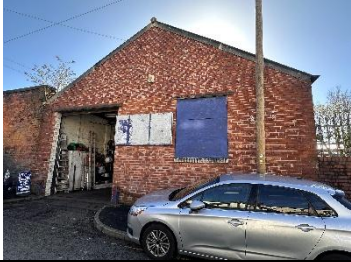
| 163 | St Alban's Street,<br>Rochdale, OL16 1UU | Boundary wall<br>positioned to the<br>North of the site,<br>facing from the<br>external site perimeter | | Garage structure to the rear of Speedwell Garage; accessed from St Albans Street; left side vertical abutment to adjacent high-level wall is poor. Garage does not appear tied into this wall and differential movement of boundary wall observed. |

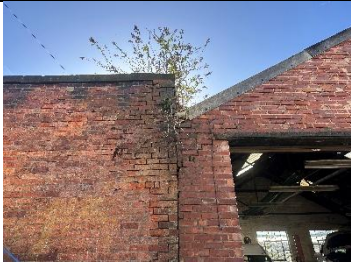
| 164 | St Alban's Street,<br>Rochdale, OL16 1UU | Boundary wall<br>positioned to the<br>North of the site,<br>facing from the<br>external site perimeter | | Solid masonry wall. Buddleia growth and displacement of brick courses at the vertical junction to the top of wall abutment. Missing pointing to several areas. Stone copings displaced. Wall out of plumb/ not tied into adjacent. |

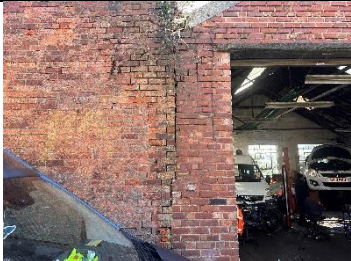
| 165 | St Alban's Street,<br>Rochdale, OL16 1UU | Boundary wall<br>positioned to the<br>North of the site,<br>facing from the<br>external site perimeter | | Vertical junction has opened up circa 10-20mm. Suspected asbestos cement guttering where buddleia growth is observed. Stepped cracking extends approximately 6 brick courses up to concrete lintel over opening which is cracked. |

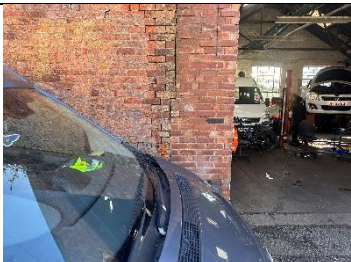
| 166 | St Alban's Street,<br>Rochdale, OL16 1UU | Boundary wall<br>positioned to the<br>North of the site,<br>facing from the<br>external site perimeter | | Missing pointing and spalled brickwork are present along the vertical junction all the way to ground level to the masonry boundary wall. High level wall does not appear tied into or toothed into the adjacent structure along this junction. |

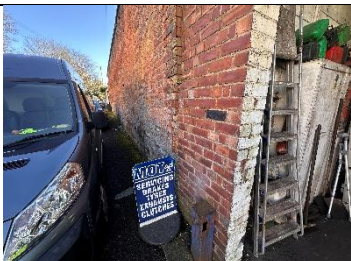
| 167 | St Alban's Street,<br>Rochdale, OL16 1UU | Boundary wall<br>positioned to the<br>North of the site,<br>facing from the<br>external site perimeter | | Solid masonry boundary walling appears out of plumb/ not tied into adjacent structure. The wall is flush for 13 brick courses from ground level and begins to protrude and step outwards from the site, approximately 30-35mm. |

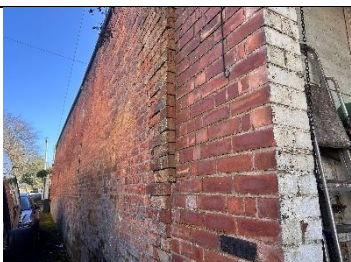
| 168 | St Alban's Street,<br>Rochdale, OL16 1UU | Boundary wall<br>positioned to the<br>North of the site,<br>facing from the<br>external site perimeter | | Solid masonry boundary walling appears out of plumb/ not tied into adjacent structure. The wall is flush for 13 brick courses from ground level and begins to protrude and step outwards from the site, approximately 30-35mm. |
