## Survey Report

Stid Fold Barn  
Barnfield Lane  
Wardle  
OL12 9PN

Survey date: 28<sup>th</sup> May 2026

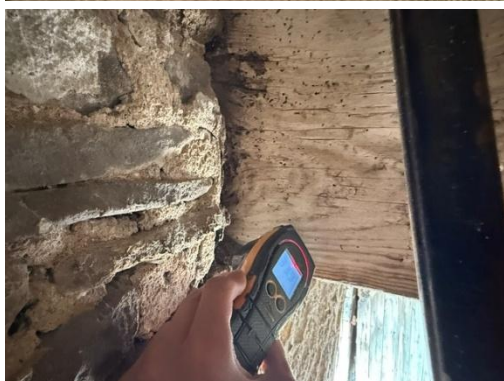
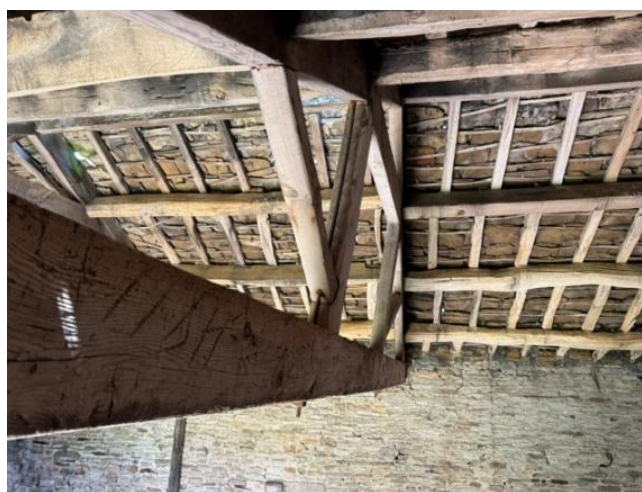
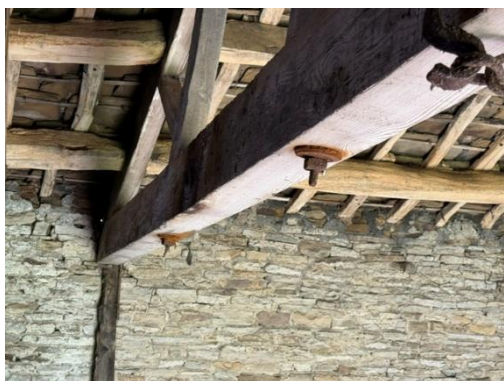
The principal truss located to the right-hand side when viewed internally displays evidence of distortion (image below). Whilst this may be historic movement associated with the age and construction of the building, assessment of the structural significance of this movement falls outside the scope of our inspection. We therefore recommend you refer this to your structural engineer.

No evidence of timber decay was noted to the exposed and accessible principle trusses.

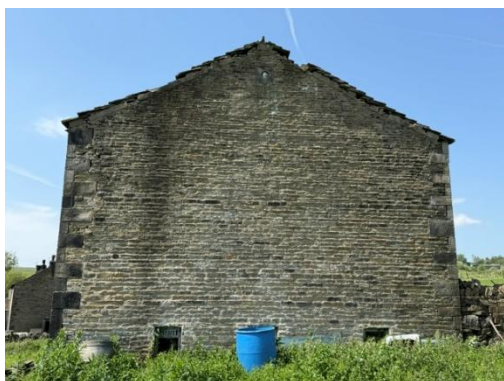
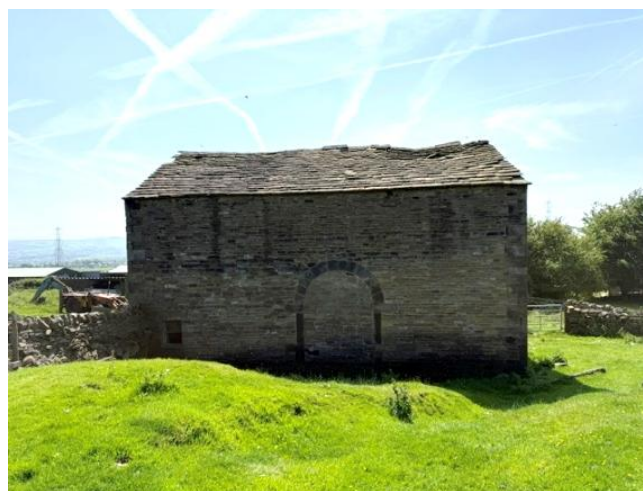
Images below shows the rear elevation, and images 14 and 15 show the side elevations.
