# **ARBORICULTURAL REPORT & Impact Assessment to BS 5837:2012 at:**

***Land South of  
Wallis Avenue,  
Rochdale  
OL16 4PS***

Report Date: *April 2026*

Reference: *AWA7343*

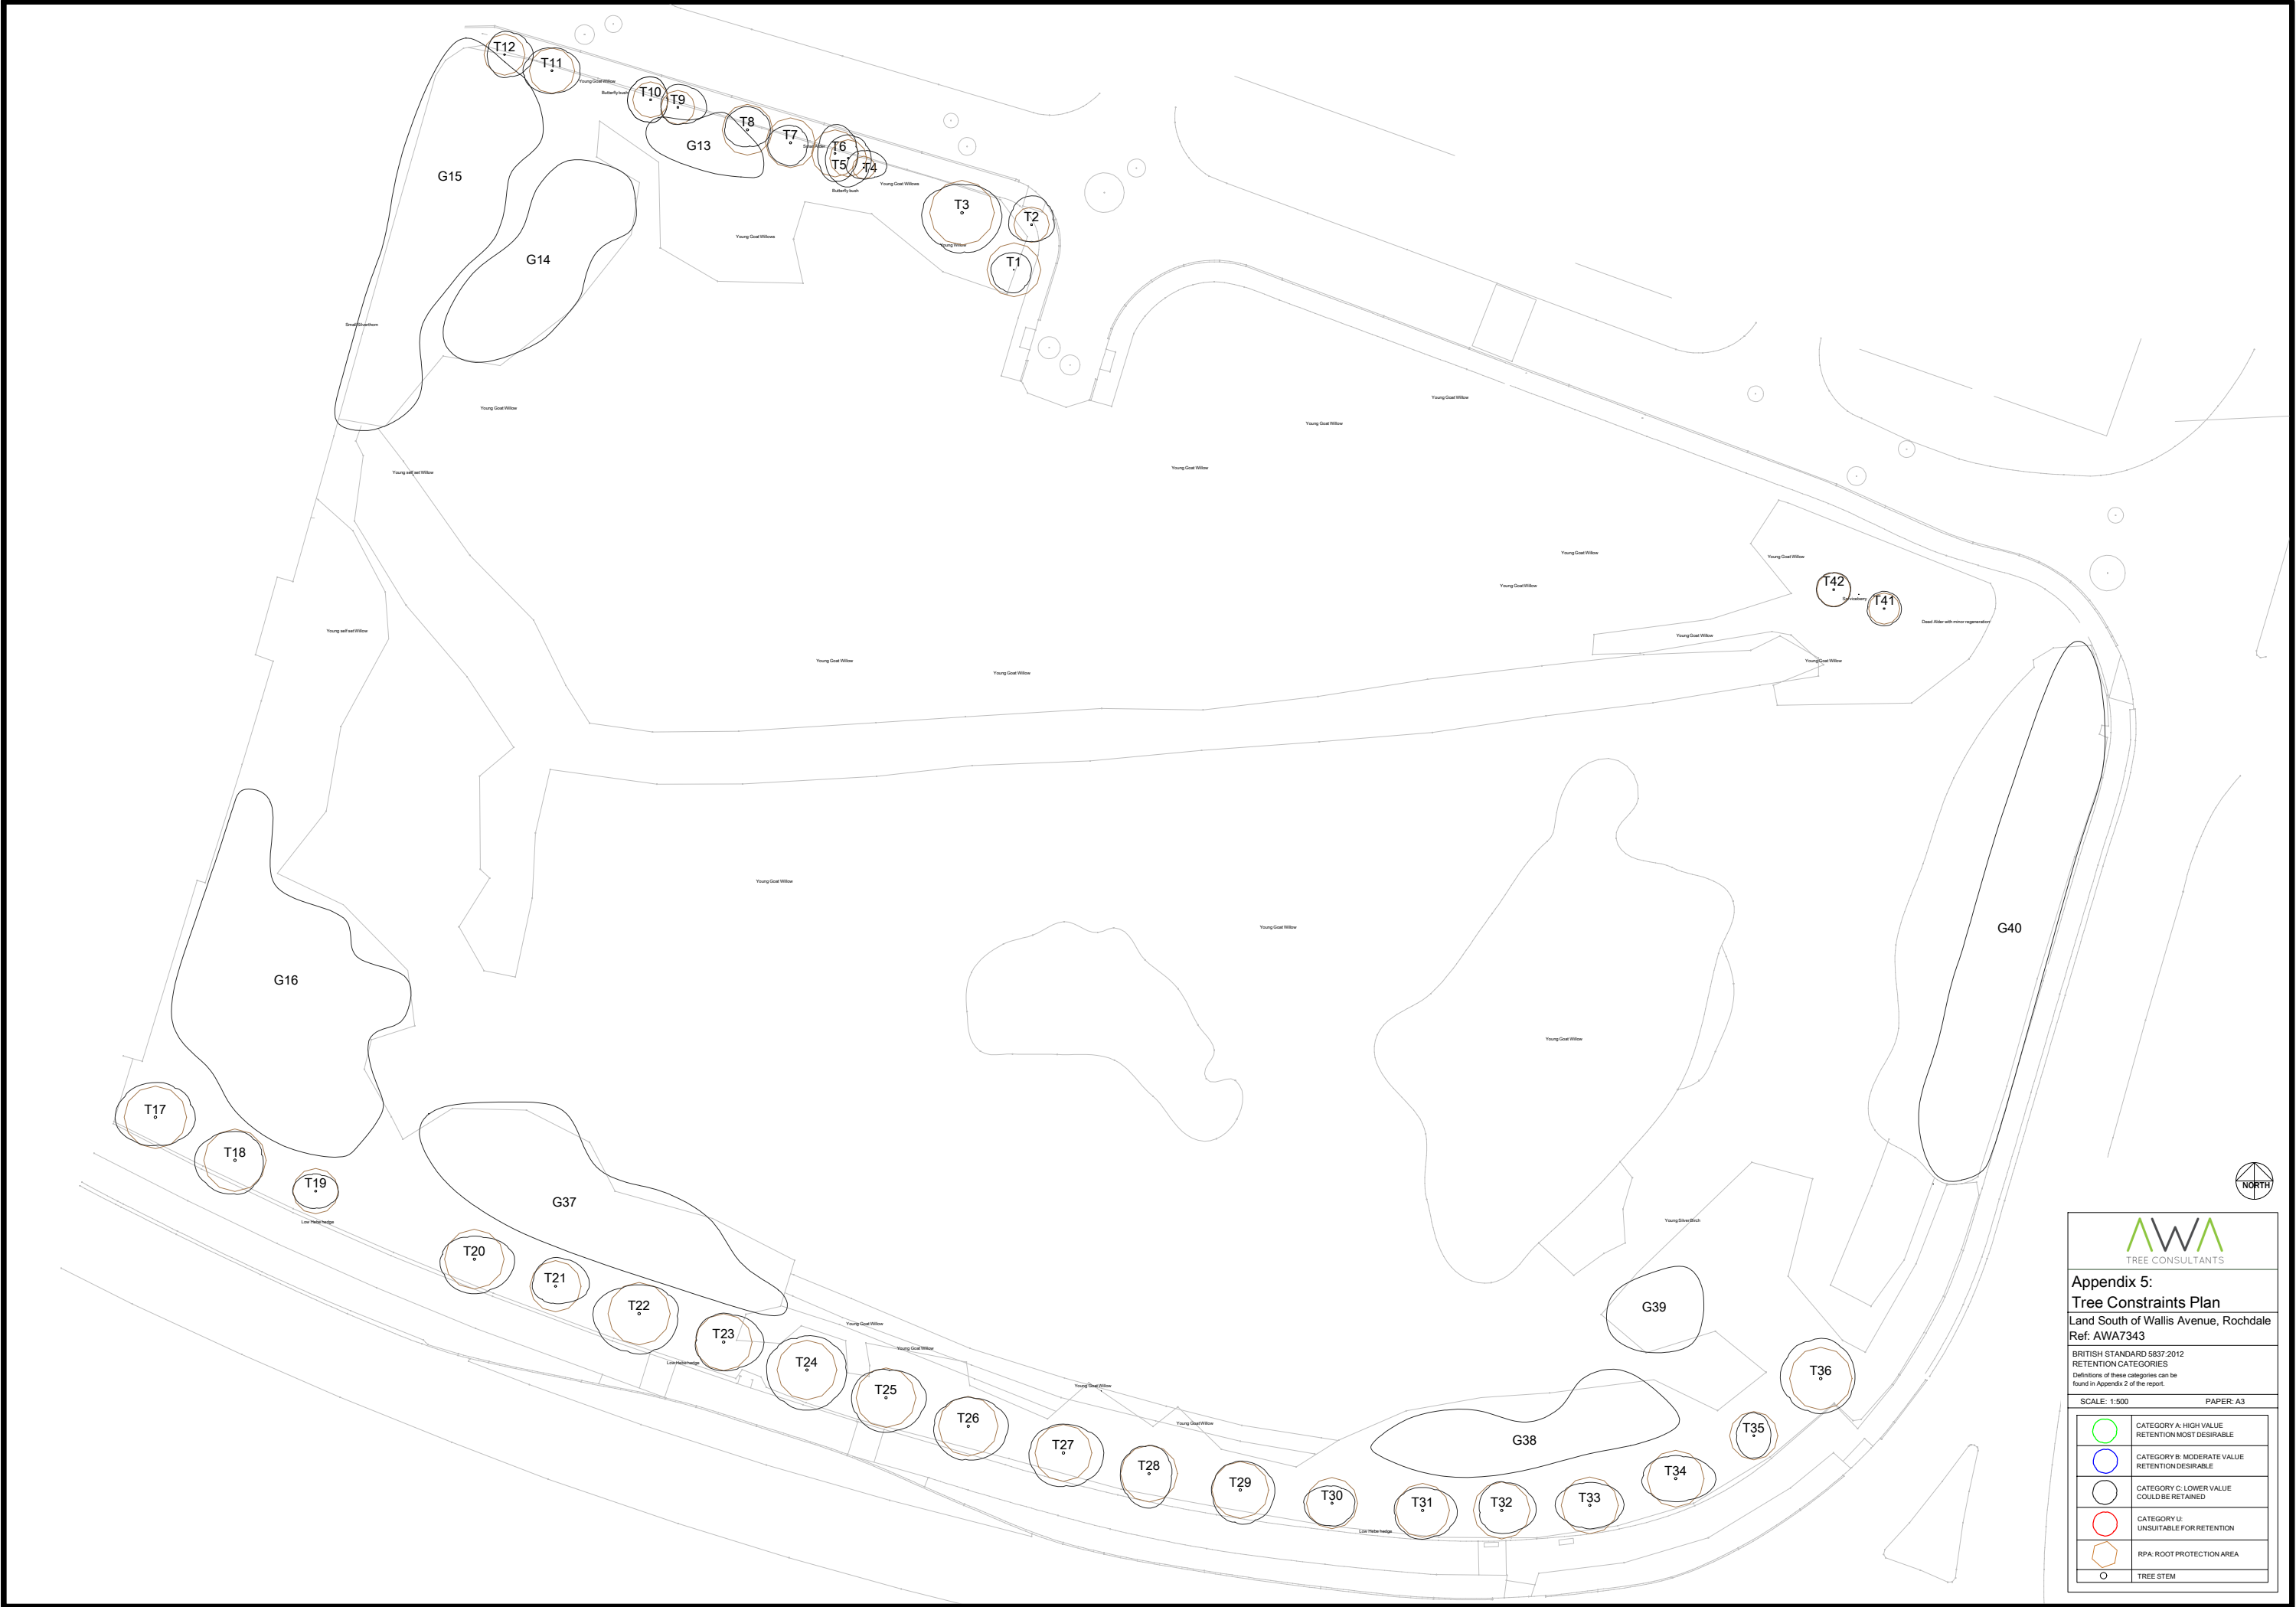
**Appendix 5:**  
**Tree Constraints Plan**  
Land South of Wallis Avenue, Rochdale  
Ref: AWA7343

A total of 42 items of woody vegetation were surveyed, comprising individual trees and groups or hedges. Of these: 42 are low value (Category C).

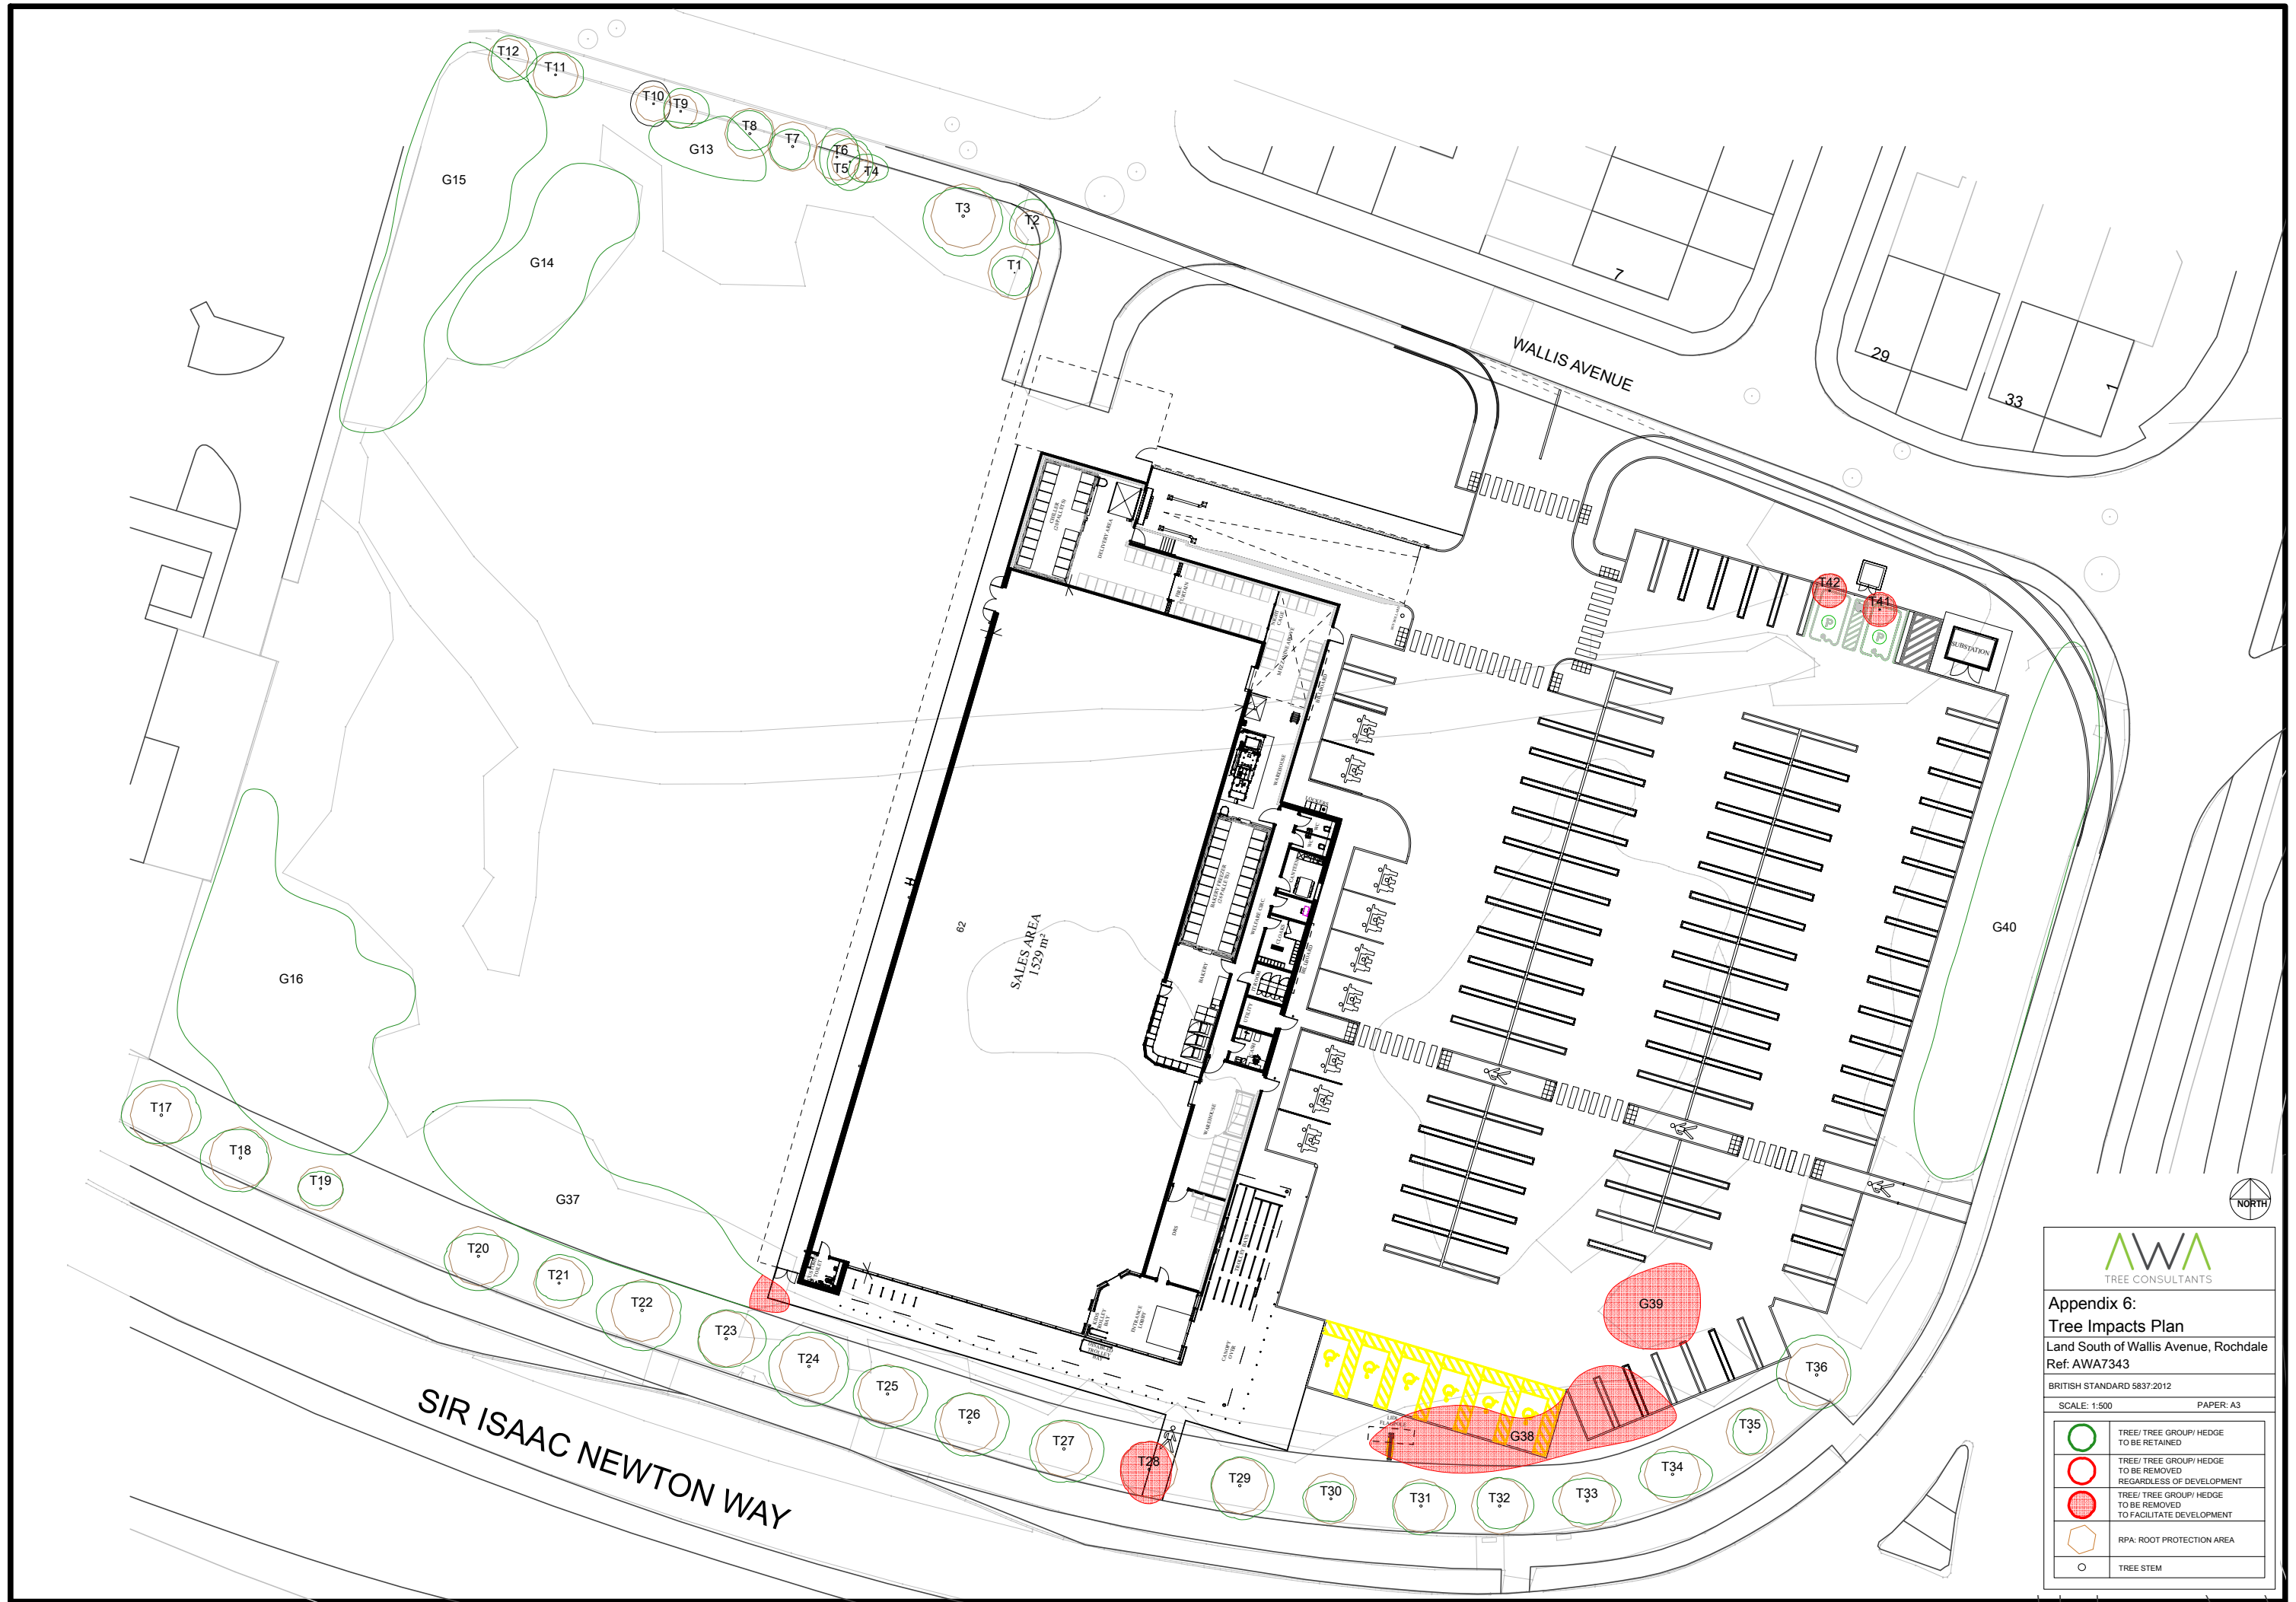
**Appendix 6:**  
**Tree Impacts Plan**  
Land South of Wallis Avenue, Rochdale  
Ref: AWA7343

The proposed development will require the removal of five trees and groups (T28, T41, T42, G38 and G39), with one additional group (G37) subject to partial removal. Given the low quality of the affected trees, the resulting arboricultural impact is considered negligible.

The layout of the development has been designed to minimise encroachment into Root Protection Areas (RPAs), with only minor incursions into a trees' RPAs, which are not expected to significantly affect tree health. Mitigation measures, including protective fencing and 'no-dig' construction methods, are recommended where necessary.
