# **Rochdale Cricket Lacross and Squash Club**

## **Flood Risk Assessment & Drainage Strategy**

**September 2026**

**Soul Padel Ltd**

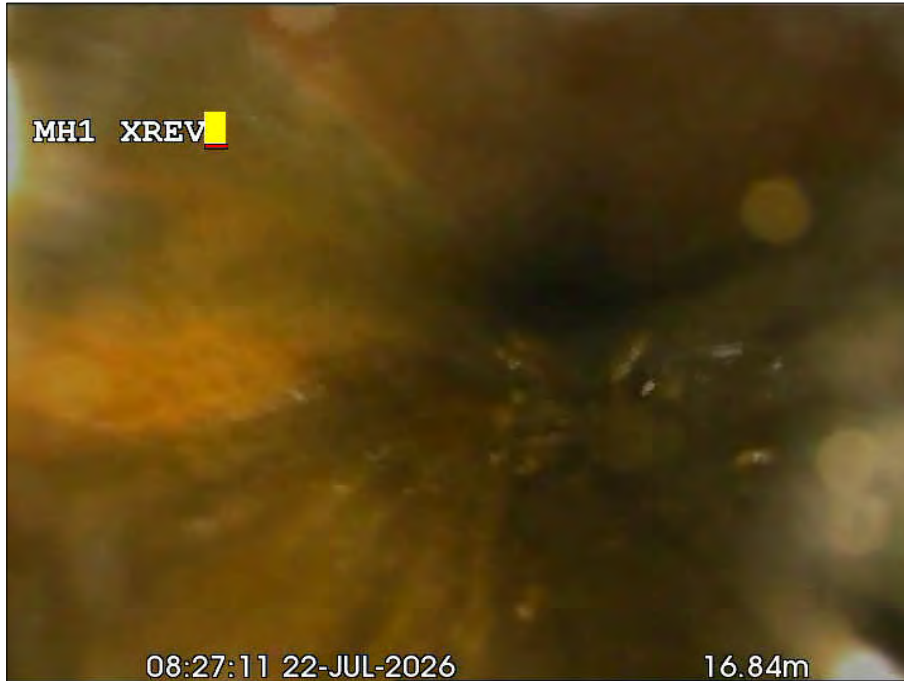
Photo: 21\_8a, 00:00:00  
17m, Debris silt, 10 % cross-sectional area loss, Start

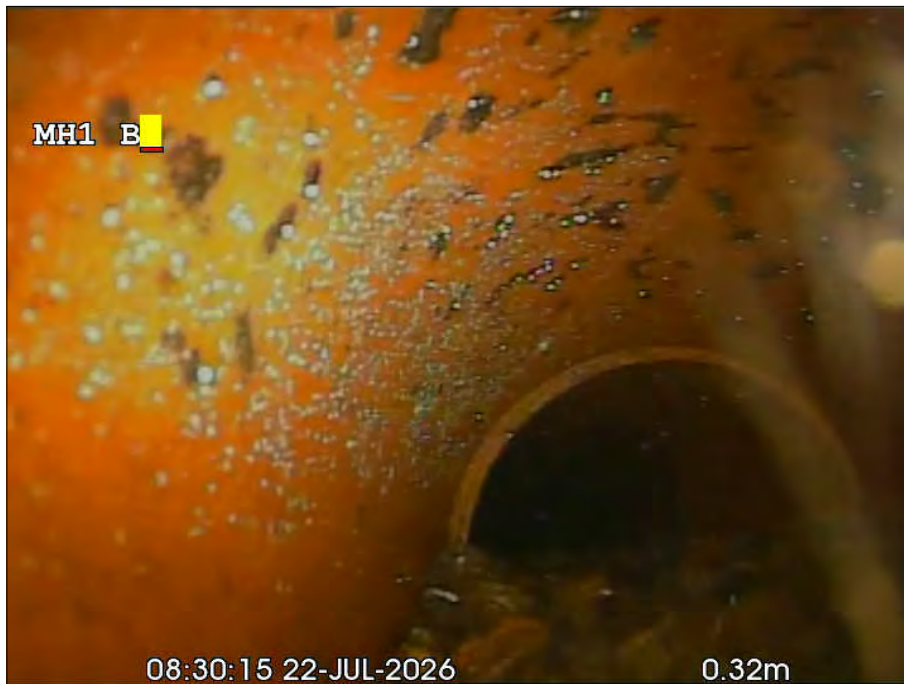
Photo: 231\_5a, 00:00:00  
0.7m, Debris, 40 % cross-sectional area loss, Changed

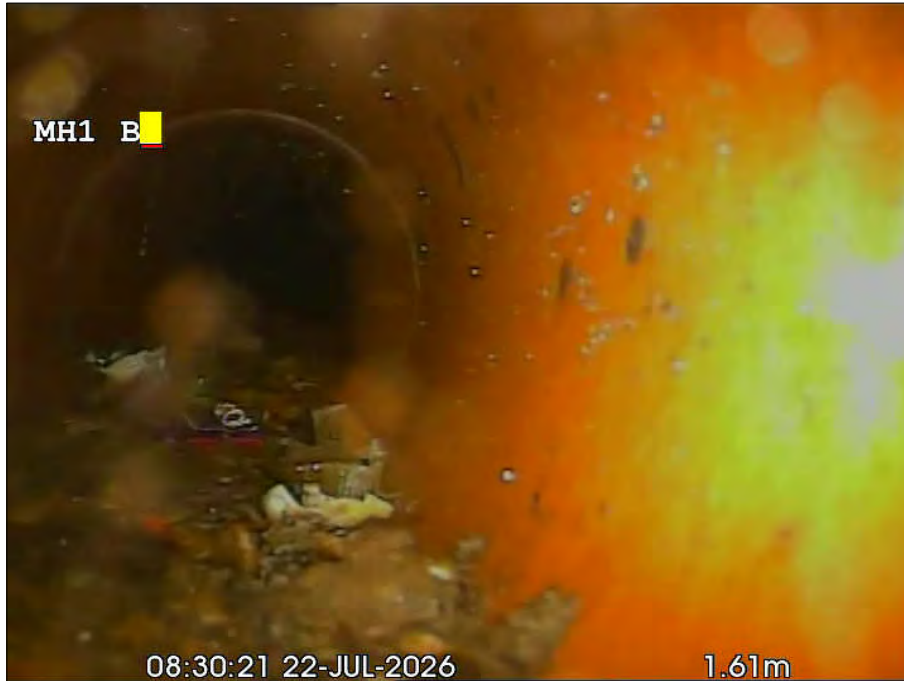
Photo: 232\_6a, 00:00:00  
1.6m, Debris, 10 % cross-sectional area loss, Changed

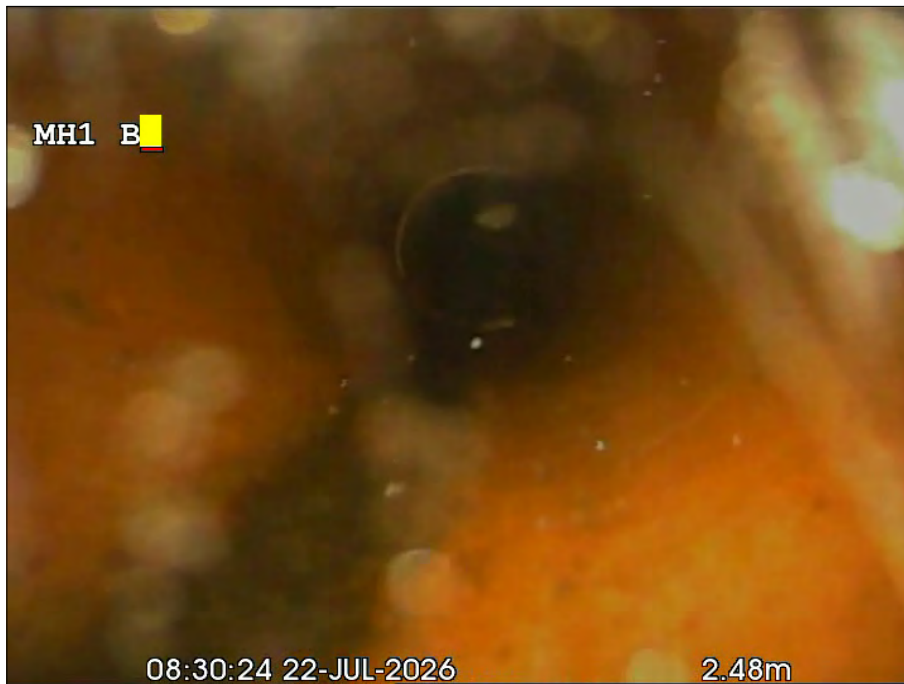
Photo: 233\_7a, 00:00:00  
2.5m, Debris, 10 % cross-sectional area loss, Finish

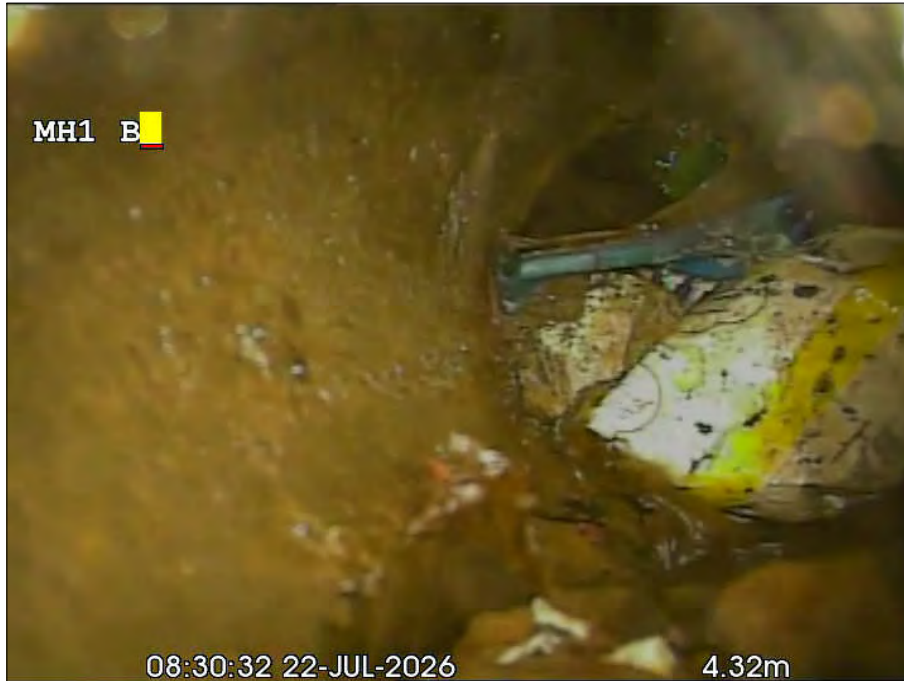
Photo: 235\_10a, 00:00:00  
4.4m, Obstruction, 60 % height/diameter loss

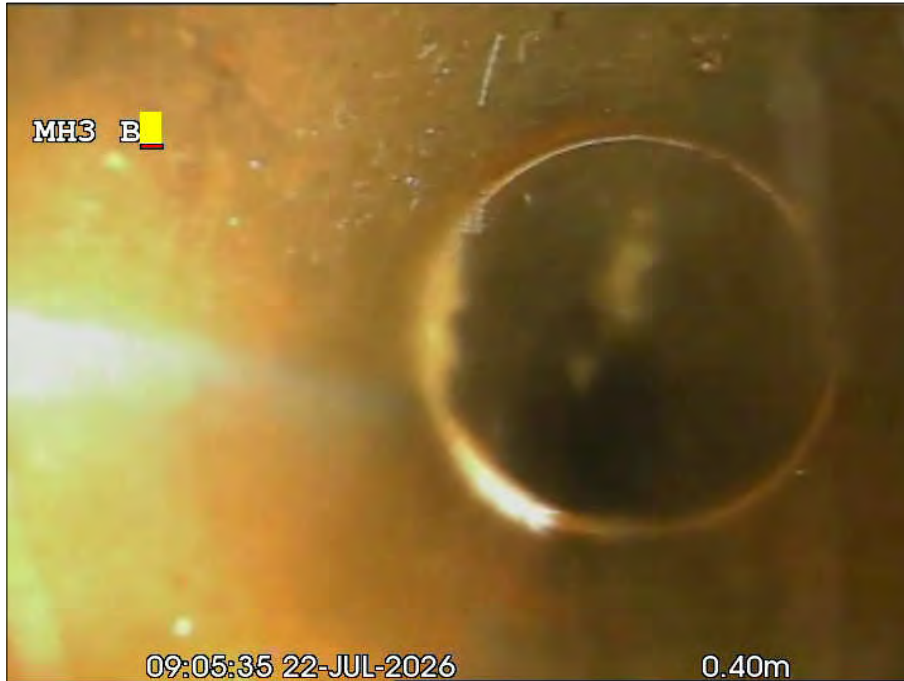
Photo: 7\_4a, 00:00:00  
0.5m, Joint displaced. Medium

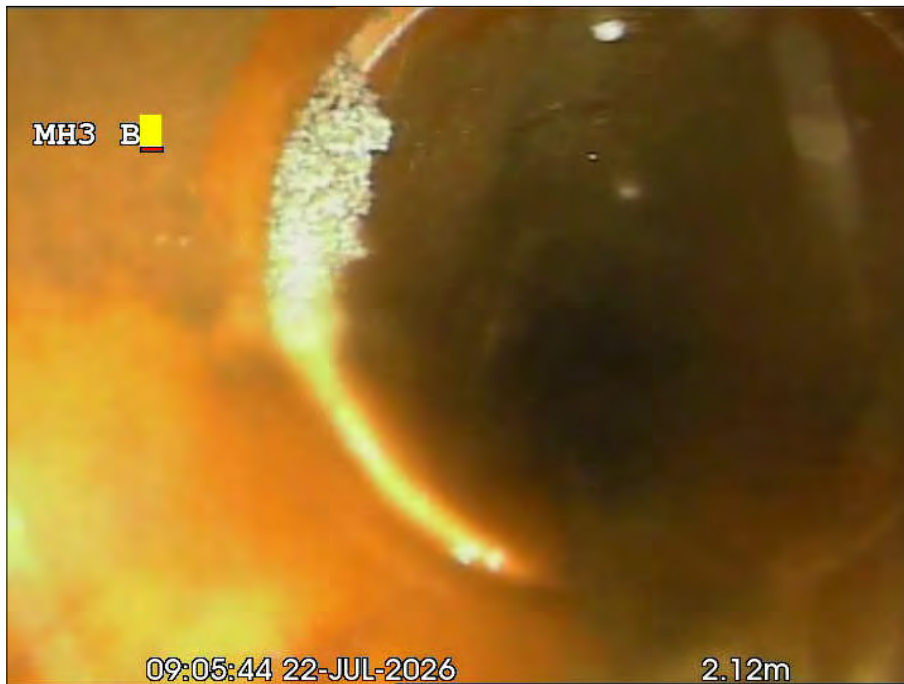
Photo: 7\_5a, 00:00:00  
2.2m, Joint displaced. Medium

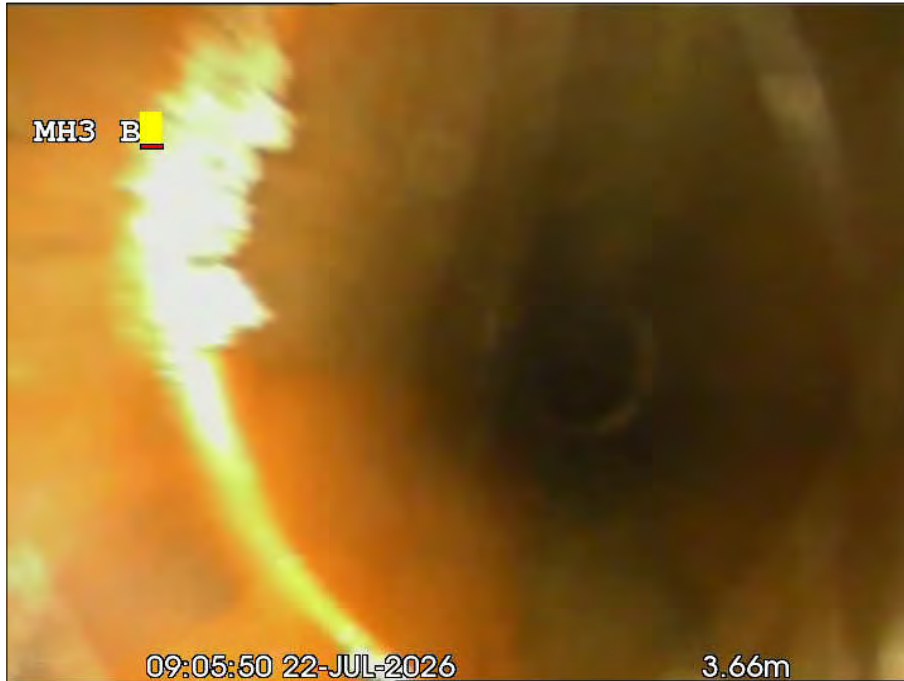
Photo: 7\_6a, 00:00:00  
3.7m, Joint displaced. Medium

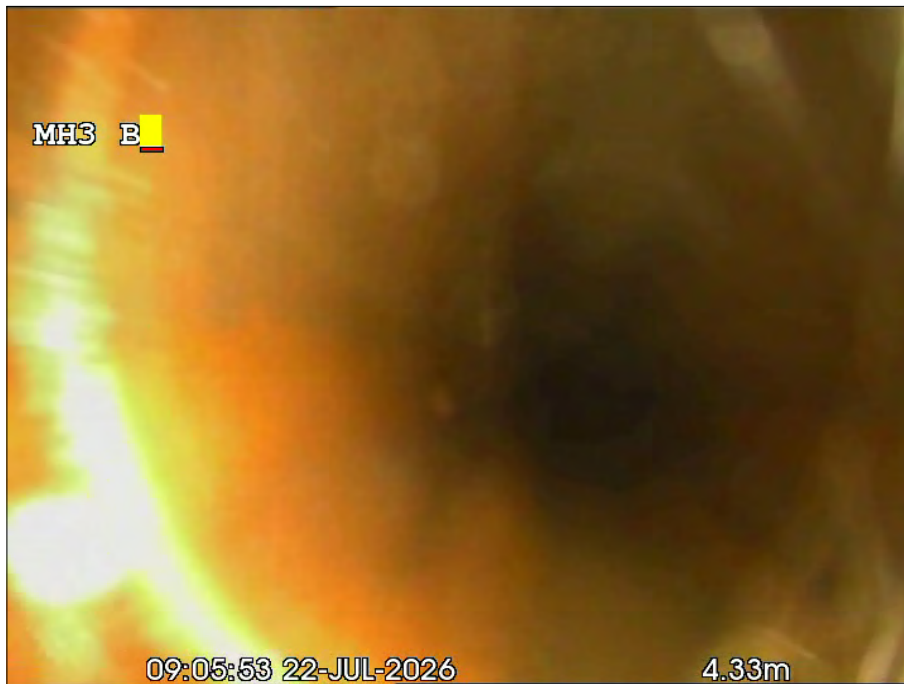
Photo: 7\_7a, 00:00:00  
4.4m, Joint displaced. Medium

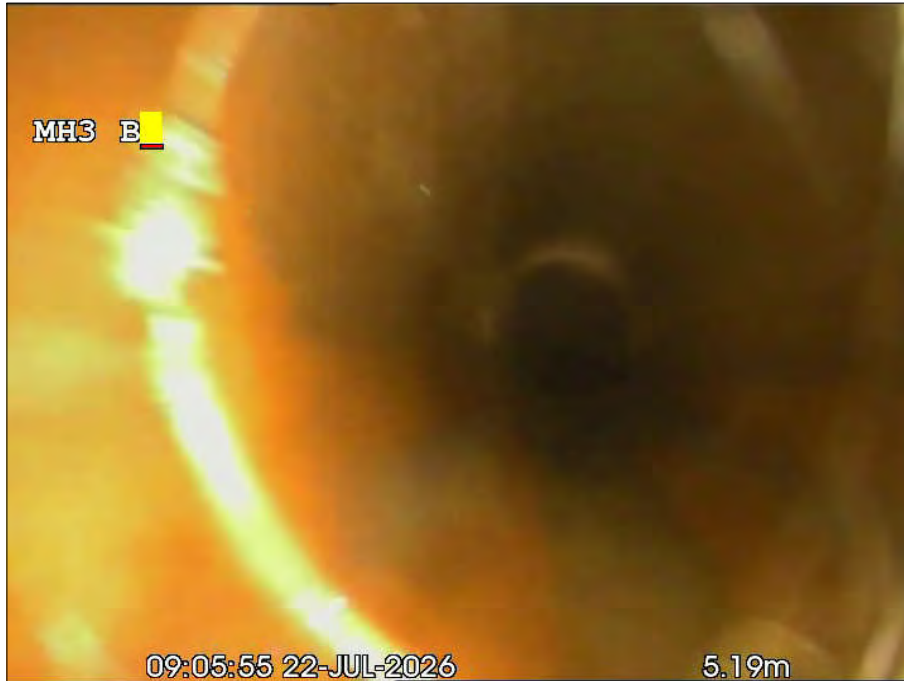
Photo: 7\_8a, 00:00:00  
5.1m, Joint displaced. Medium

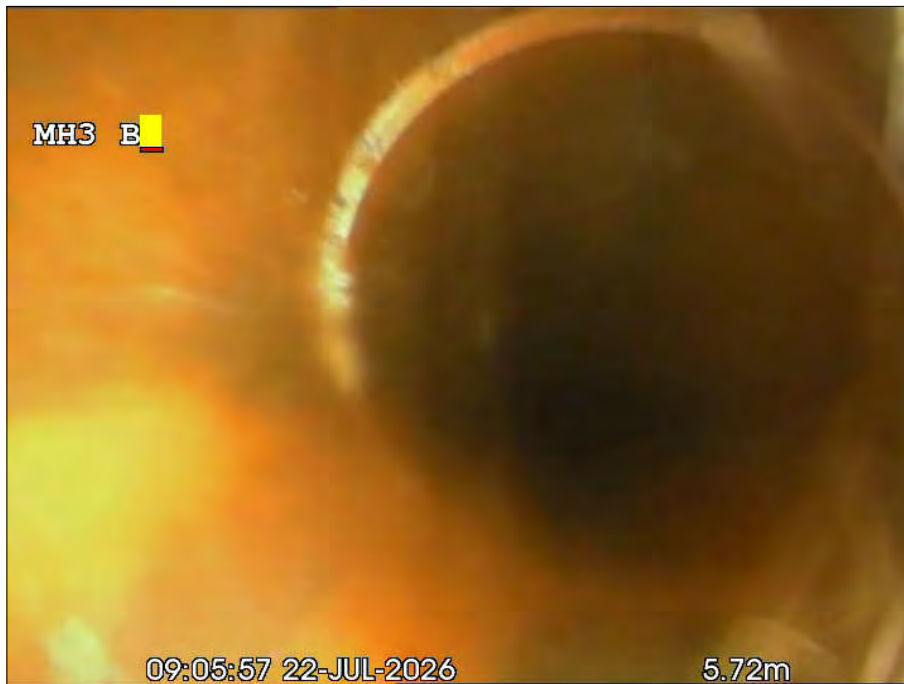
Photo: 7\_9a, 00:00:00  
5.8m, Joint displaced. Medium

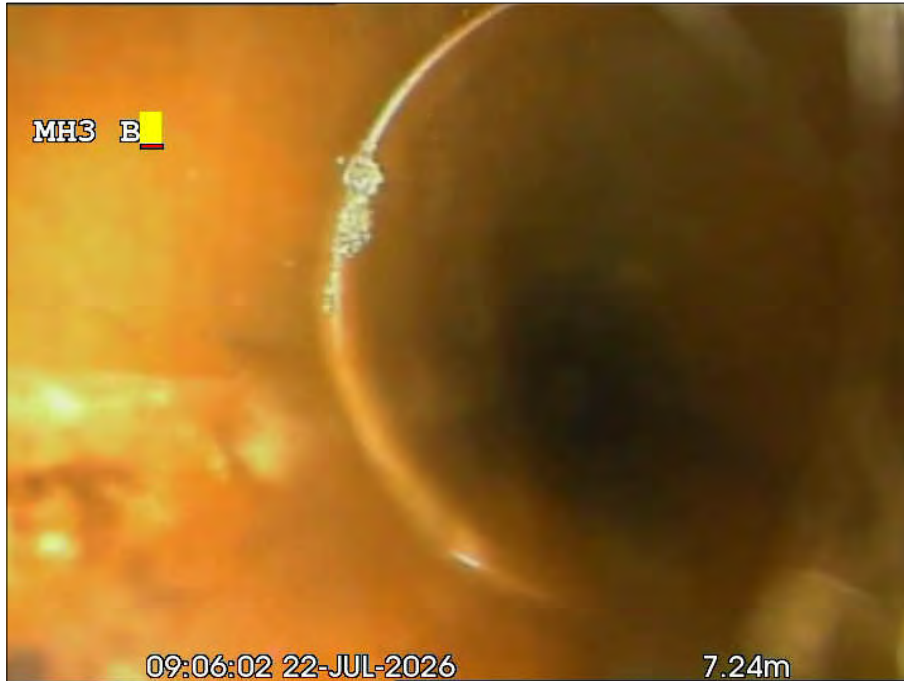
Photo: 60\_10a, 00:00:00  
7.3m, Joint displaced. Medium

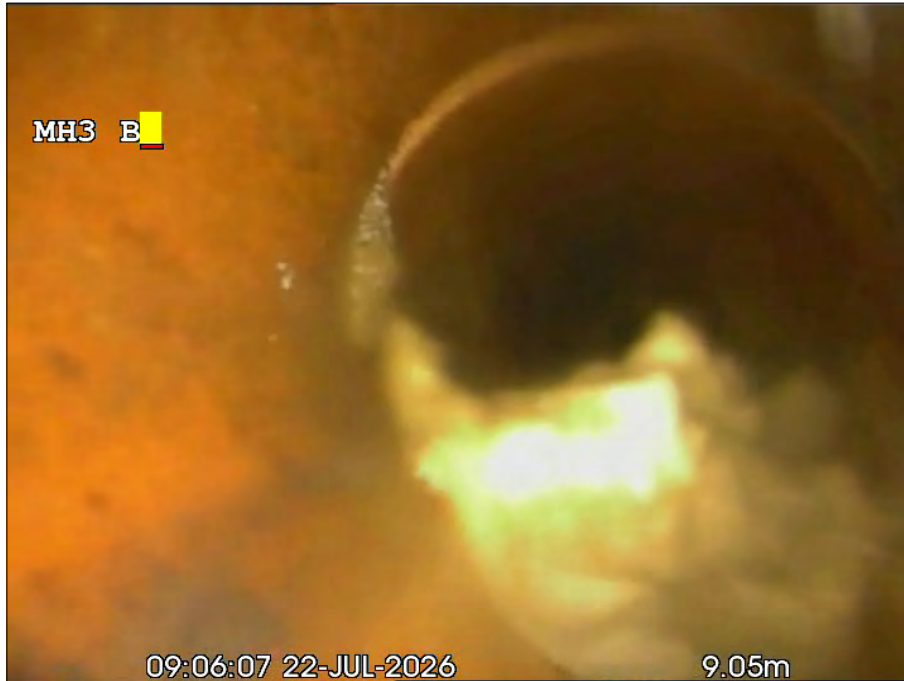
Photo: 62\_12a, 00:00:00  
9.1m, Debris silt, 25 % cross-sectional area loss

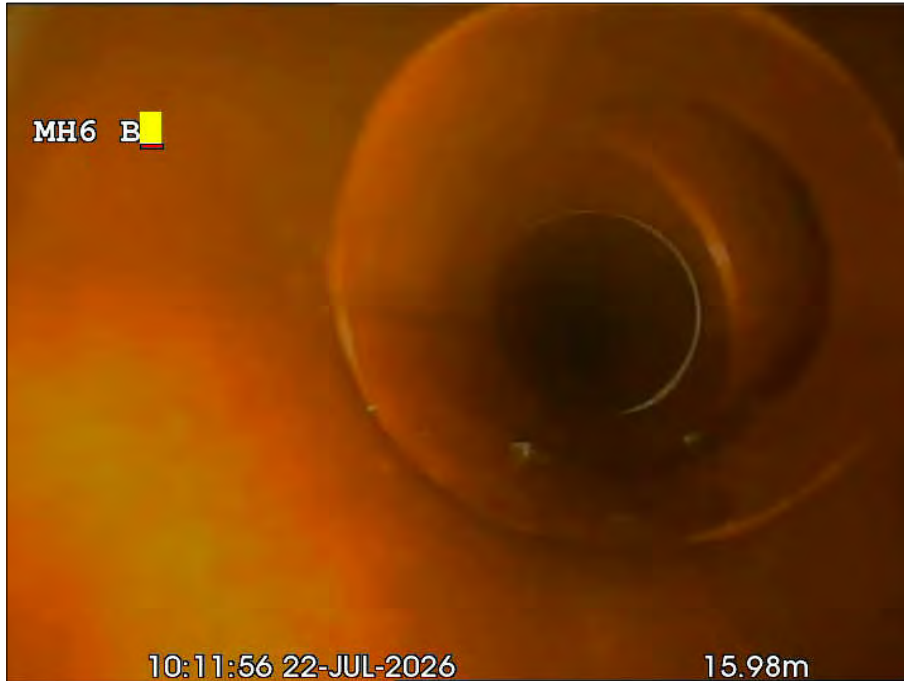
Photo: 29\_8a, 00:00:00  
16.2m, Junction at 03 o'clock, dia 100 mm

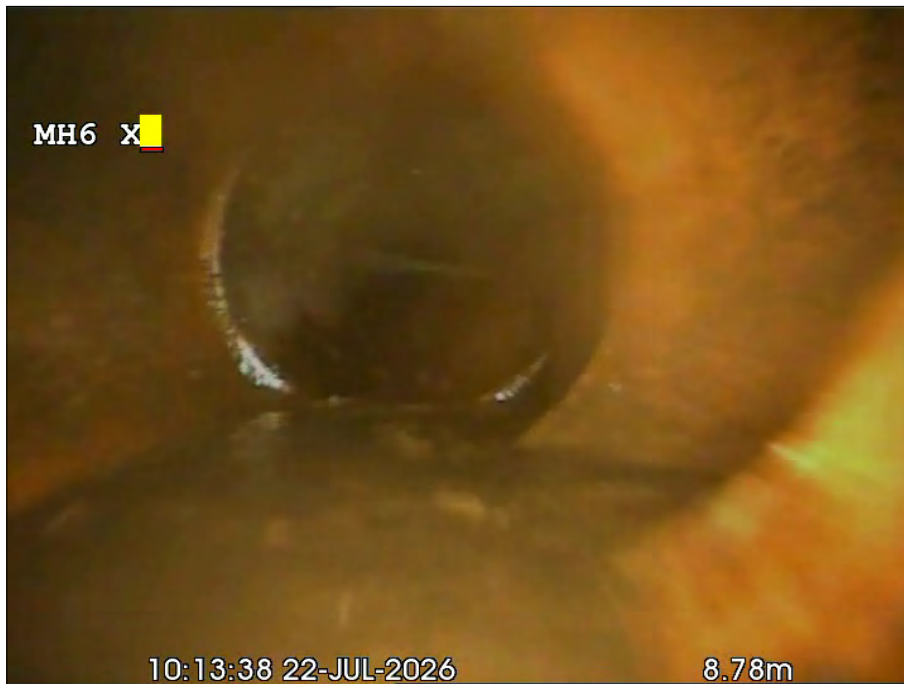
Photo: 30\_5a, 00:00:00  
8.7m, Junction at 03 o'clock, dia 100 mm

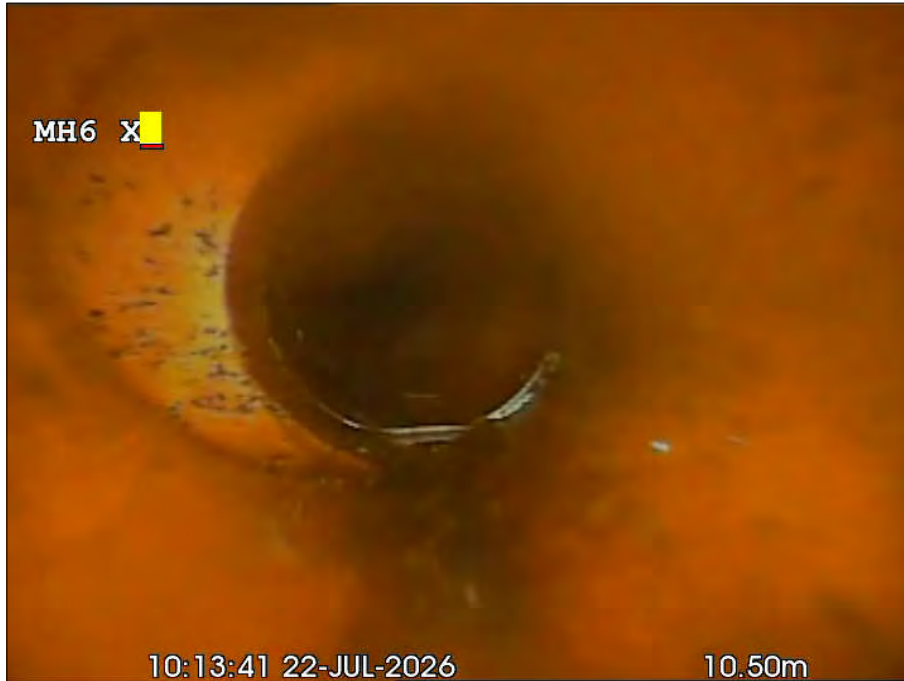
Photo: 30\_6a, 00:00:00  
10.7m, Junction at 09 o'clock, dia 100 mm

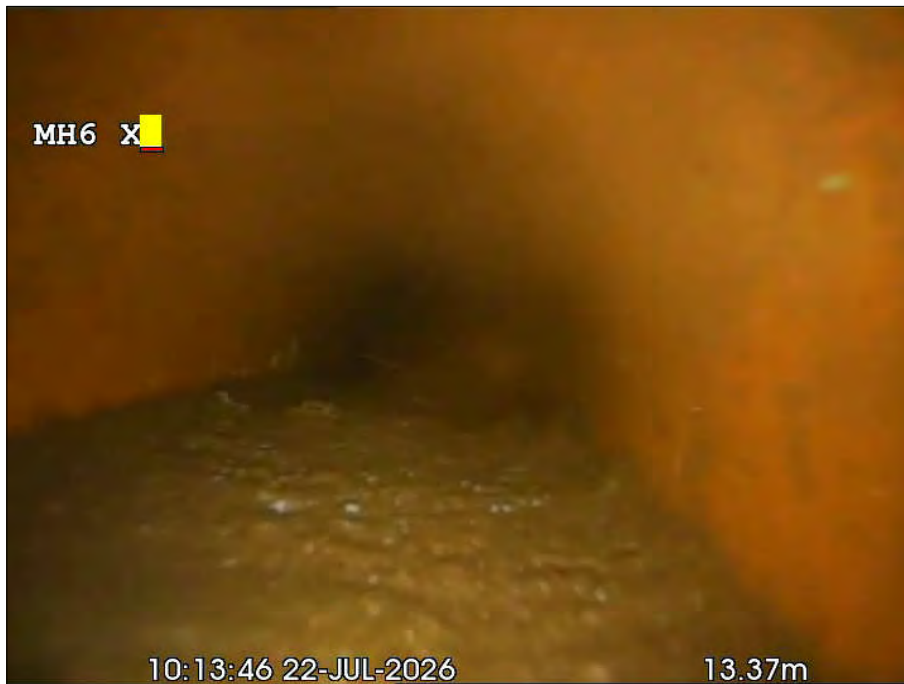
Photo: 30\_7a, 00:00:00  
13m, Debris silt, 25 % cross-sectional area loss, Changed

The sewers with high levels of silt or blockages to be jetted to extend the CCTV drainage survey, if any of these areas are deemed critical or of high importance. We recommend full statutory record information be obtained to confirm site findings and to position undetectable services which may be present.

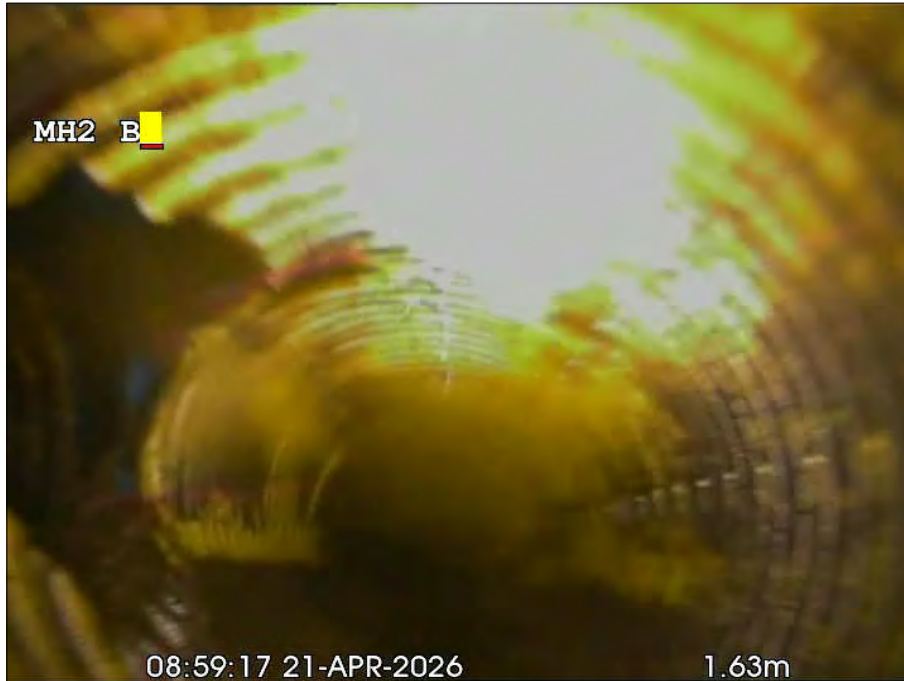
Photo: 279\_4a, 00:00:00  
1.6m, Connection, at 09 o'clock, dia 80 mm

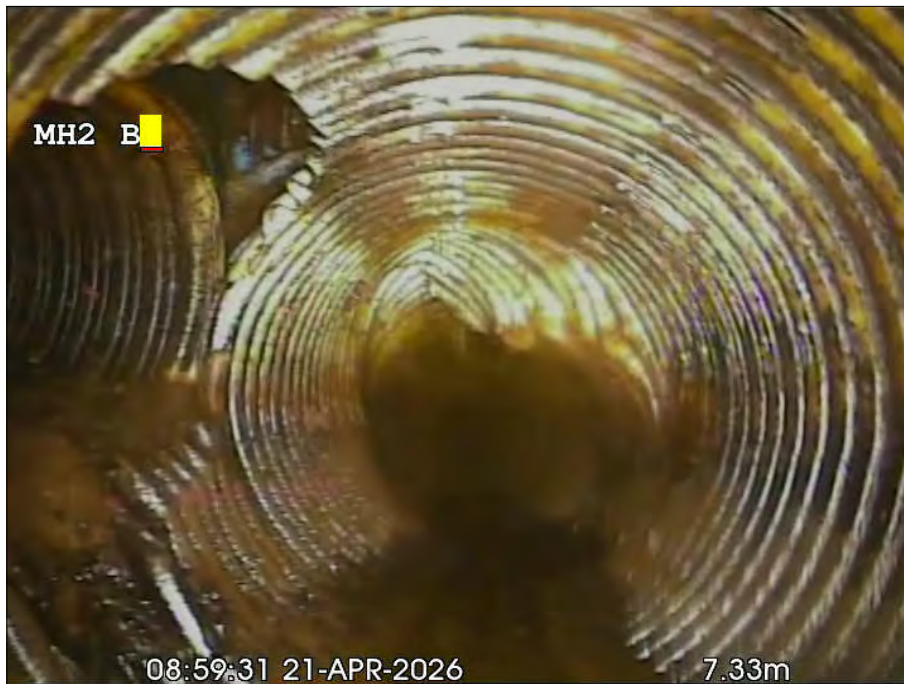
Photo: 280\_5a, 00:00:00  
7.3m, Connection, at 09 o'clock, dia 80 mm

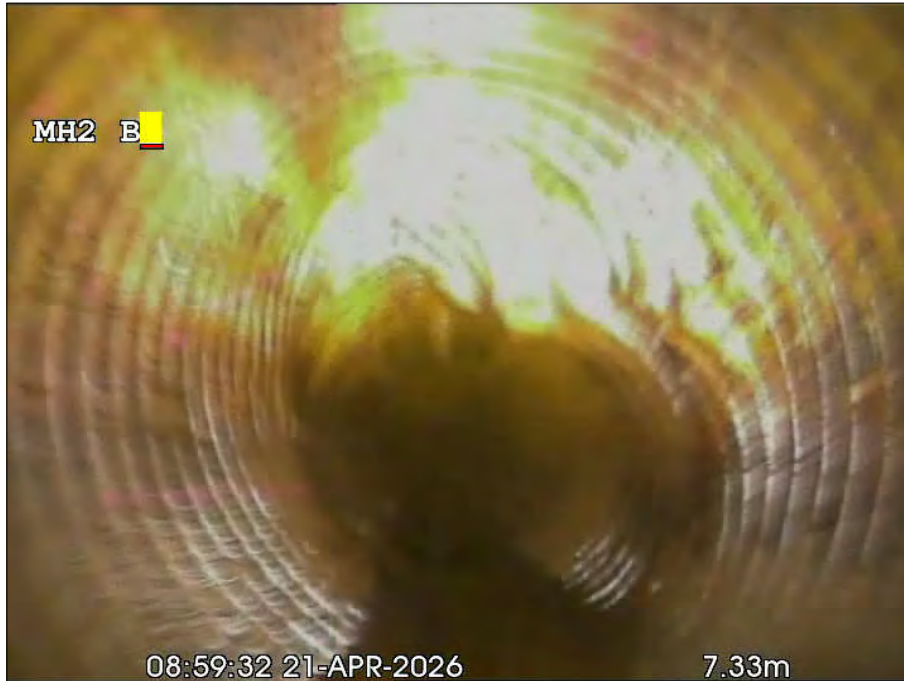
Photo: 281\_6a, 00:00:00  
7.5m, Sewer Deformed, 20 %

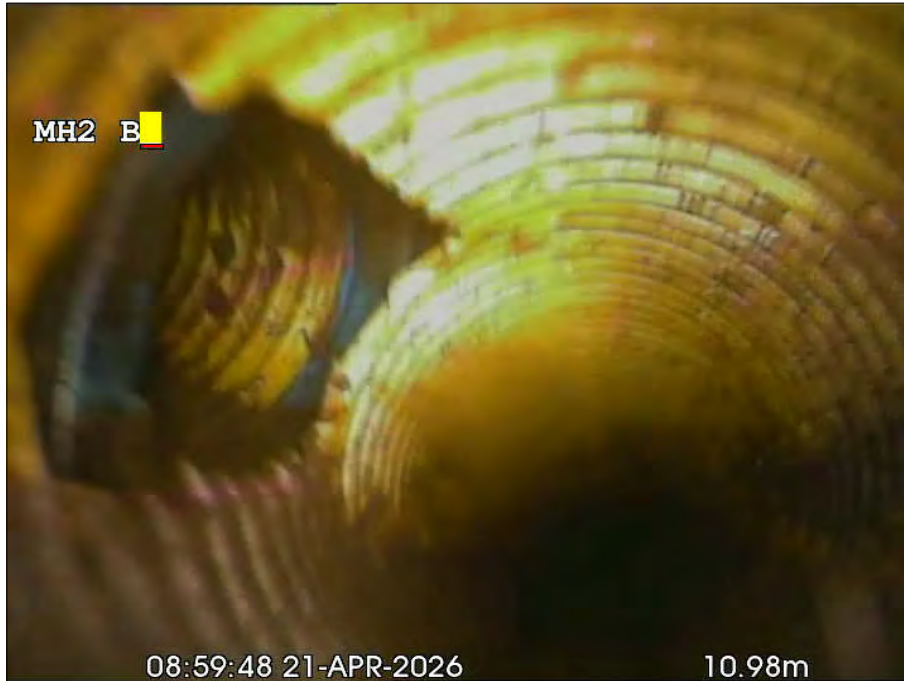
Photo: 283\_8a, 00:00:00  
11m, Connection, at 09 o'clock, dia 80 mm

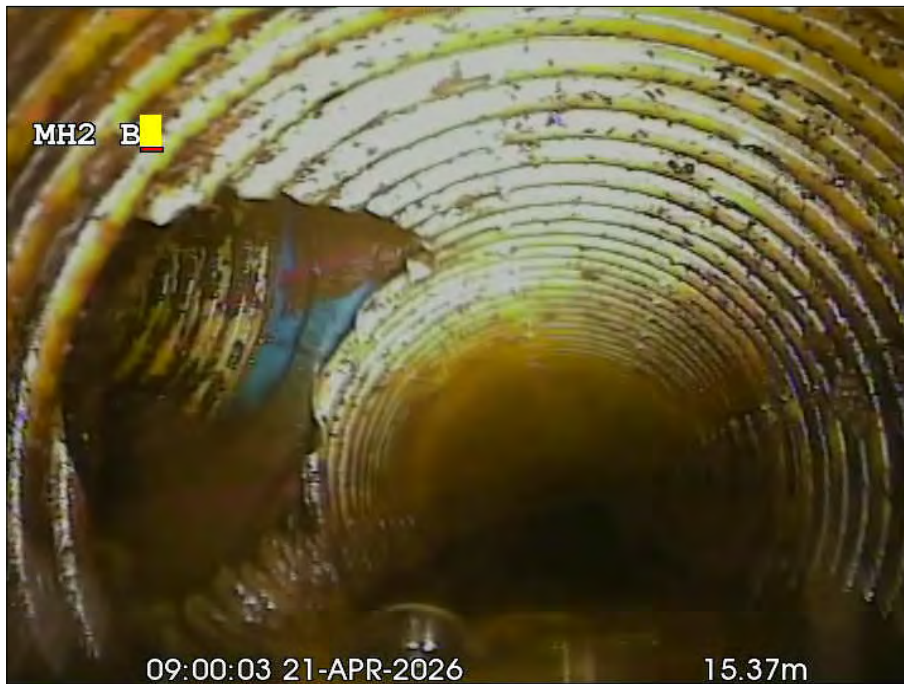
Photo: 284\_9a, 00:00:00  
15.4m, Connection, at 09 o'clock, dia 80 mm

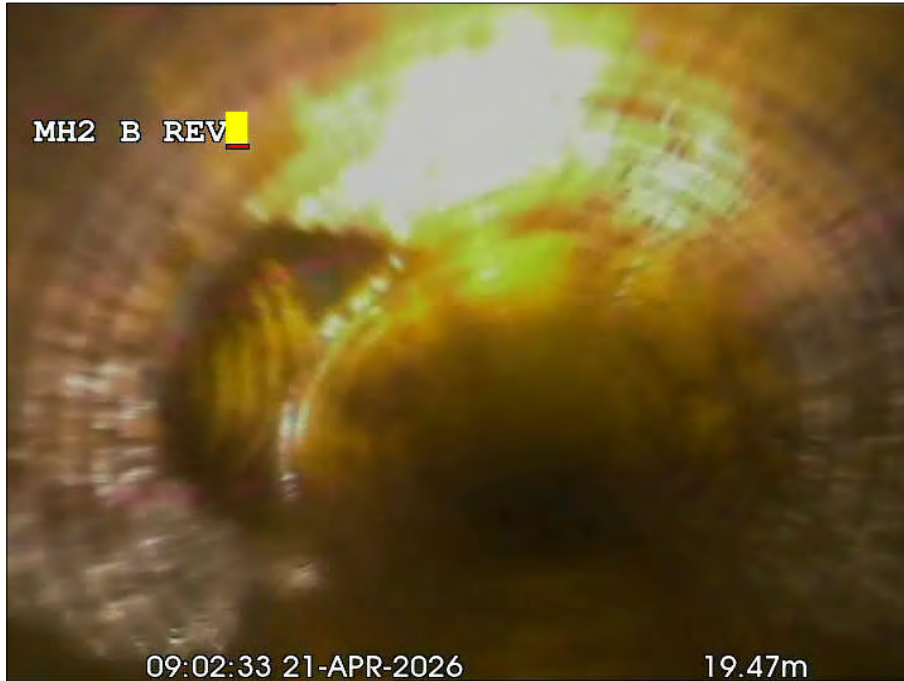
Photo: 290\_10a, 00:00:00  
19.5m, Connection, at 09 o'clock, dia 100 mm

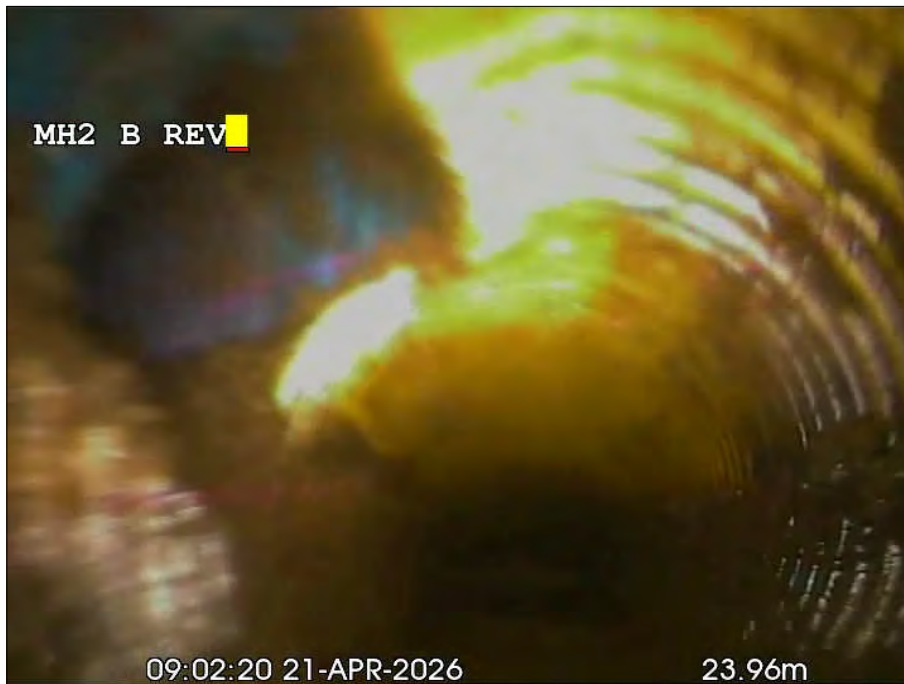
Photo: 32\_11a, 00:00:00  
24m, Connection, at 09 o'clock, dia 80 mm

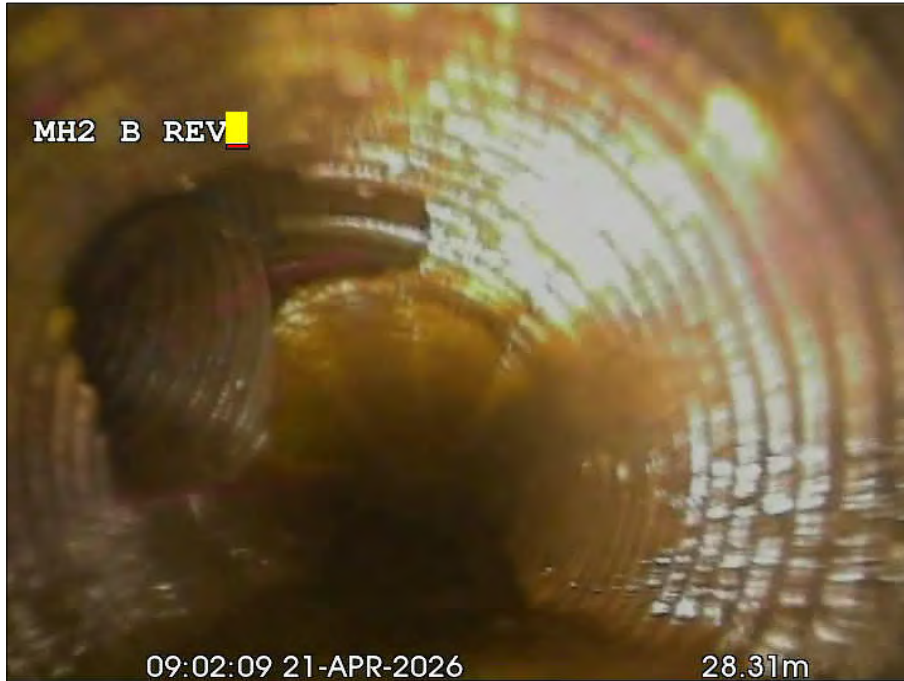
Photo: 32\_12a, 00:00:00  
28.5m, Connection, at 09 o'clock, dia 80 mm

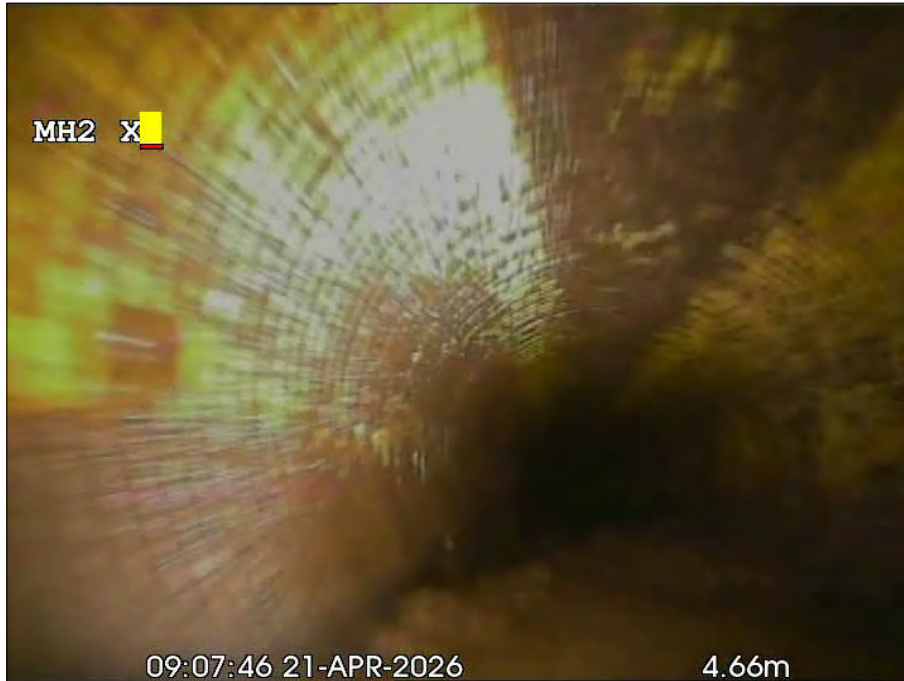
Photo: 301\_4a, 00:00:00  
4.6m, Debris silt, 5 % cross-sectional area loss

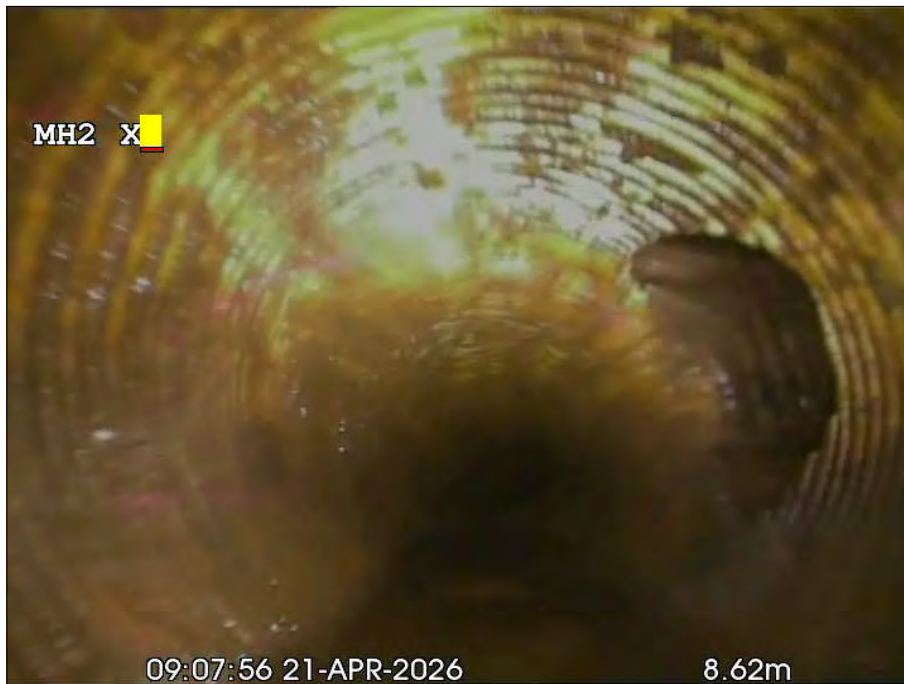
Photo: 304\_7a, 00:00:00  
8.8m, Junction at 03 o'clock, dia 100 mm

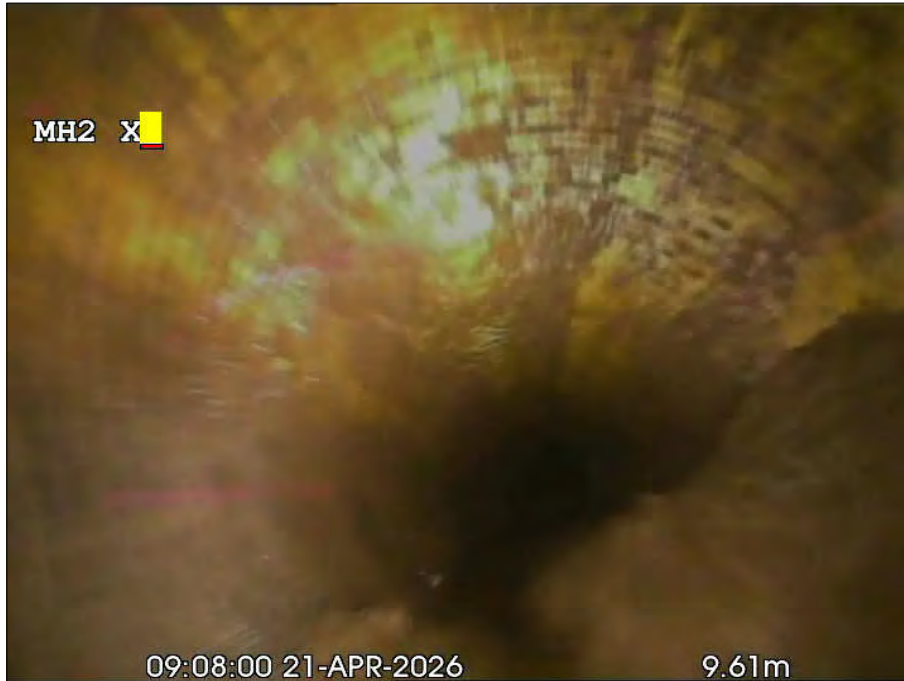
Photo: 305\_8a, 00:00:00  
9.6m, Debris silt, 20 % cross-sectional area loss, Start

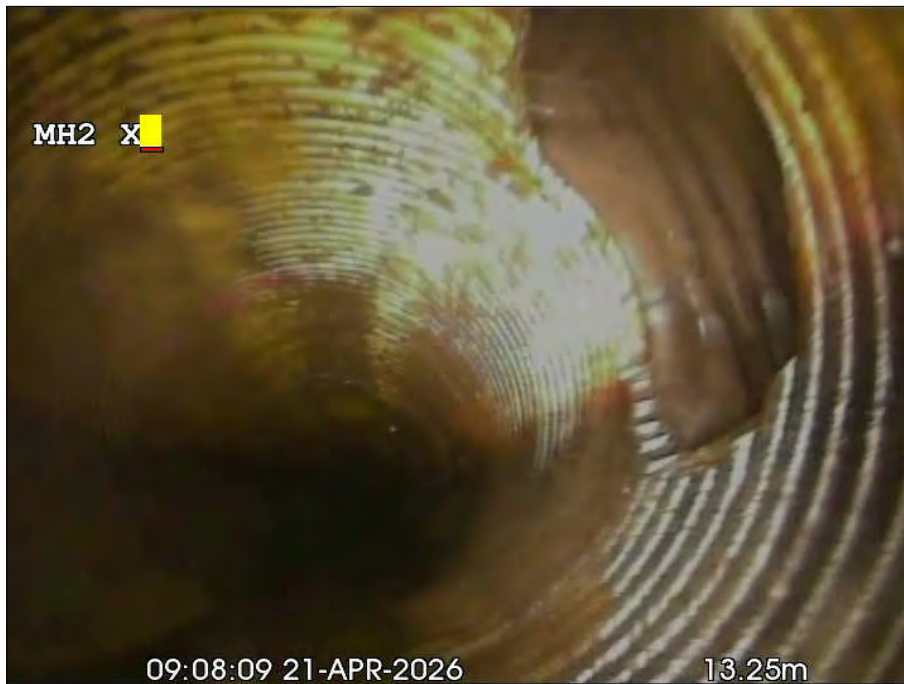
Photo: 308\_10a, 00:00:00  
13.3m, Junction at 03 o'clock, dia 100 mm

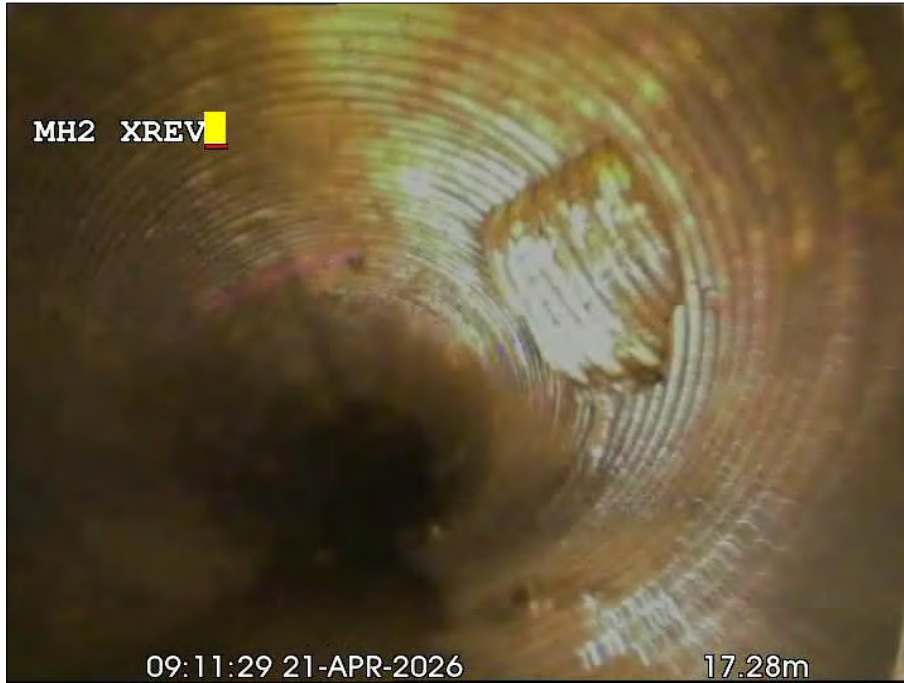
Photo: 314\_11a, 00:00:00  
17.4m, Connection, at 03 o'clock, dia 80 mm

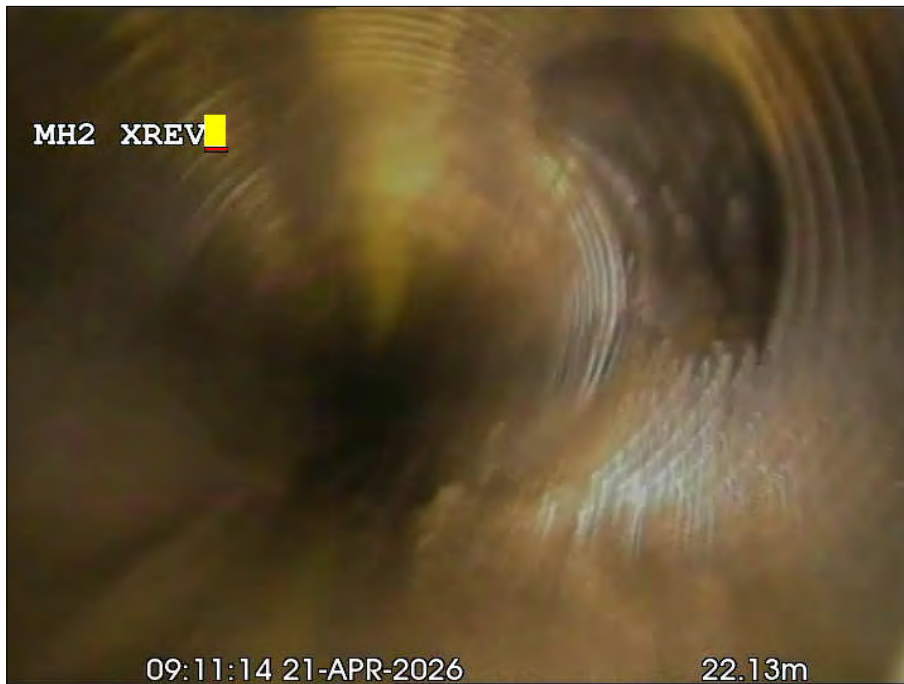
Photo: 34\_12a, 00:00:00  
22.2m, Junction at 03 o'clock, dia 100 mm

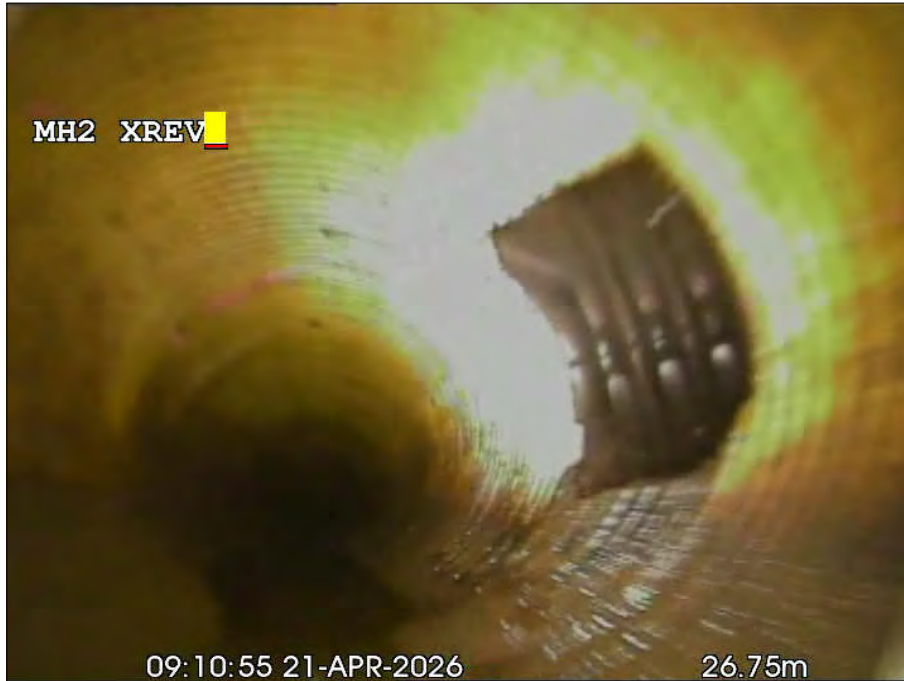
Photo: 34\_13a, 00:00:00  
26.8m, Junction at 03 o'clock, dia 100 mm

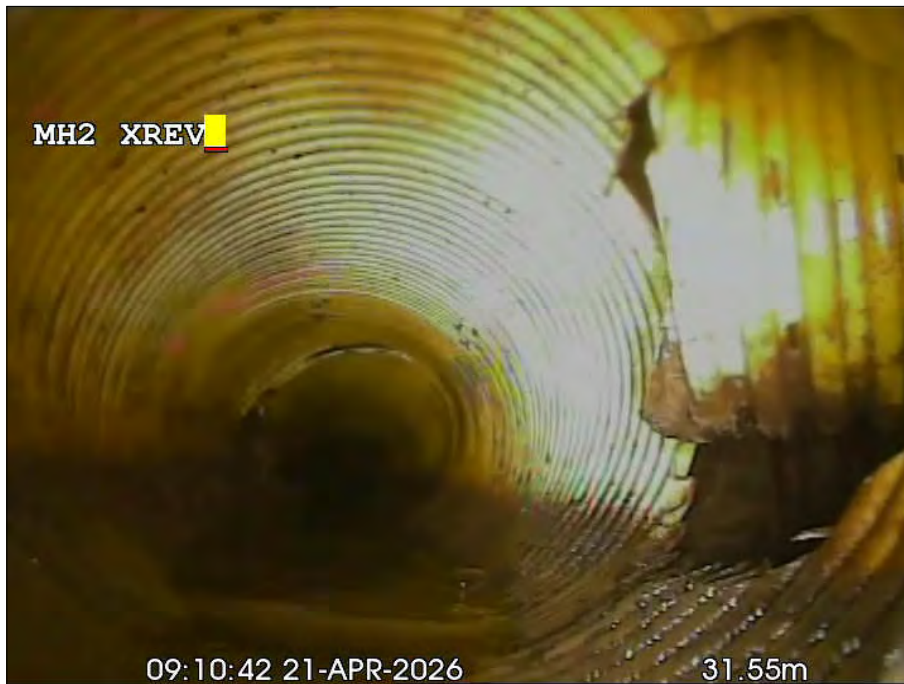
Photo: 34\_14a, 00:00:00  
31.9m, Connection, at 03 o'clock, dia 80 mm

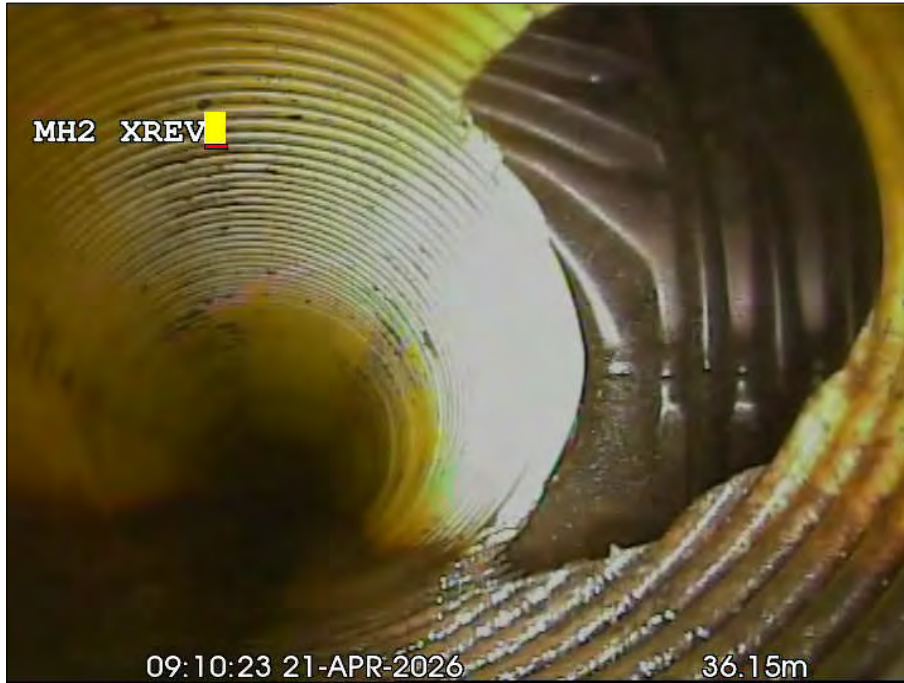
Photo: 34\_15a, 00:00:00  
36.2m, Junction at 03 o'clock, dia 100 mm

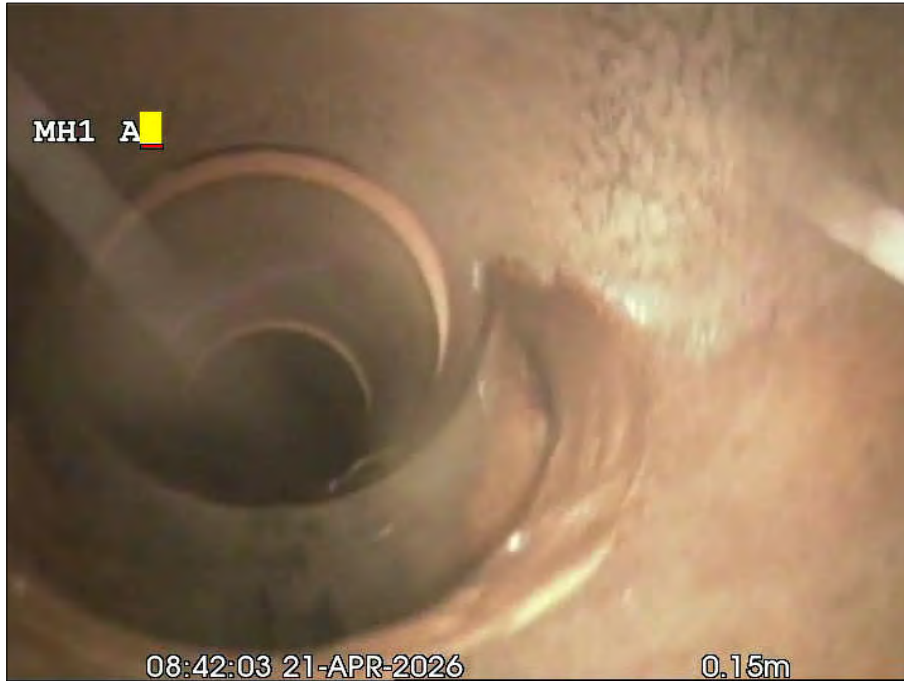
Photo: 317\_4a, 00:00:00  
0.1m, Junction at 06 o'clock, dia 150 mm
