# Contaminated Land Phase Two Intrusive Investigation for Proposed Residential development at 615 Edenfield Road, Rochdale, OL11 5XE.

Prepared for:

Building Design Services  
418 Bury Road  
Rochdale  
OL11 5EU.

September 2026

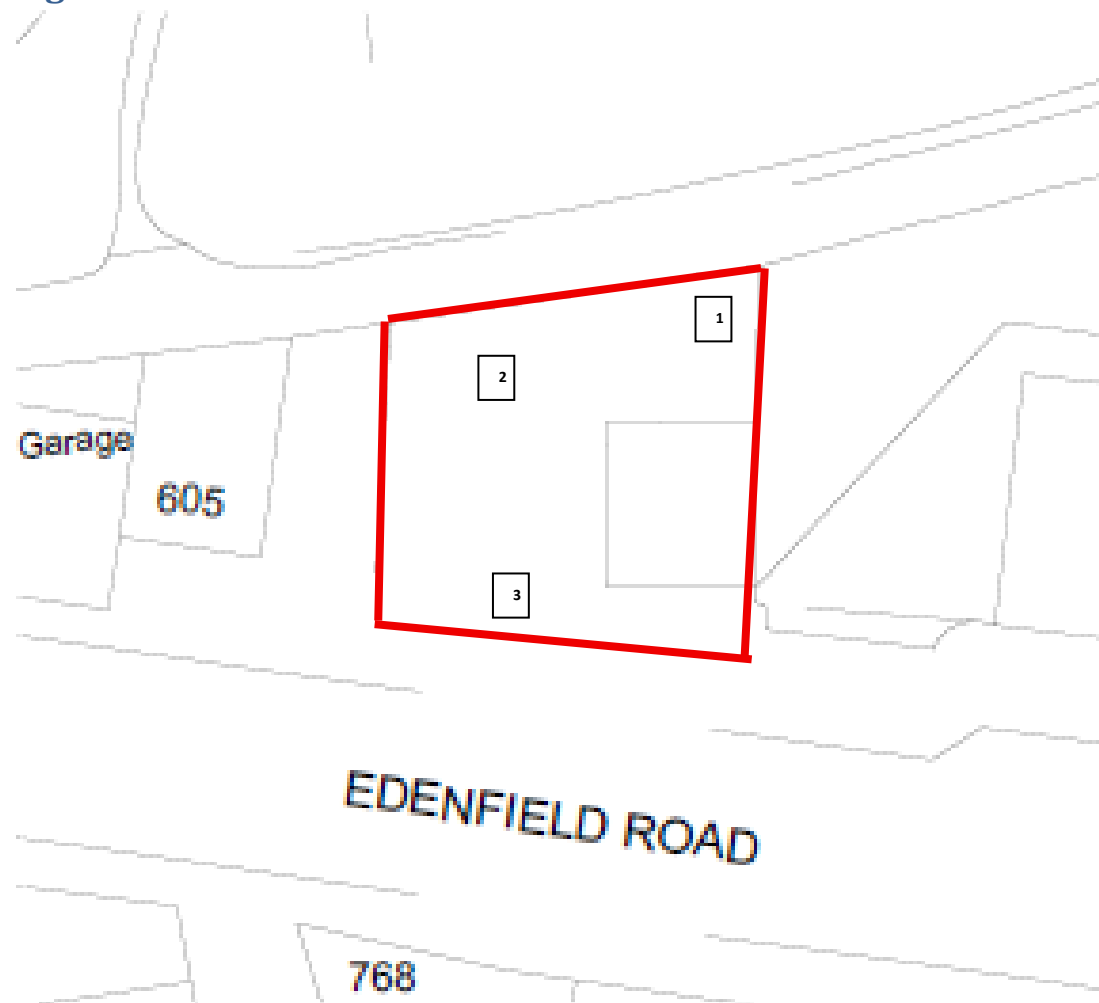
**Figure 2 - Trail Hole Locations.**

A site visit was conducted on the 26<sup>th</sup> August 2026 to undertake an intrusive investigation. Three sample locations were chosen across the site, the locations are shown in Figure 2.

The second sample was located to the rear southeast corner with a surface of asphalt, then concrete sand stone rock was again found down to the base at 0.9m bgl, the sample taken between 0.35-0.6m

Elevated levels of lead were however found in Trail holes 1, 2 and the shallow sample of trail hole three.
