# Validation Report

Site: Land at Greenbooth Road and Edenfield Road, Norden

Reference: 17-330-R1

Date: January 2025

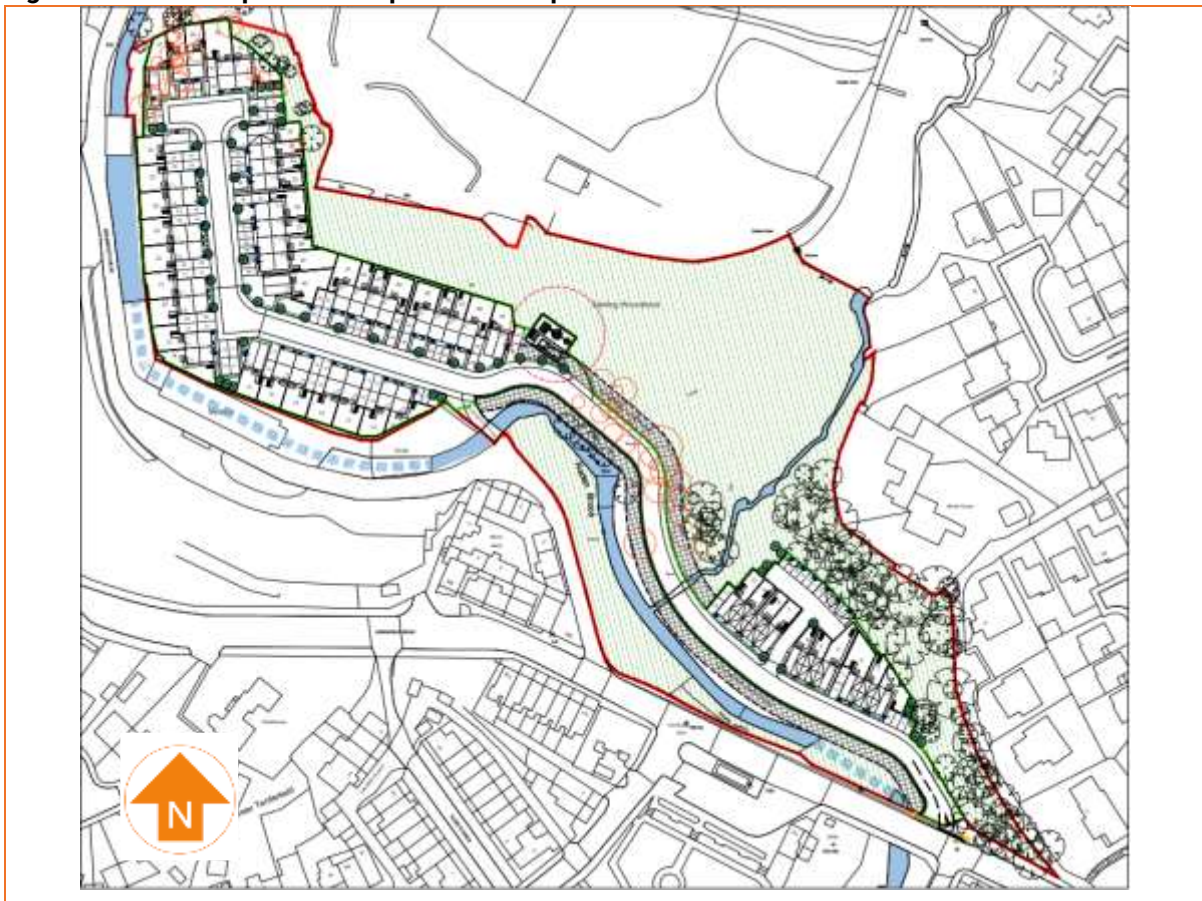
**Figure 1**      **Snapshot of Proposed Development**

E3P has been provided with a detailed planning layout (ref: 20/01170/OUT) detailing the proposed construction, which is presented in Drawing 17-330-002 and included in APPENDIX III. A snapshot is presented below in Figure 1.

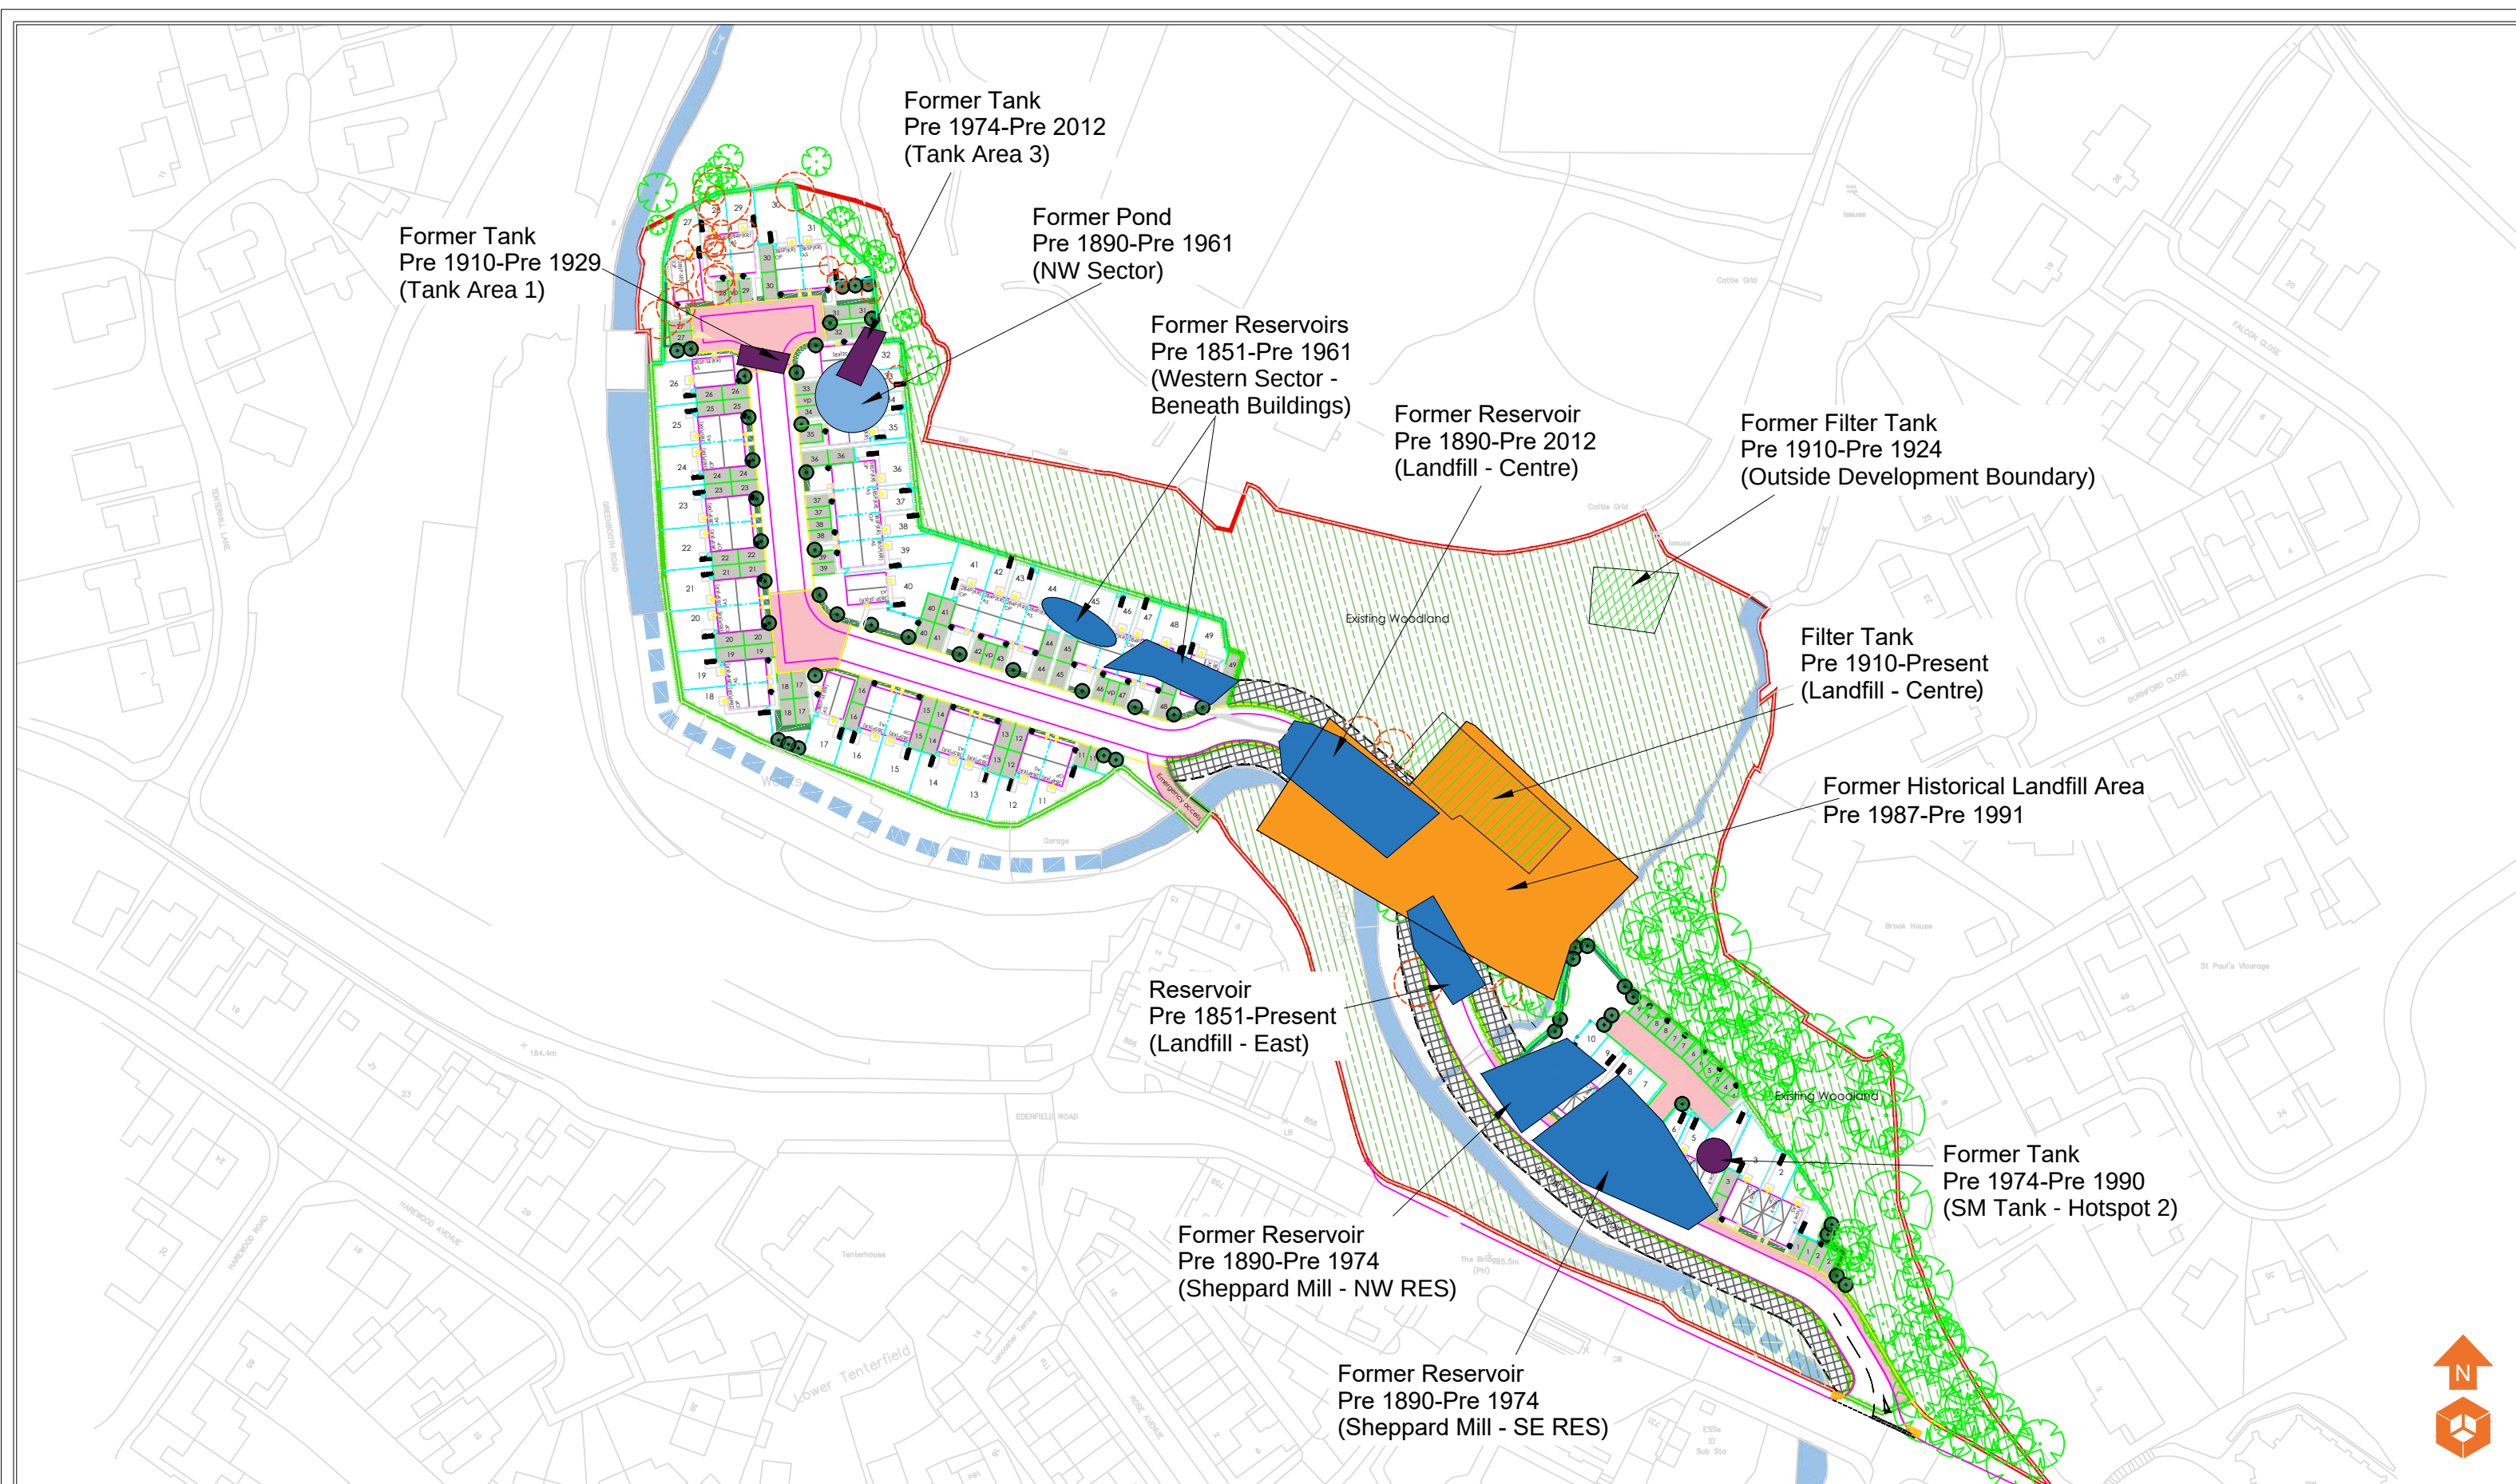
- Historical Features
- Former Ponds
  - Former Reservoir
  - Former Tanks
  - Former Filter Tanks
  - Former Historical Landfill Area

During the remediation and enabling works, all historical “reservoirs” and ponds were delineated with a watching brief down to the natural strata with all materials demonstrating unsuitable geotechnical properties being removed and replaced with geotechnically suitable materials that were placed and compacted in accordance with the E3P Geotechnical Engineering Specification (E3P Report 16-465-R4-1 dated September 2023, Section 6).

It is noted that during the full depth turnover of the historic landfill area, E3P did not identify any potential sources of ground gas. The landfill materials generally comprised of hardcore and brick (associated with the demolition of the former Woodhouse Mill buildings), and organic materials identified within the two reservoirs located within the historic landfill boundary were removed and disposed of off-site at a licensed waste facility. Given that no potential source of ground gas remains within the historic landfill area, no development is being undertaken within the boundary of the historical landfill area (other than the construction of a road and pumping station), and gas protection measures are currently proposed for the residential properties located to the west (CS2) and east (vapour resistant membrane), E3P does not consider further gas assessment of the historical landfill area to be necessary.

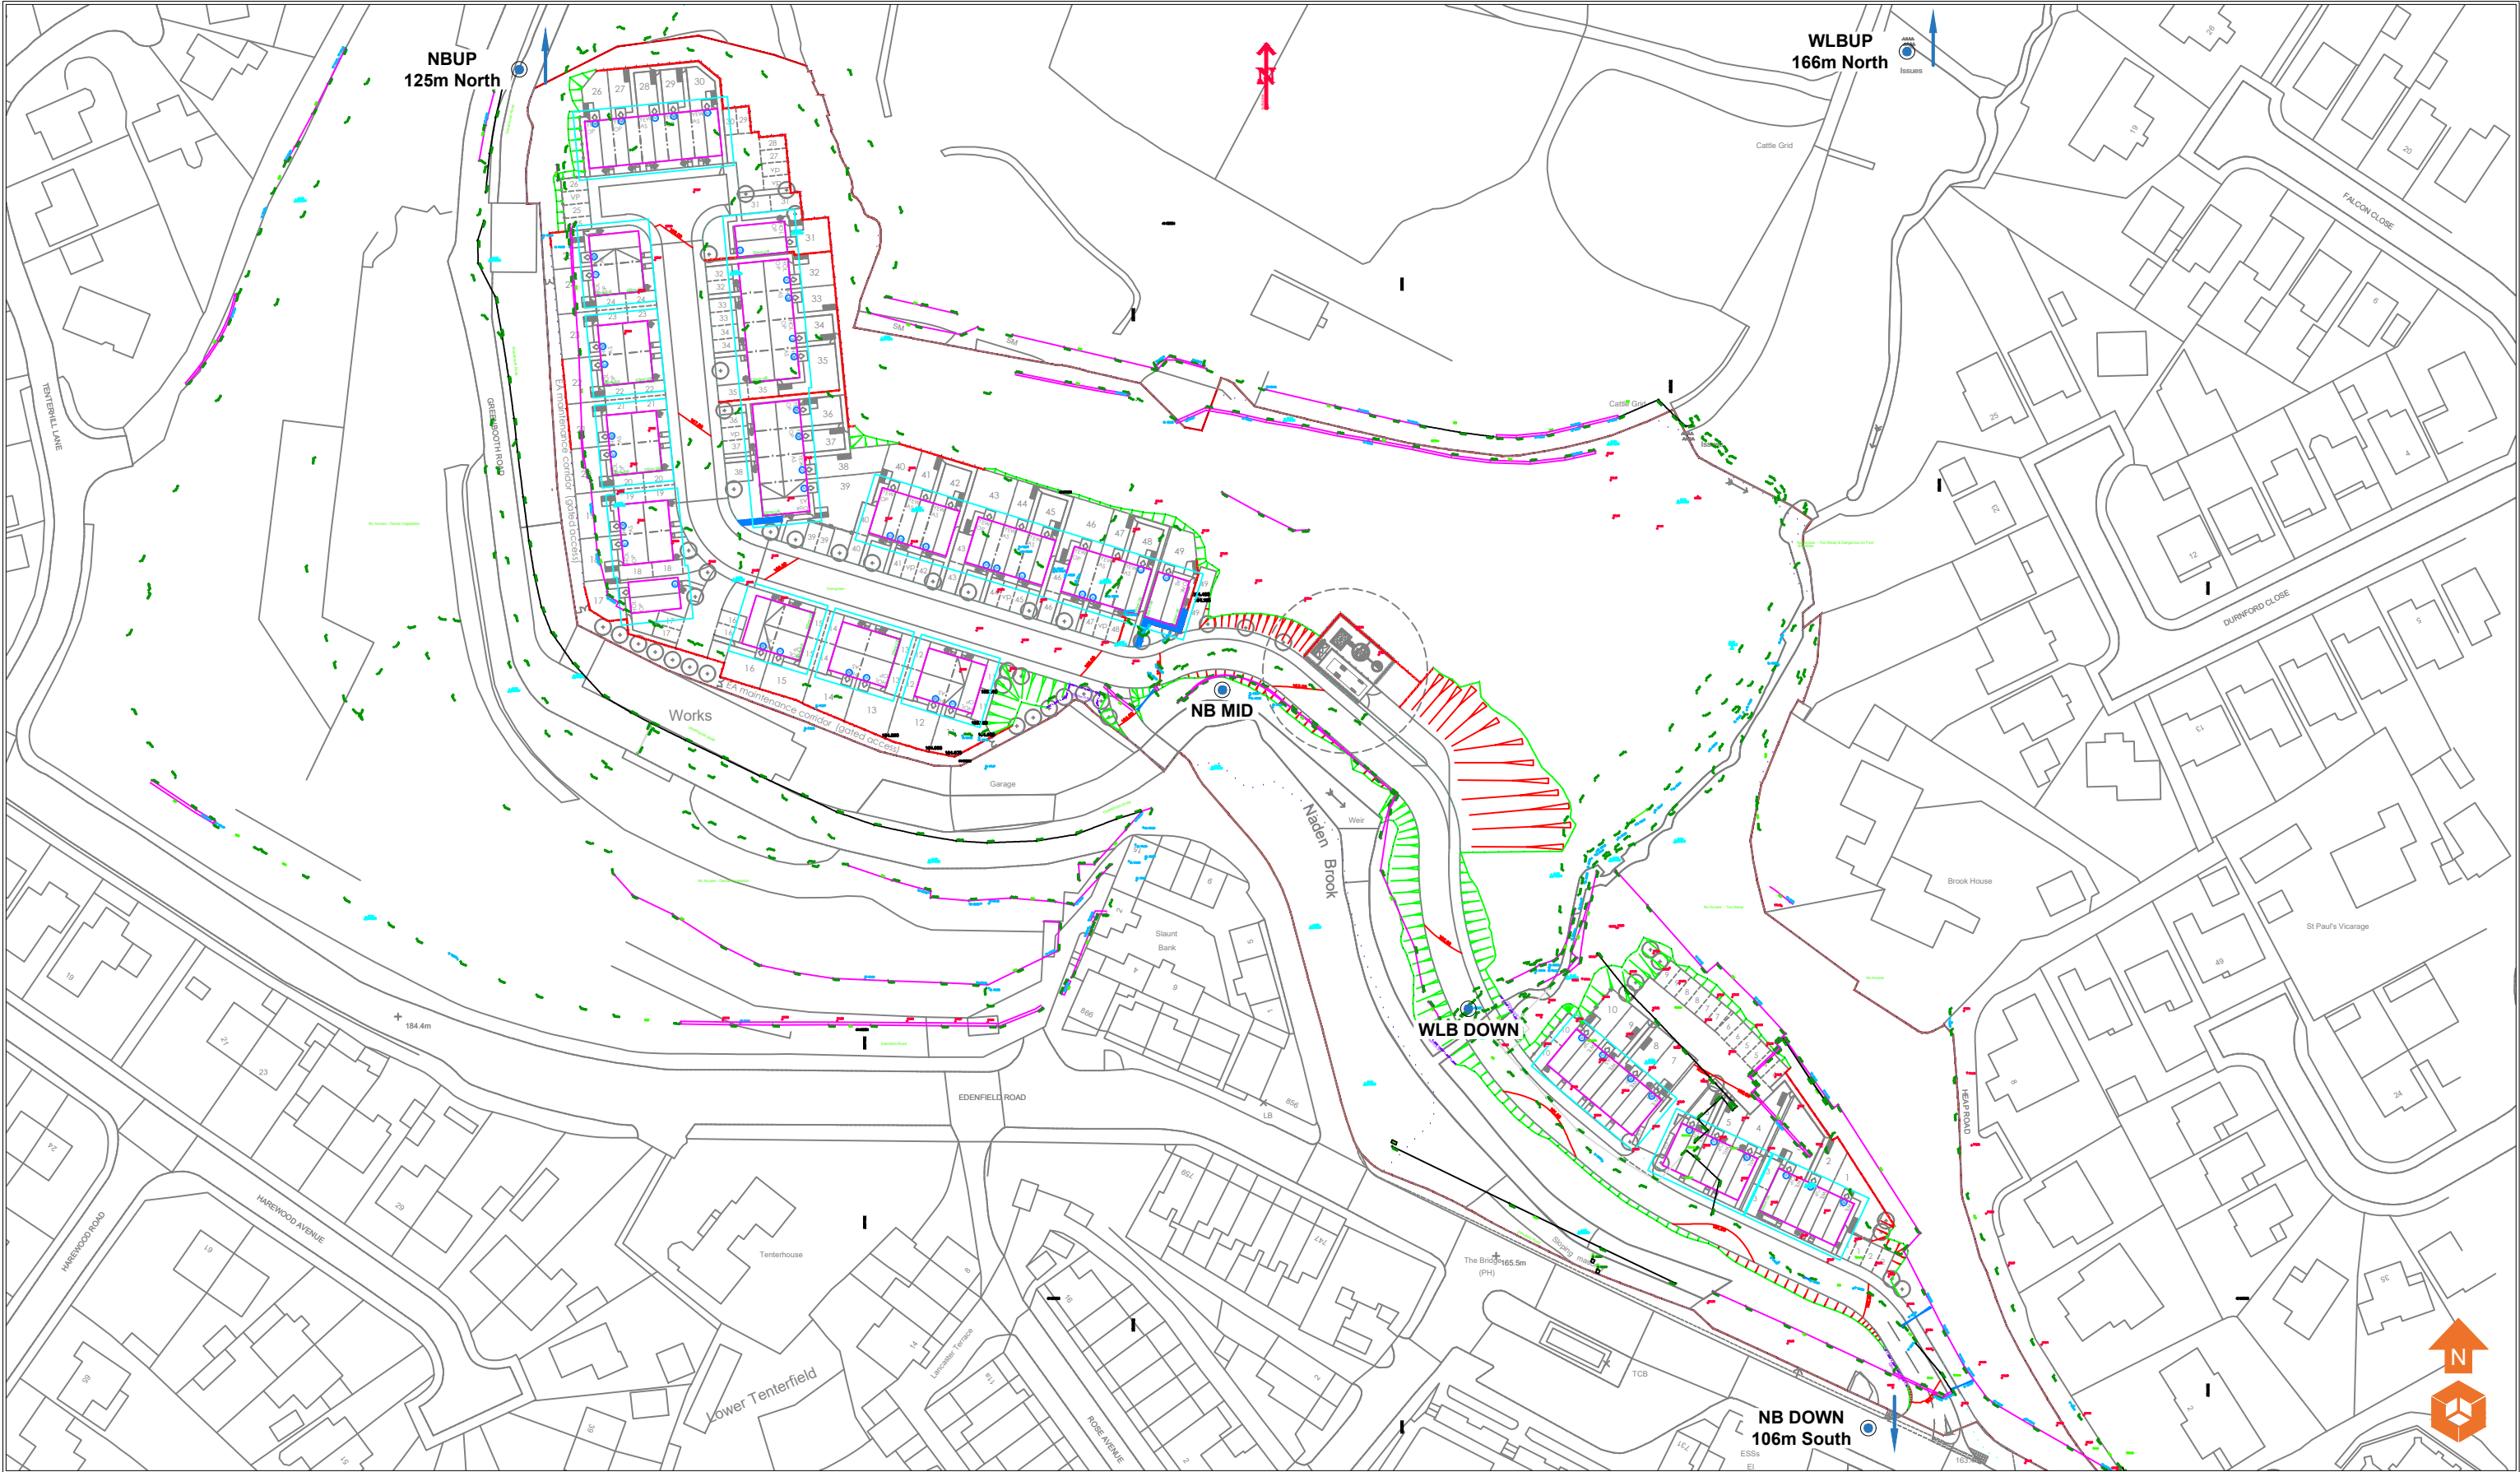
Remediation Sample Location  
Plan - Waters

Location Symbols

Approximate Sample Location

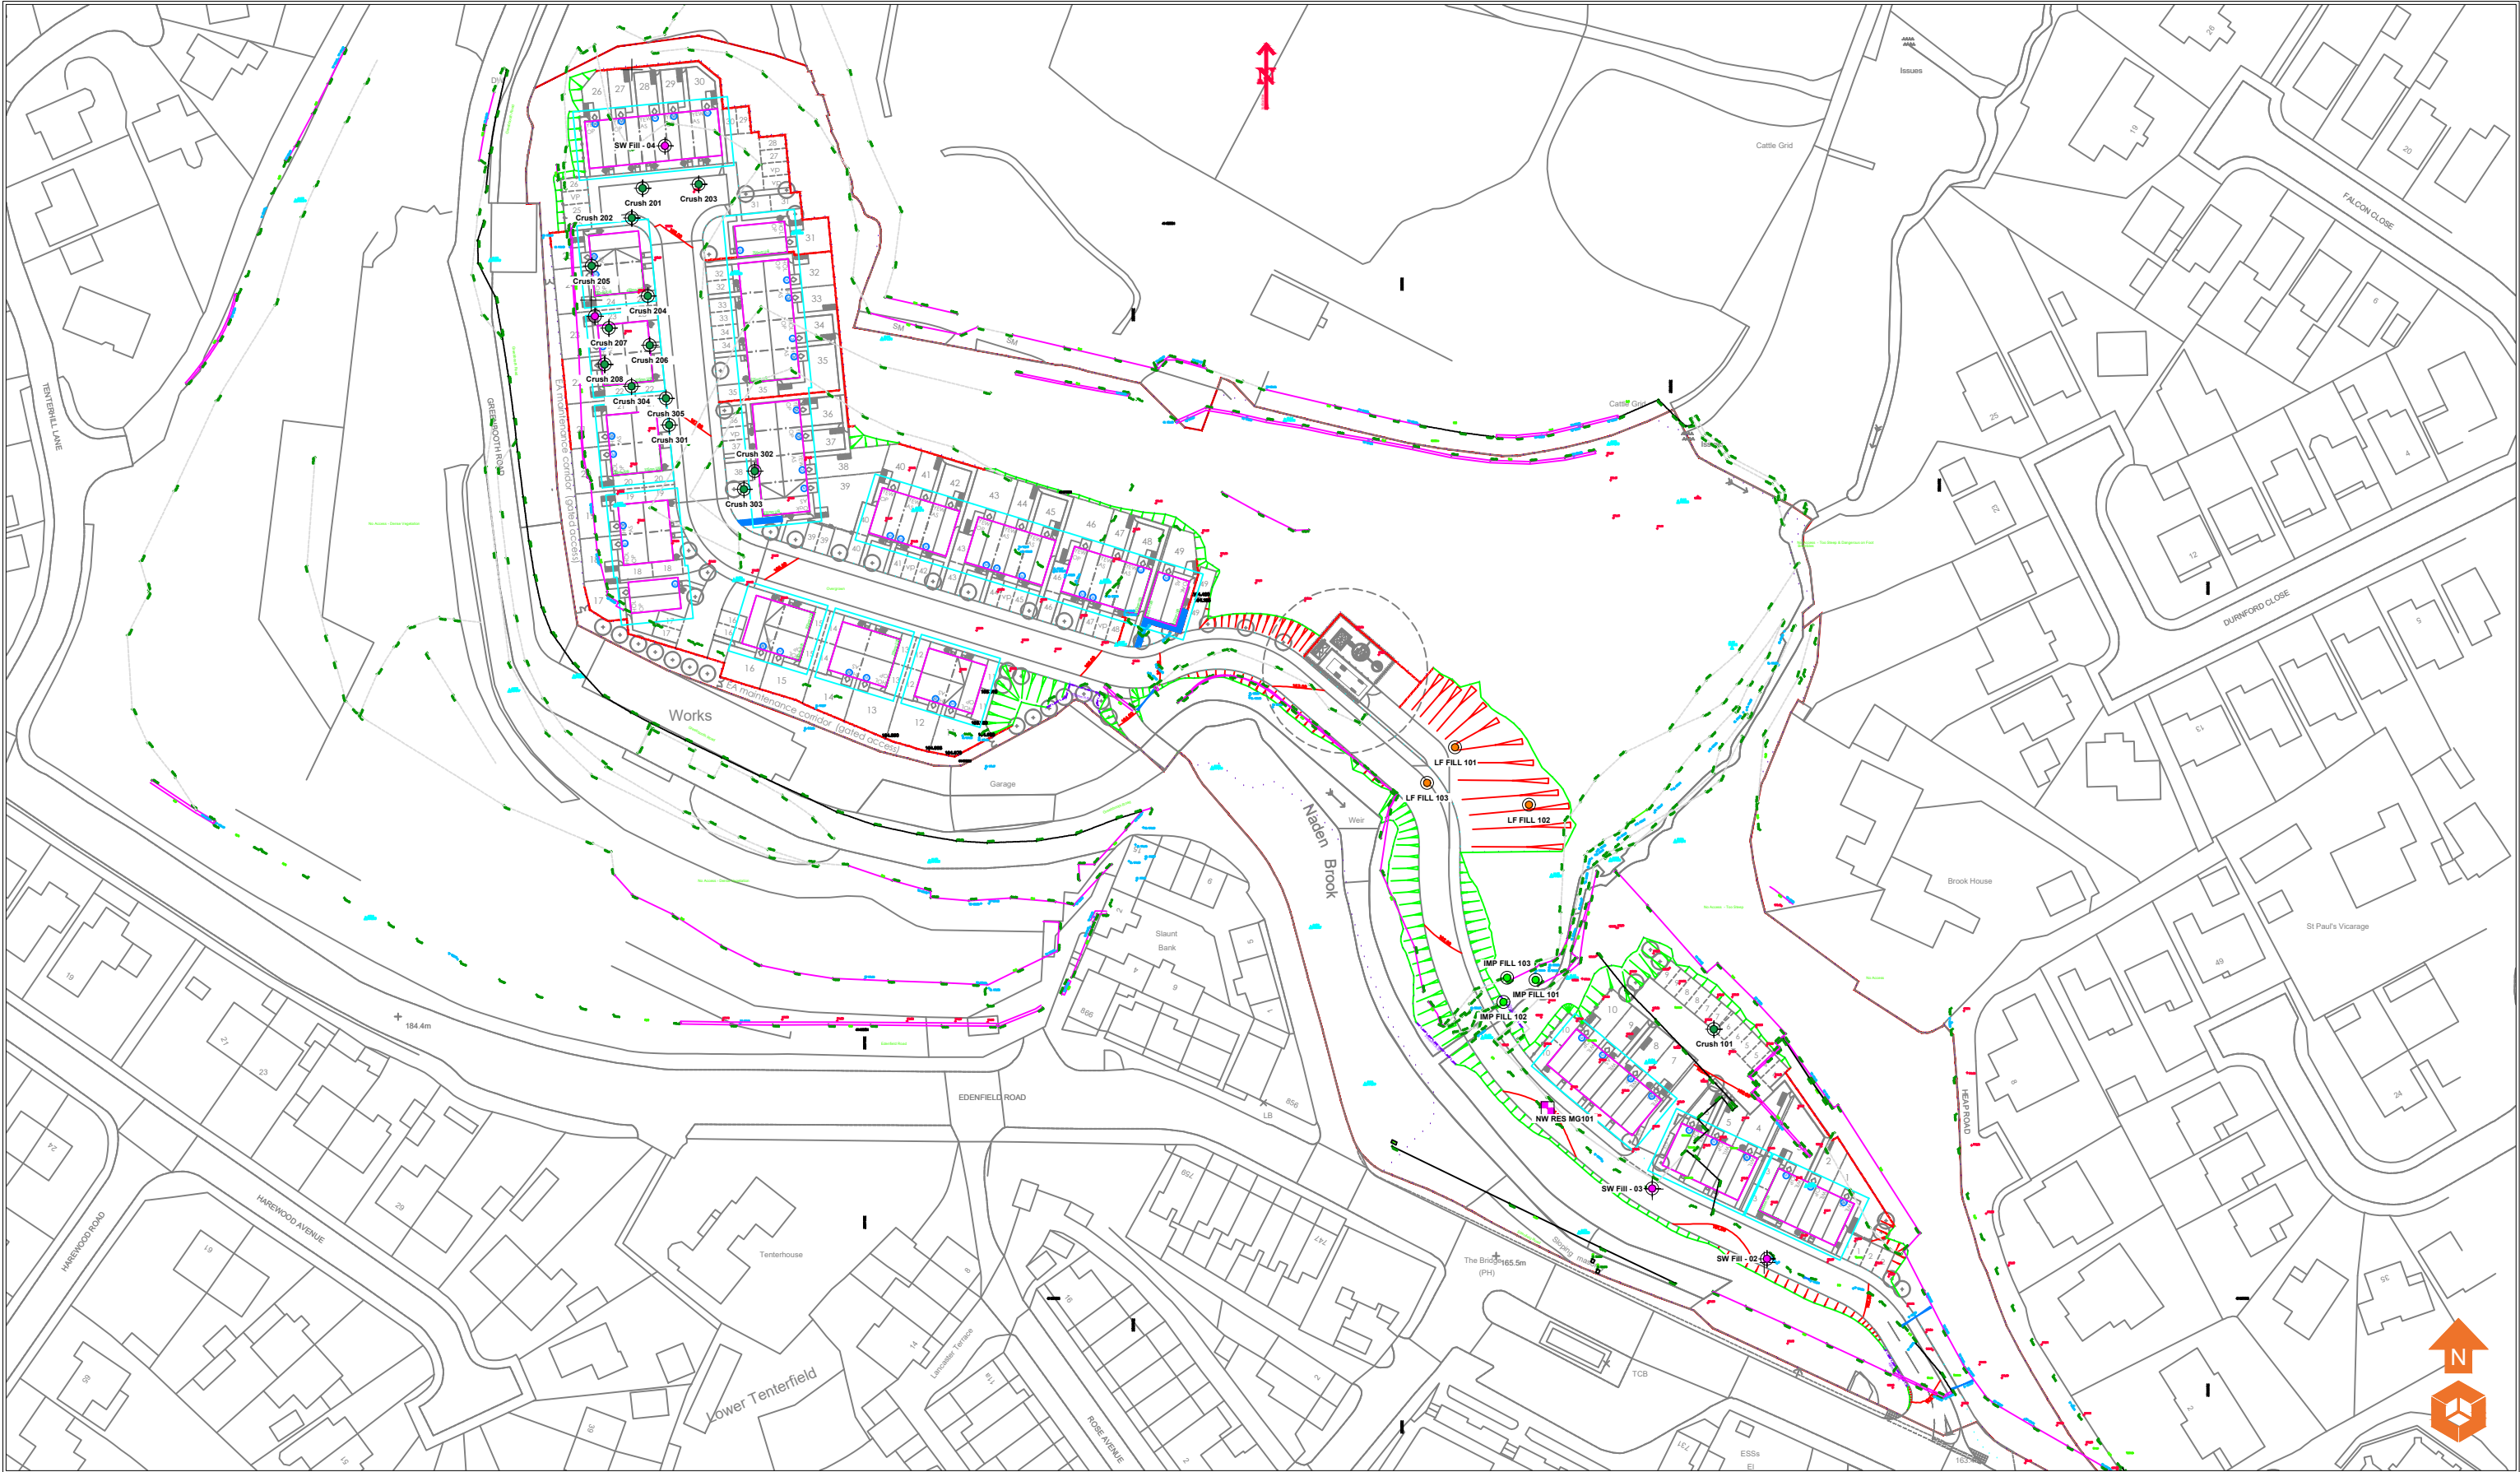
Remediation Sample Location  
Plan - Geotechnical

Location Symbols

Approximate Sample Location

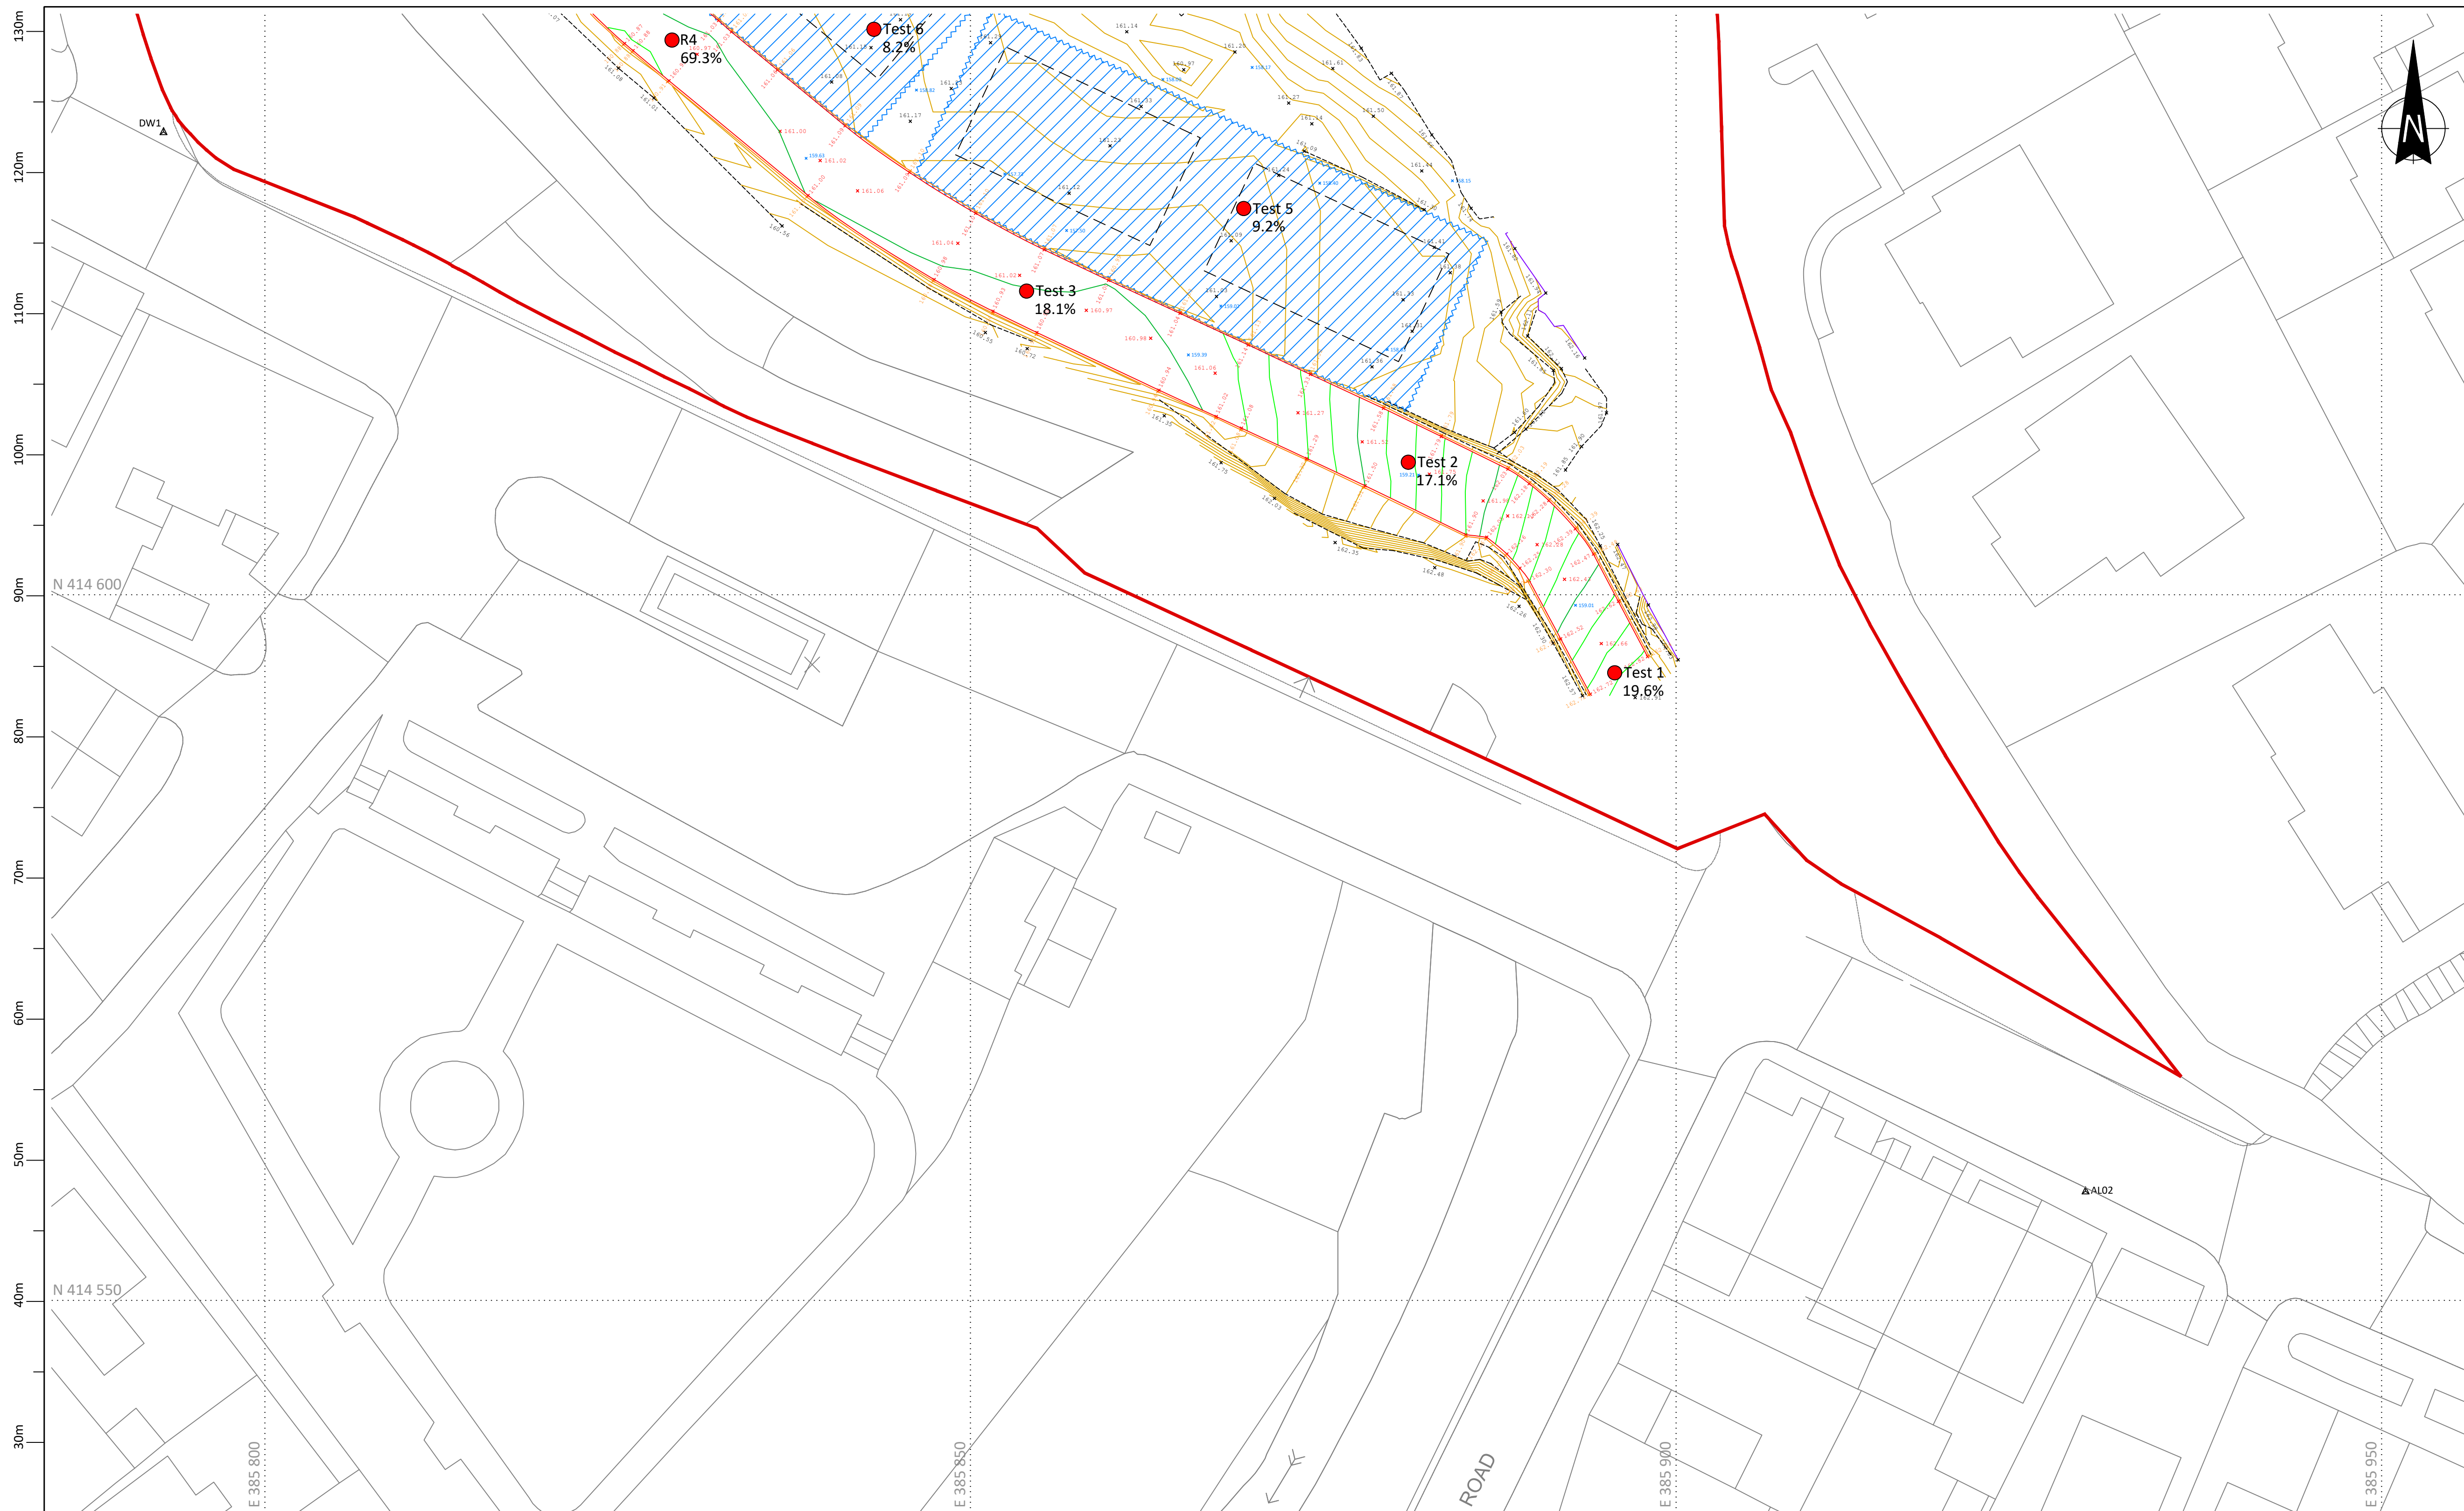
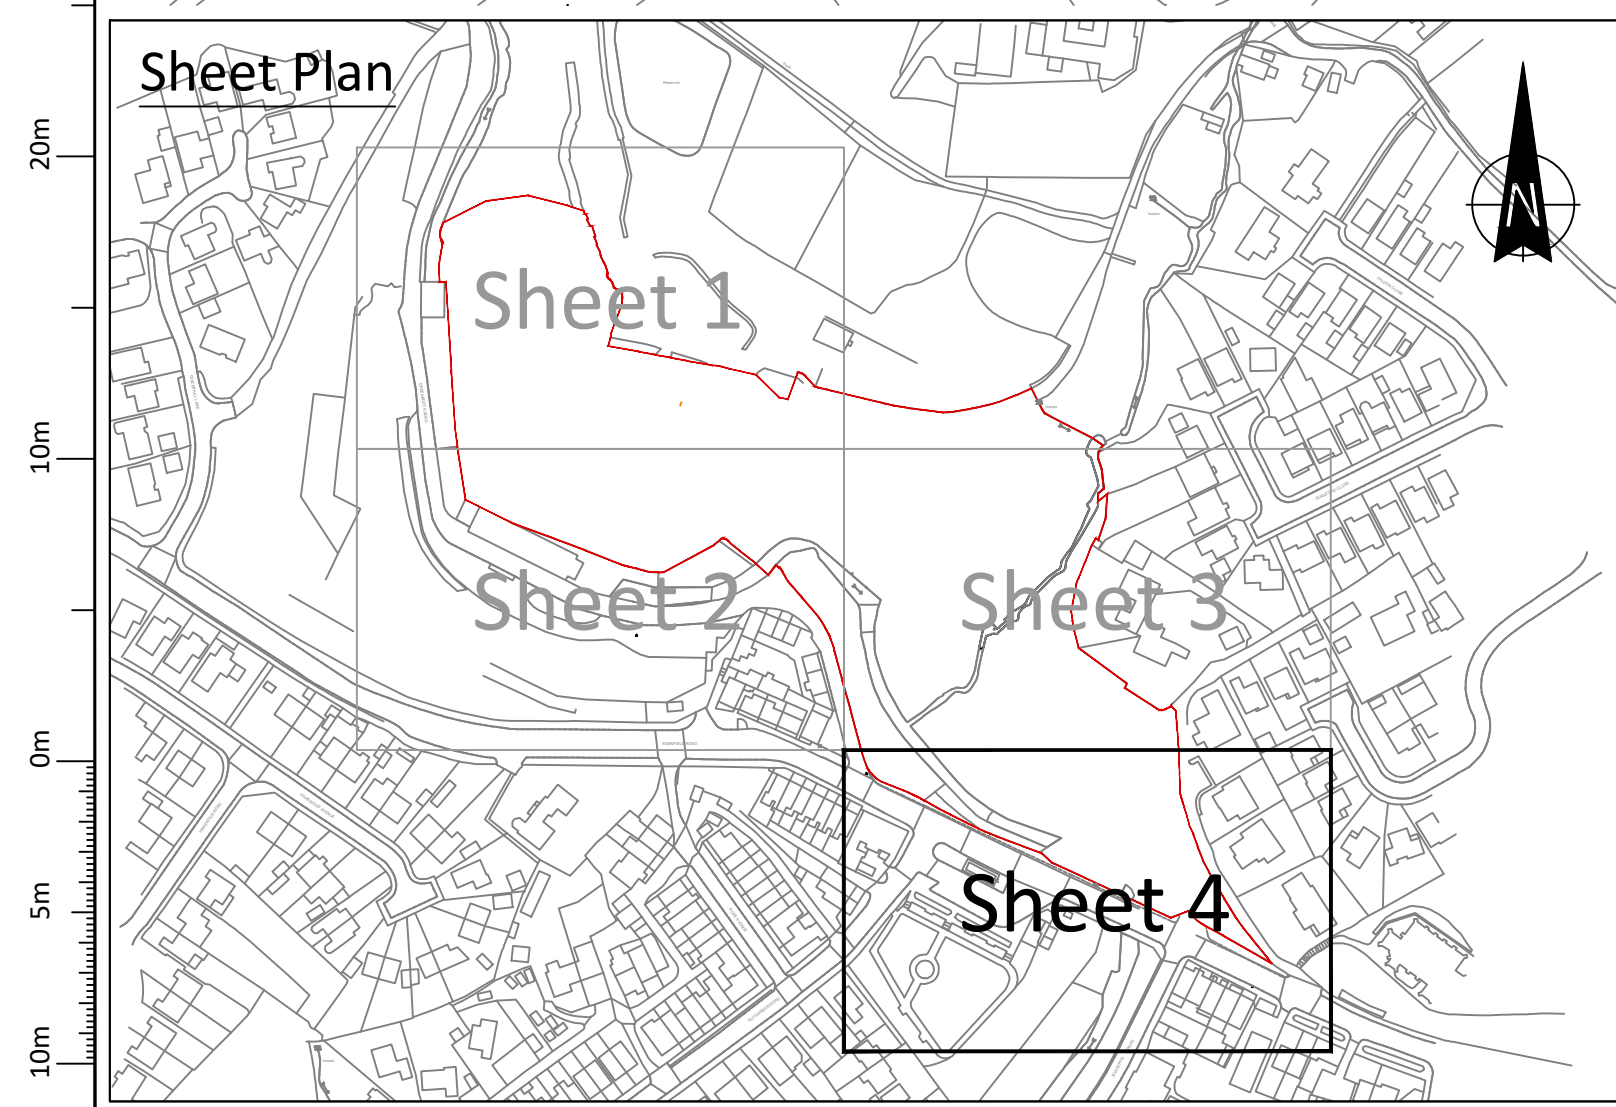
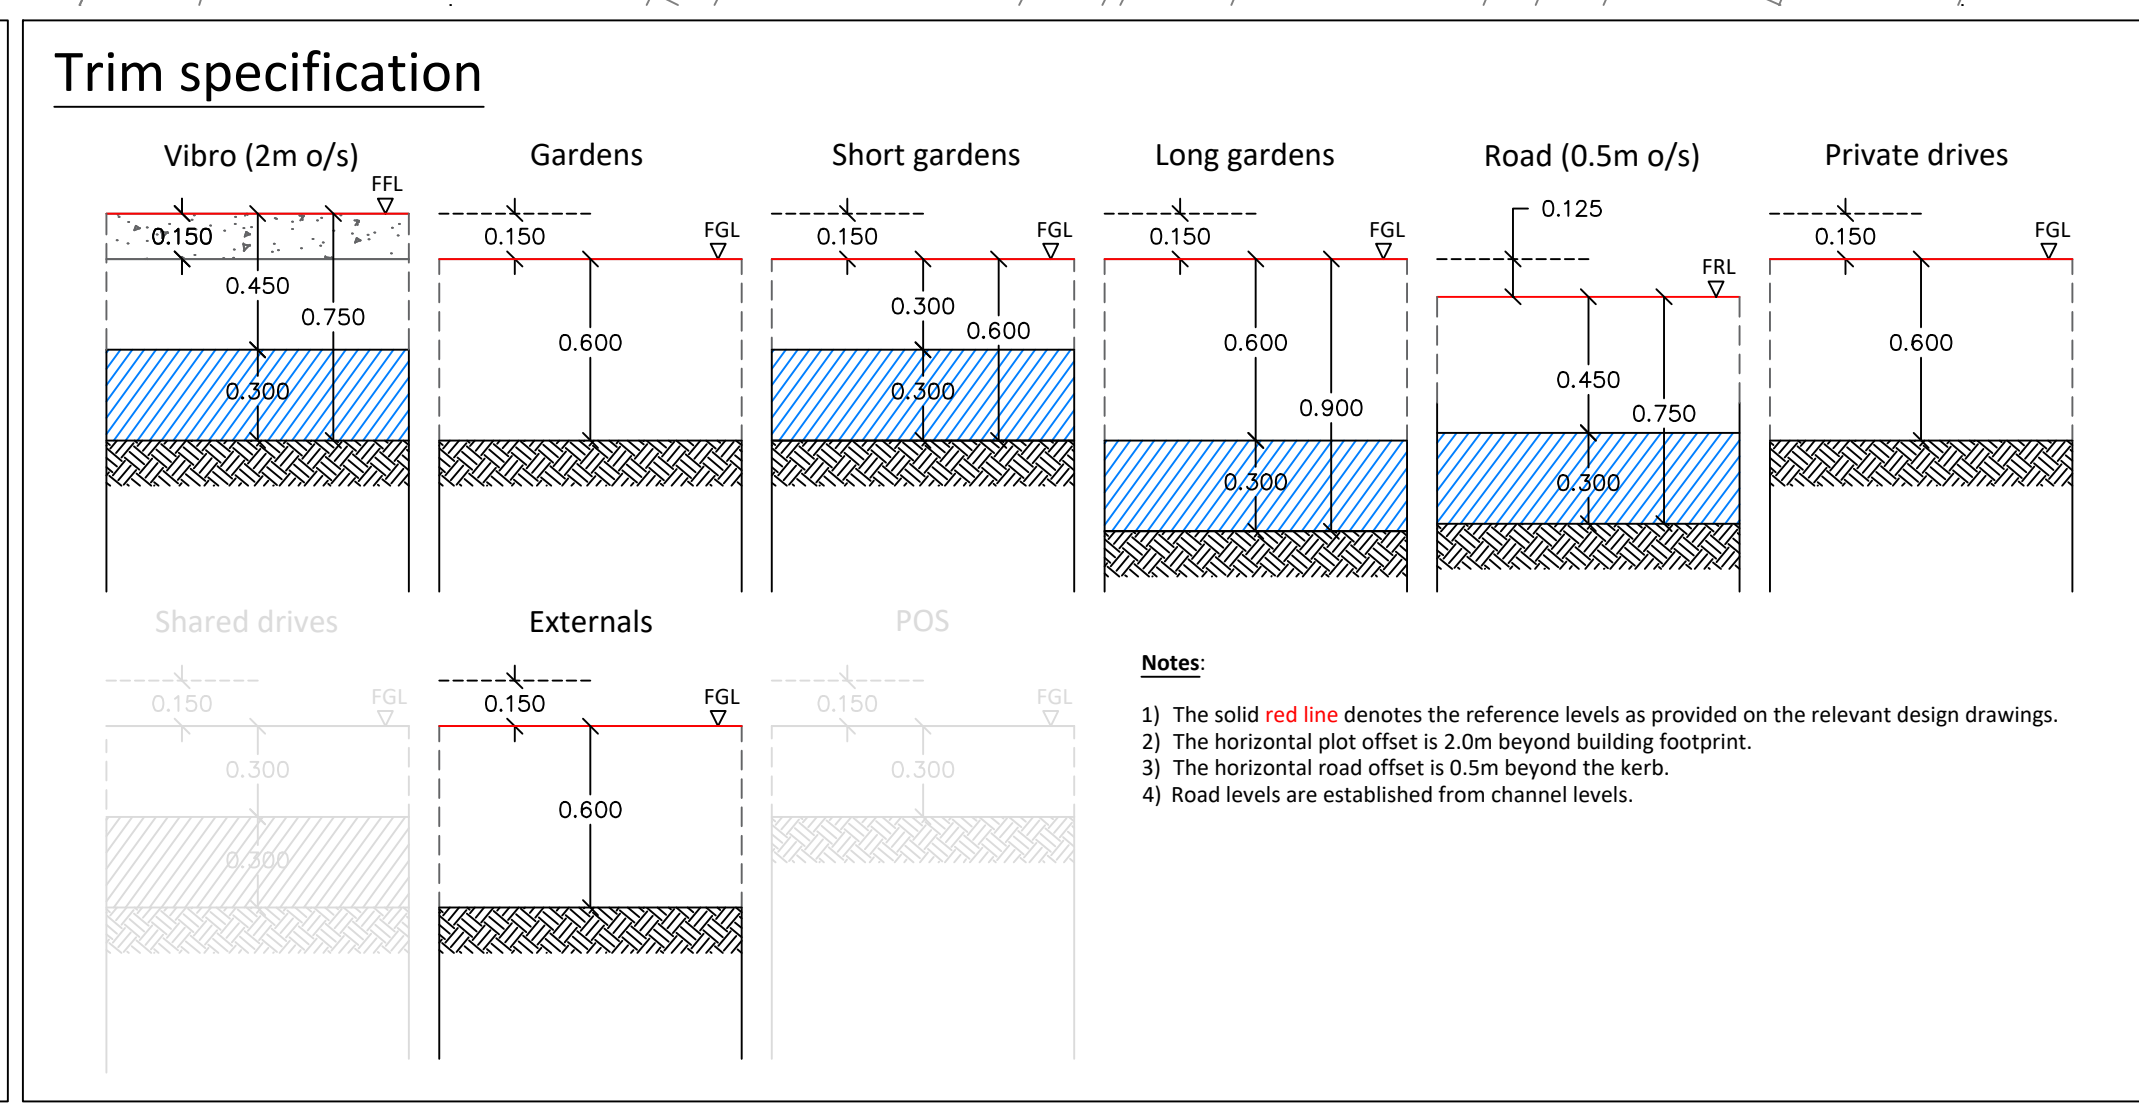
1. This plan is to be read in conjunction with all other associated reports/drawings/information.
2. The development layout depicted on this drawing was extracted from drawing 'EDE-APP-XX-00-DR-C-1400-PDF FINISHED LEVELS AND RETAINING WALLS (dref bound).DWG.dwg' supplied digitally by the Client.

3. The required foundation solution is as detailed on drawing 'EDE-APP-XX-00-DR-S-2000-P2 FOUNDATION ZONING PLAN.pdf' provided digitally by the Client.

4. The site trim specification is as specified/agreed by with the Client; and as detailed.
5. Due to the potential for live services and issues associated with withdrawal of support; remediation works have been carried out to within circa 1m of the site boundary (unless otherwise stated).

6. The location of services as detailed are approximate only (unless otherwise stated).
7. As agreed with the Client, the initial length of road (to the bend), has been constructed circa 1.0m to the east to accommodating existing site features near the entrance.
