# Validation Report

Site: Land at Greenbooth Road and Edenfield Road, Norden

Reference: 17-330-R1

Date: January 2025

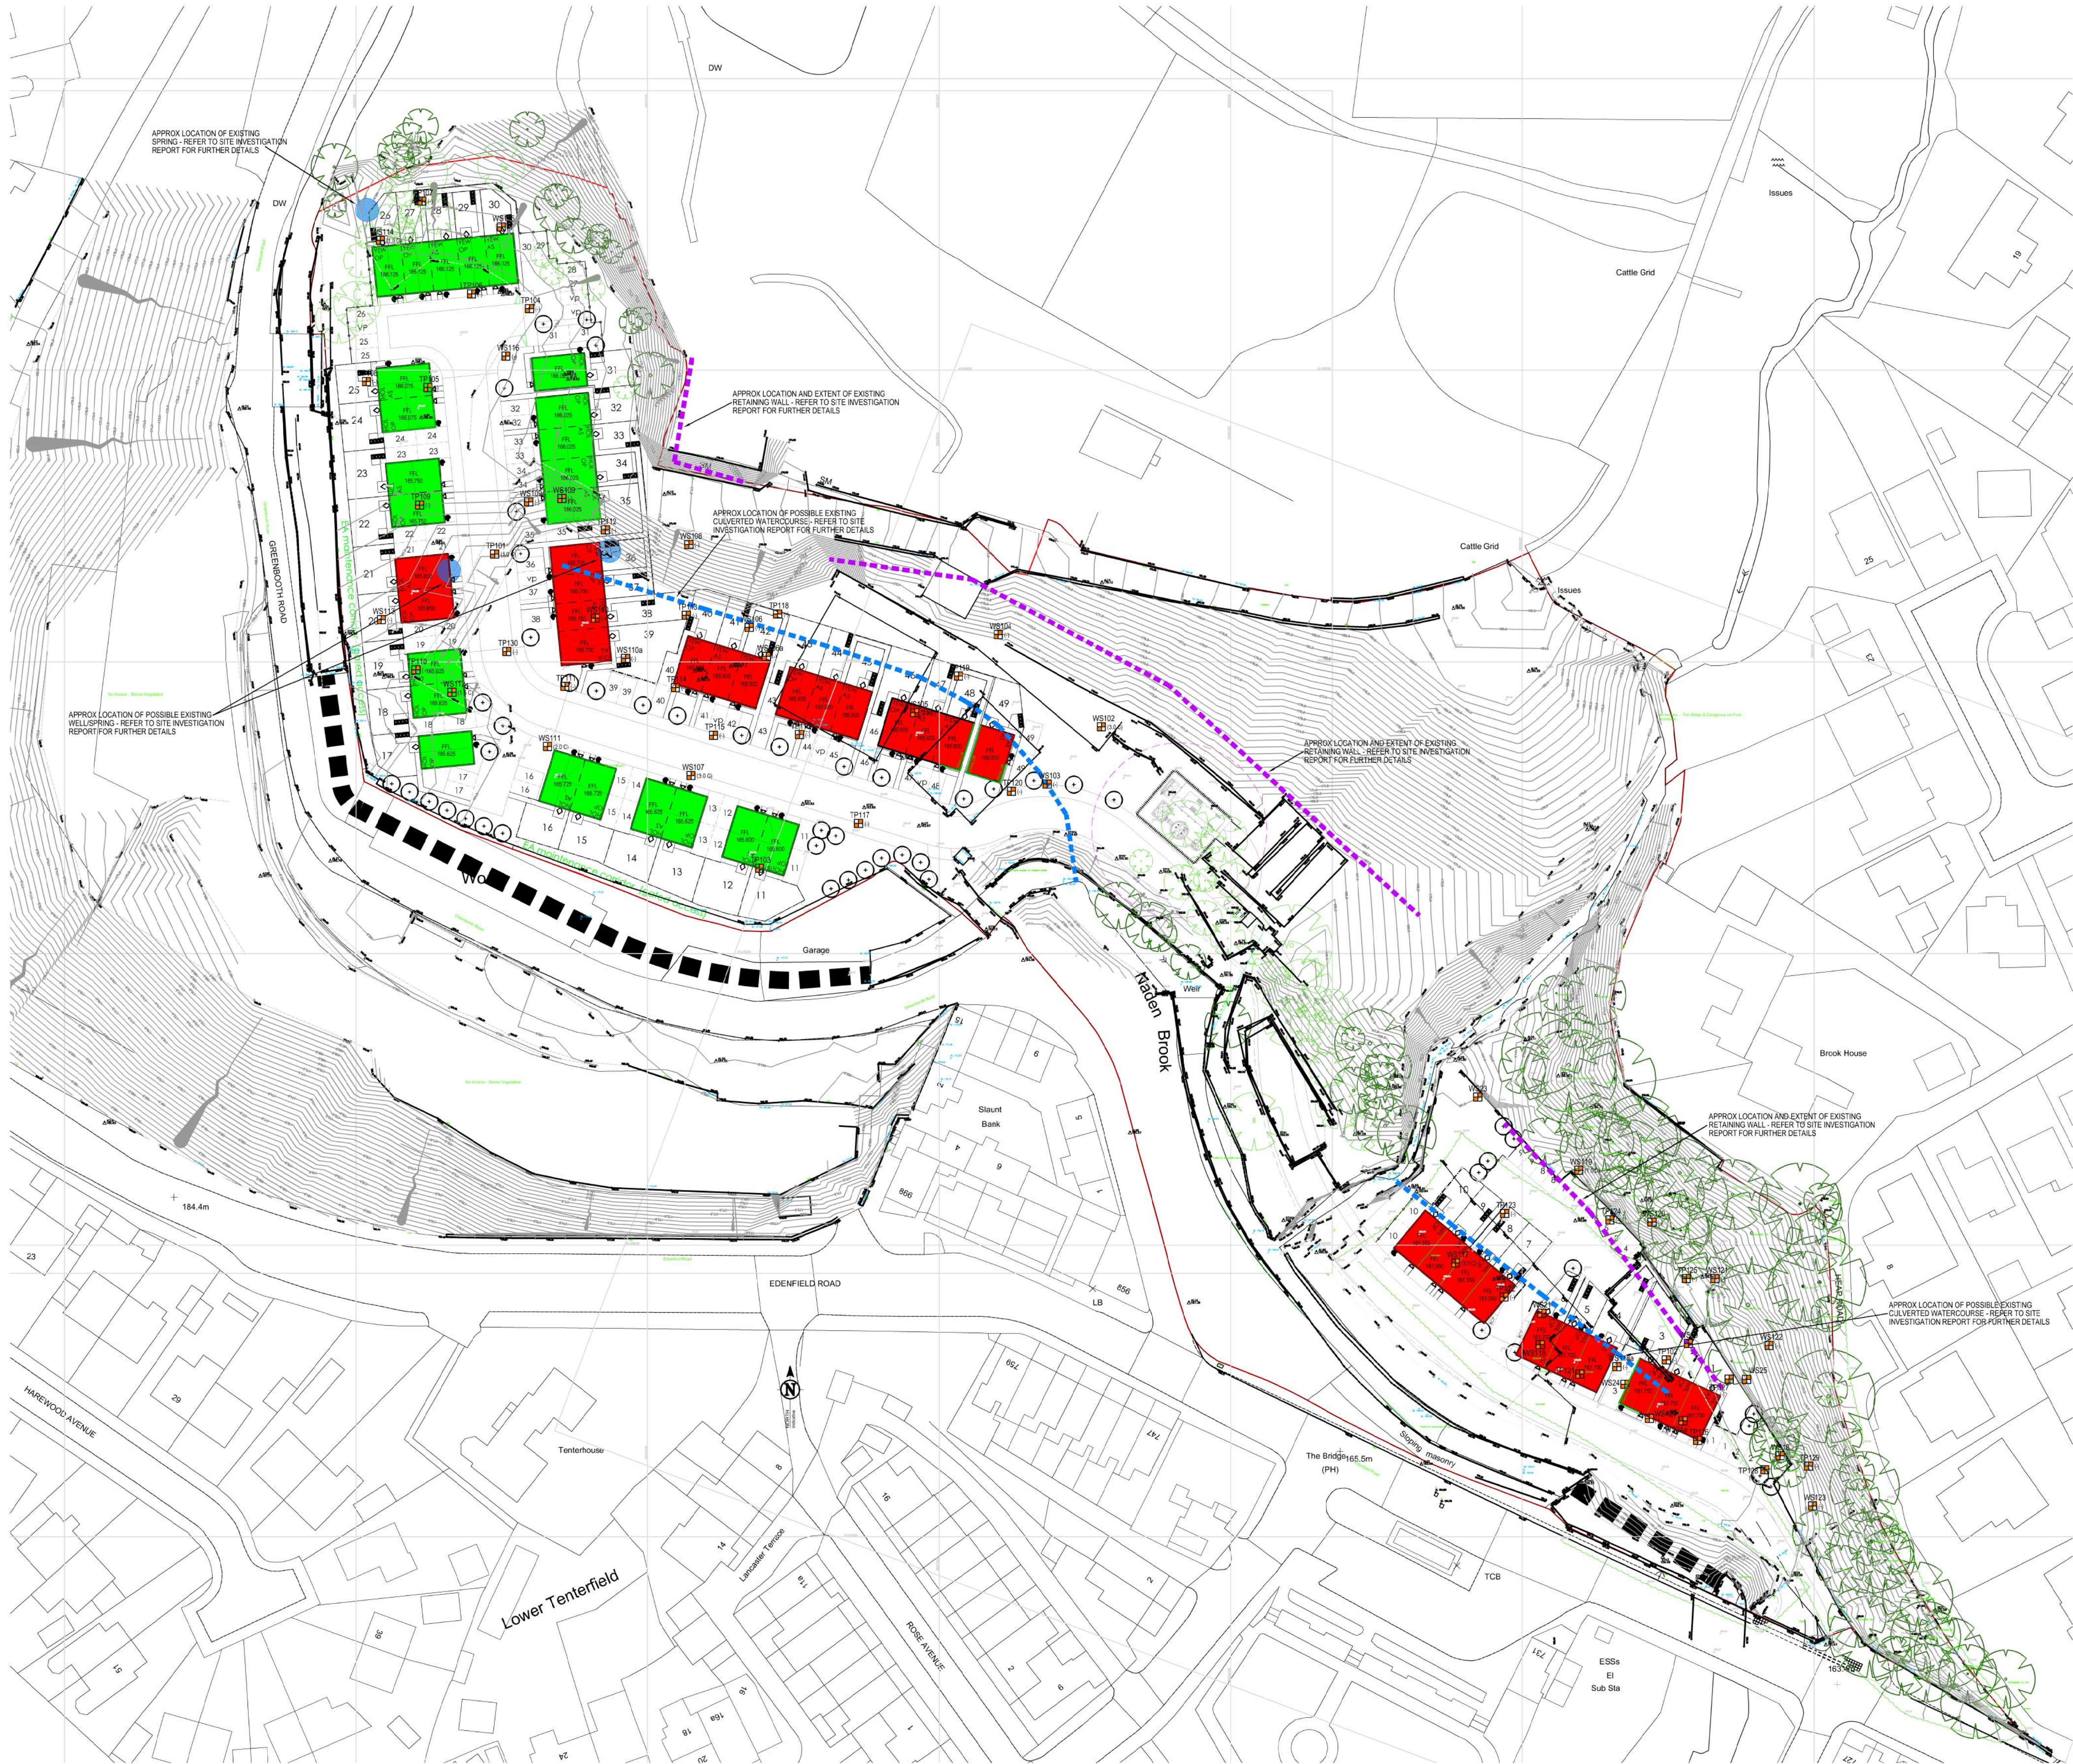
**NOTE**  
ALL HEAVE/TREE INFLUENCING IS TO BE IGNORED AS THE SITE WILL BE FULLY TURNED OVER AND REMEDIATED TO REMOVE ALL EXISTING/RELIC OBSTRUCTIONS etc ALONG WITH ANY COHESIVE MATERIAL (TO BE REPLACED WITH SUITABLE GRANULAR MATERIAL IN LINE WITH NHBC GUIDANCE AND RECOMMENDATIONS)

| Plot | Proposed Slab Level | Existing Ground Level | Foundation Type | Foundation Formation Level (corner) | | | | DEPTH OF CONCRETE | | | |

EDE-AJP-XX-00-DR-S-2000-P1 – Foundation Zone Plan.
