REPAIR WORKS TO THE WINDOWS/WALLS - GENERAL NOTES

EXISTING NW AND SW  
ELEVATIONS - PROPOSED REPAIR  
WORK

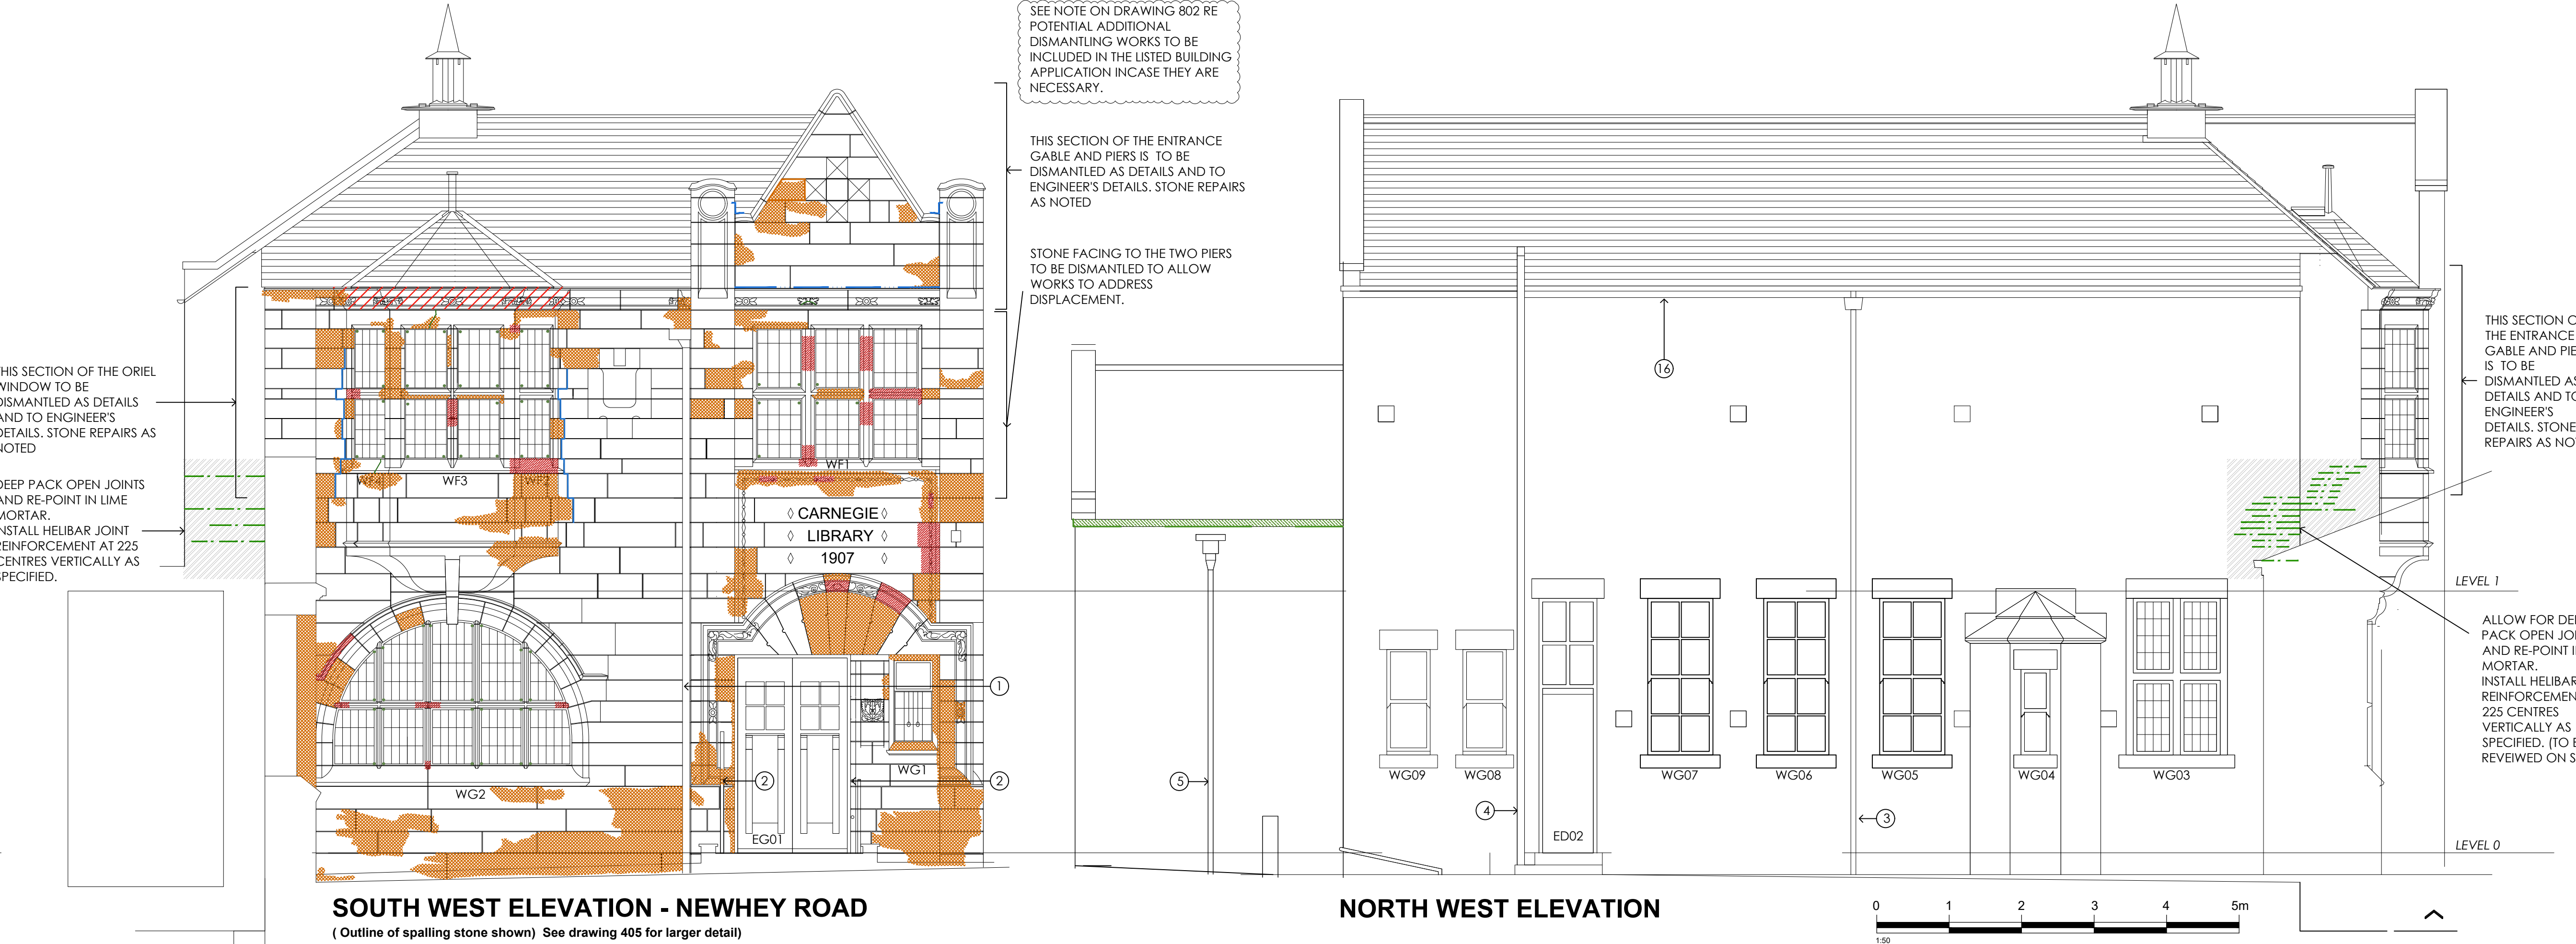
CAREFULLY REMOVE LOOSE/SPALLING STONE AND RE-DRESS TO MATCH ADJACENT STONEMWORK AND TO CLEAN STRAIGHT LINE.

RESIN / STITCH REPAIR TO STONE OR COPING.

INDENT REPAIR TO THE STONEMWORK. REQUIREMENT FOR INDENT WORKS TO BE REVIEWED ON SITE WITH CONTRACTOR PRIOR TO WORKS COMMENCING.

CAREFULLY REMOVE CAST IRON RWP (AS TAGGED ON WEST ELEVATION) AND REPAIR PARTS WHERE POSSIBLE INCLUDING SPLITS TO HOPPER AND EAR BAND. ALLOW FOR THE REPLACEMENT OF ONE SECTION OF THE RWP (TO BE OMITTED IF NOT REQUIRED) ALLOW FOR THE REMOVAL OF ALL RUST AND LOOSE PAINT, PRIMING AND RE-DECORATION. REPAINTED IN COLOUR TO MATCH ORIGINAL. ALL FIXINGS TO BE RENEWED WITH STAINLESS STEEL WITH ISOLATION SLEEVES AND NEW SPACERS.

CLEAN AND PAINT HANDRAIL/ FIXING PLATES AND CHANGE SCREWS FOT STAINLESS STEEL. ETCH AND PAINT TO MATCH RAILS.

CAREFULLY REMOVE CAST IRON RWP TO ALLOW THE REMOVAL OF RUST AND LOOSE PAINT FROM ALL SIDES. PREPARE, PRIME AND FULLY RE-DECORATE IN COLOUR TO MATCH THE EXISTING. INSTALL STAINLESS STEEL FIXINGS WITH ISOLATION SLEEVES TO PREVENT INTERACTION WITH IRON COMPONENTS. FULLY RE-FIX.

12. ALLOW FOR THE DISMANTLING OF THIS SECTION OF GUTTER (INCLUDING THE RETURN AT THE CORNER) TO ALLOW THE FULL REPLACEMENT OF THE EXISTING PLYWOOD FASCIA. NEW FASCIA TO BE HIGH GRADE NORTH AMERICAN DOUGLAS FIR AND TO BE FULLY PRIMED AND DECORATED TO ALL SIDE. RE-INSTALL GUTTER. ALL FIXINGS TO BE STAINLESS STEEL. ENSURE SEPARATION FROM ALUMINIUM.

13. AS 12 ABOVE BUT TO THE SECTION OF ROOF THAT IS CONCEALED BY THE PARAPET (SEE ROOF PLAN)

14-16. REMOVE RWP AS REQUIRED TO ALLOW THE FULL PREPARATION, RE-DECORATION OF THE FASCIA BOARD. RE-INSTALL GUTTER/RWPS. RE-SEAL ALL JOINTS
