| PROJECT | SMP - St Mary's CE Primary School | | | | |
| TITLE | Roof - Fabric Repair Plan | | | | |

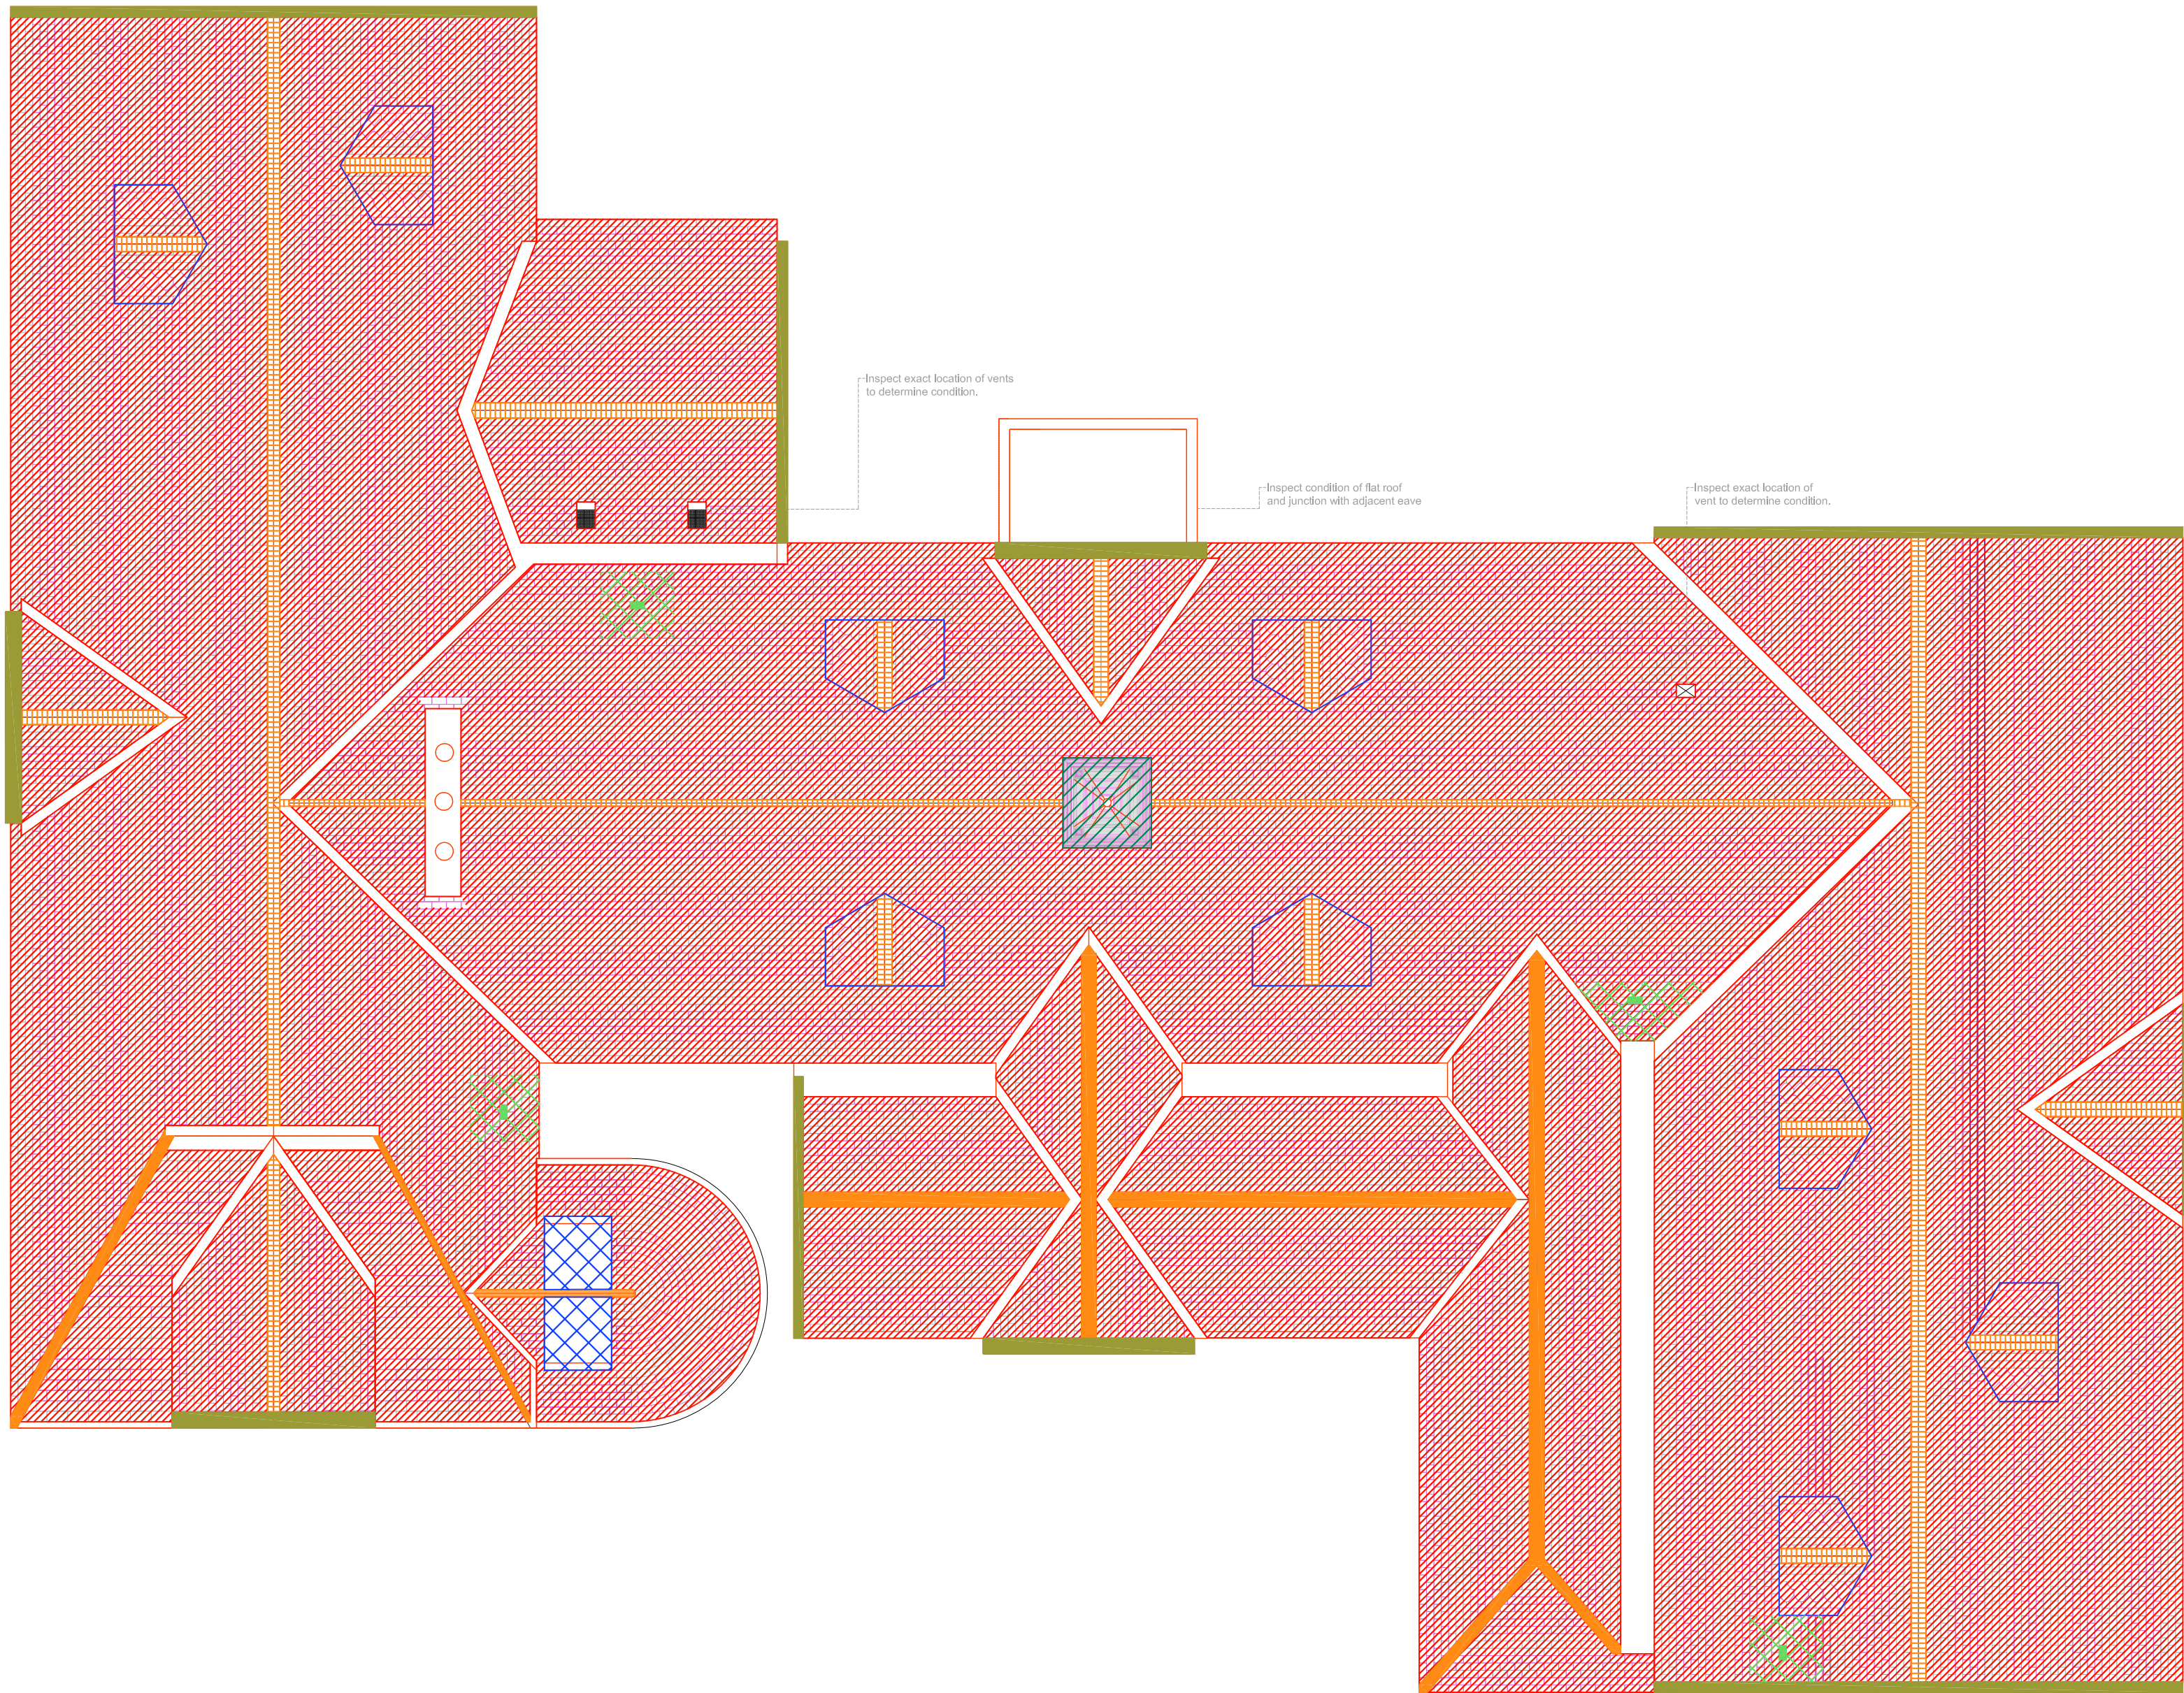
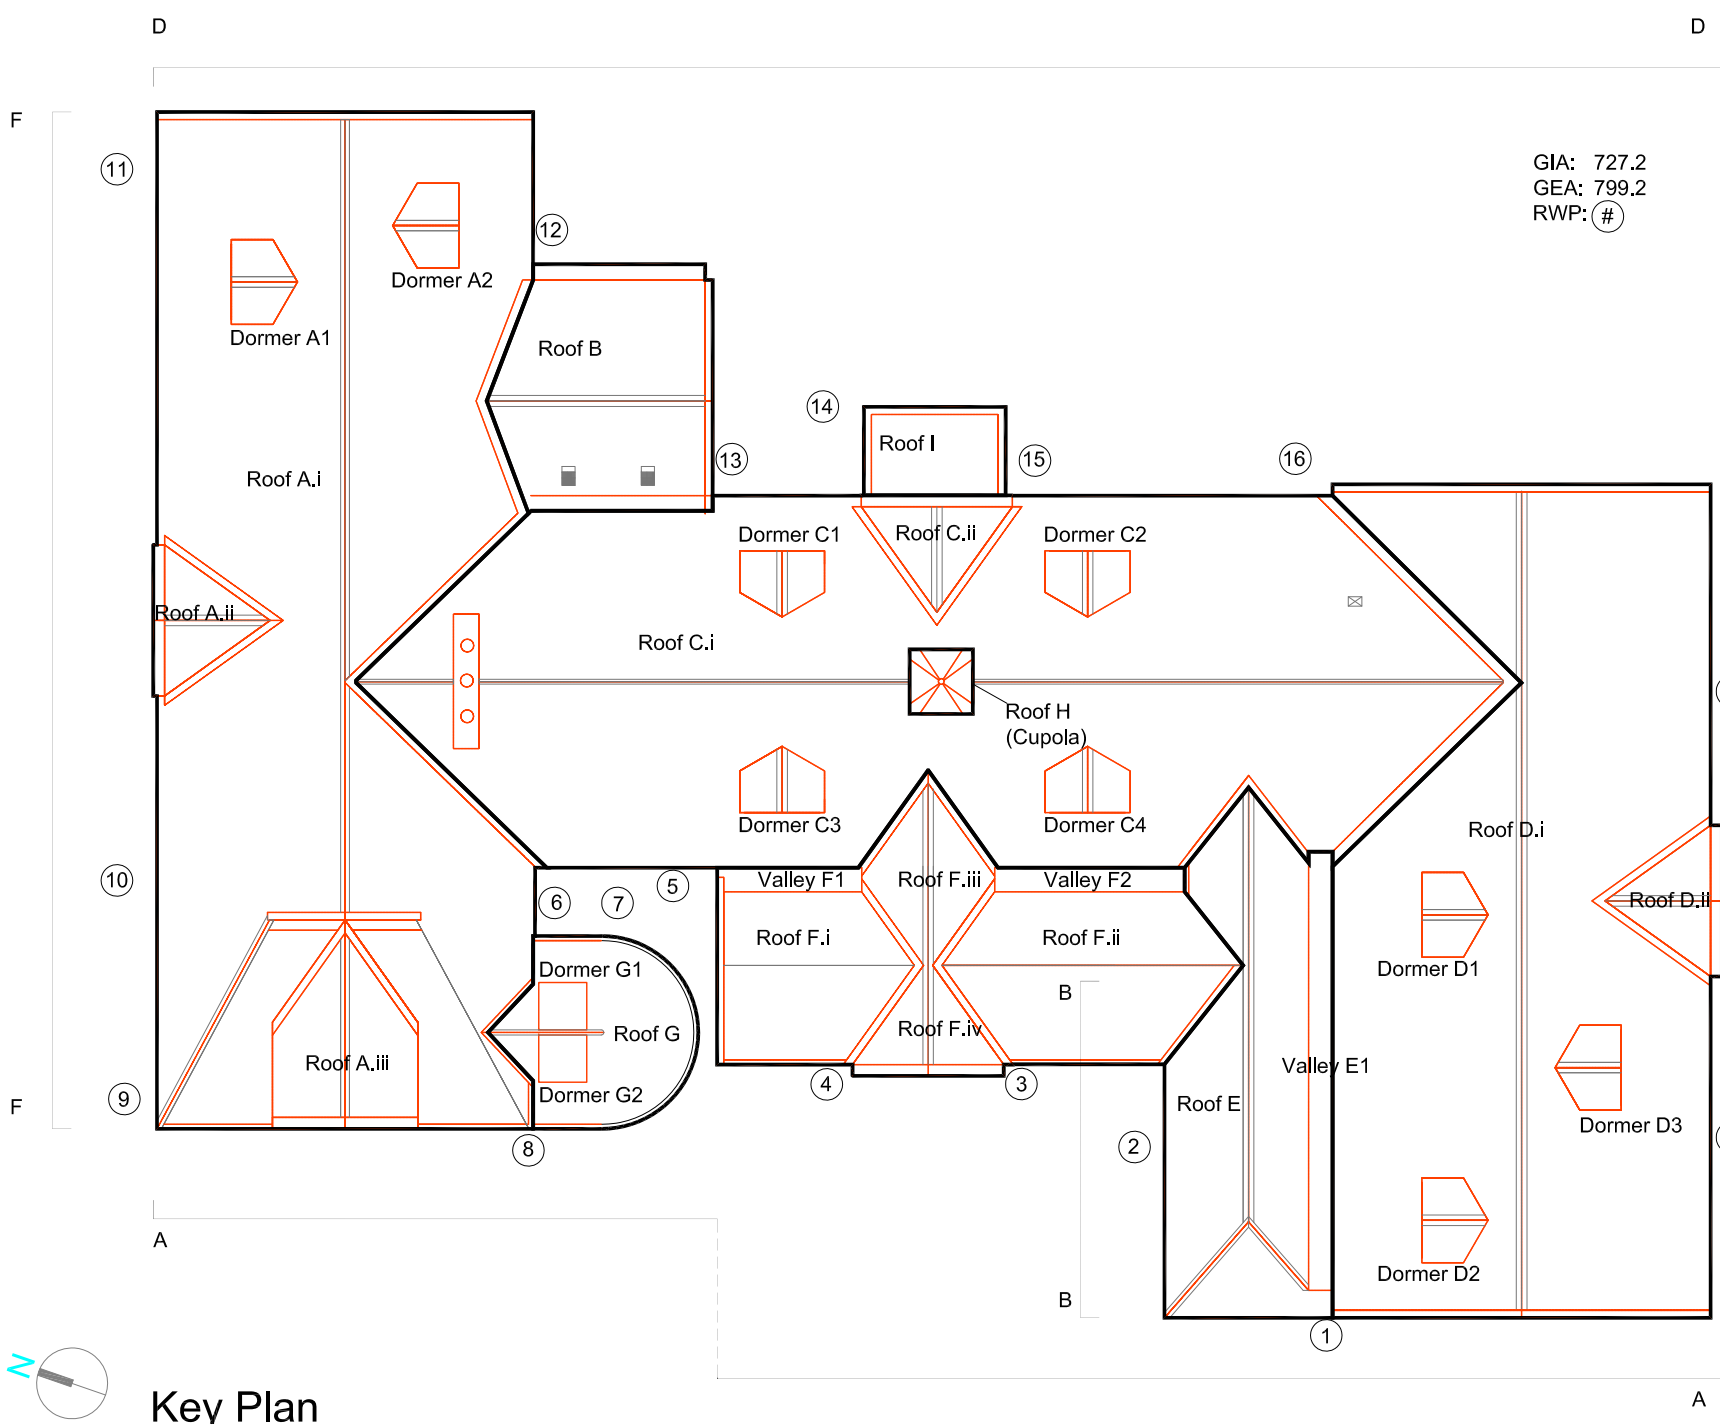
- Key:
- Roof Slate Restoration: 762sqm / 8220sqft  
Strip existing slate roof coverings and set aside salvaged slates for re-use. Strip existing battens, felt, lead-lined gutters and gutter structure then safely dispose of any defective material. Insulate, re-felt, batten, counter batten existing roof slope.  
As per detail A-A in drawing SMP-SEV-XX-XX-DR-A-03100 (Typical Roof Build-Up)

- Dormer Window: 09 no.  
Splice in new timbers where appropriate. Access to be provided for detailed inspection and methodology agreed. Carefully sand down and repaint in appropriate materials as per the specification. Roofing section per detail F-F in drawing SMP-SEV-XX-XX-DR-A-03105 (Typical Dormer Window)

- Cupola: 01 no.  
Splice in new timbers where appropriate. Access to be provided for detailed inspection and methodology agreed. Carefully sand down and repaint in appropriate materials as per the specification. Cupola roofing is as per the building's other slate roof eaves, but is at a steeper gradient.

- Ridge Tiles: 105 Lm.  
Ridge tiles to be removed and set aside with salvaged tiles for re-use.  
Replace damaged tiles as per the existing style. Ridge ventilation provided with new linear vent.  
Ridge venting per detail F-F in drawing SMP-SEV-XX-XX-DR-A-03105 (Typical Dormer Window)

- Ridge Tiles: 50 Lm  
Ridge tiles to be removed and set aside with salvaged tiles for re-use.  
Replace damaged tiles like-for-like.
  - Stone Capping:  
Take up and re-bed existing stone capping pieces and re-point. Ensure appropriate stiff mortar (NHL 3.5 Lime Mortar) applied to capping sections. Sample cappings to be provided to ensure secure structure.

- Non-Gabled Dormer Windows:  
'Shed Dormer' windows with flat felt topping.  
Splice in new timbers where appropriate. Access to be provided for detailed inspection and methodology agreed. Carefully sand down and repaint in appropriate materials as per the specification. Re-felt top cover if deemed necessary after inspection.

- Slate Tiles:  
Grey and Grey-Purple slate tiles.  
To be relocated in the same location/pattern as existing.
  - Bat Slate: [Dashed Hatch Approx. Location, Solid Hatch Exact Location]  
Integrated Bat access slate: metal vent to allow access for bats into roof void, with sufficient gap cut into roof structure underneath. Fitted within a hole cut to slate which is placed over the vent to reduce visual impact. 1no. Bat Slate located in area of observed bat emergence (west wing of the building, facing north, adjacent to Dormer D2) and then 3no. supplementary 'enhancement slates' along remaining wings (north, east, south).
