| WINDOW & DOOR SCHEDULE | | | | |

LISTED BUILDING APP.

REPAIRS TO WINDOWS AND GLAZING

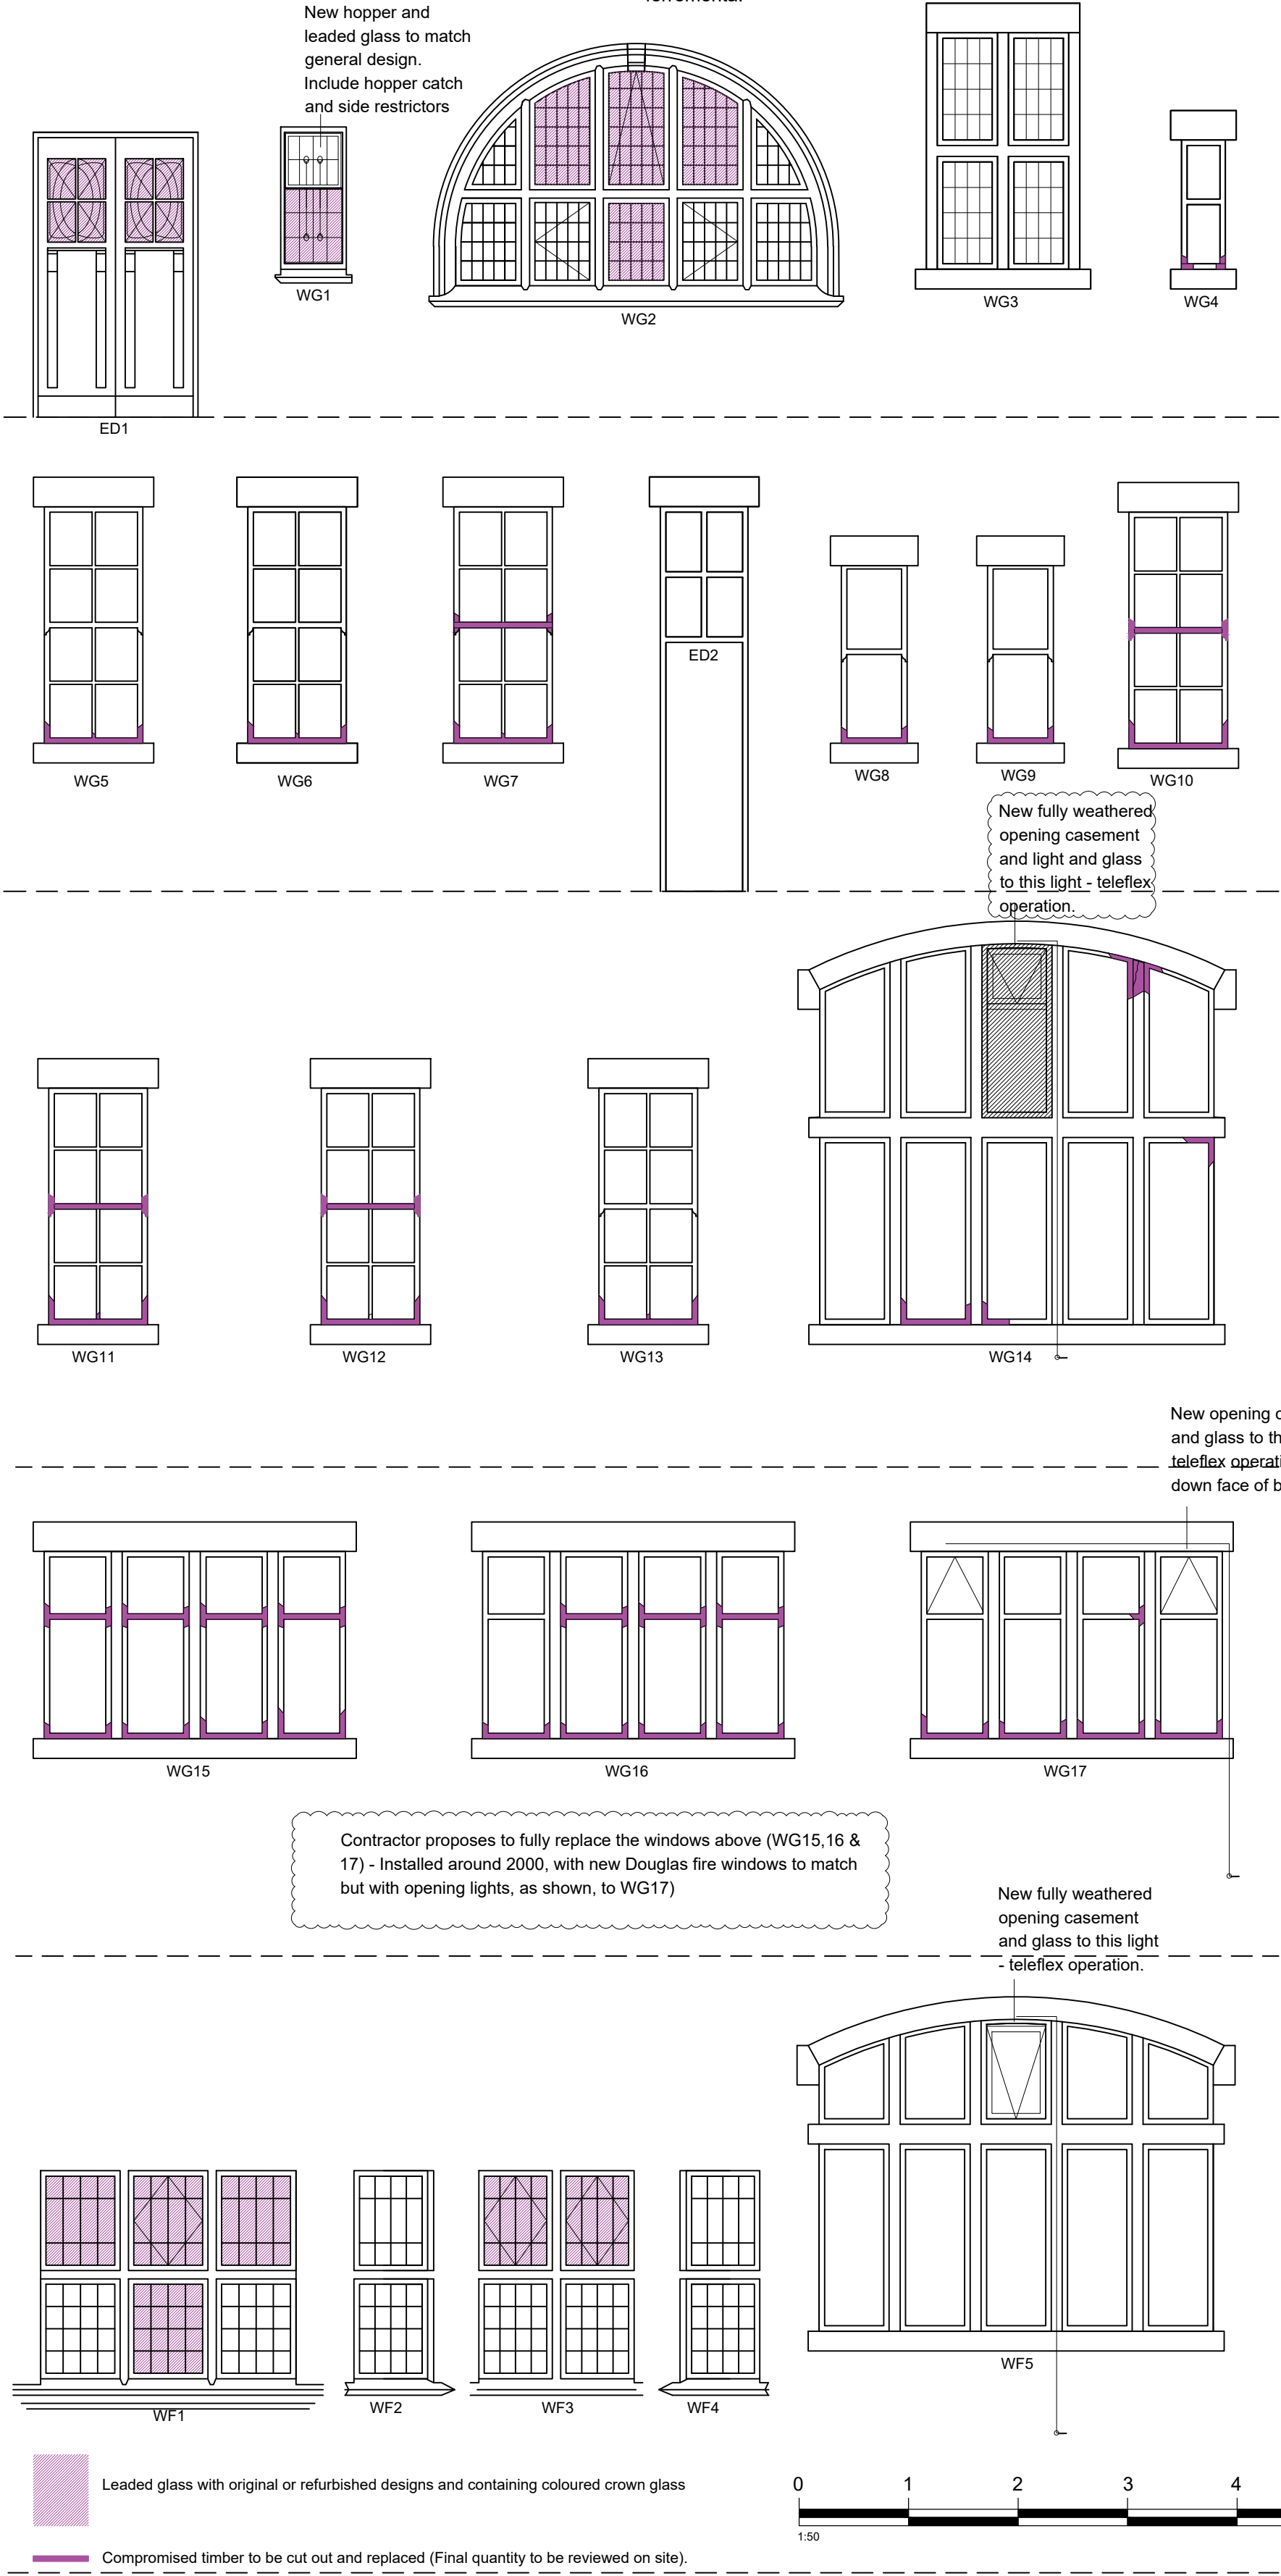
Works as noted and illustrated above to be fully co-ordinated with stonework repair and dismantling works detailed elsewhere and in accordance with the general specification/scope of works..
