| Project | Heywood Civic Centre<br>LCpl Stephen Shaw MC Way, Heywood<br>Greater Manchester, OL10 1LW | Status | Stage 4 |
| Drg Title | Demolition & Enabling - West True Elevations F, G, H | Scale | As Indicated |
| Drg No. | 564-K2A-B1-ZZ-DR-A-20-153 | Revision | P03 |

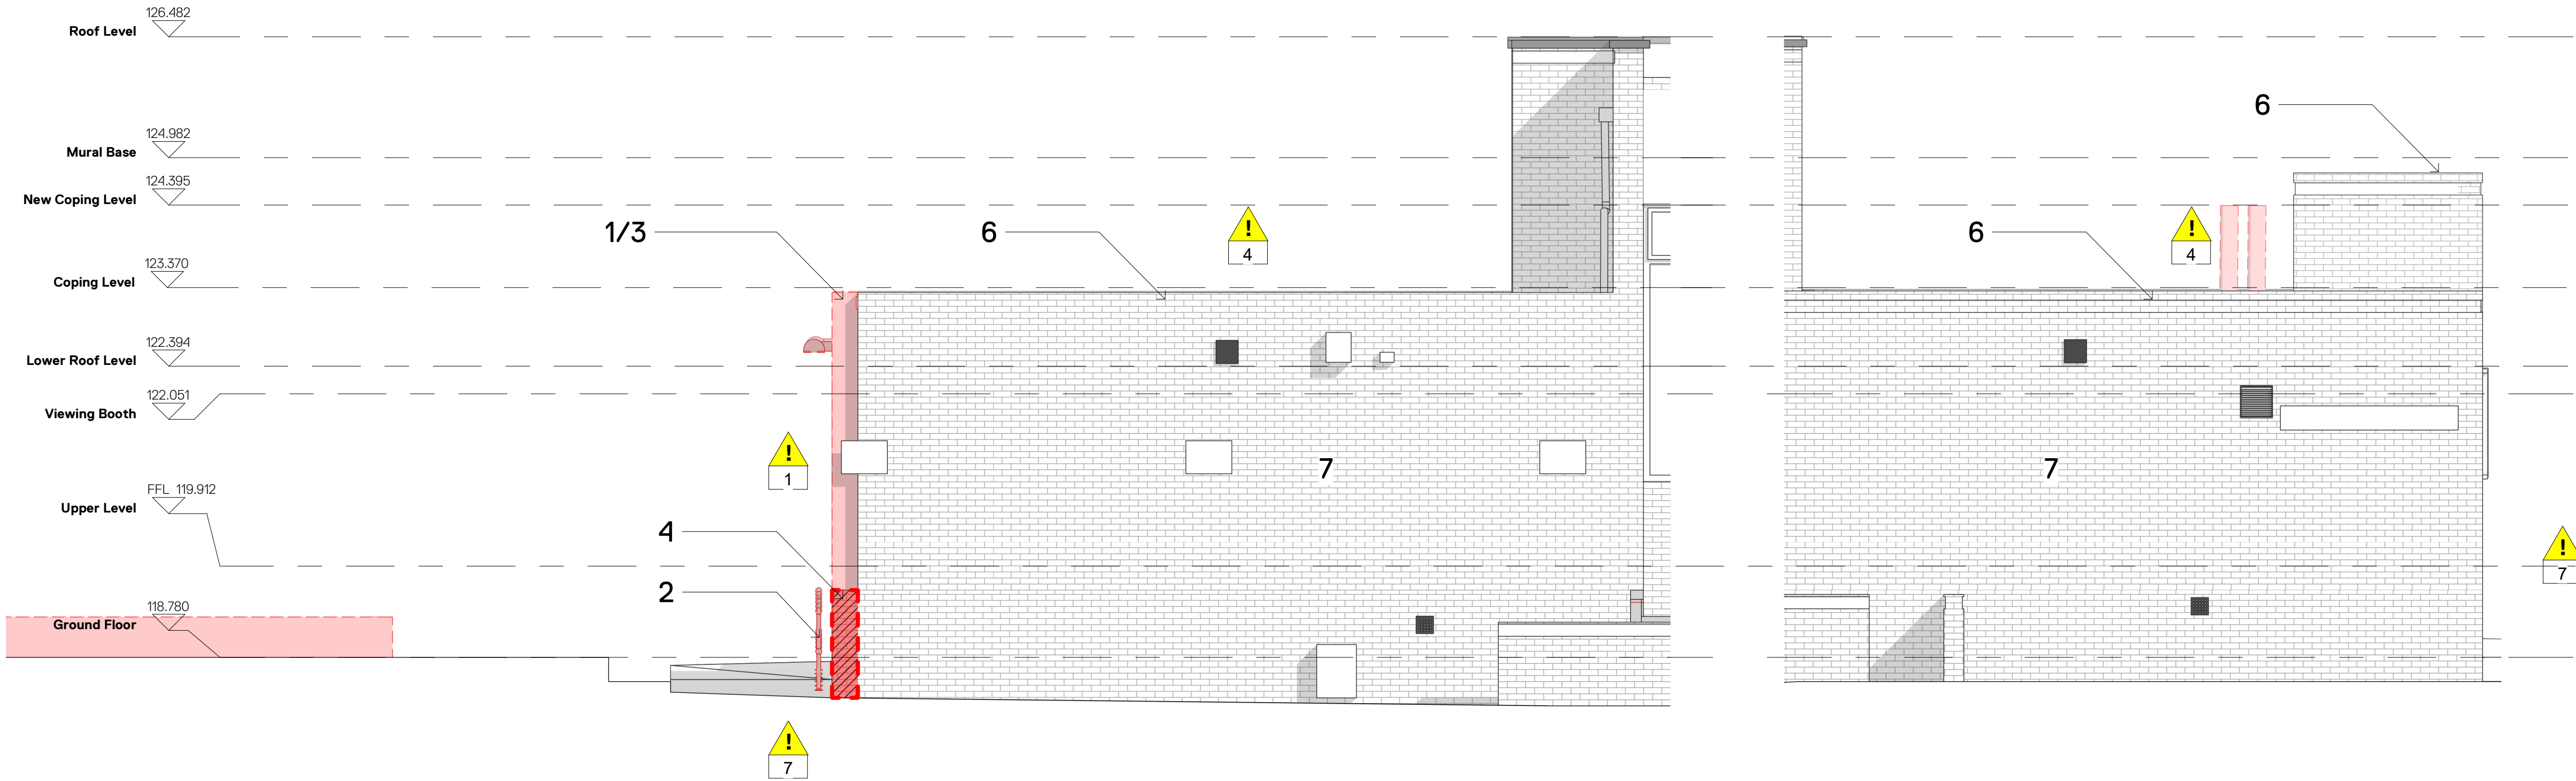
Demolition & Enabling - True West Elevation - F

- Existing wall / brickwork to be removed and brick to be retained. S.E and contractor to review foundations to ensure suitability for new proposed wall. Window within wall to be removed.

- Existing fencing / barriers to be removed.
- Front elevation, signage, doors and windows all to be demolished.
- NB - Only remove masonry leaf down to exposed foundation level. Internal enclosure not to be demolished. Contractor to inspect ground conditions. Further works to this area to be discussed and agreed with S.E

- Contractor to review condition of decorative panels. NB - Possible Asbestos present. Remediation / Removal works to be agreed.
- Contractor to inspect condition of parapets and associated flashings to understand full scope of remediation works. Upper levels not being removed. All areas to replacement roof / finish will require new parapet / copings. Contractor to ensure cavity is protected during construction.

- Contractor to inspect condition of mortar to understand full scope of remediation works.
- Contractor to inspect condition of all windows and report any damage, wear and tear to understand full scope of remediation works.

- Damage to brickwork to corner. Contractor to review and make good.
- NB: Original etched window with council emblem to be carefullt removed and retained.
