| Drg No. | 564-K2A-B1-ZZ-DR-A-20-152 | Scale | As indicated |

152 - Demolition & Enabling - True North Elevation - D

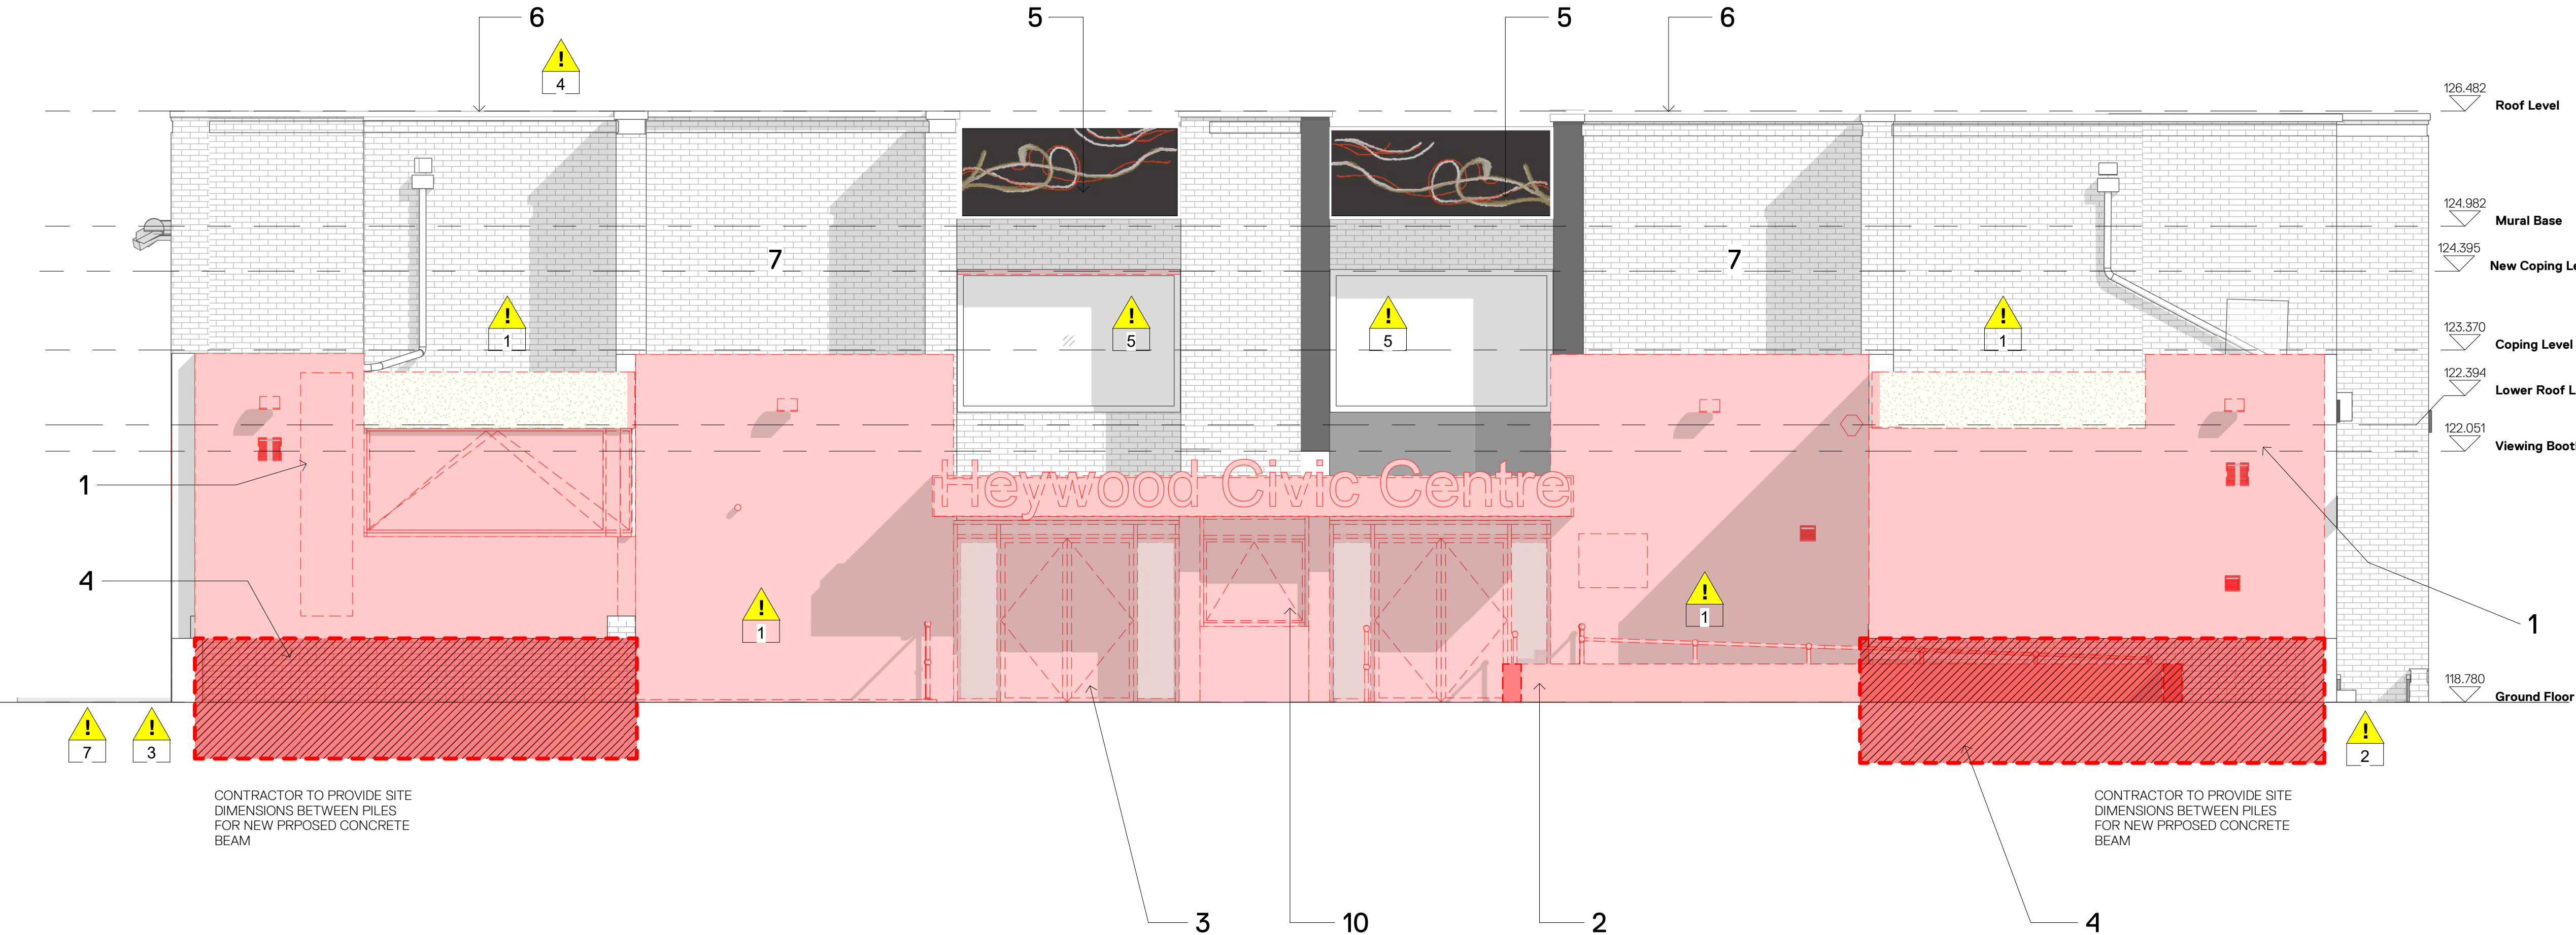
- Existing wall / brickwork to be removed and brick to be retained. S.E and contractor to review foundations to ensure suitability for new proposed wall. Window within wall to be removed.

- Existing fencing / barriers to be removed.
- Front elevation, signage, doors and windows all to be demolished.
- NB - Only remove masonry leaf down to exposed foundation level. Internal enclosure not to be demolished. Contractor to inspect ground conditions. Further works to this area to be discussed and agreed with S.E

- Contractor to review condition of decorative panels. NB - Possible Asbestos present. Remediation / Removal works to be agreed.
- Contractor to inspect condition of parapets and associated flashings to understand full scope of remediation works. Upper levels not being removed. All areas to replacement roof / finish will require new parapet / copings. Contractor to ensure cavity is protected during construction.

- Contractor to inspect condition of mortar to understand full scope of remediation works.
- Contractor to inspect condition of all windows and report any damage, wear and tear to understand full scope of remediation works.

- Damage to brickwork to corner. Contractor to review and make good.
- NB: Original etched window with council emblem to be carefullt removed and retained.
