| Project | Heywood Civic Centre<br>LCpl Stephen Shaw MC Way, Heywood<br>Greater Manchester, OL10 1LW | Status | Stage 4<br>Tender |
| Drg Title | Demolition & Enabling - East True Elevations A, B, C | Scale | As indicated |

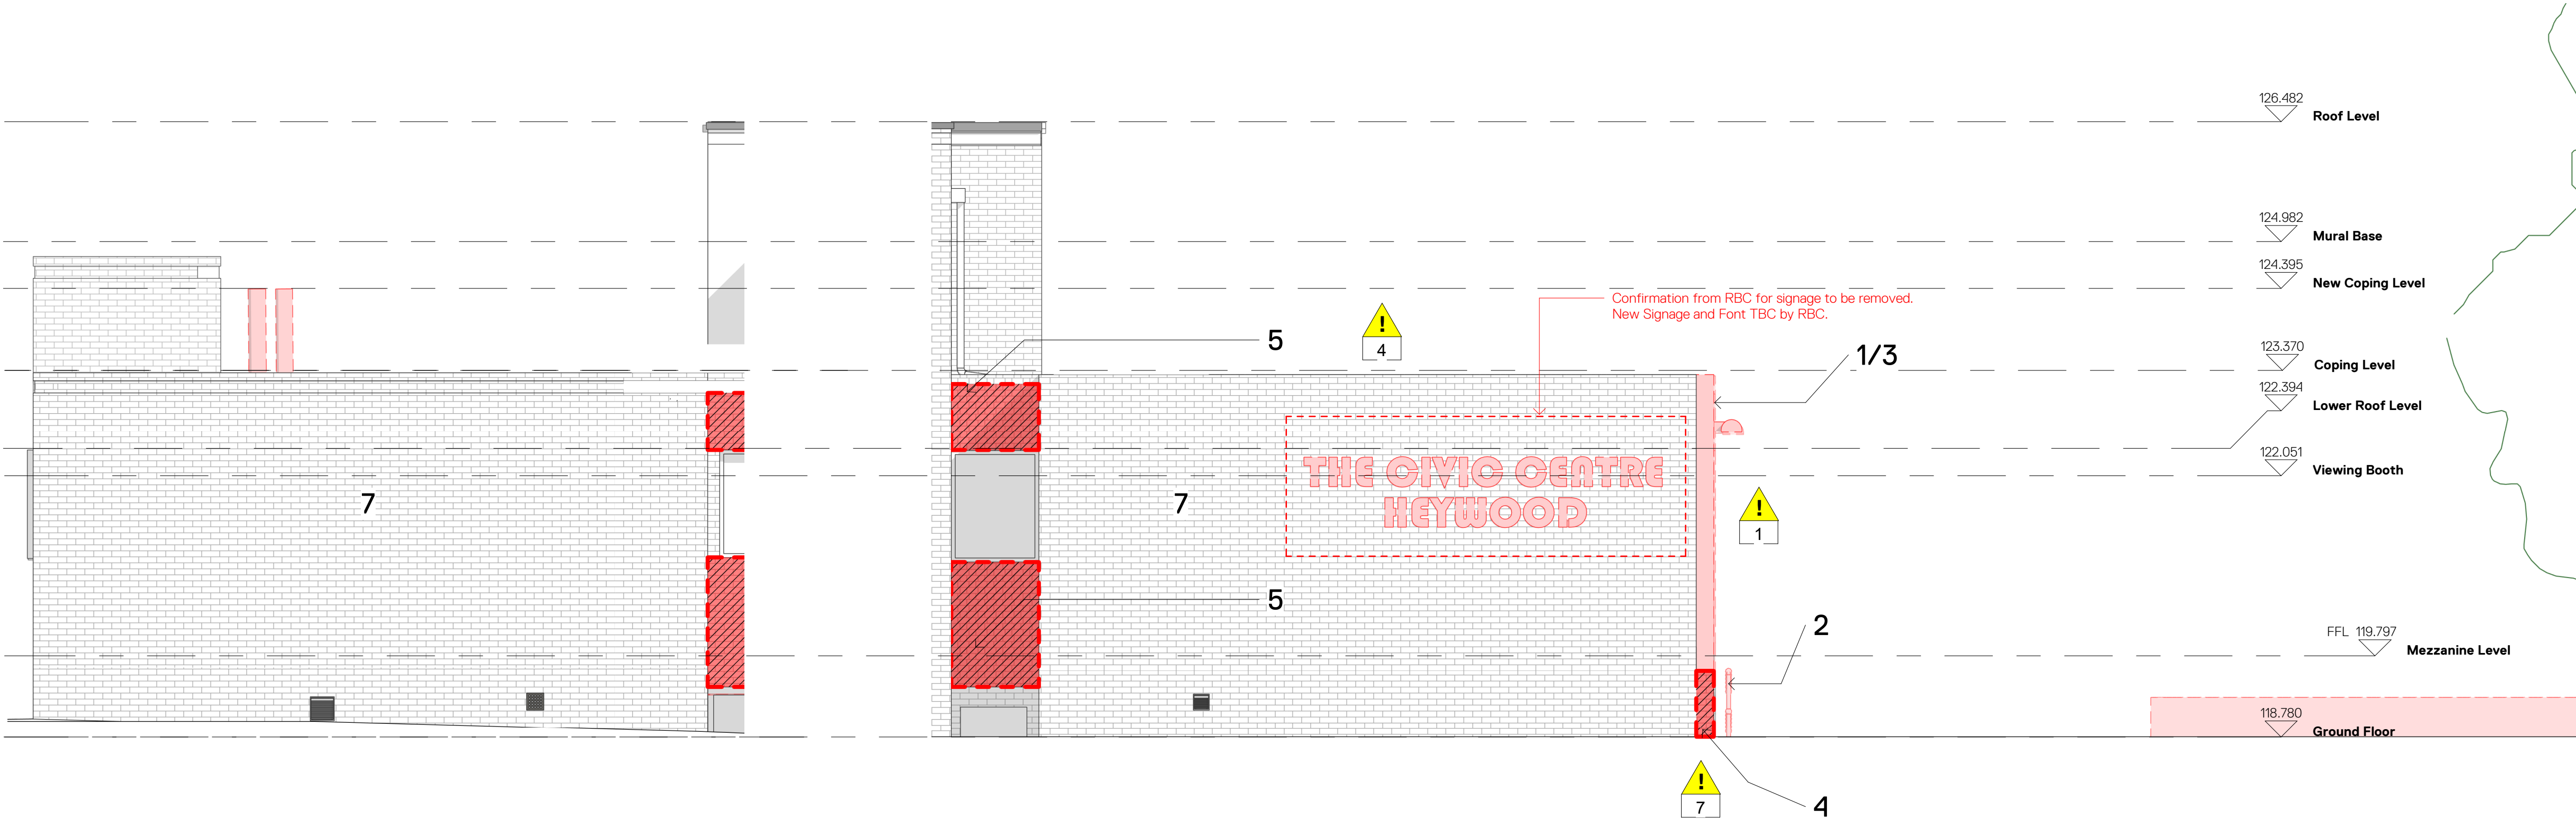
Demolition & Enabling - True East Elevation - A

Demolition & Enabling- True East Elevation - C

Elevation Demolition

- Existing wall / brickwork to be removed and brick to be retained. S.E and contractor to review foundations to ensure suitability for new proposed wall. Window within wall to be removed.

- Existing Fencing / barriers to be removed.
- Front elevation, signage, doors and windows all to be demolished.
- NB - Only remove masonry leaf down to exposed foundation level. Internal enclosure not to be demolished. Contractor to inspect ground conditions. Further works to this area to be discussed and agreed with S.E

- Contractor to review condition of decorative panels. NB - Possible Asbestos present. Remediation / Removal works to be agreed.
- Contractor to inspect condition of parapets and associated flashings to understand full scope of remediation works. Upper levels not being removed. All areas to replacement roof / finish will require new parapet / copings. Contractor to ensure cavity is protected during construction.

- Contractor to inspect condition of mortar to understand full scope of remediation works.
- Contractor to inspect condition of all windows and report any damage, wear and tear to understand full scope of remediation works.

- Damage to brickwork to corner. Contractor to review and make good.
- NB. Original etched window with council emblem to be carefully removed and retained.
