| Project | Heywood Civic Centre<br>LCpl Stephen Shaw MC Way, Heywood<br>Greater Manchester, OL10 1LW | Status | Stage 4 |
| Drg Title | Demolition & Enabling South True Elevations I | Scale | As indicated |
| Drg No. | 564-K2A-B1-ZZ-DR-A-20-151 | Revision | P05 |

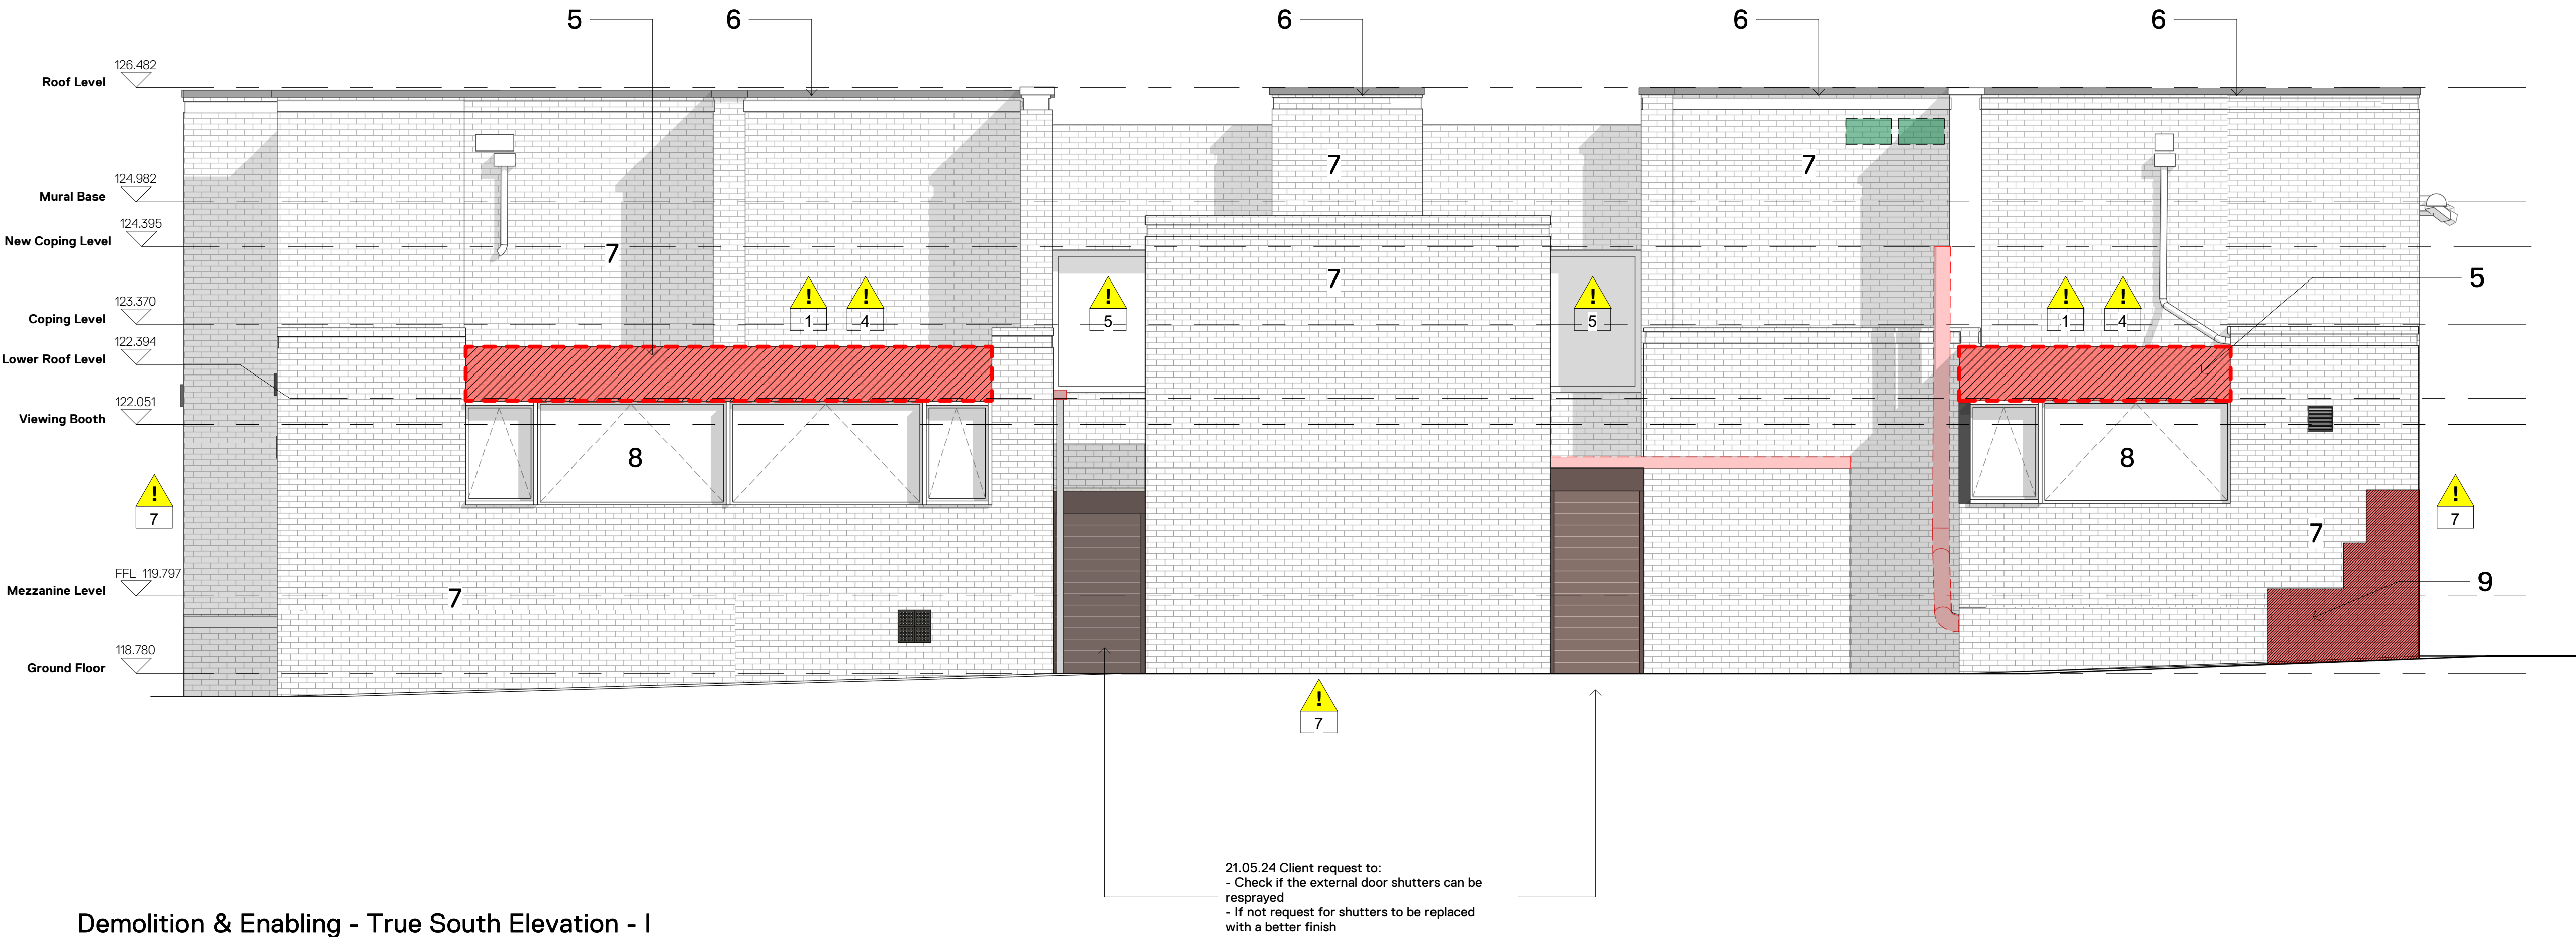
Demolition & Enabling - True South Elevation - I

Demolition Key

- Existing Element to be Demolished - Extent of items to be confirmed on site with contractor & client

1. Existing wall / brickwork to be removed and brick to be retained. S.E and contractor to review foundations to ensure suitability for new proposed wall. Window within wall to be removed.

2. Existing fencing / barriers to be removed.
3. Front elevation, signage, doors and windows all to be demolished.
4. NB - Only remove masonry leaf down to exposed foundation level. Internal enclosure not to be demolished. Contractor to inspect ground conditions. Further works to this area to be discussed and agreed with S.E

5. Contractor to review condition of decorative panels. NB - Possible Asbestos present. Remediation / Removal works to be agreed.
6. Contractor to inspect condition of parapets and associated flashings to understand full scope of remediation works. Upper levels not being removed. All areas to replacement roof / finish will require new parapet / copings. Contractor to ensure cavity is protected during construction.

7. Contractor to inspect condition of mortar to understand full scope of remediation works.
8. Contractor to inspect condition of all windows and report any damage, wear and tear to understand full scope of remediation works.

9. Damage to brickwork to corner. Contractor to review and make good.
10. NB: Original etched window with council emblem to be carefullt removed and retained.
