# Holy Trinity, Parkfield

Design and Access Statement  
May 2023

Project name: Holy Trinity, Parkfield

Project number: 9221

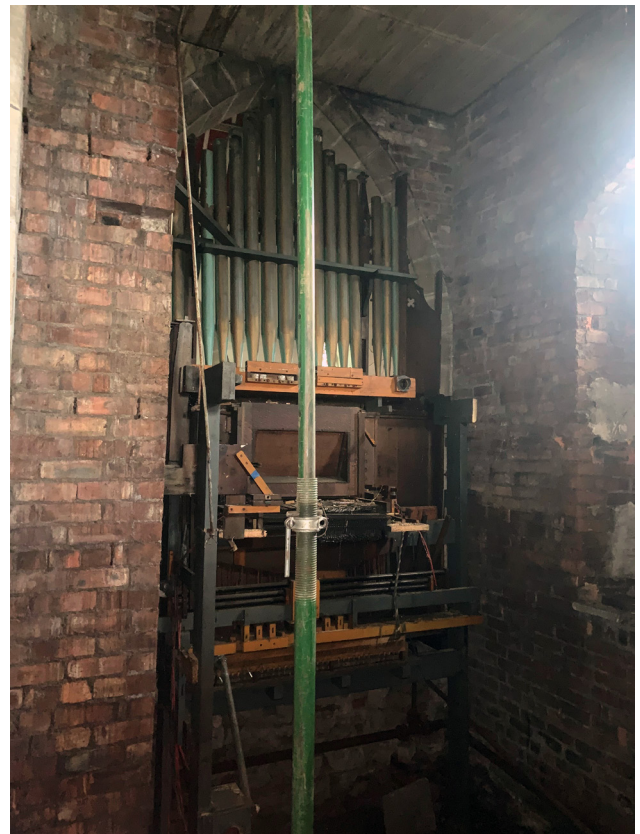
Remaining part of the Organ in Organ Chamber.

The organ chamber has since been cleared of all material and now presents an 18 inch void below floor level. Ongoing ingress of dry rot has also resulted in damage to the pulpit and lectern.

The existing organ to be removed due to the ingress of dry rot. The organ screen is to be reinstated to contain the organ pipes above.

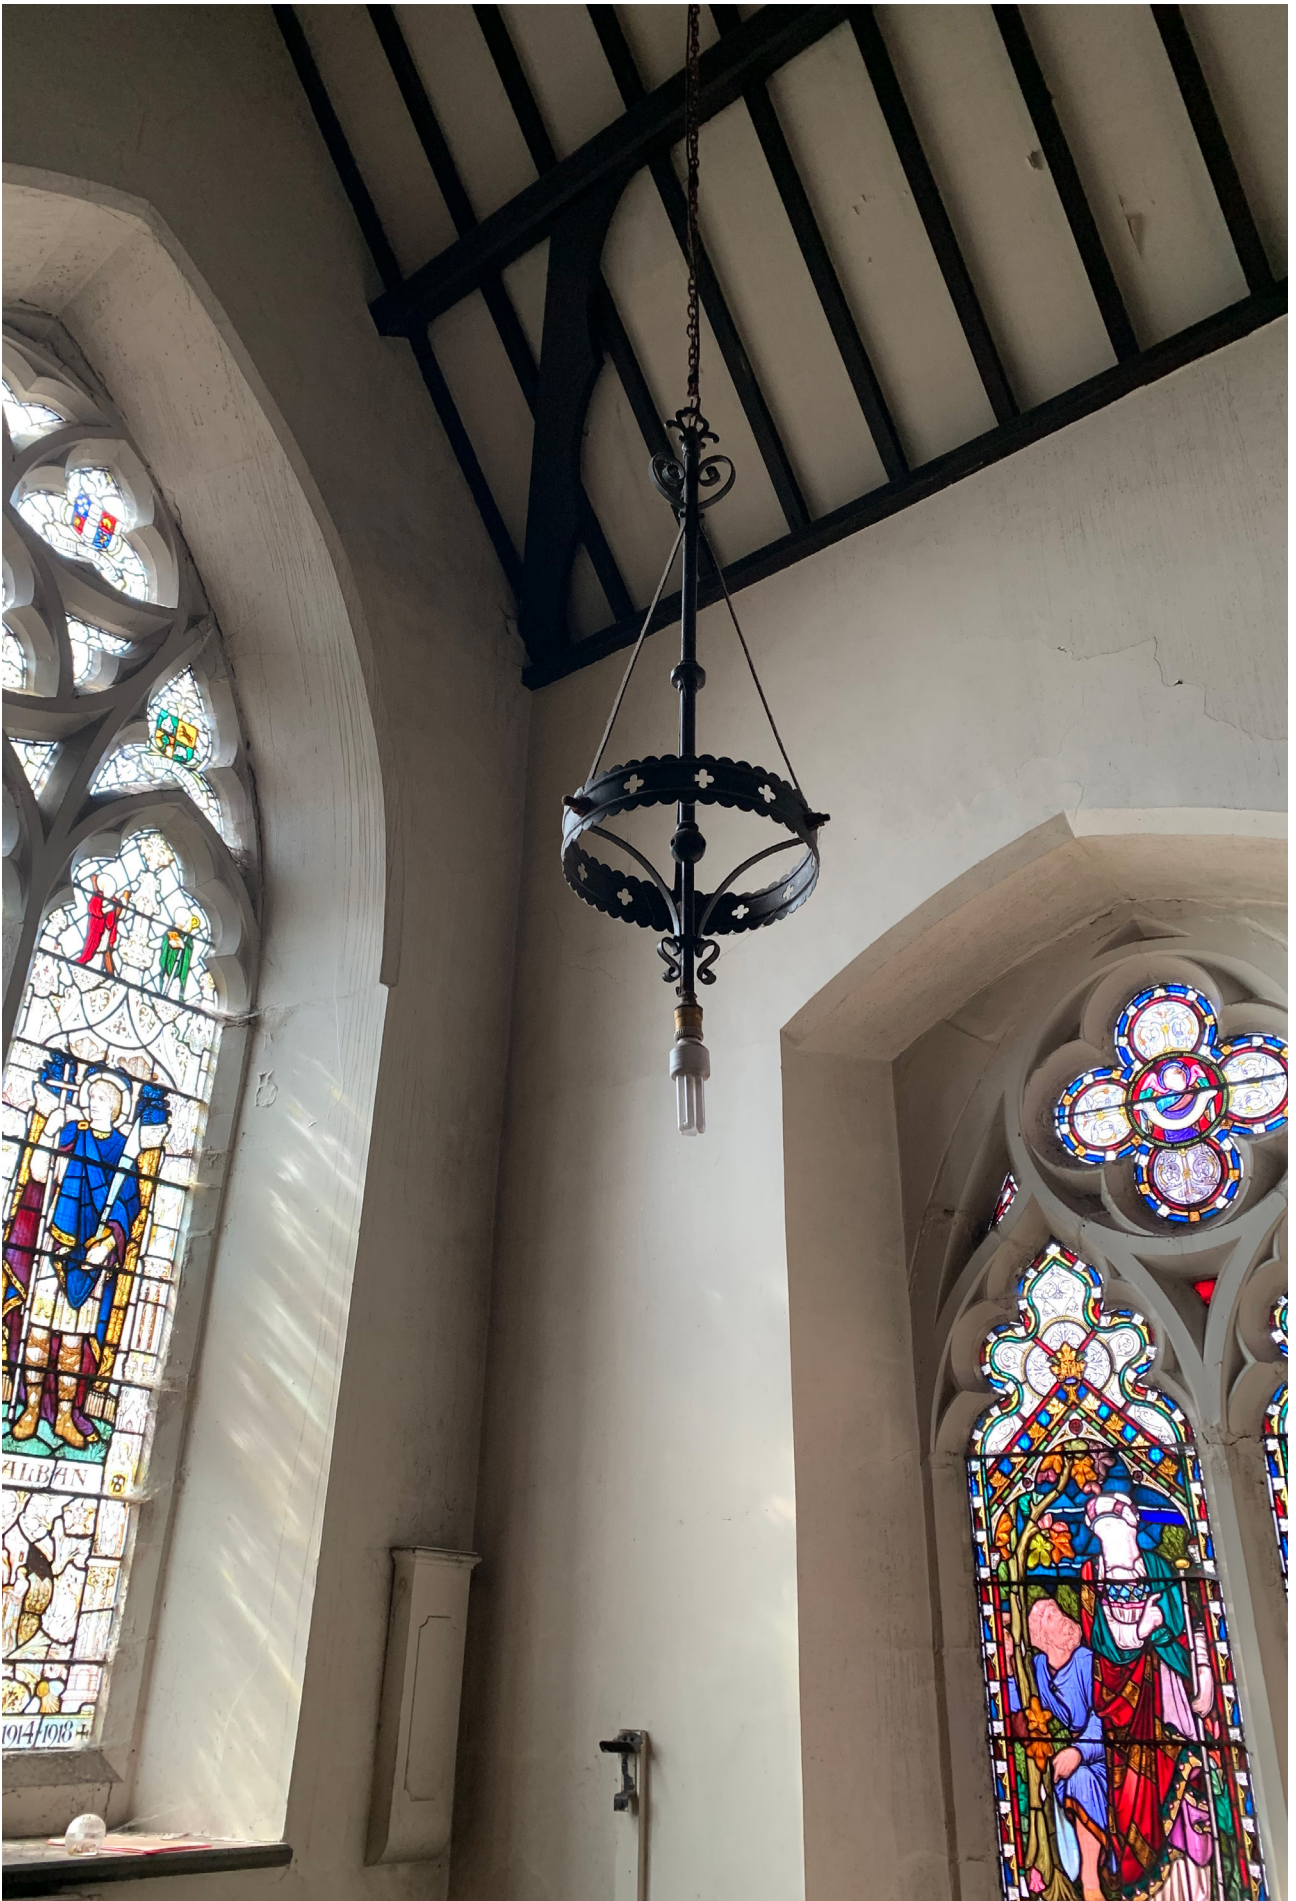
Existing Stained Glass Windows and Chandelier in Transept.

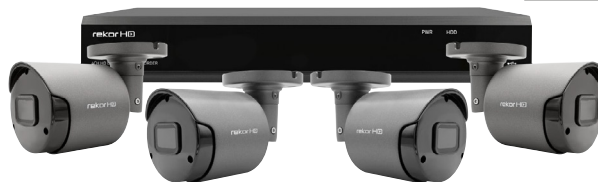
**Description:** 8 Channel HD 4TB DVR & Grey Bullet Camera CCTV Kit

| 8 Channel HD 4TB DVR | | 3.6mm Lens 2MP HD Bullet Camera - Grey | |
