**Nos 21 and 23 Wilson Street and Former Hope Chapel,  
Hope Street, Rochdale**

***Heritage Impact Statement***

**May 2019**

**Prepared for Alex Mijares**  
**by**  
**Marion Barter Associates Ltd**

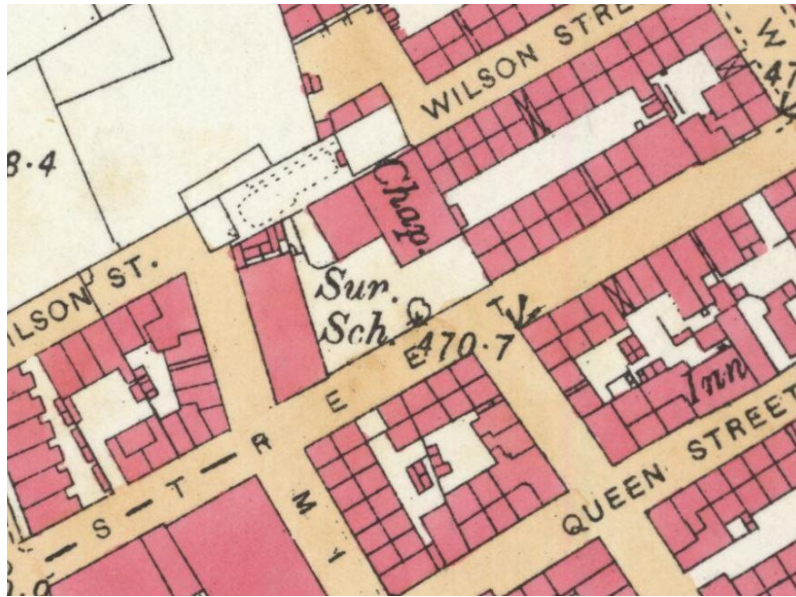
*Fig.6: detail from OS map, surveyed 1890-1, scale 1:2500 (Touchstones, Rochdale)*

Several phases of improvements are known to have been carried out during Eddison's pastorship. The 1910 booklet records that 'In 1887, through the generosity of Mrs. Mary Ann Tweedale, of Bagslate, the Chapel house was enlarged'. An additional 3-storey double-depth extension was built on the west side of the original house, with an entrance facing west; in recent years this part of the building has been known as No.21 Wilson Street and the earlier part of the house as No.23. OS mapping surveyed in 1890-1 shows the house with its present footprint (Fig.6).

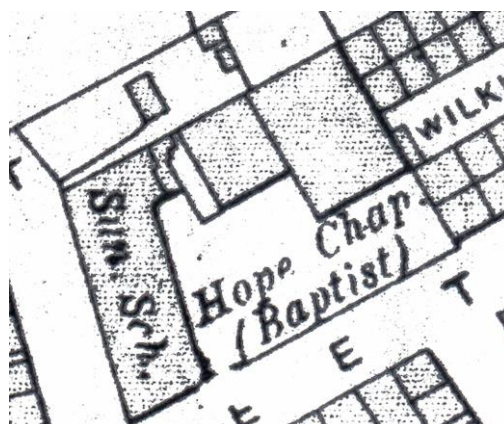
Fig.11: enlarged school on OS map, surveyed 1908 1:2500 (Touchstones)

Under Eddison the Sunday school was altered and extended to the north (Figs.10 and 11), to plans drawn by Rochdale architects Butterworth and Duncan in 1901; a commemorative stone on the north elevation is dated 1901.

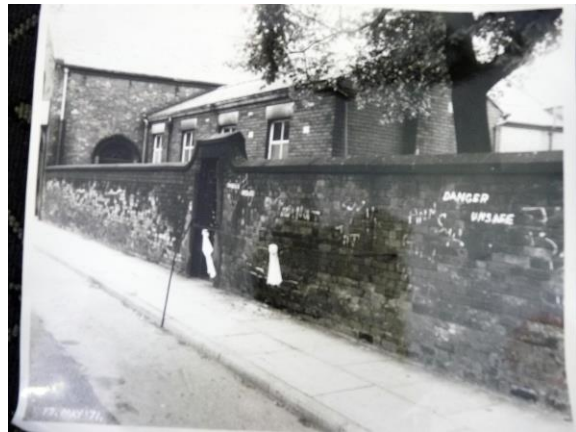
*Fig.13: 1920 school extension and front wall, in 1971 (photo seen in chapel, 2019)*

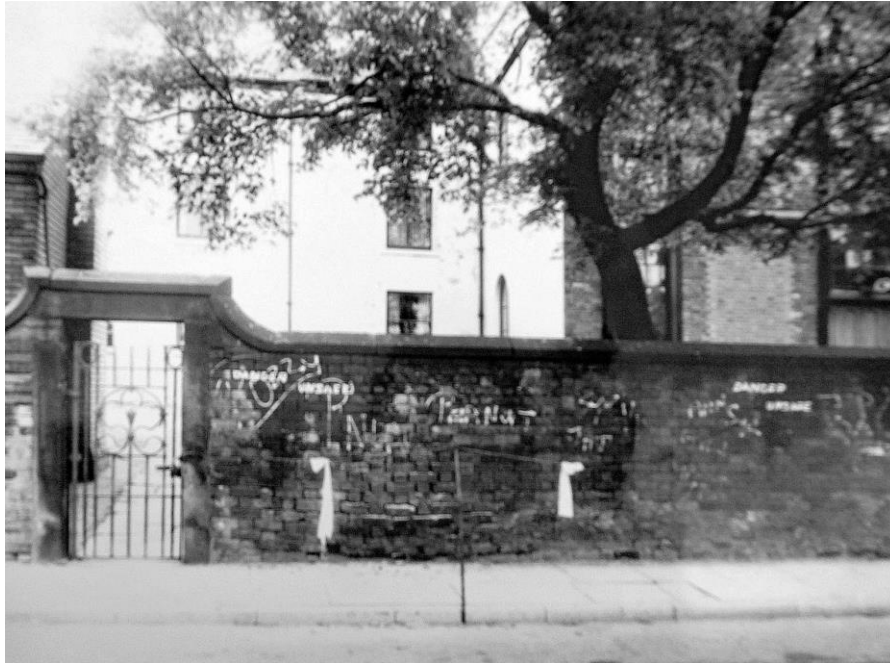
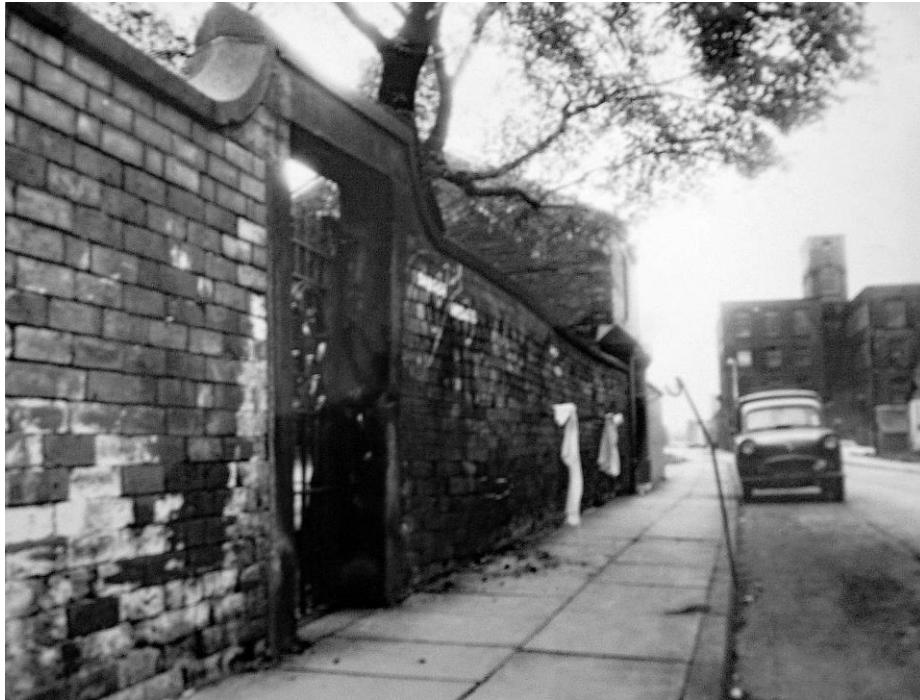
*Fig.15: front wall in c.1971 (photograph in chapel, 2019)*

*Fig.16: photograph of front wall from the west, c1971 (photograph in chapel 2019)*

and 16) and a 1953 drawing of the chapel<sup>16</sup> show a continuous high brick wall with stone copings and two gateways along the Hope Street frontage. This wall was rebuilt west of the chapel entrance sometime after 1971 when photographs recorded the wall in a dangerous condition; the existing brick wall is topped with steel railings west of the chapel gateway, which were in place by 1988. The photographs also show a tree in the burial ground.

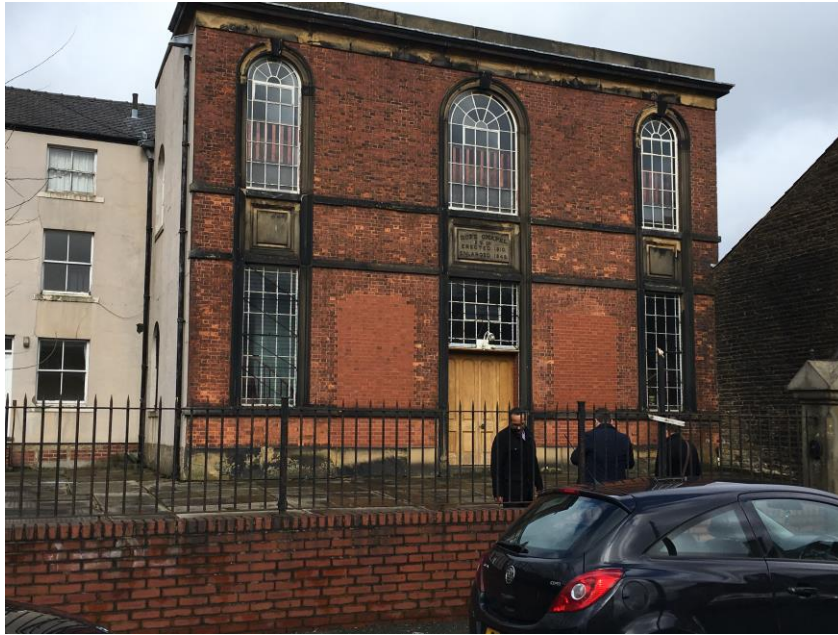
The 2-storey, 3-bay front elevation, dating from 1848, is in an unusual classical style with the window architraves arranged to form three full-height arches in the elevation. There are semi-circular headed windows to the first floor and square-headed windows below, with moulded ashlar panels between ground and first floor windows. The central panel is inscribed HOPE CHAPEL/ ERECTED 1810/ENLARGED 1848. The central doorway with a pair of panelled doors was inserted when the pair of original arched doorways were blocked, sometime in the 20<sup>th</sup> century. The windows all have margin glazing and probably date from 1848.

*Fig.17: front elevation*

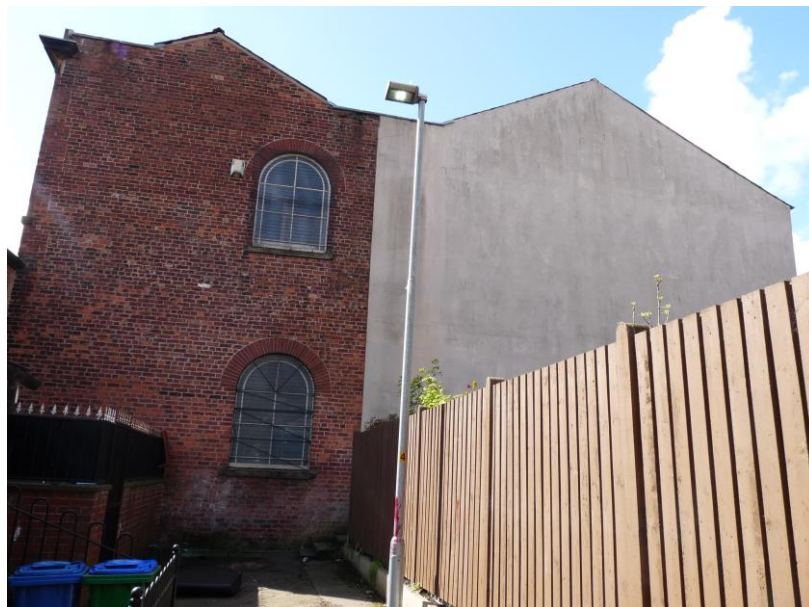
The rendered west gable end of the south part of the chapel has arched windows dating from 1848 to the gallery and ground floor. The east gable end is in two parts; the junction between the 1810 building and the 1848 extension is expressed by the roof valley and the exposed brickwork to the 1848 gable-end contrasting with the render to the 1810 gable-end.

*Fig.18: east elevation, with 1848 addition to the left (south)*

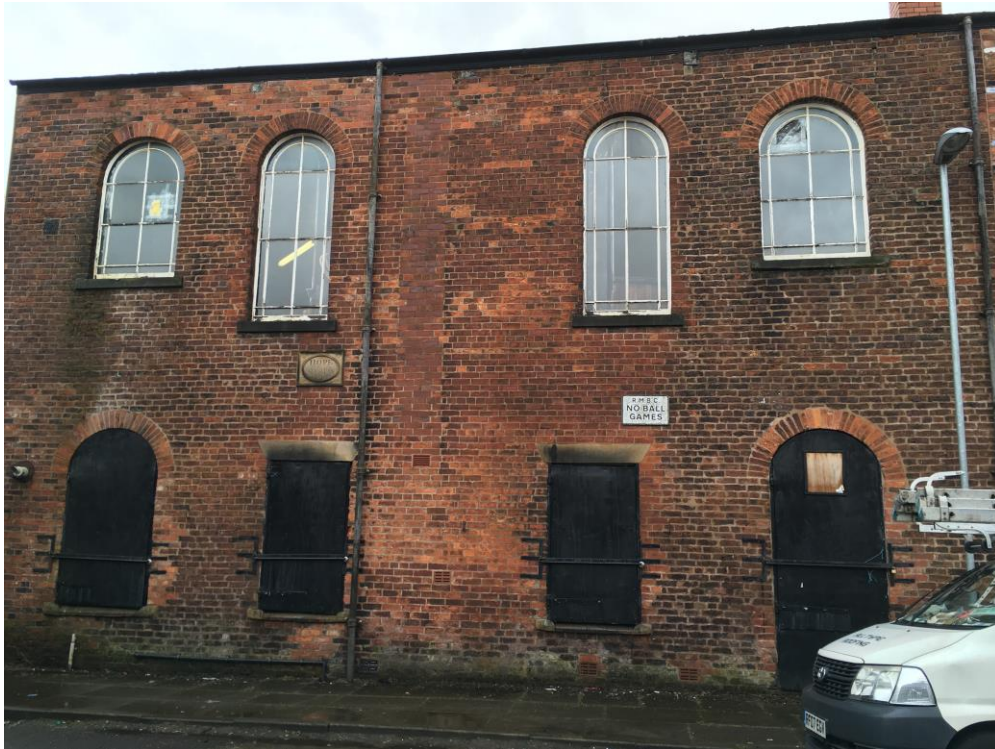
The north elevation facing Wilson Street has mainly semi-circular headed windows with two square-headed windows with sandstone lintels to the ground floor. The ground floor windows and arched doorway (originally a window) to the vestries have security shutters. The first floor windows have margin-glazing (of 1848 as on the south elevation). The shorter first floor windows express the position of the side galleries. The stone plaque on the north side of the elevation is inscribed HOPE CHAPEL/1810.

*Fig.19: rear elevation from the north*

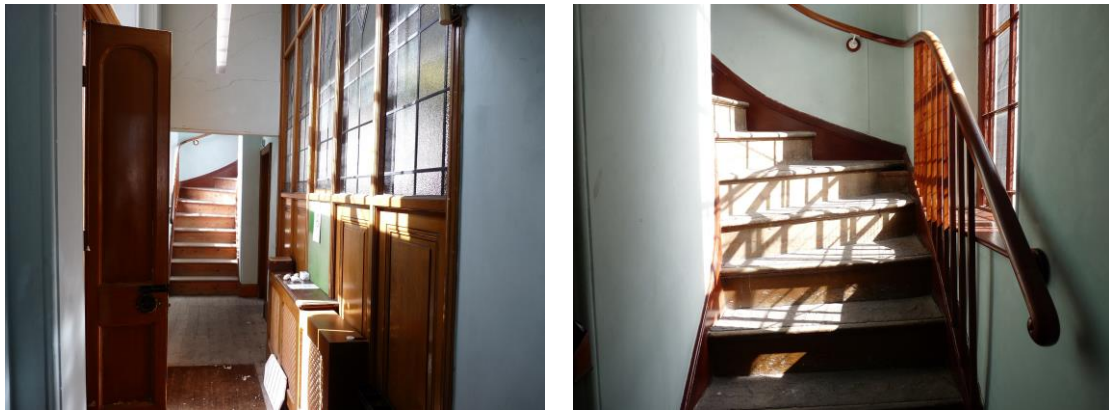
The interior of the chapel is one large volume, except for a narrow vestibule to the south entrance. The entrance vestibule has a pine boarded floor, with a timber and glazed screen between the church and vestibule, with leaded glass; the screen is not shown on the 1888 plan (Fig. 8) and its style indicates an early 20<sup>th</sup> century date. From east and west ends of the vestibule, matching staircases lead to the galleries, each with stick balusters and moulded ramped handrails, probably of 1848; the

grained finish is more recent. The vestibule walls are partly plastered. Above head height are sections of partitions removed below at an unknown date, to create the present space after the doorways were altered.

*Fig.20: vestibule from the east with inserted C20 screen (LH) and east stairs (RH)*

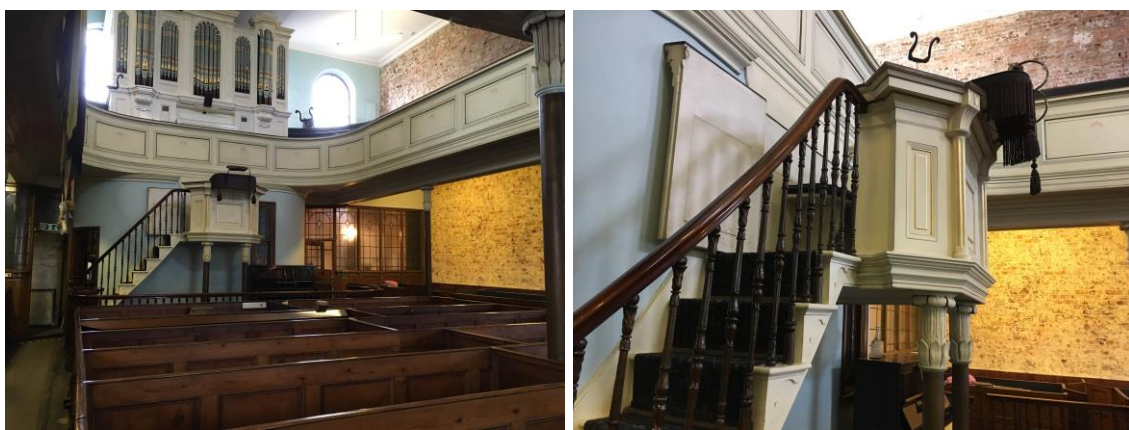
The main body of the chapel is rectangular in plan and a double-height volume, with galleries on four sides. All the walls are plain plastered walls except the east wall which has not been re-plastered following repairs (the brickwork is exposed). The flat ceiling is divided into two parts by a downstand beam on the line of the original south (front) wall, supported by cast-iron columns. A painted timber pulpit forms the focal point at the north end; this has a panelled front, cast-iron columns with lotus capitals and a staircase with a mahogany handrail and moulded balusters (probably all of c1848). In front of the pulpit is a low dais with curved balustrade of similar design to the pulpit balusters. Behind the pulpit a curving plaster wall encloses the original vestry; the vestry extensions to east and west have glazed timber screens inserted after 1910.

*Fig.21: chapel interior from the south (LH) with pulpit (RH)*

The gallery is the main feature of the space, lining all four sides of the upper part of the chapel, with curved corners (Fig.21). The gallery is supported on cast iron columns with similar lotus capitals to the pulpit columns. The panelled gallery front is painted with stencilled decoration, with mahogany top rail.

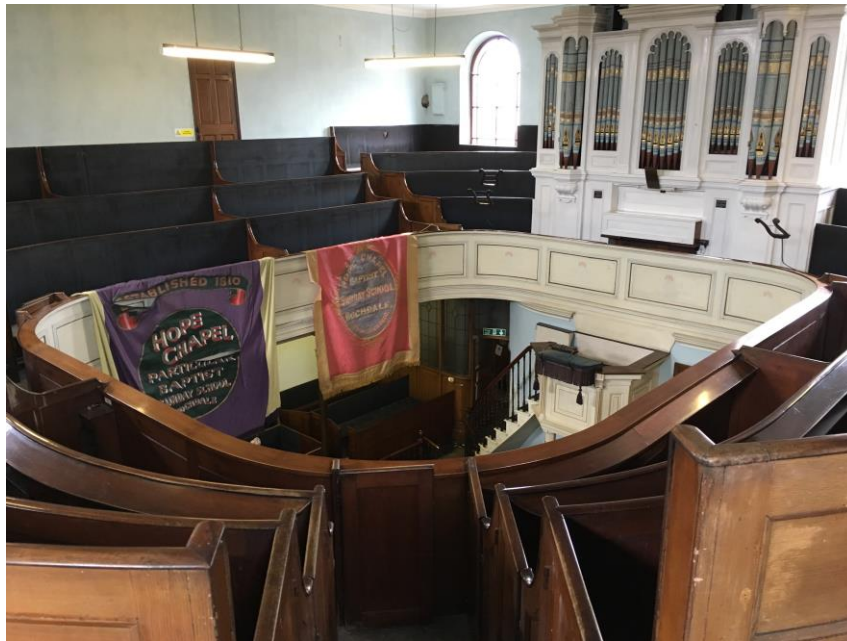
*Fig.22: chapel interior from south-east corner of the gallery*

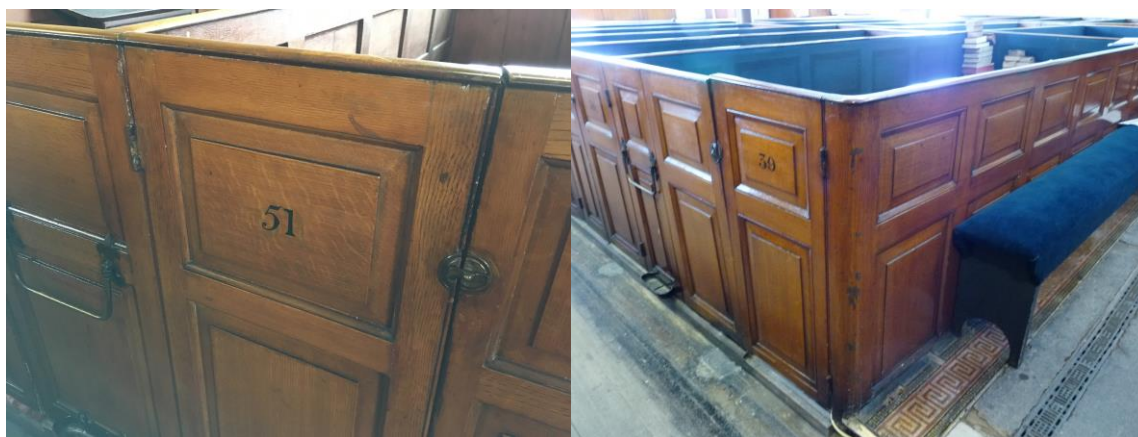
The ground floor and gallery are filled with panelled box pews of similar design. The layout is the same as shown on the seating plan dated 1888 (Fig.8); the ground floor is arranged with three blocks of pews, separated by two aisles. The gallery and all the pews probably date from 1848 when the chapel was extended, and their style and the decorative detail is consistent with this date. The pews appear to be of pine, with a grained finish. Ground floor pews have fielded panels and those on the gallery have plainer recessed panels, all have mahogany top rails, a relatively lavish detail. Pew doors have brass swivel catches and painted numbers, and there are fitted iron and brass umbrella stands. The pew backs are lined with baize and there were originally cushions (removed). The floor to the ground floor is partly covered with linoleum with Greek key motif, probably 19<sup>th</sup> century.

*Fig.23: numbered pews on the ground floor*

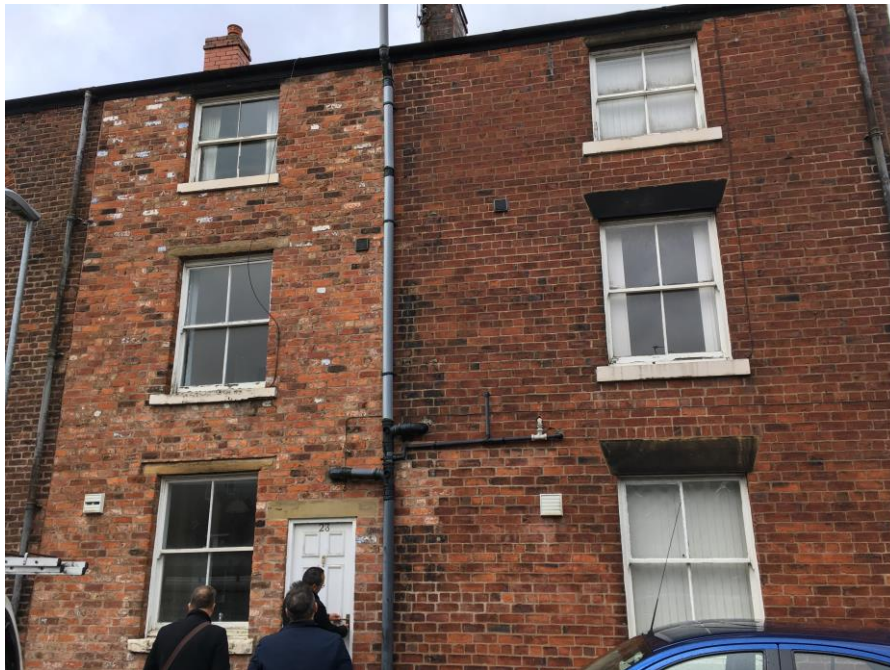
**No.23 Wilson Street** to the east is the earlier part of the former pastor's house, built in 1810 at the same time as the chapel. This has an entrance doorway from the north off Wilson Street, although when first built it may have had a side entrance from the west which faced a garden. The north elevation was rebuilt in brick, in the mid 1990s; photographs prior to the work show this part of the building with slate-hung brick walls. The south elevation is rendered above a brick plinth which has a blocked basement window to the east of the entrance steps (these are modern brick). The rendering was last done in the 1990s when the doorway was inserted (the door is not shown in historic).

*Fig.25: north elevations of No.21 Wilson Street (right) and No.23 (left)*

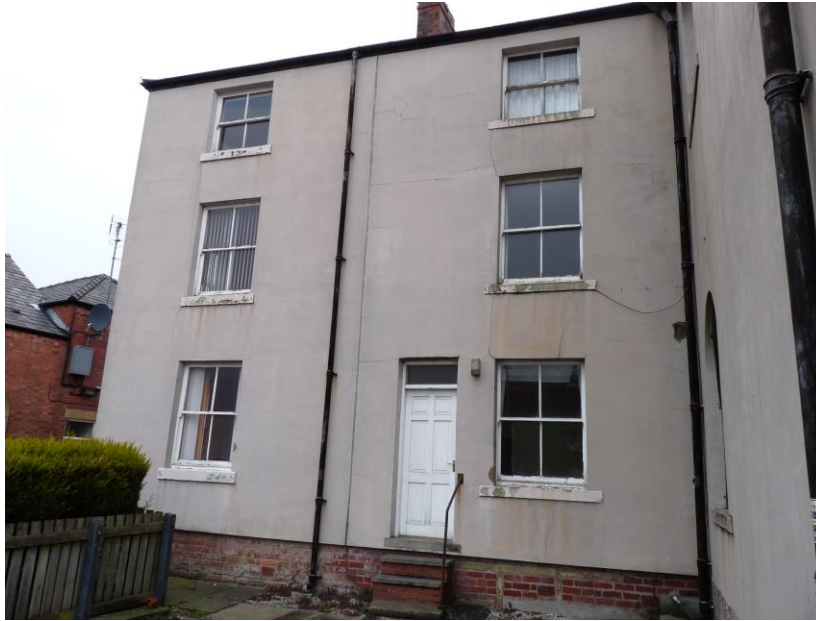
*Fig.26: south elevations of Nos.21 (left) and 23 (right)*

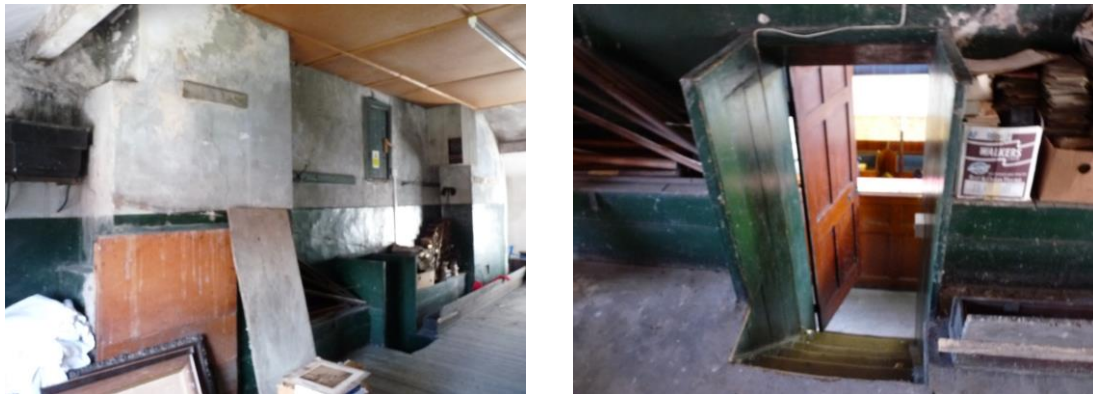
*Fig.28: second floor refreshment room above No.23 Wilson Street*

A single room occupies the whole floor, with access via a doorway from the east, with a short narrow staircase up from the gallery; the door from the chapel at the foot of the stairs is panelled. The room is lit from north and south by 4-pane sash windows. The walls are plain plastered, and the ceiling is lined with modern hard board; wall finishes are in poor condition. The room has not been used for some time, but contains some archive photographs and other material associated with the chapel.

The former refreshment room on the top floor of No.23 Wilson Street has high historical significance for its purpose in relation to the chapel, but the plain space has few architectural features and is in poor condition; it has medium significance for architectural value.

*Impact:* the proposal introduces a new staircase and partitions to the upper room, which has not previously been connected to the house. As the architectural value of the room is low, the impact is low. The disused room is in poor condition and will benefit from repairs and a new use; this outweighs the harm to the historical significance of the room.

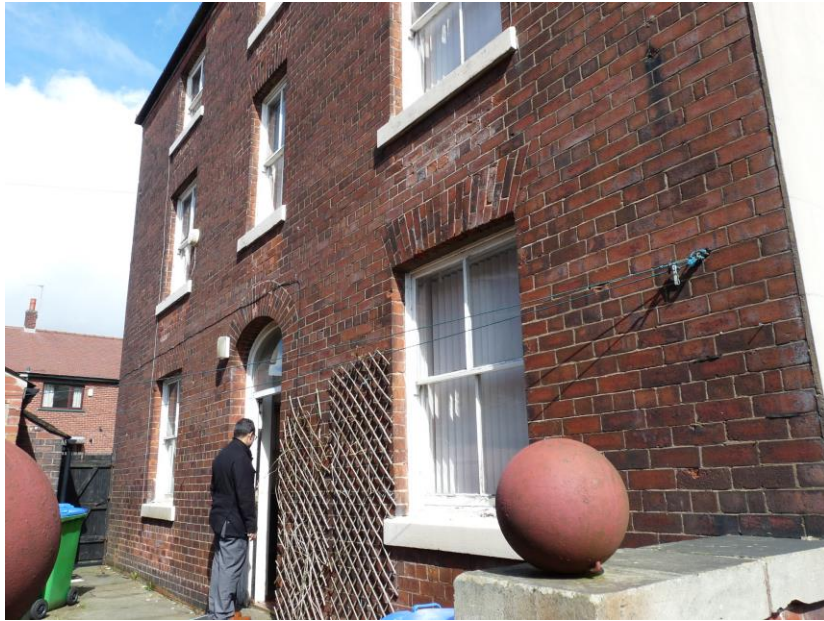
**No. 21 Wilson Street** to the west was added in 1887, to create a larger pastor's house. The 3-storey house is built of red brick laid in English garden wall bond with a hipped slate roof. The entrance is on the west elevation, which is double-fronted with a central doorway flanked by 4-pane sashes. The door is a modern panelled door, with a plain fanlight. The north elevation is also brick but the south elevation was rendered as part of the mid 1990s repair project. The north and south elevations each have one sash window per floor.

*Fig.29: west elevation of No.21*

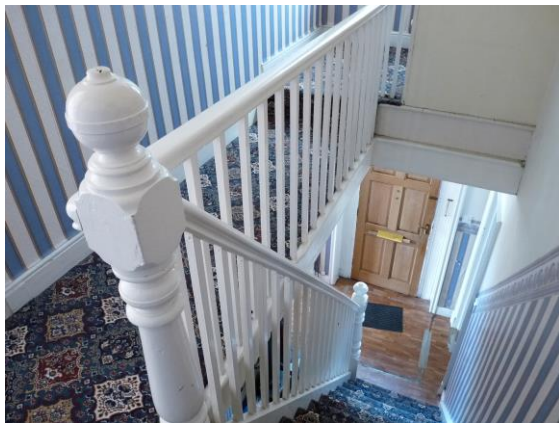
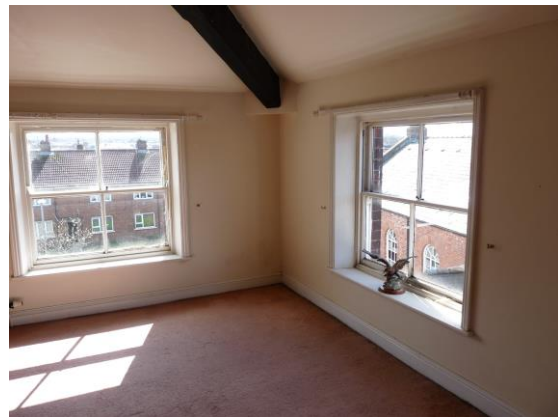
The interior of the house is arranged with a central lobby at the foot of the staircase and one room either side on the ground floor. The modern kitchen is to the north with a sitting room to the south. The straight flight staircase is typical of the late 19<sup>th</sup> century with turned newels, stick balusters and moulded handrail. No historic doors or chimneypieces are in situ, but windows and doorways have moulded architraves which appear to be original. On the top floor, the roof timbers are exposed below the sloping ceiling.

*Fig.30: staircase (LH), and top floor room (RH)*

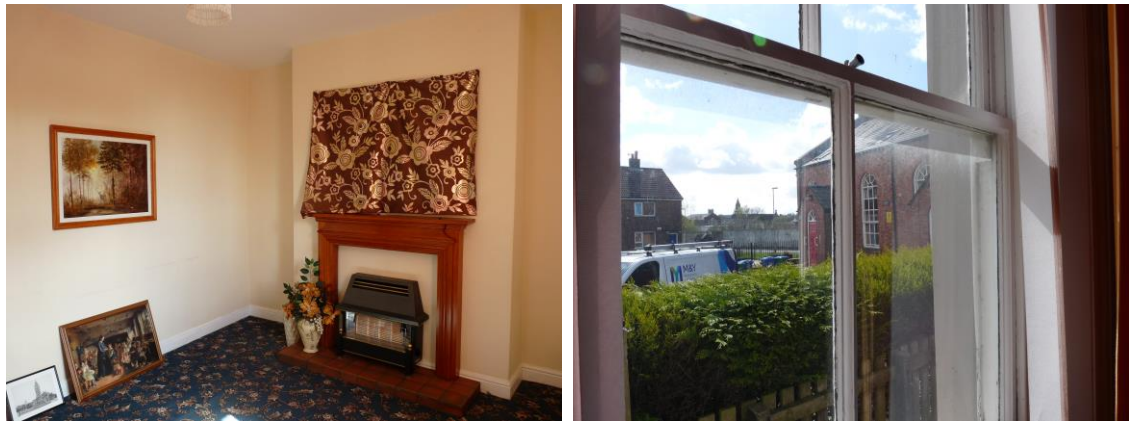
*Fig.31: lounge (LH), with 1880s sash window (RH)*

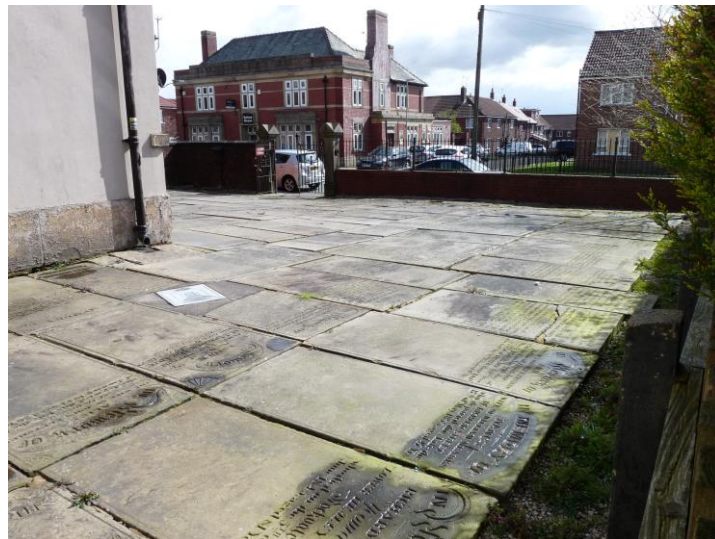
*Fig.32: ledger stones in the burial ground, from the north-west*

The burial ground is completely laid with inscribed ledger stones, all dating from no later than 1855 when the burial ground was closed for new burials. The earliest stone is dated 1811. It is probable that there are some human remains below the stones.
