**STOCK NOOK FARM, DOCTOR FOLD LANE, HEYWOOD**

An inspection of the barn/outbuildings at Stock Nook Farm was carried out during Wednesday 30<sup>th</sup> June 2022; the inspection being undertaken in order to comment upon the overall structural stability of the units. The subsequent report is being prepared in order to satisfy Planning Application requirements.

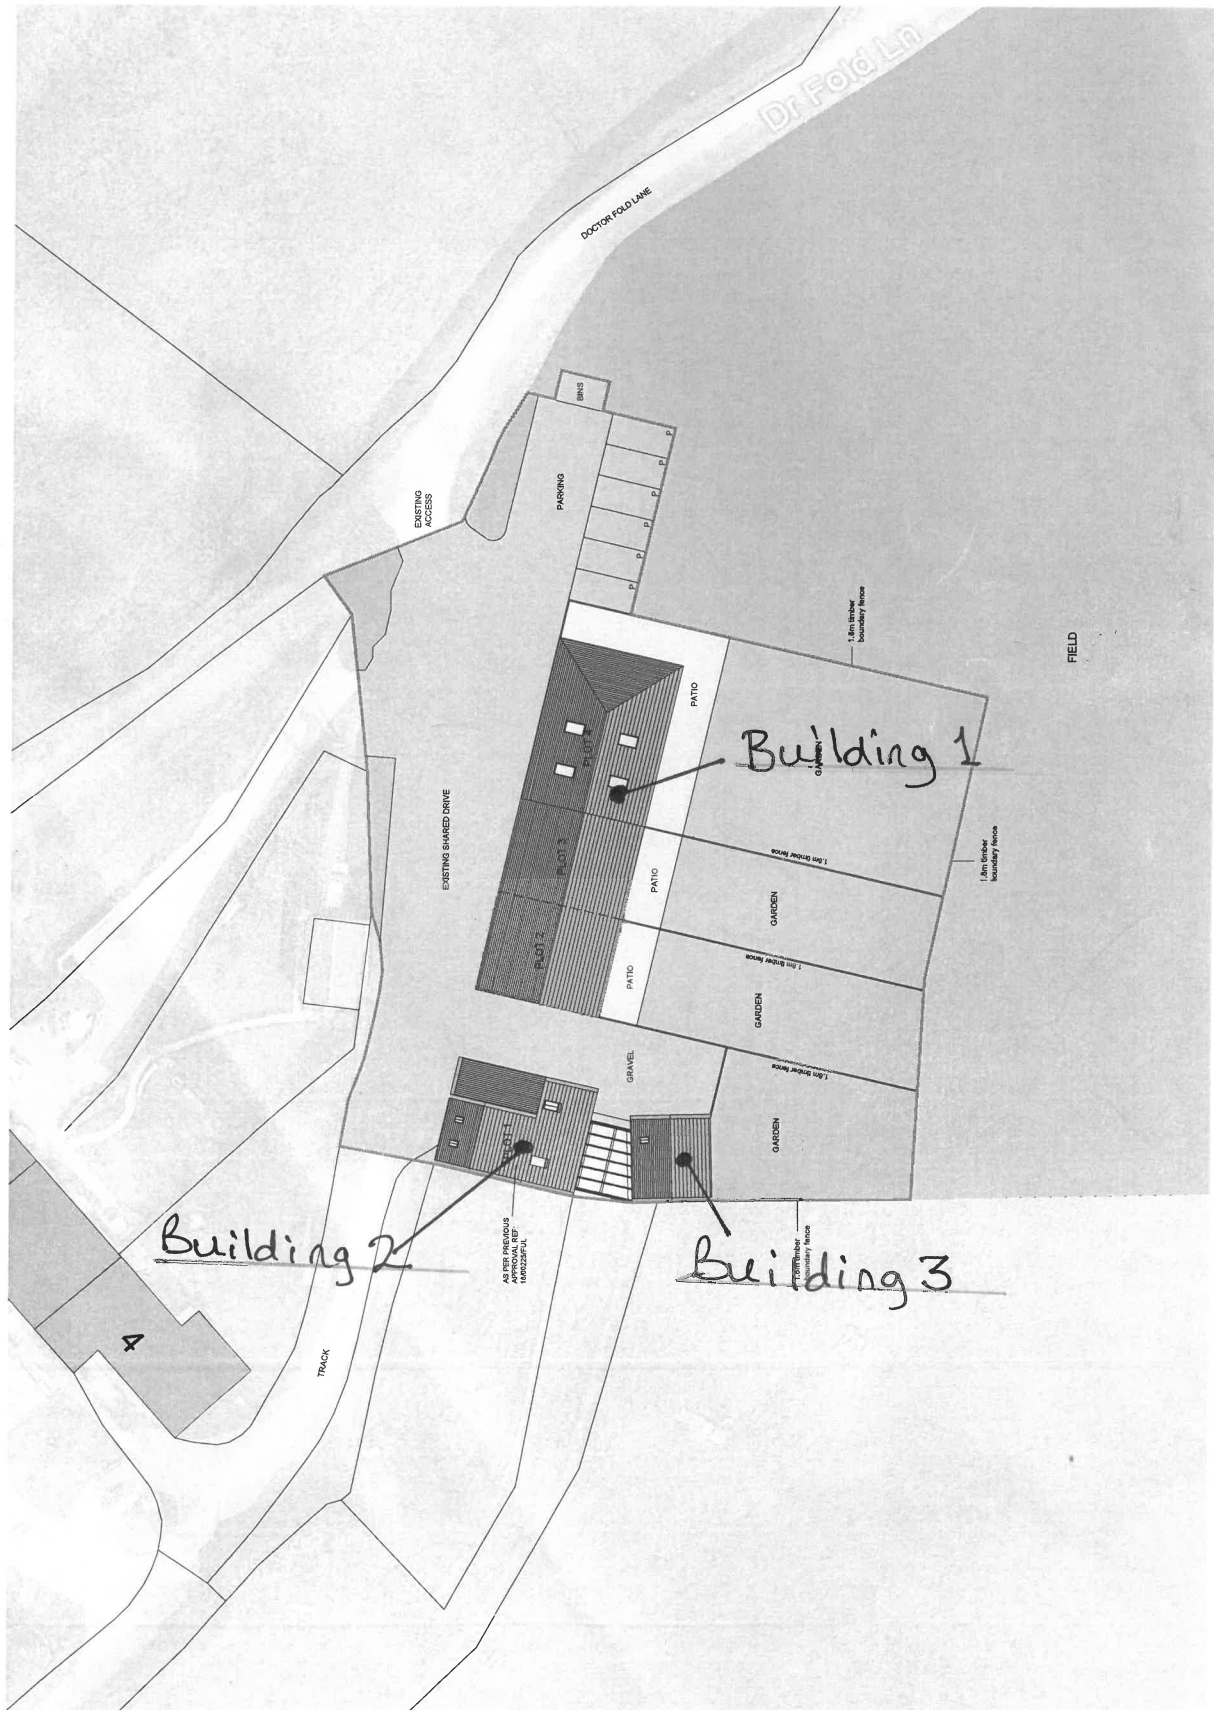
For the purpose of this report, buildings have been described as buildings 1, 2 & 3 with buildings 2 & 3 ultimately being linked. These are shown on the attached figure.
