**KINGSWAY BUSINESS PARK - PLOT W,  
ROCHDALE**

**REMEDIATION STRATEGY**

**For: David Wilson Homes & Rexel Group**

**R3119-R01-v2**

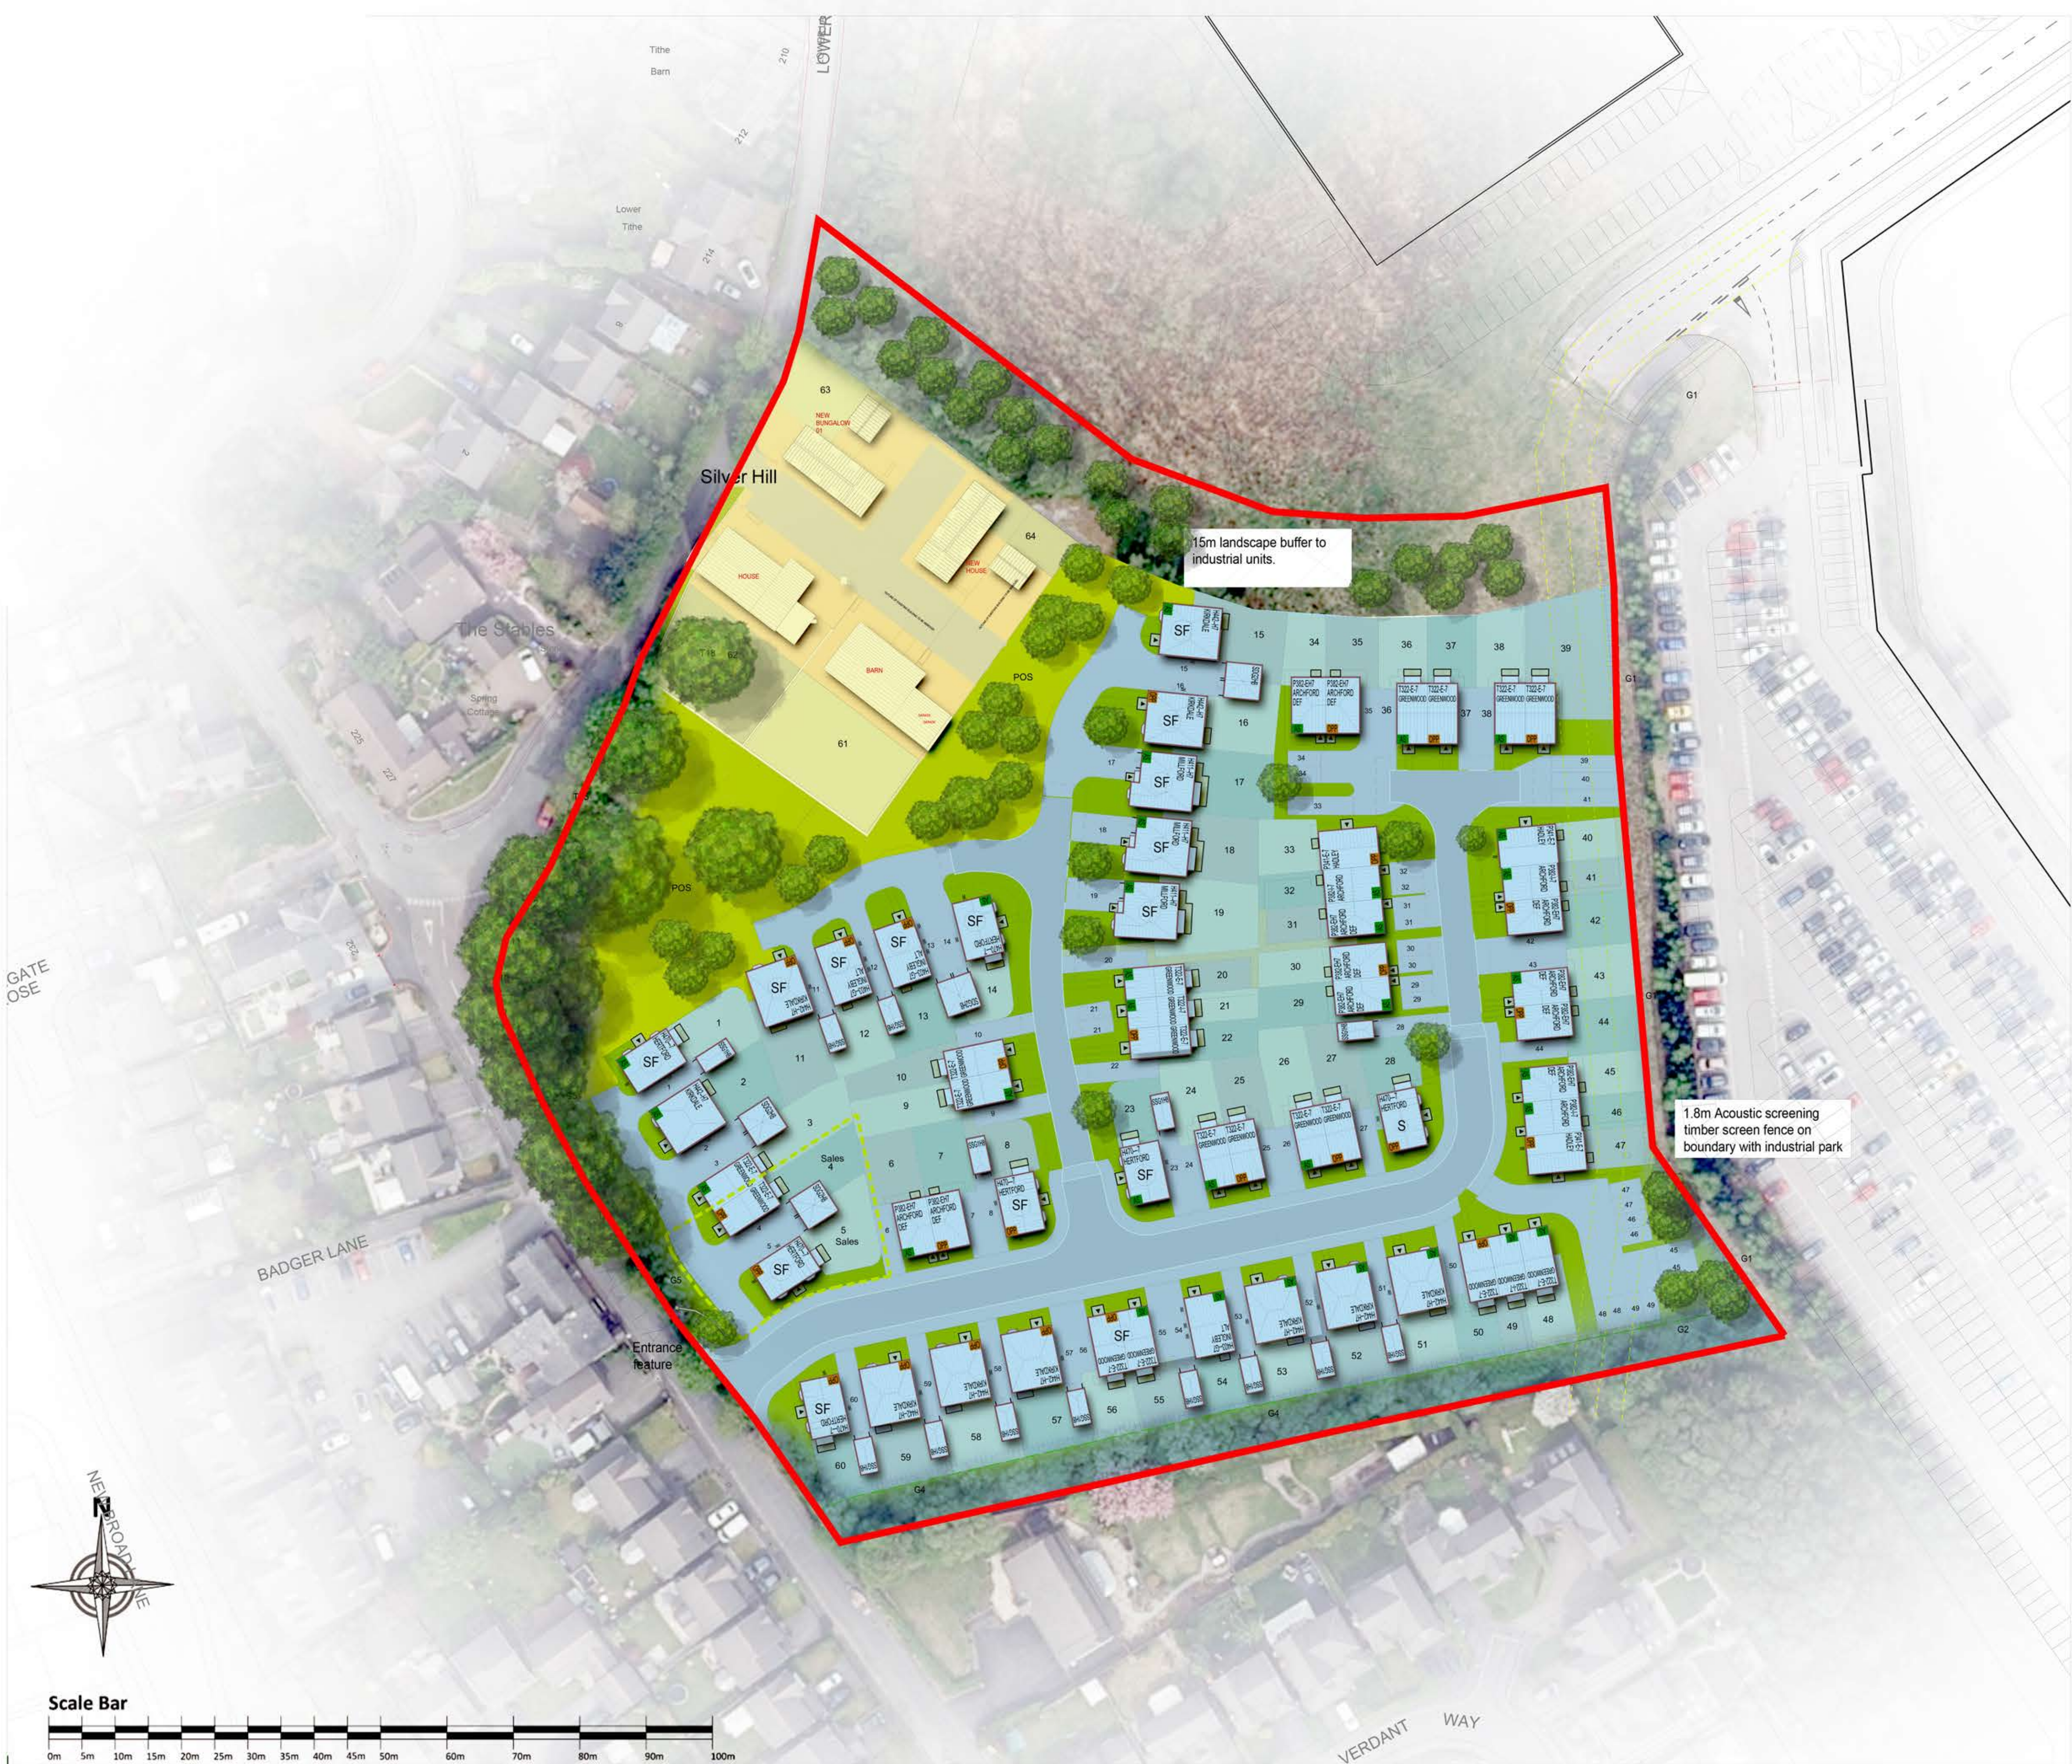
# KINGSWAY PLOT W PHASING PLAN

- Development Boundary
- Sales Arena
- Sewer Easement
- FS Feature Stone Plot
- Site Entrance Feature
