# **Heritage statement to support the conversion of the basement at Frazer Cottage, 102 Syke Road Rochdale.**

**Prepared by          Steven Haslehurst**  
**CRISP Architecture**

**Revision A**

**Date: 4<sup>th</sup> January 2024**

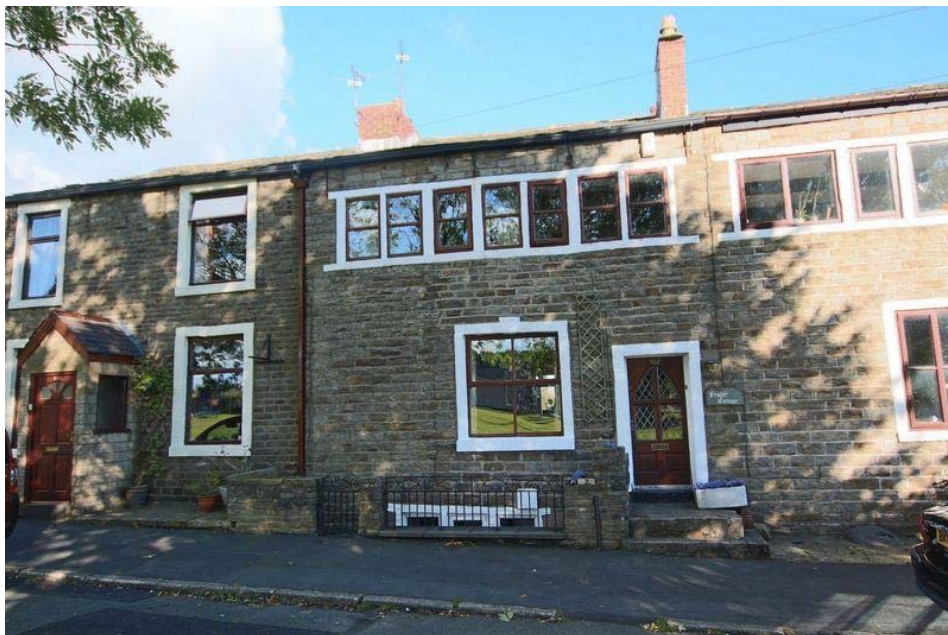
View of the Front (West) Elevation

the west elevation of number 102 is built of water-shot coursed sandstone. The ground floor has a two light wooden top hung sash window in a stone surround under a key-stone lintel. The first floor is marked by a line of weavers' windows in stone. The cellar is lit by a three light mullioned window in stone. The rear elevation is of rendered stone with square timber windows in stone surrounds and a pair of French windows. The roof is covered with stone, with brick chimney stacks.

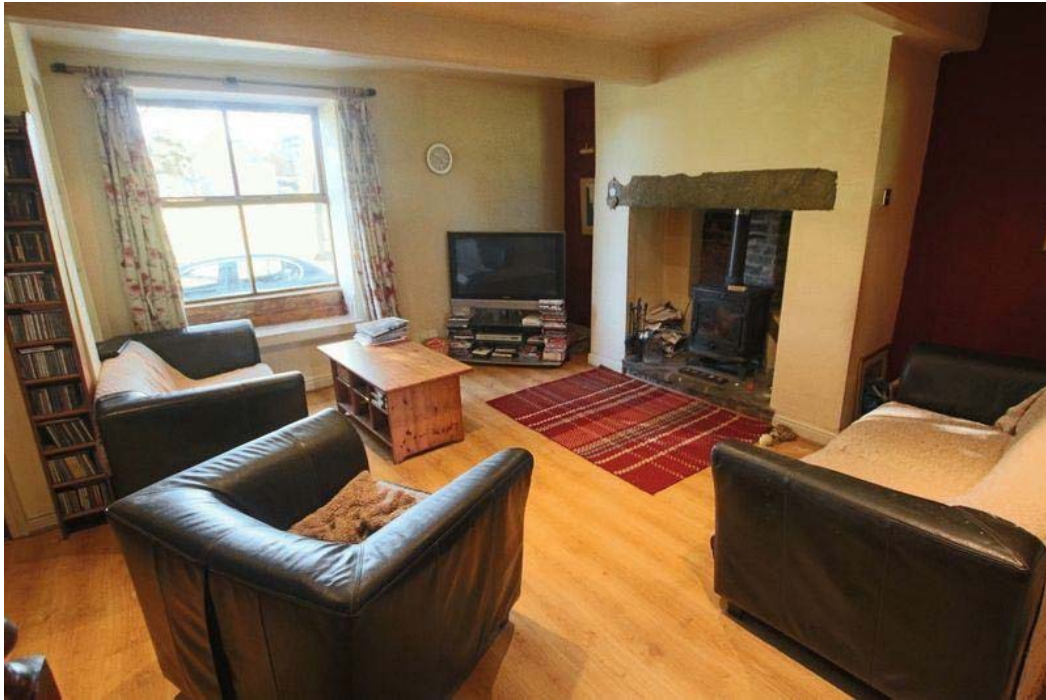
The ground floor contains a large fireplace with a stone bressummer projecting from the wall. The upper storey is supported on exposed plain timber beams. The upper storey is modernised but contains the exposed stone surrounds and mullions of the weavers' windows and a cast iron register grate. The garret is supported on exposed moulded timber beams.

Current Lounge showing fireplace

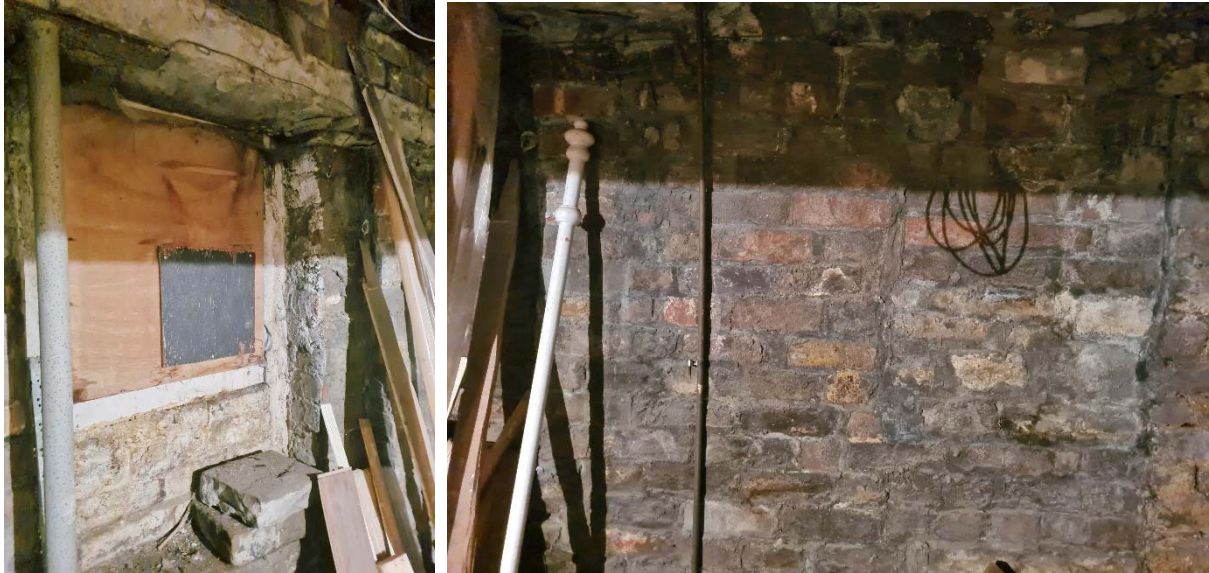
The basement on the front and rear elevations consists of water-shot stonework on the outer face and brickwork on the inner face. This method of masonry was known as ‘ramped’ masonry in the Rochdale area and was popular from about 1740 and died out at about 1840. The images below shows the inner and outer leaf.

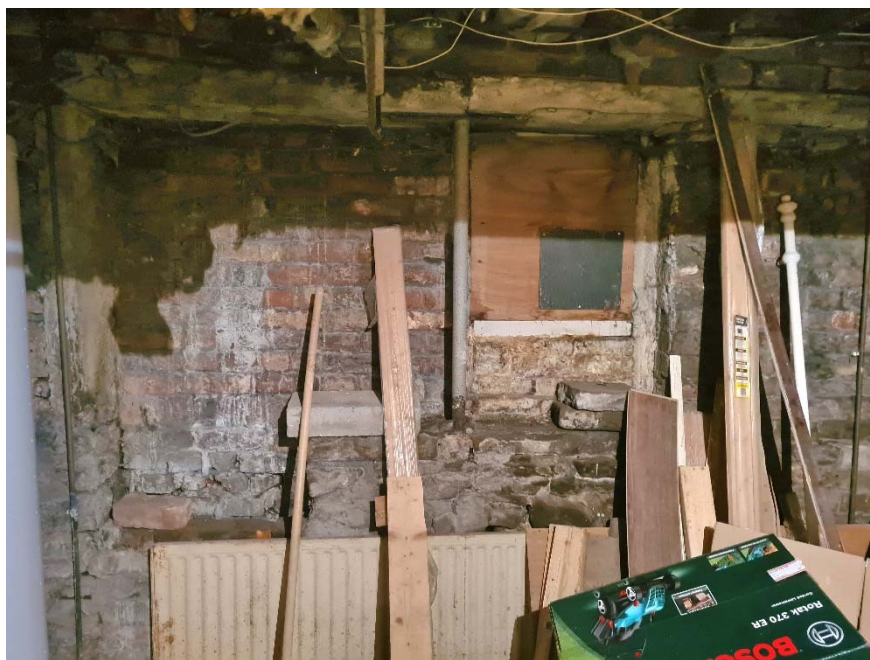
The below image shows the original bricked up doorway, which from the style and type of bricks is believed to have happened in either the late 19<sup>th</sup> century or at the beginning of the 20<sup>th</sup> century. The area behind the wooden panel is a lightwell that is no longer used, as can be seen from the image below the bricked up doorway. There is also a crack in the lintel above the opening where the prop is located.

Extent of bricked up rear door

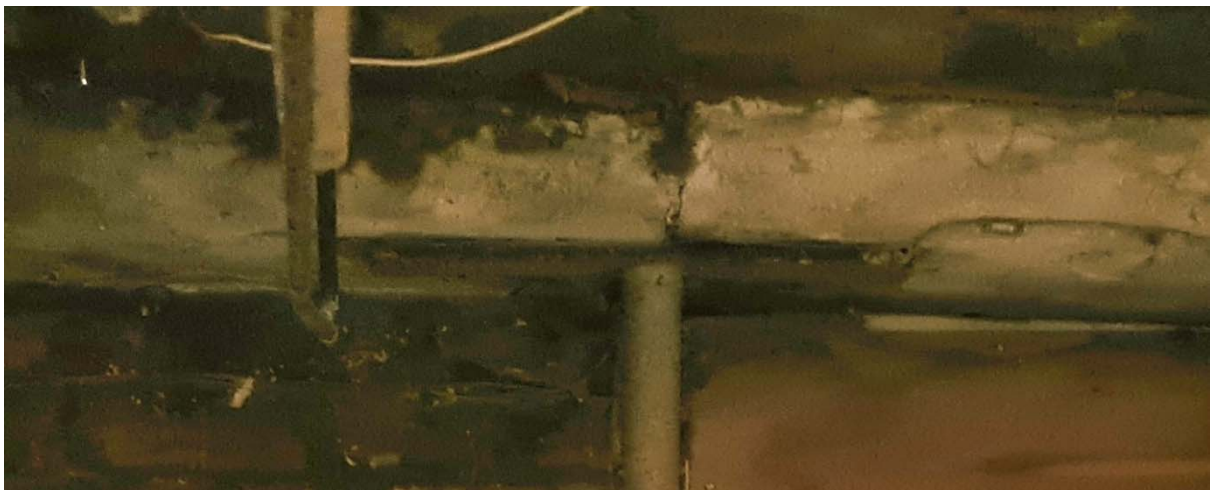
The existing lintel above the bricked in doorway has a significant crack in it, as can be seen in the picture below.

It is anticipated that the window lintel will be repaired with helical bars. These reinforcement bars can be used with brick or masonry lintels. Once installed these stainless steel bars improve strength with minimum disruption.

As a last measure if the helical bar system above is ruled out due to space and the existing beam can not be easily removed and repaired a like for like replacement will be found.

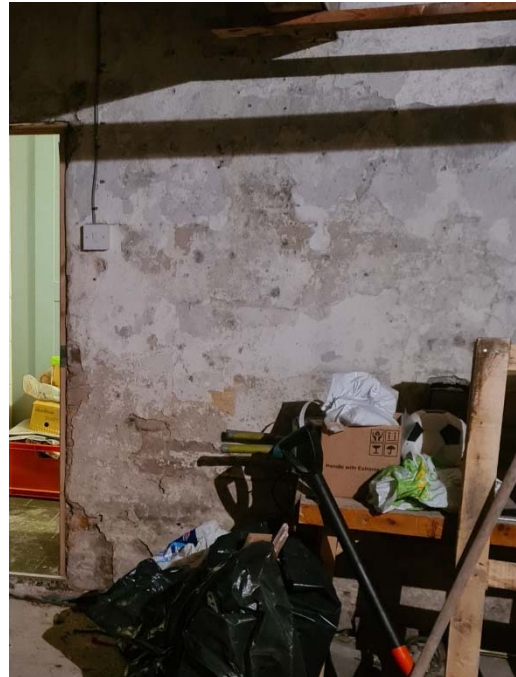
The internal masonry walls that divide the area into four being the wall that runs from north to south between the lounge and workshop, and the wall that runs from east to west, between the storage area and workshop, and utility area and WC are of brick construction with a plaster finish in some areas.

Wall between workshop and storage

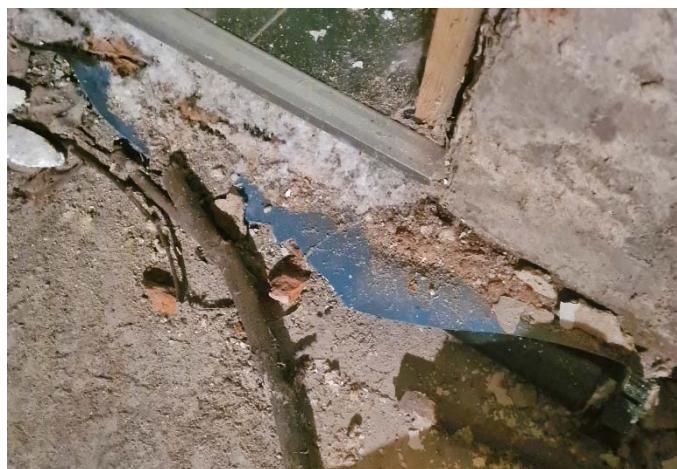
The existing floor is concrete throughout the basement area. In the storage area, utility area, hall in front of the front basement door and the lounge area a blue DPC has been laid and a screed put down in these areas, this is evident in the below area, and happened before 2016 when the current owners purchased the property.

Blue DPM showing under the storage room screed.

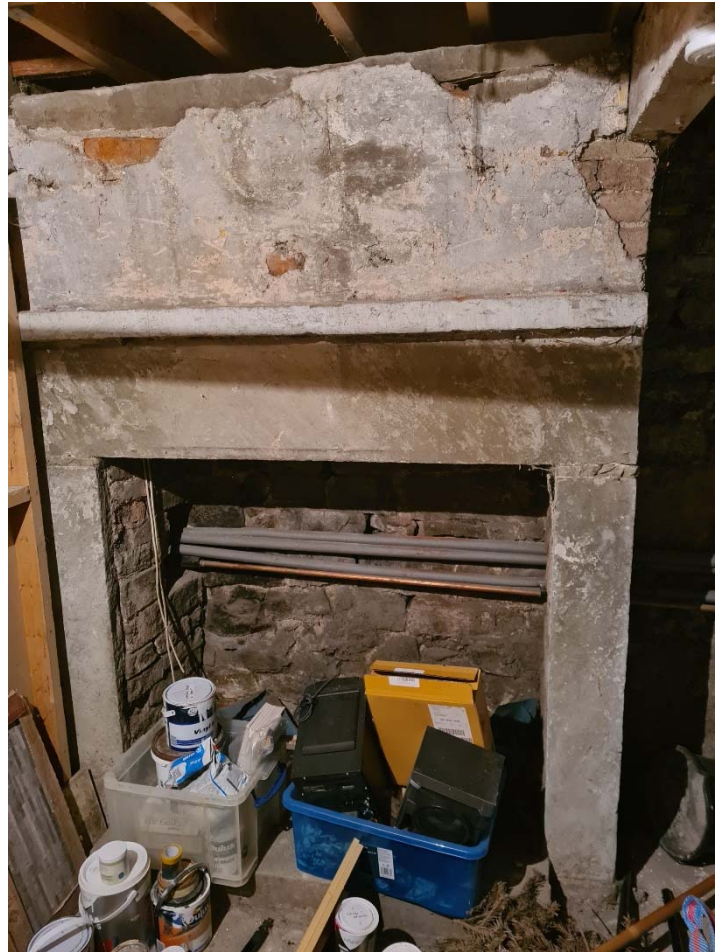
The below image shows the existing random rubble wall that divided the terraced houses with two leaves of brickwork forming the walls of the fireplace. This is then coated with old lime plaster. The fireplaces are only blocked off at the top by the timber floor above.

Existing workshop fireplace

The fireplace in the workshop is the best example of what both would of originally looked like.

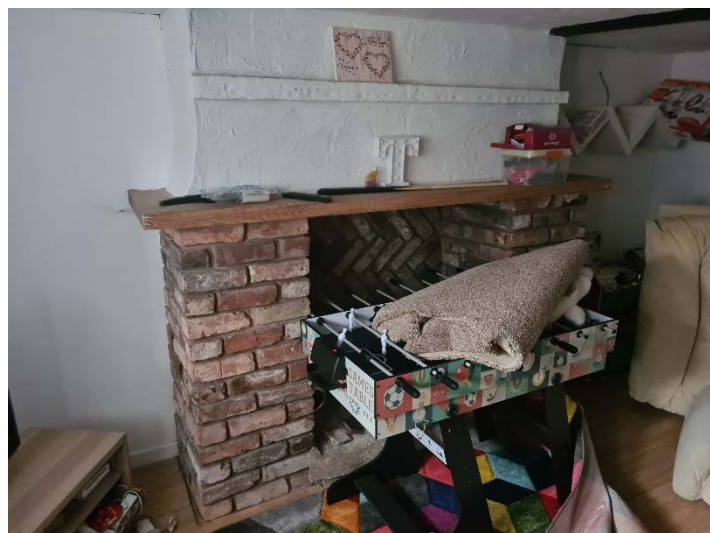
The fireplace in the existing basement lounge it is anticipated would have been similar in design to the workshop fireplace. However, when the previous tenants refurbished some areas of the basement they added a brick feature surround to the base.

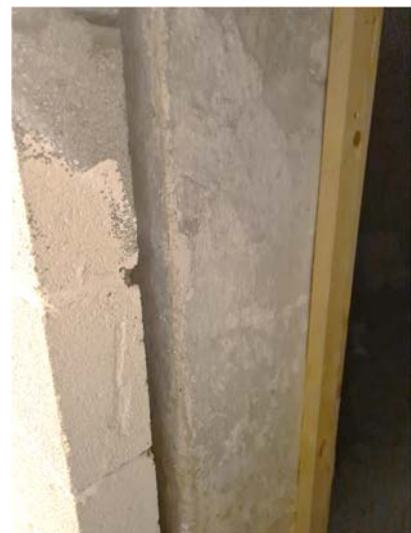
The image to the right shows the relationship between the existing brick and plaster walls and the blockwork wall
