Phase I Geoenvironmental Site Assessment  
Plot 3, Pilsworth Road, South Heywood

Reference: 11-697-R11-2  
Date: November 2022

# PHASE I GEOENVIRONMENTAL SITE ASSESSMENT

Plot 3  
Pilsworth Road  
South Heywood  
OL10 2TT

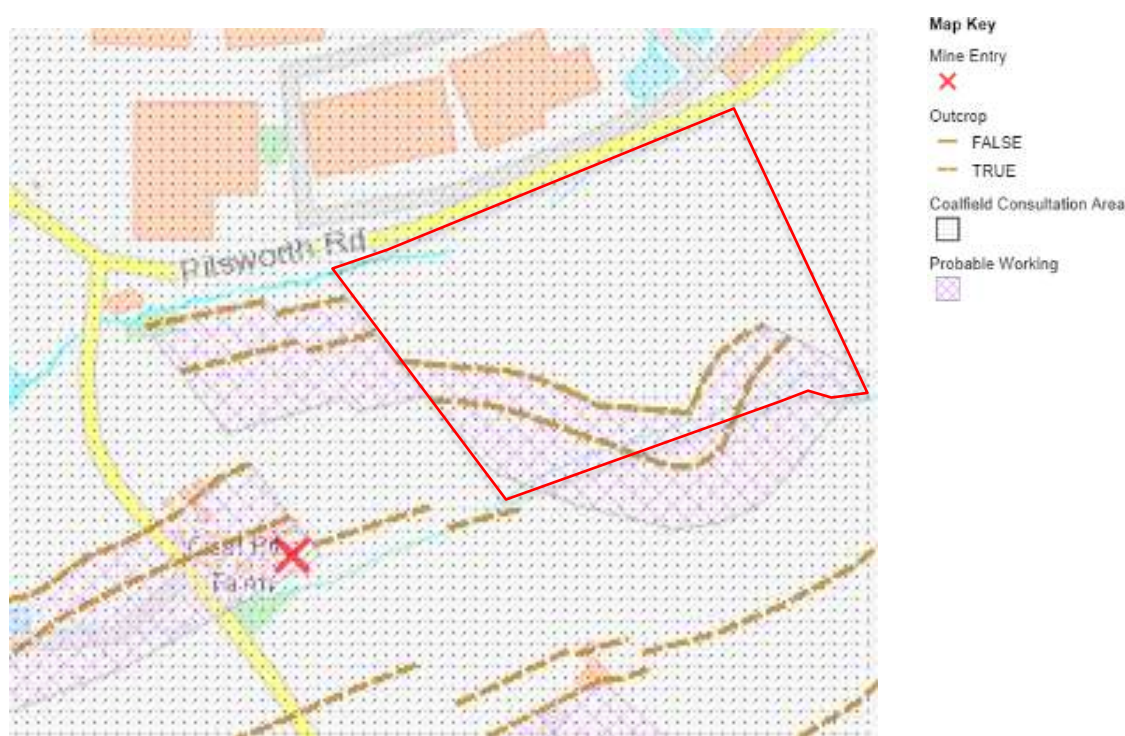
**FIGURE 4.1 EXCERPT OF THE COAL AUTHORITY ONLINE VIEWER**

In the first instance, E3P has reviewed the Coal Authority Online Viewer and an excerpt of this is presented as Figure 4.1. The south of the site lies within a development high risk area. The map shows two coal outcrops in the south of the site with probable shallow workings to the south of the outcrops. A mine entry is present at Coal Pit Farm circa 300 m west of the site.
