Biodiversity Metric Report

Land at Greenbooth Road/Edenfield Road, Norden

Reference: 80-742-R2-4

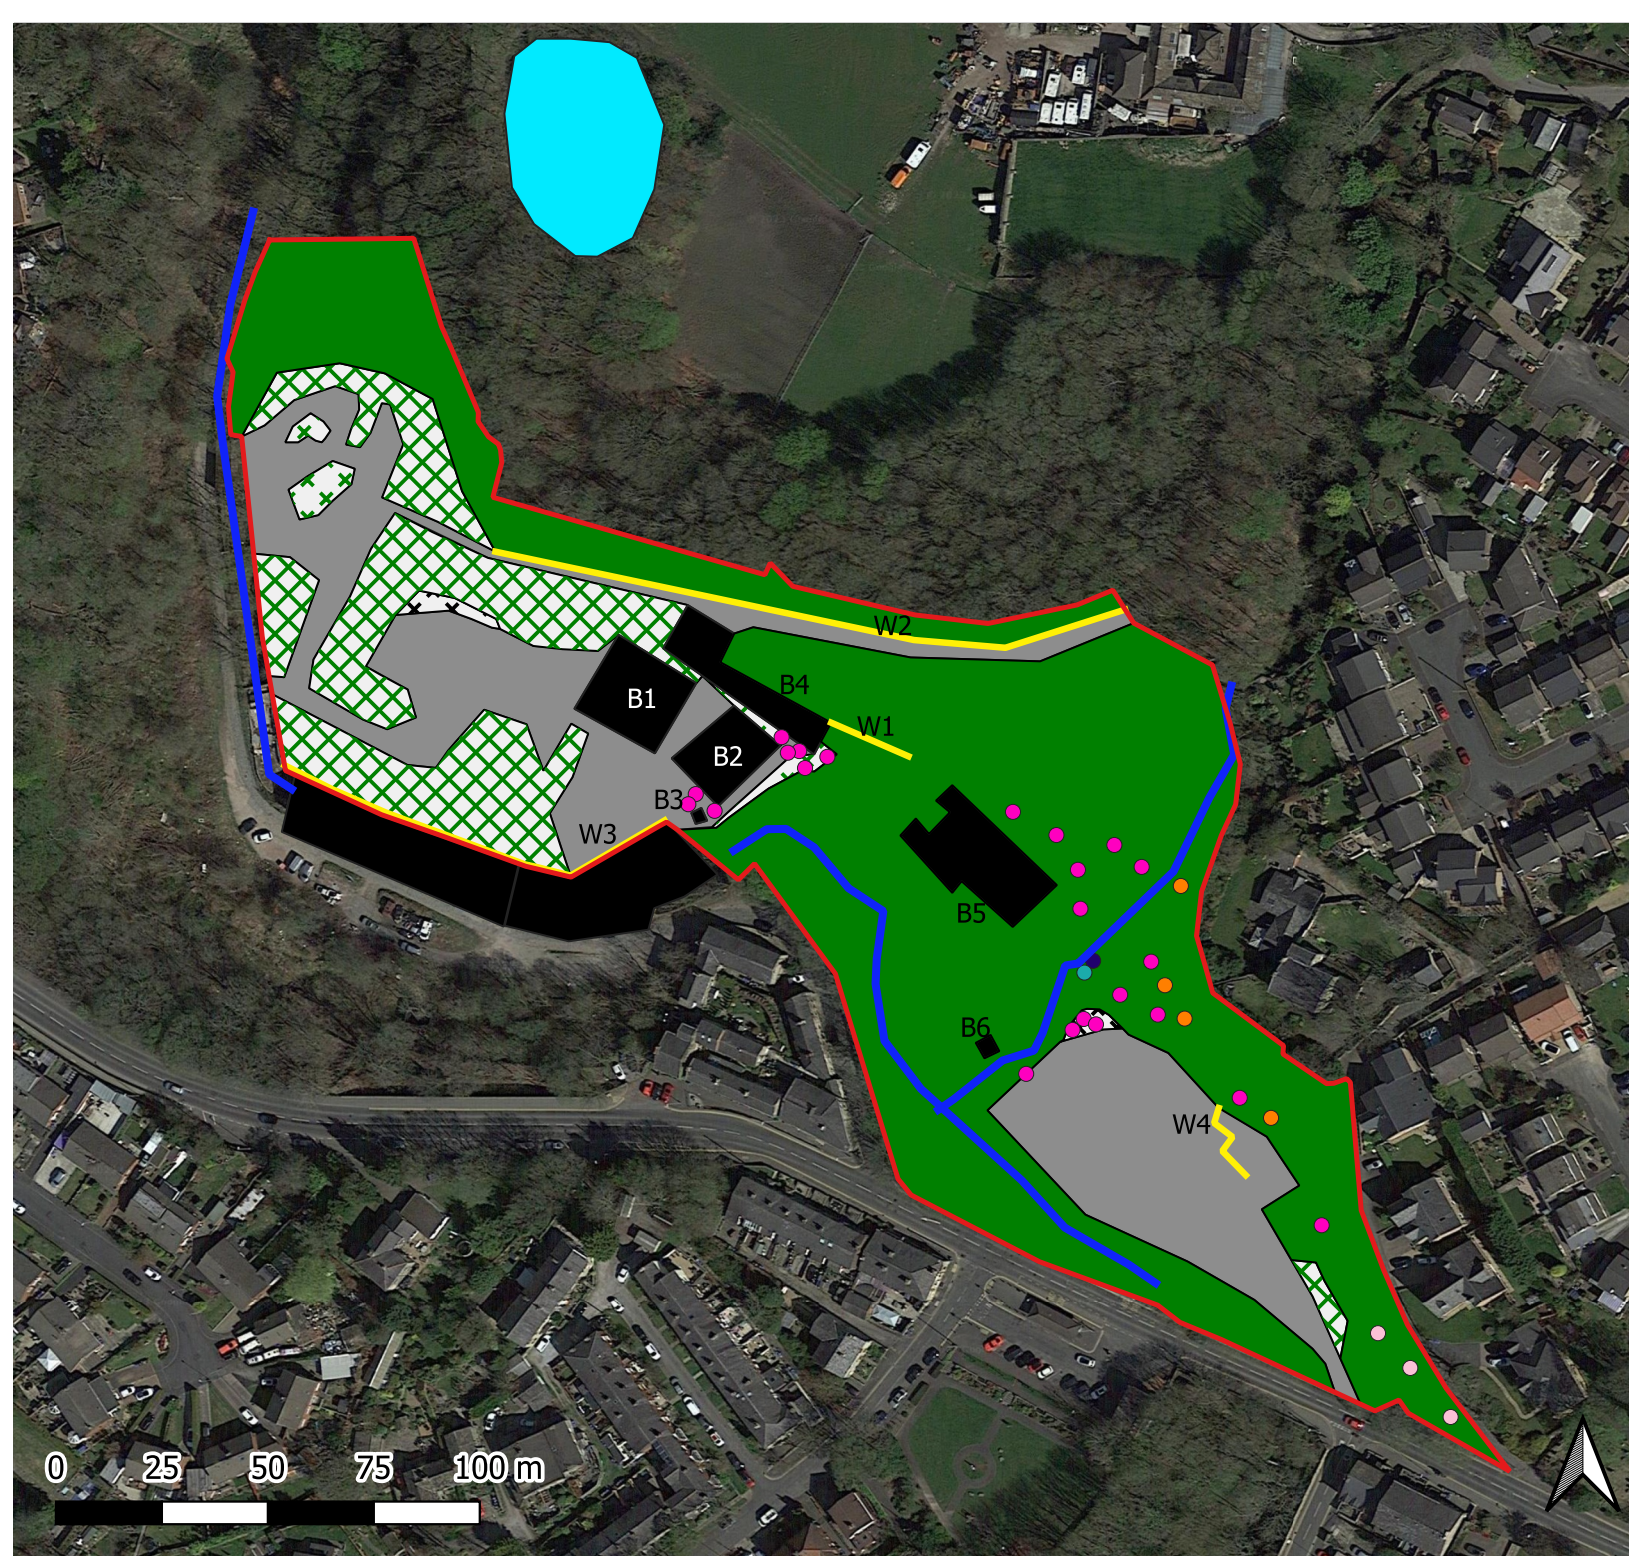
## **PHASE 1 HABITAT PLAN**

- Site boundary
- Running water
- Wall
- Yellow archangel identified in 2020
- Wall cotoneaster identified in 2020
- Montbretia identified in 2020
- Himalyan balsam
- Rhododendron
- Broadleaved woodland
- Buildings
- Scattered scrub
- Dense scrub
- Ephemeral/short perennial
- Hardstanding
- Waterbody

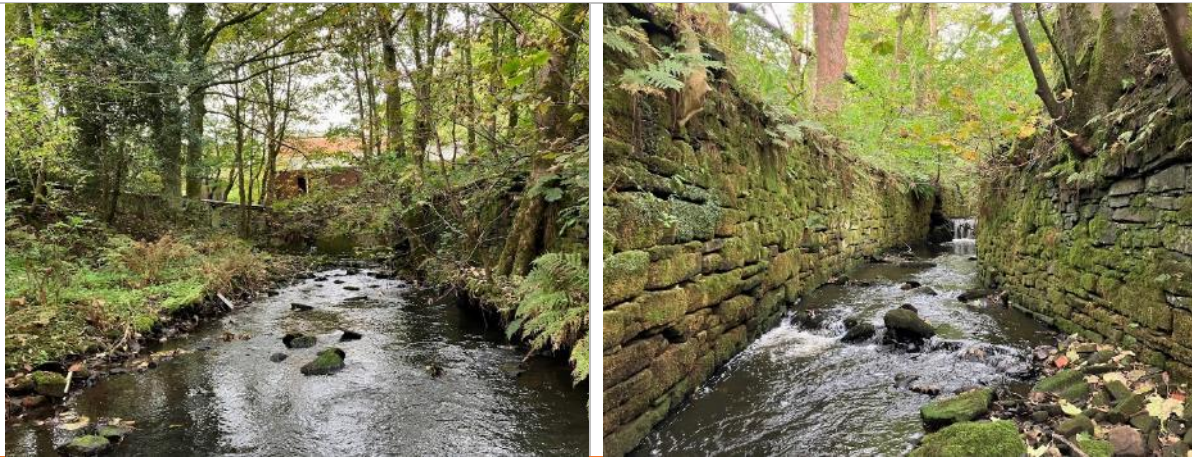
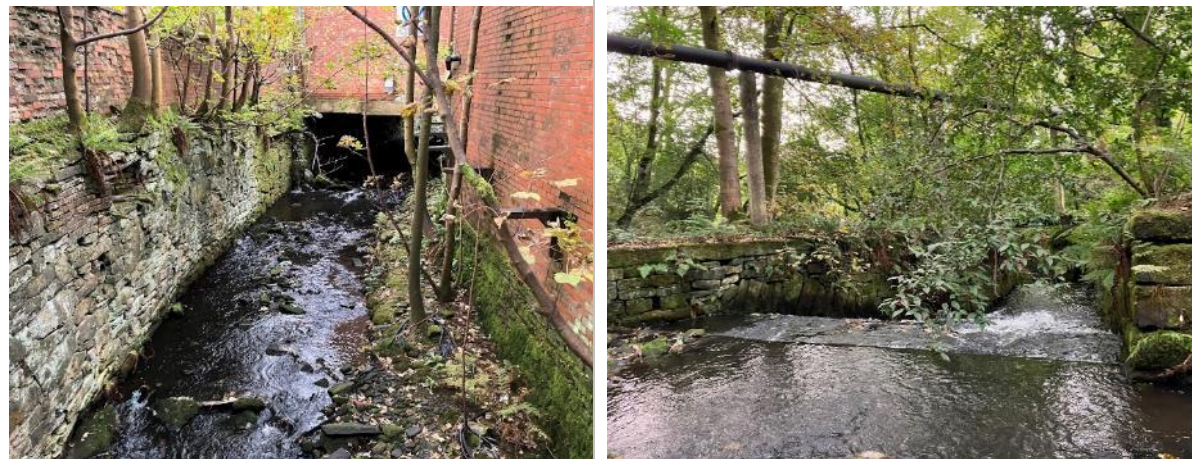
| NADEN BROOK | | | |
|---|---|---|---|
| UPSTREAM GRID REFERENCE | SD 85614 14955 | DOWNSTREAM GRID REFERENCE | SD 85835 14619 |

The average river width was approximately 5 m and as such five contiguous modules of 20 m in length were used during the MoRPh5 survey. A total length of 100 m was surveyed, comprising over 20% of the length of Naden Brook flowing through or within 10 m of the site. As such, a single MoRPh5 survey was deemed appropriate to provide a condition for the brook. Please see Appendix VI for the survey area.

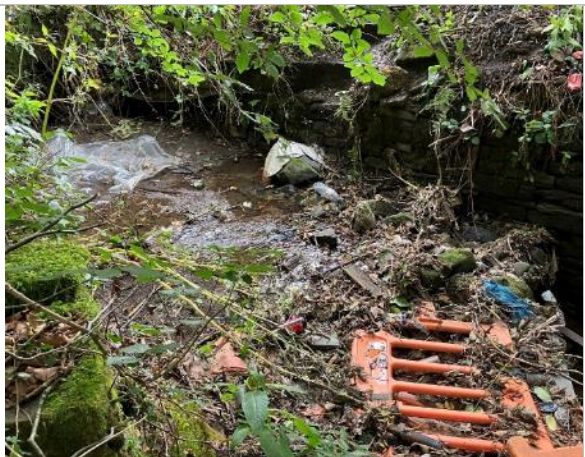
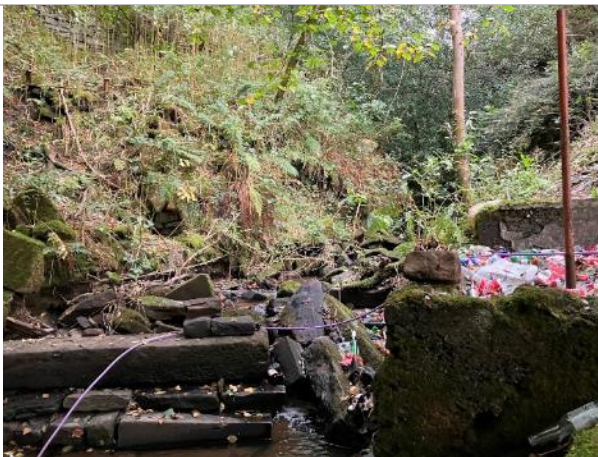
| WOODHOUSE LANE BROOK | | | |
|---|---|---|---|
| UPSTREAM GRID REFERENCE | SD 85921 14881 | DOWNSTREAM GRID REFERENCE | SD 85814 14668 |

The average river width was less than 5 m and as such five contiguous modules of 10 m in length were used during the MoRPh5 survey. A total length of 50 m was surveyed, comprising over 20% of the length of Woodhouse Lane Brook flowing through or within 10 m of the site. As such, a single MoRPh5 survey was deemed appropriate to provide a condition for the brook. Please see Appendix V for the survey area.
