Phase I Geoenvironmental Site Assessment  
Land to the West of New Street, Littleborough

Reference: 15-075-R1-2

Date: July 2022

# **PHASE I GEOENVIRONMENTAL SITE ASSESSMENT**

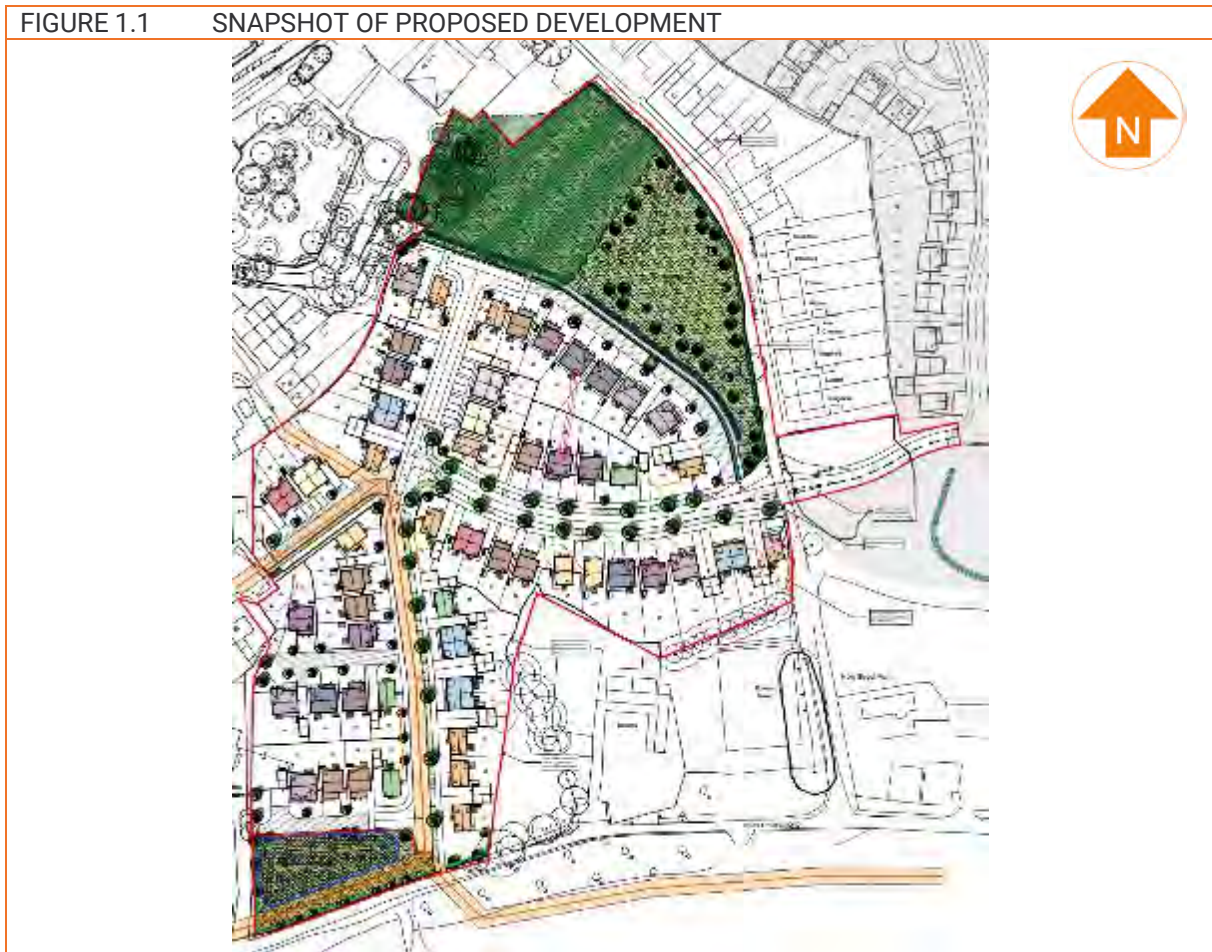
FIGURE 1.1 SNAPSHOT OF PROPOSED DEVELOPMENT

A snapshot of the proposed development layout is indicated in Figure 1.1.

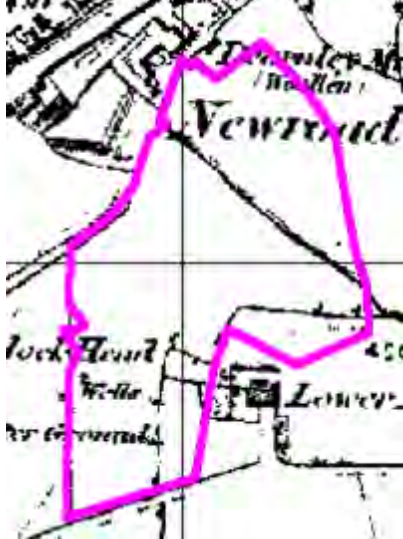
| MAP EDITION | HISTORICAL LAND USE | HISTORICAL MAP EXCERPT |
|---|---|---|
| <p><b>1851</b><br/><b>1:10,560</b></p> | <p>The Site is undeveloped agricultural land.</p> <p>Wells are recorded in the west of the Site.</p> <p>A watercourse flows from northwest to southeast in the north of the Site.</p> <p>Field boundaries are present in the south and east of the Site.</p> | |

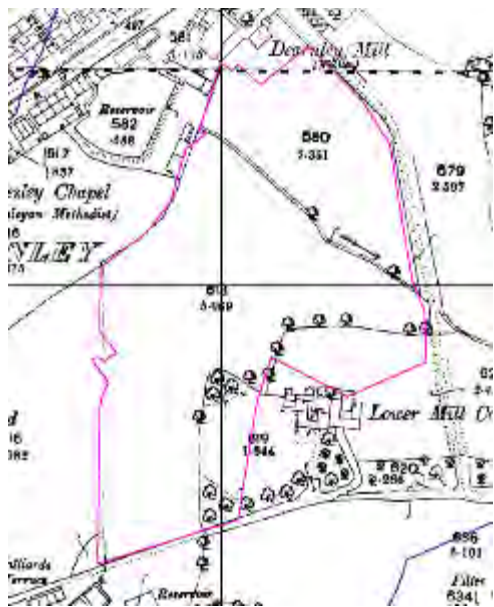
| MAP EDITION | HISTORICAL LAND USE | HISTORICAL MAP EXCERPT |
|---|---|---|
| <p><b>1893</b><br/><b>1:2,500</b></p> | <p>The wells are no longer recorded.</p> <p>Tanks are located off-site at the northwest boundary.</p> | |

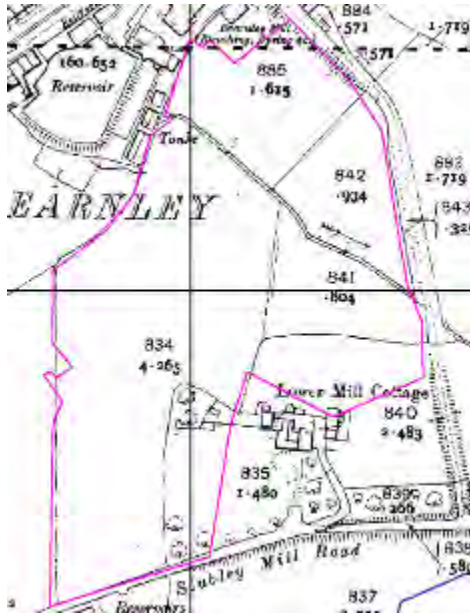
| MAP EDITION | HISTORICAL LAND USE | HISTORICAL MAP EXCERPT |
|---|---|---|
| <p><b>1910</b><br/><b>1:2,500</b></p> | <p>Additional field boundaries are present in the centre and north of the Site.</p> <p>Small structures are present in the south of the Site associated with Lower Mill Cottage to the east.</p> | |

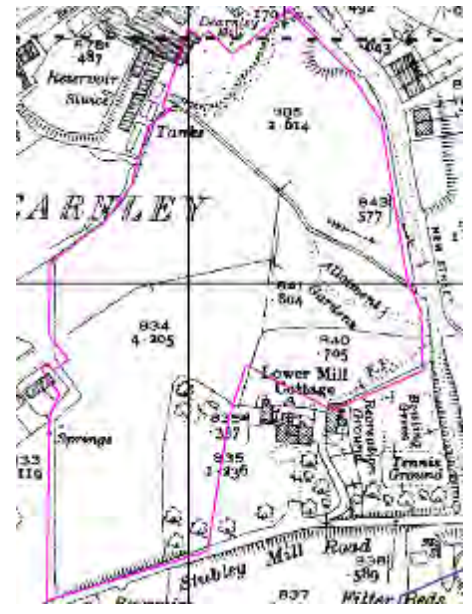
| MAP EDITION | HISTORICAL LAND USE | HISTORICAL MAP EXCERPT |
|---|---|---|
| <p><b>1930</b><br/><b>1:2,500</b></p> | <p>Two springs are present at the western boundary.</p> <p>A sand pit is present in the northwest corner and an additional excavation (possible clay pit) is present in the northeast.</p> <p>The field boundary in the north is no longer present.</p> <p>Allotment Gardens are recorded in the east and a possible track is present leading to the Allotments.</p> <p>A footpath is present in the southeast corner.</p> <p>A cutting is shown along Stubley Mill Road to the south.</p> | |

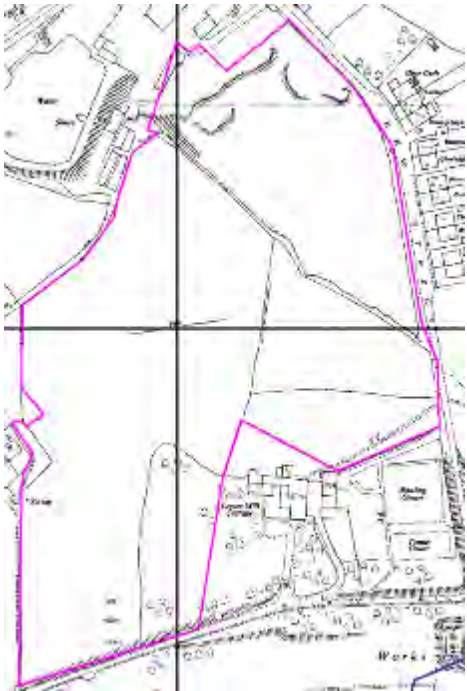
| MAP EDITION | HISTORICAL LAND USE | HISTORICAL MAP EXCERPT |
|---|---|---|
| <p><b>1960</b><br/><b>1:1,250</b></p> | <p>A pipeline is recorded in the centre of Site.</p> <p>Arisings from possible excavations are shown in the north of the Site.</p> <p>No structures are shown in the south.</p> <p>The Allotment Gardens are no longer recorded.</p> <p>One spring is shown at the western boundary.</p> | |

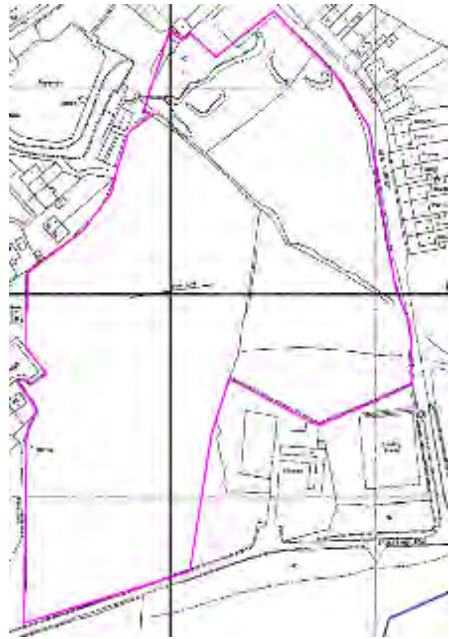
| MAP EDITION | HISTORICAL LAND USE | HISTORICAL MAP EXCERPT |
|---|---|---|
| <p><b>1992</b><br/><b>1:1,250</b></p> | <p>A field boundary has been added in the north of the Site.</p> | <p>This is a black and white historical map excerpt. A pink line outlines a large, irregular field area. To the north of this field, a new boundary line has been added, separating it from an adjacent area. The map shows surrounding streets and buildings.</p> |

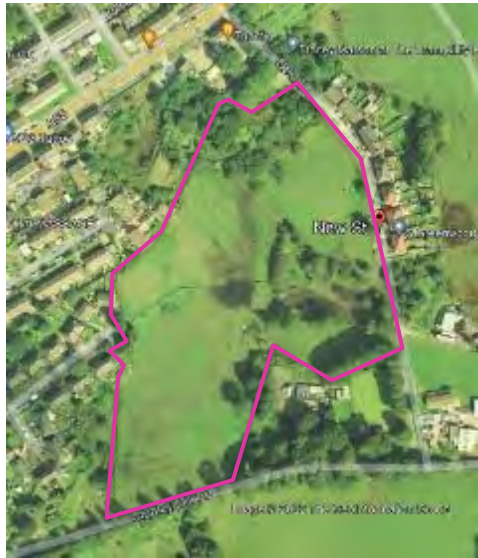
| MAP EDITION | HISTORICAL LAND USE | HISTORICAL MAP EXCERPT |
|---|---|---|
| <p><b>2000</b><br/><b>Google Earth</b><br/><b>Aerial Imagery</b></p> | <p>Two ponds appear to be present in central eastern sector.</p> | <p>This is an aerial photograph from 2000. A pink line outlines the same field area as in the 1992 map. Two distinct ponds are visible in the central eastern sector of the field. The surrounding area includes residential streets and buildings.</p> |

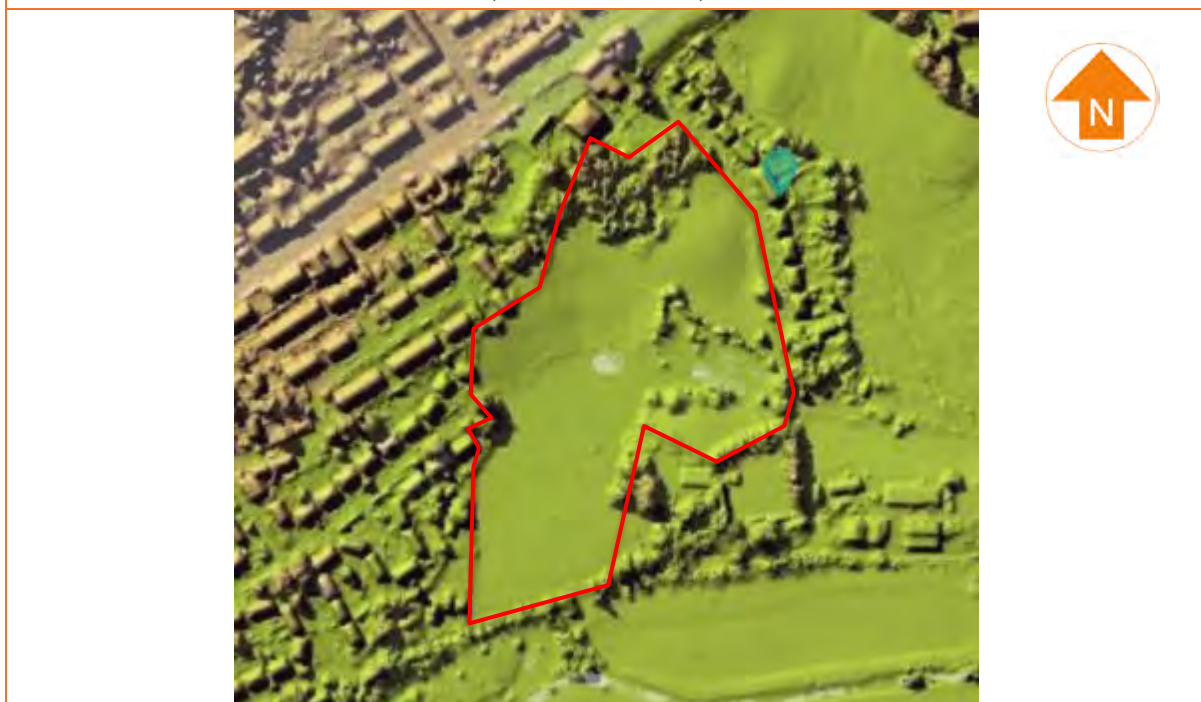
FIGURE 4.2 SURFACE LIDAR DATA (GROUNDSURE IO)

An extract showing the surface Lidar data is included in Figure 4.2.

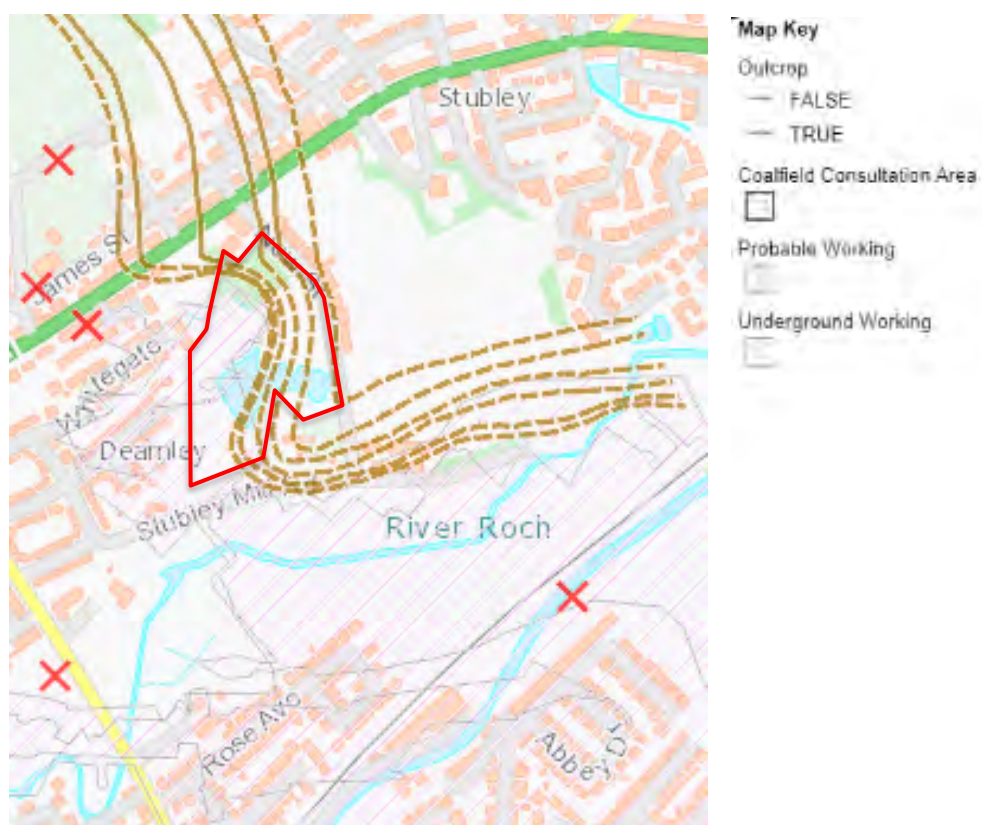
FIGURE 4.3 EXCERPT OF THE COAL AUTHORITY ONLINE VIEWER

In the first instance, E3P has reviewed the Coal Authority Online Viewer and an excerpt of this is presented as Figure 4.3. This map shows that the Site lies within a development high risk area. There are six outcrops shown on Site and an area of underground workings is shown across the western side of the Site. Probable workings are also shown across the majority of the Site.

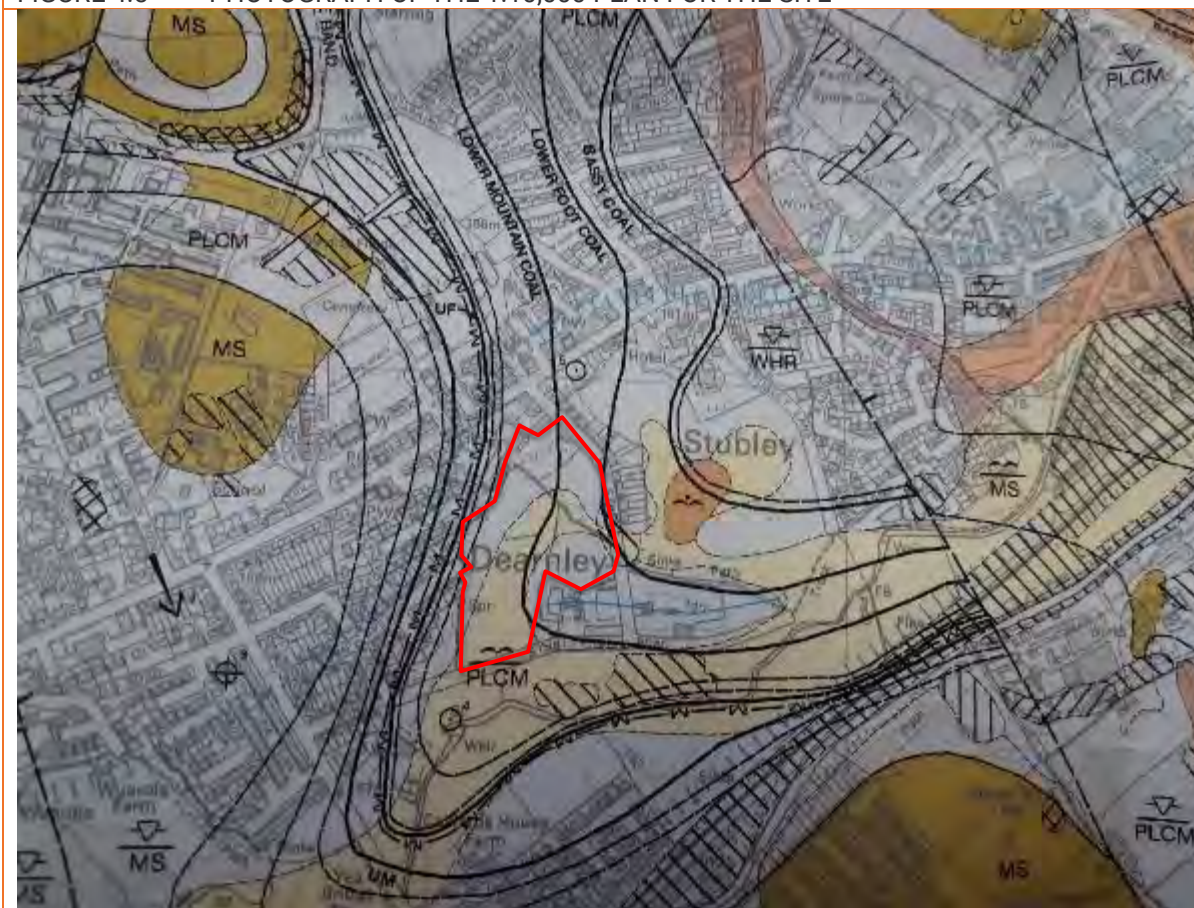
FIGURE 4.5 PHOTOGRAPH OF THE 1:10,000 PLAN FOR THE SITE

Figure 4.5 is a photograph of the 1:10,000 plan for the Site which shows the Lower Foot Coal and the Lower Mountain Coal outcropping on Site. The Upper Foot Coal outcrop is shown at the western boundary.

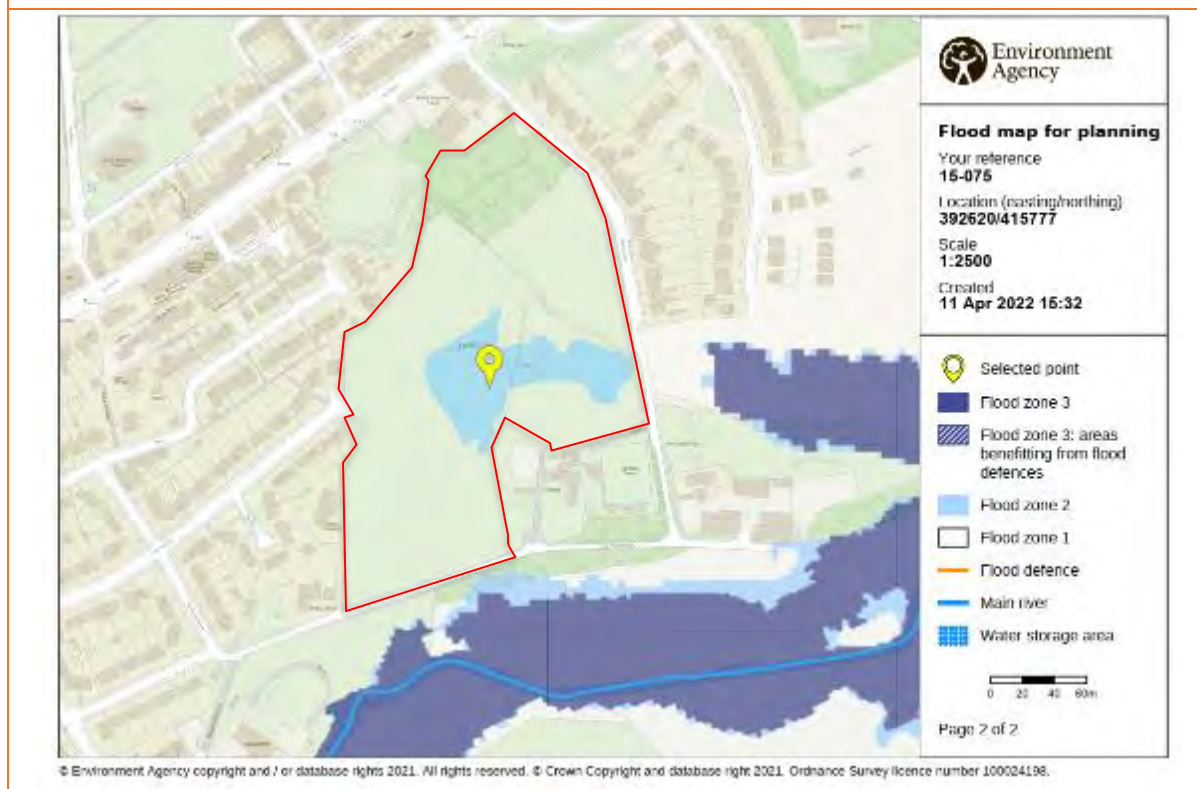
FIGURE 4.6 EA FLOOD RISK MAP

The Site is predominantly located within a currently defined “Flood Risk Zone 1”; defined as land assessed as having less than 1 in 1,000 annual probability of river or sea flooding (< 0.1%), and as such is considered to be unaffected by river flooding. The Environment Agency (EA) Flood Risk Map for the Site is presented in Figure 4.6.

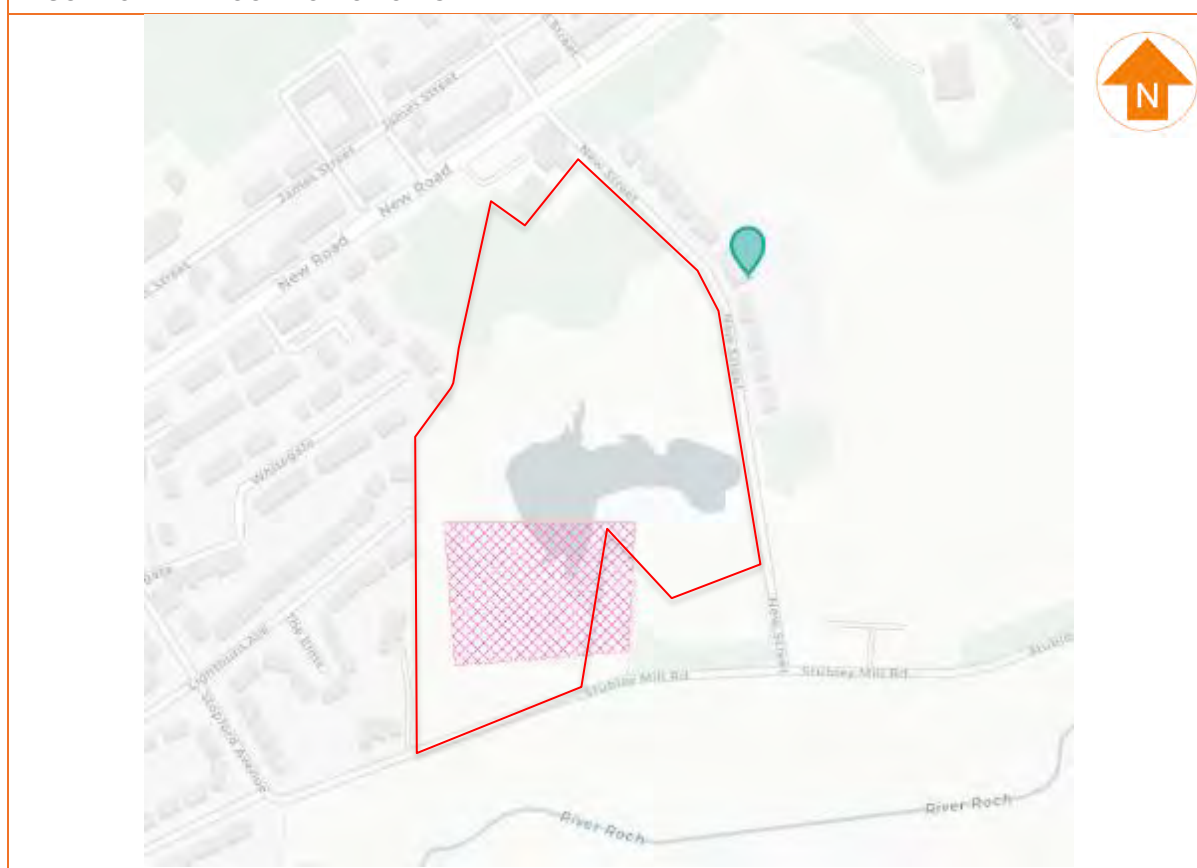
FIGURE 5.1 LOCATION OF ON-SITE LANDFILL

A historic landfill and registered landfill are recorded in the south of the Site. Inert waste was deposited between March 1988 and December 1990. The location of the landfill is shown in Figure 5.1. Remediation and enabling earthworks will be required to render this sector suitable for future development. Waste materials will need to be processed and recovered using an appropriate Environmental Permit.

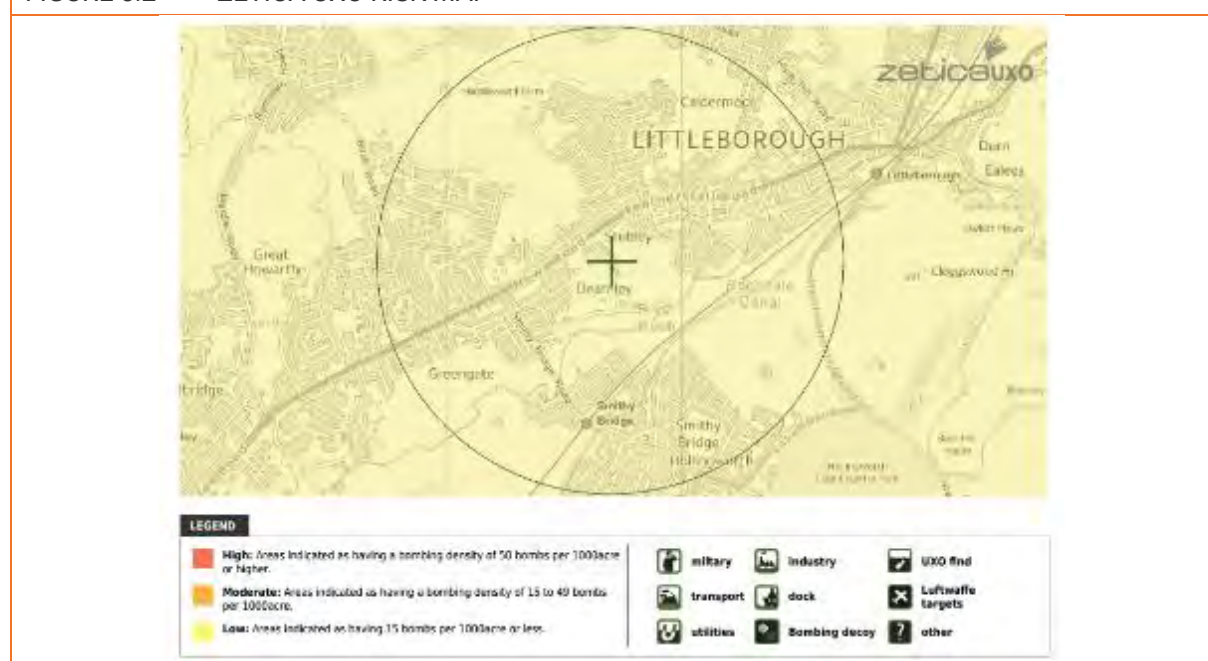
FIGURE 5.2 ZETICA UXO RISK MAP

The regional unexploded bomb risk map from Zetica (2014) indicates that the Site is in an area at low risk from possible unexploded ordnance (UXO) resulting from the Second World War. The Zetica UXO Risk Map is presented as Figure 5.2.
