# Homes England

## Asbestos Management Plan

| PROPERTY | Silverhill Farm, Lower Lane,<br>Rochdale, OL16 4PT |

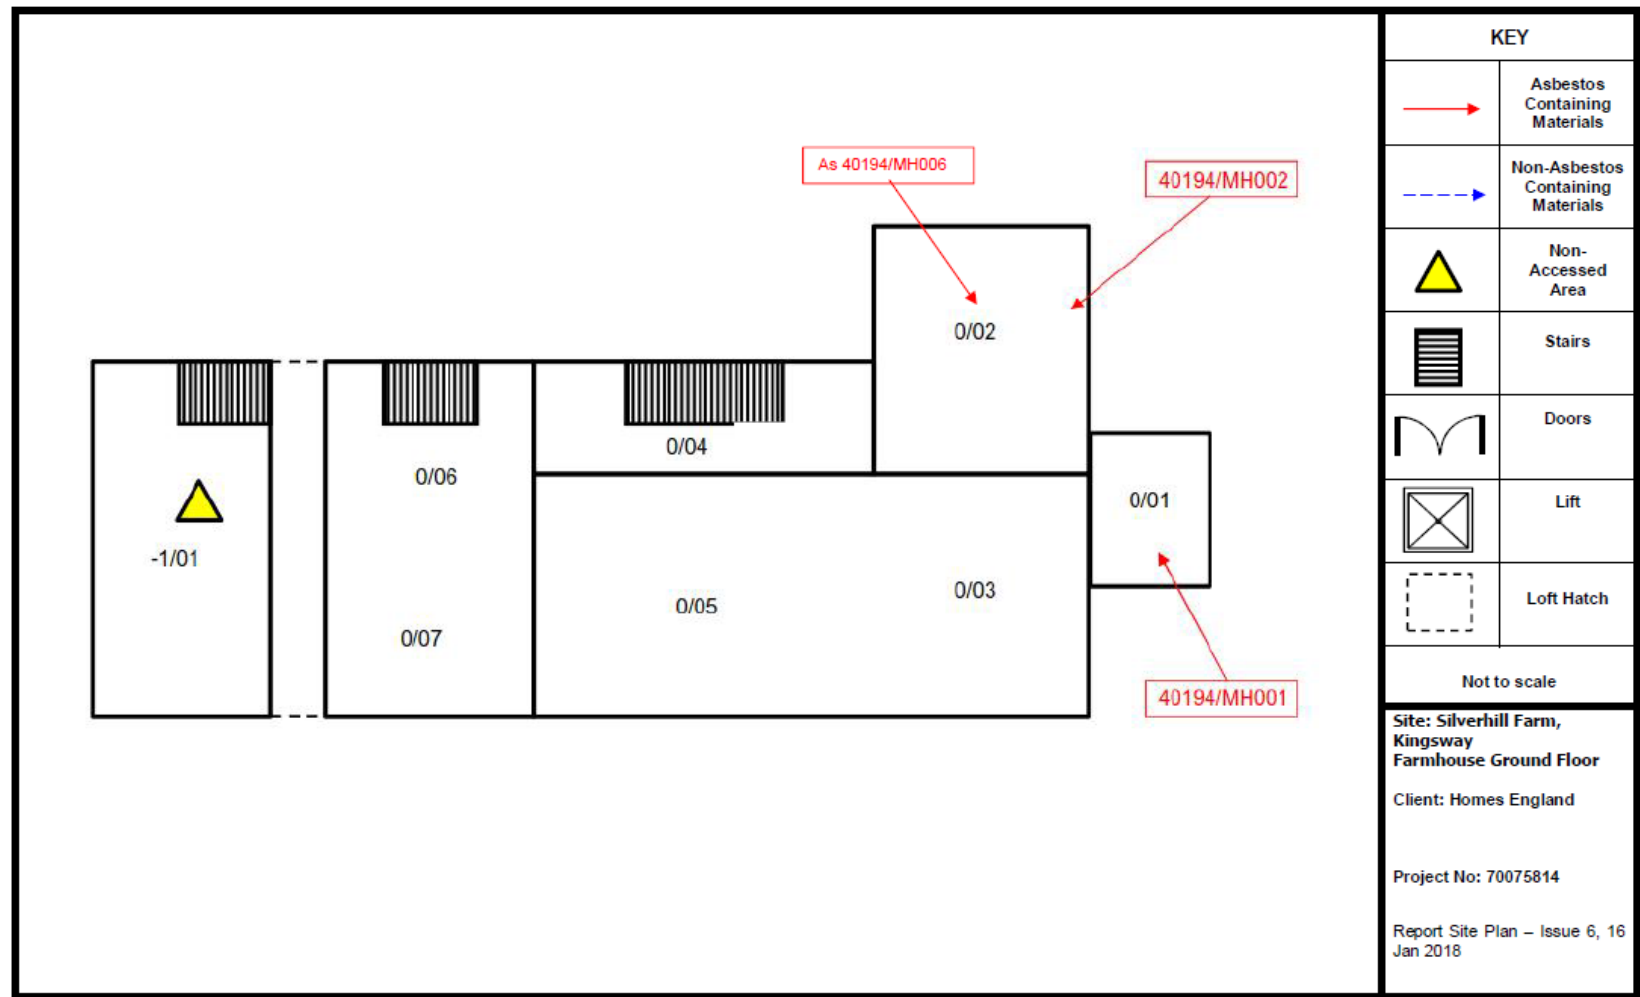
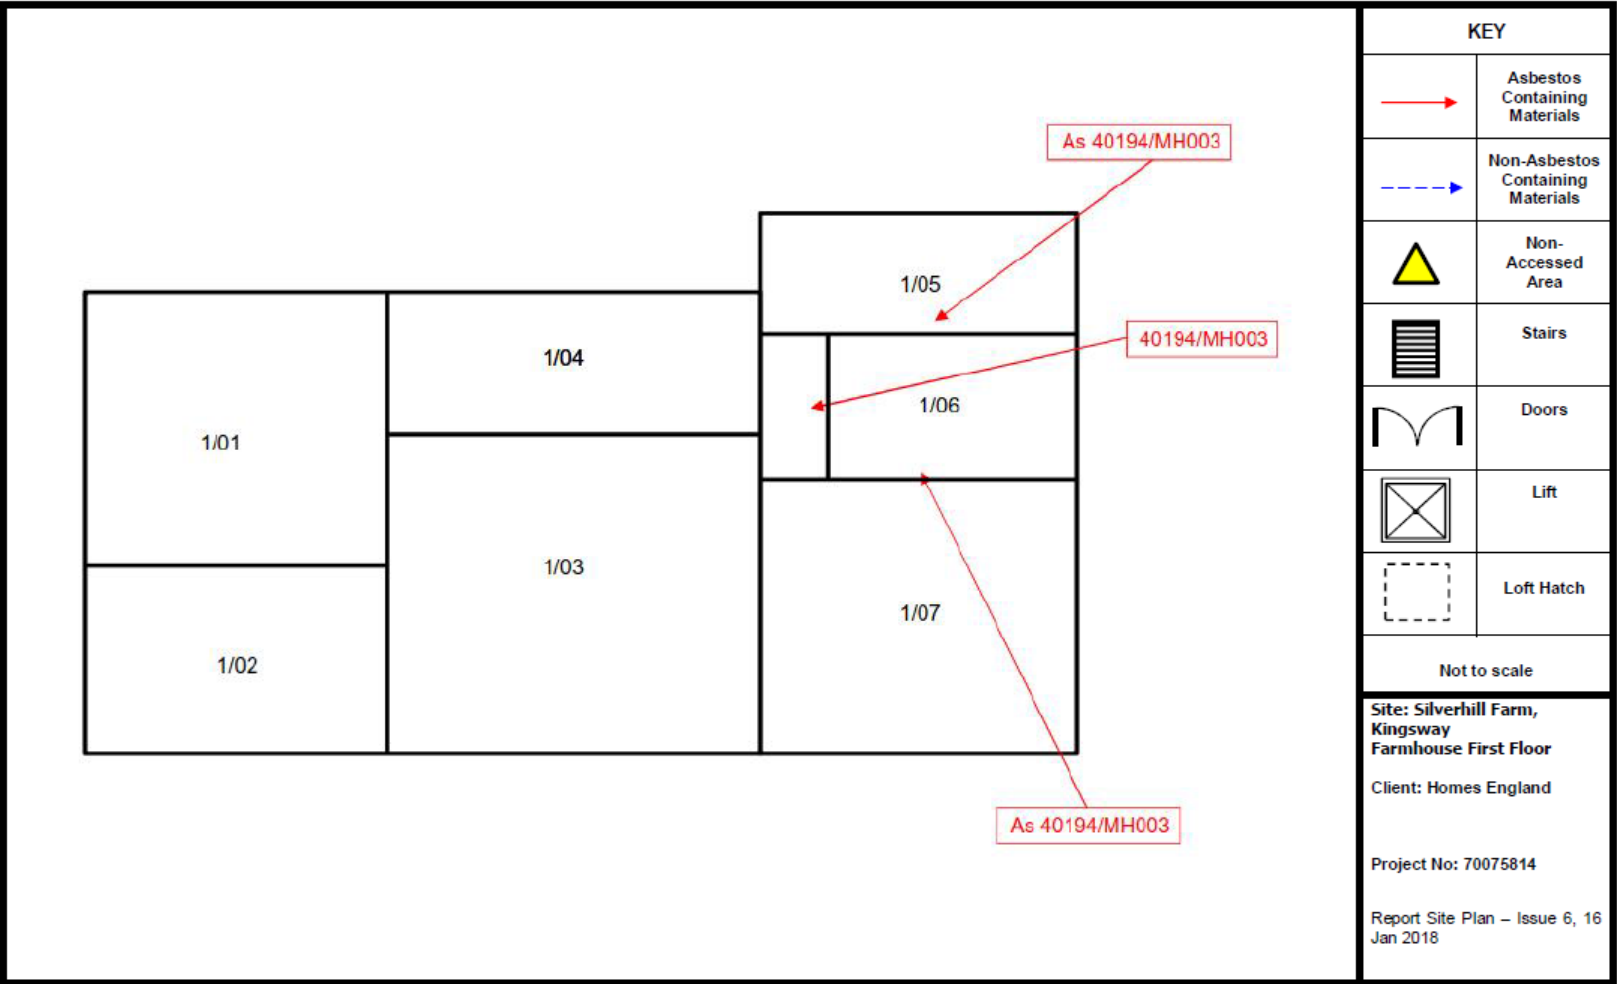
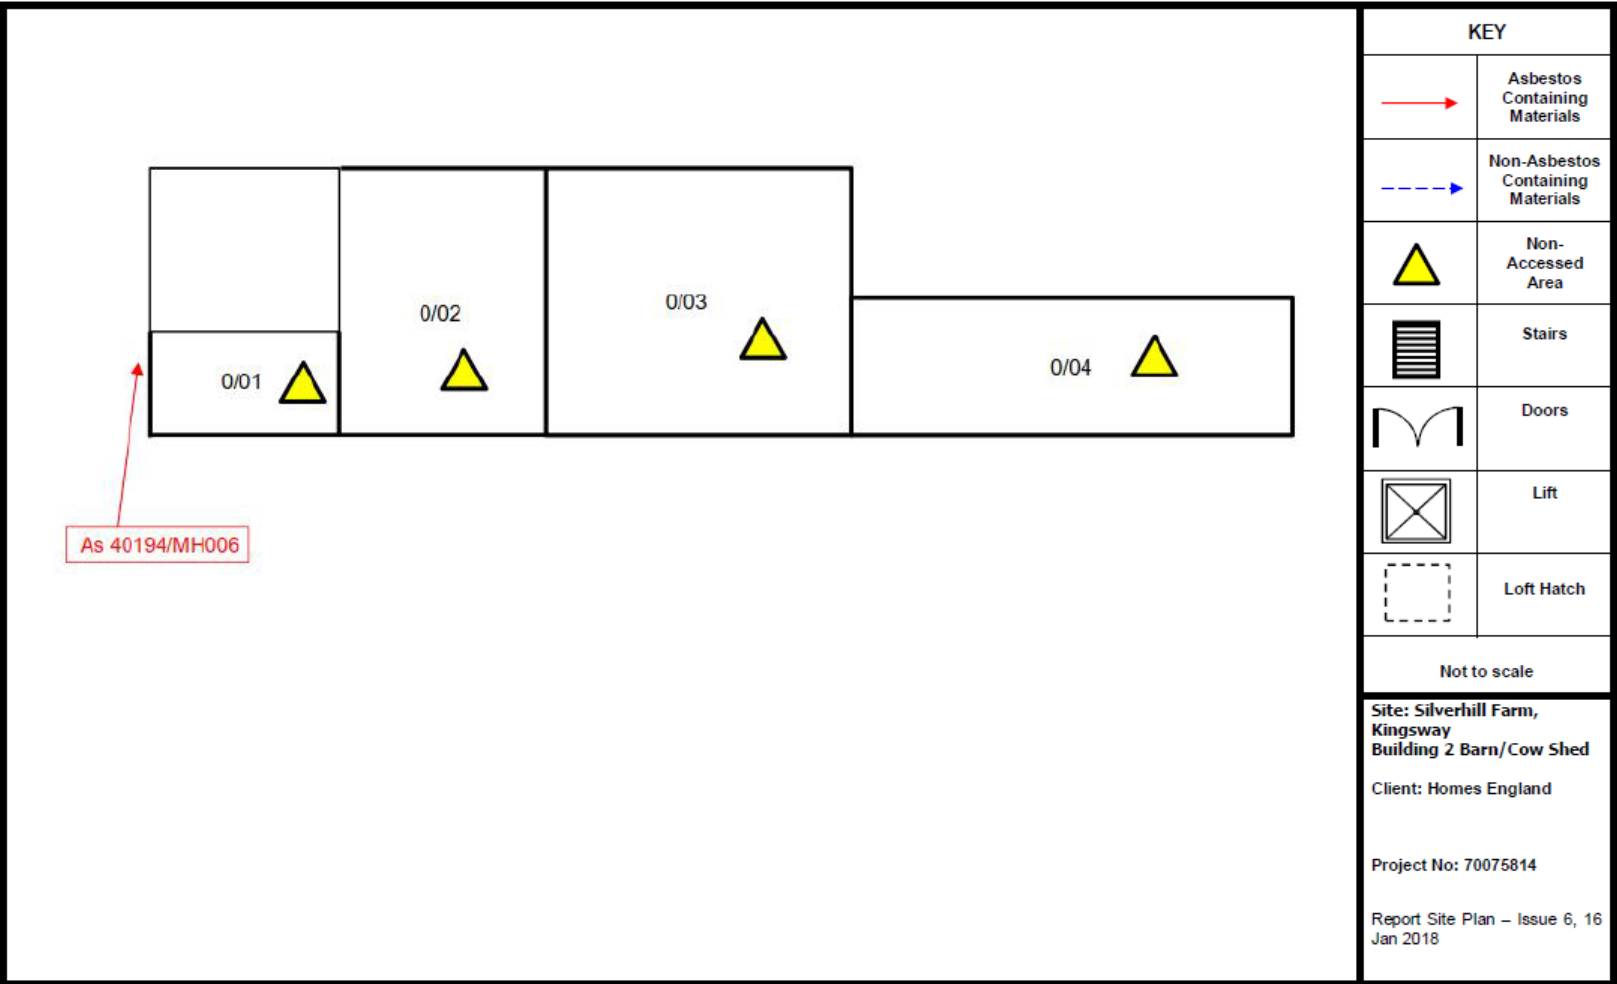
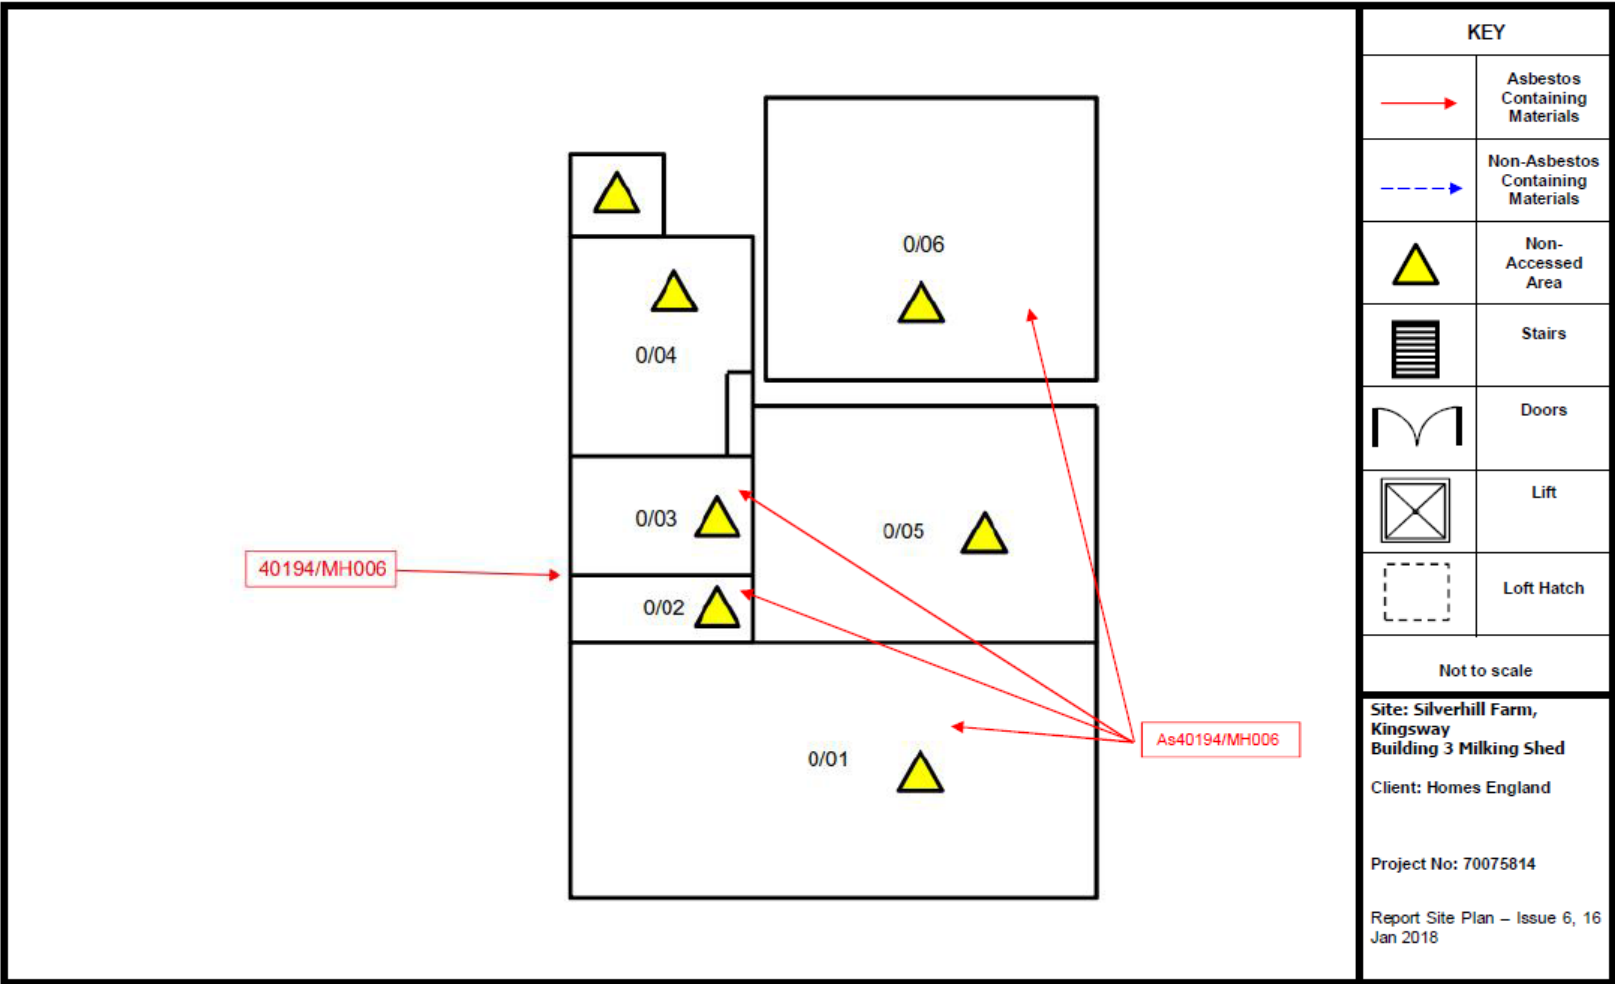
PART 4: ASBESTOS SURVEY INFORMATION  
Site Plans

NB. The project number has been omitted from the sample reference number(s) to increase drawing space.  
70075814 – Silverhill Farm
