## **WORMS EYE**

**RAMSDEN FARM, ROUNDTORN ROAD, MIDDLETON, M24 1FT – Phase 2**  
**COAL MINING RISK ASSESSMENT – Amended 10/11/24**

A residential development is proposed. Worms Eye have been commissioned to prepare a Desk Top Coal Mining Risk Assessment in order to assess the impact of coal mining on the site.

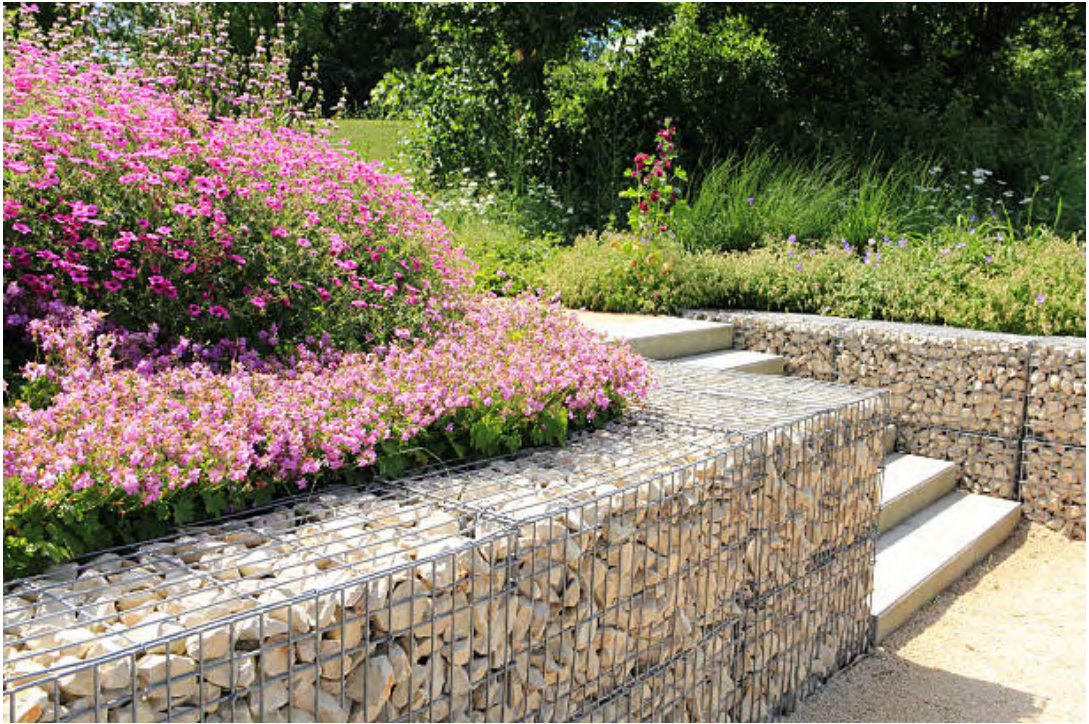
1M high gabion basket retaining walls

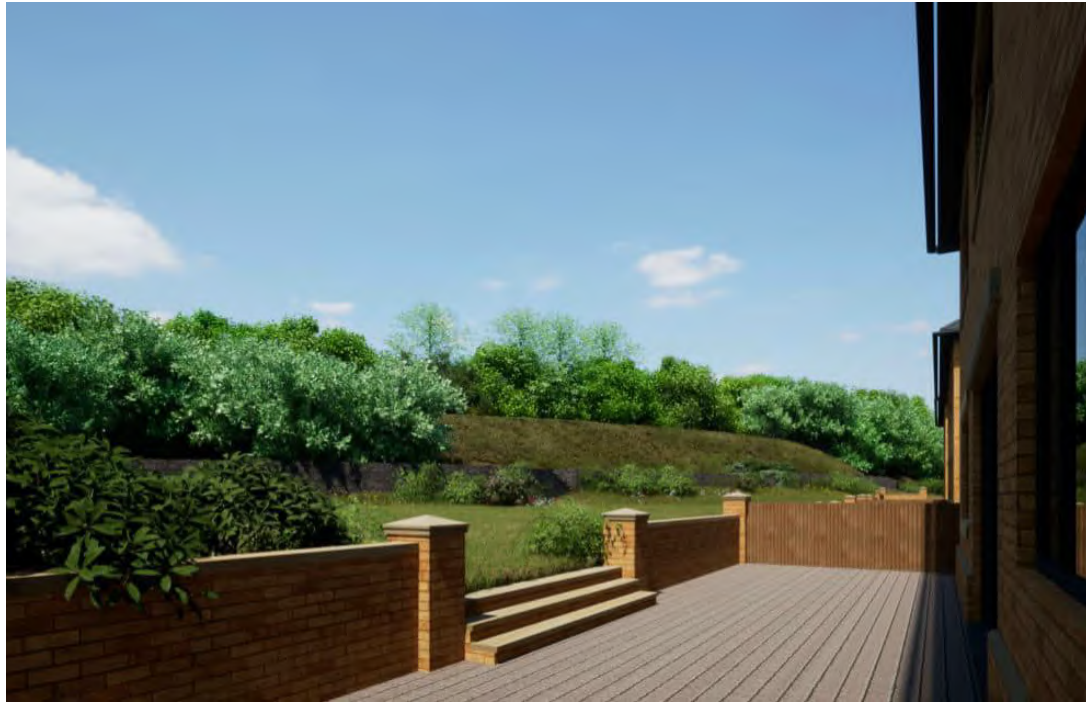
Patio and garden walls in facing bricks with stone copings to match the houses.

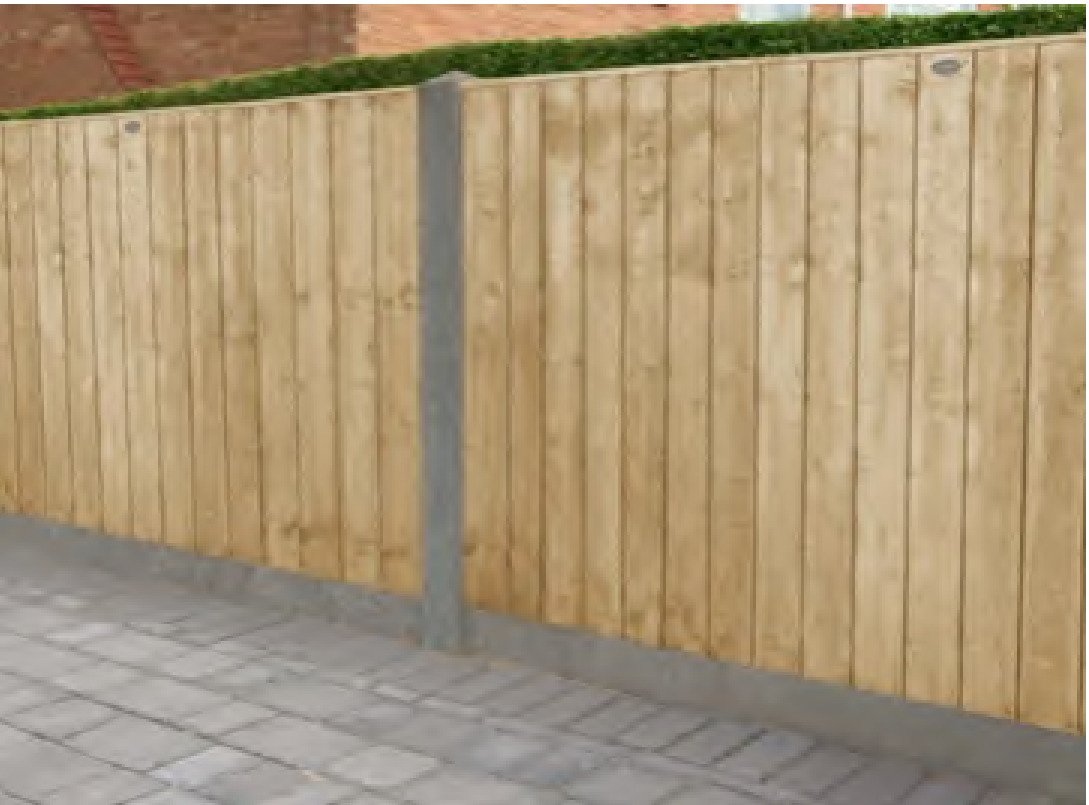
1.8m high close boarded timber fence to match the existing boundary fences to Plots 1-4

Shown here with Marshalls Tegula Paving
