# HERITAGE STATEMENT

Client: Hopwood Hall College  
Project: Conversion of Former Chapel  
Reference: HCO-SEV-XX-XX-RP-A-09100  
Date: February | 2024

| DOCUMENT TITLE | HERITAGE STATEMENT-ENABLING WORKS |

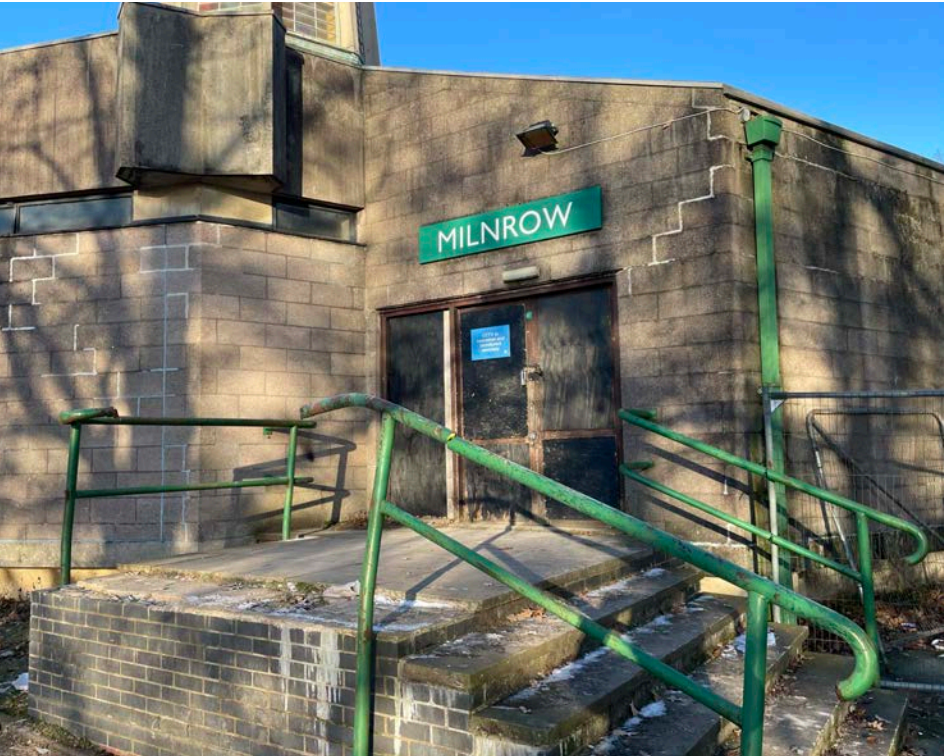
6 Steps into one of two mirroring main entrances.

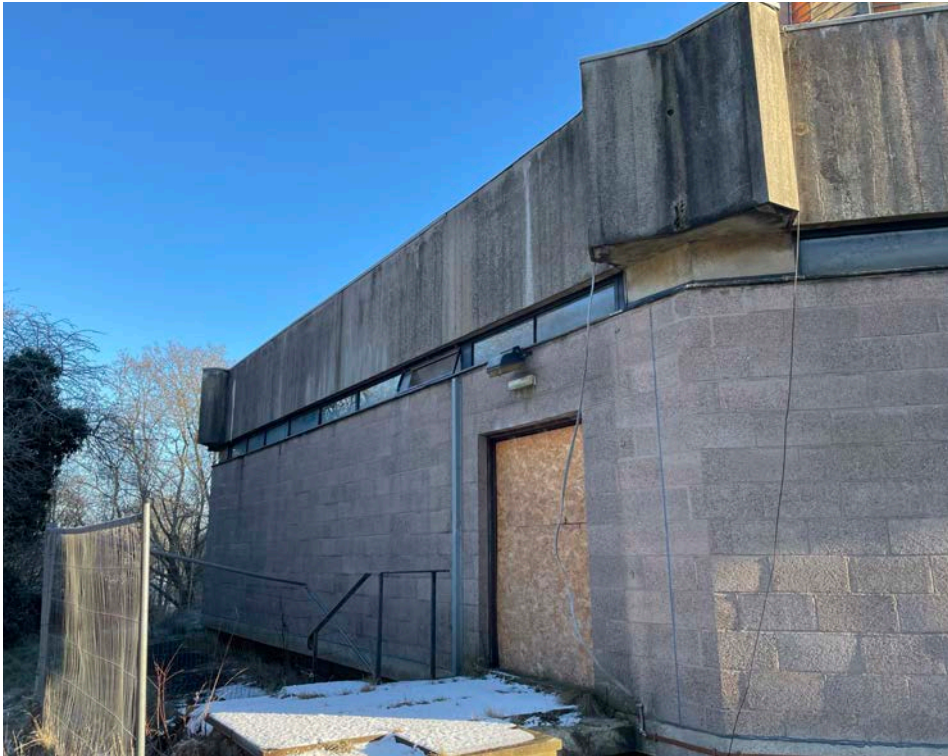
8 View looking at the existing rear access to the building.

To the south of the site there is an existing road which takes you to a small parking area. A footpath follows around the full external envelope of the building, although this is in a poor state and has been partially blocked by overgrown vegetation. External access from the rear fire escape is via a set of flying concrete landing and steps with metal handrails to the perimeter.

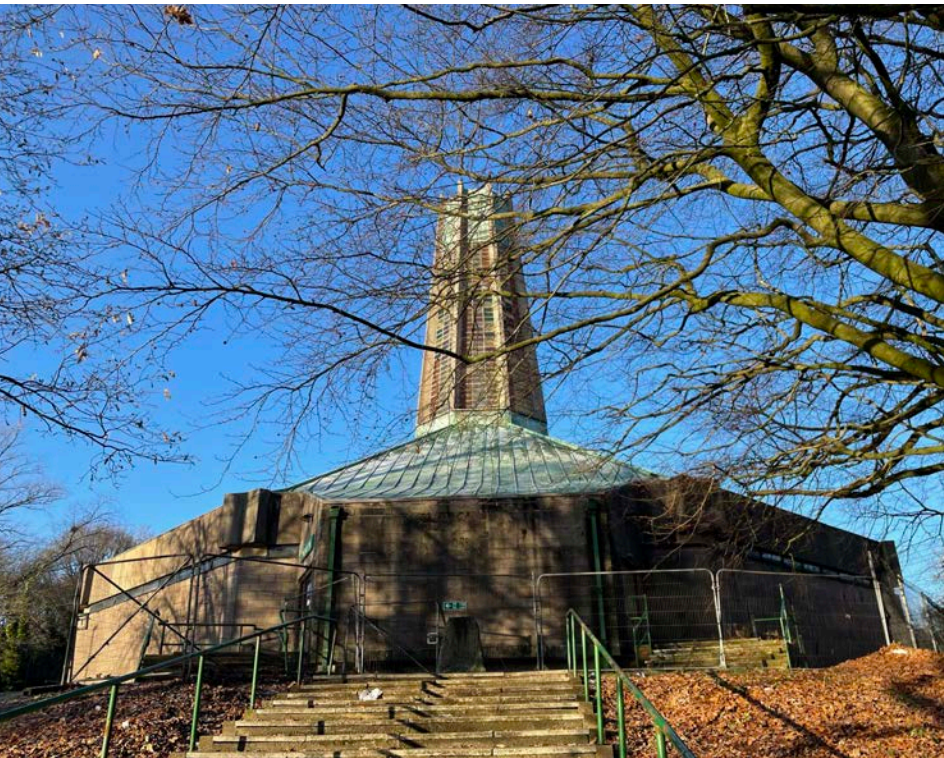
9 View from the existing stepped access up the hill towards the building from the South-West

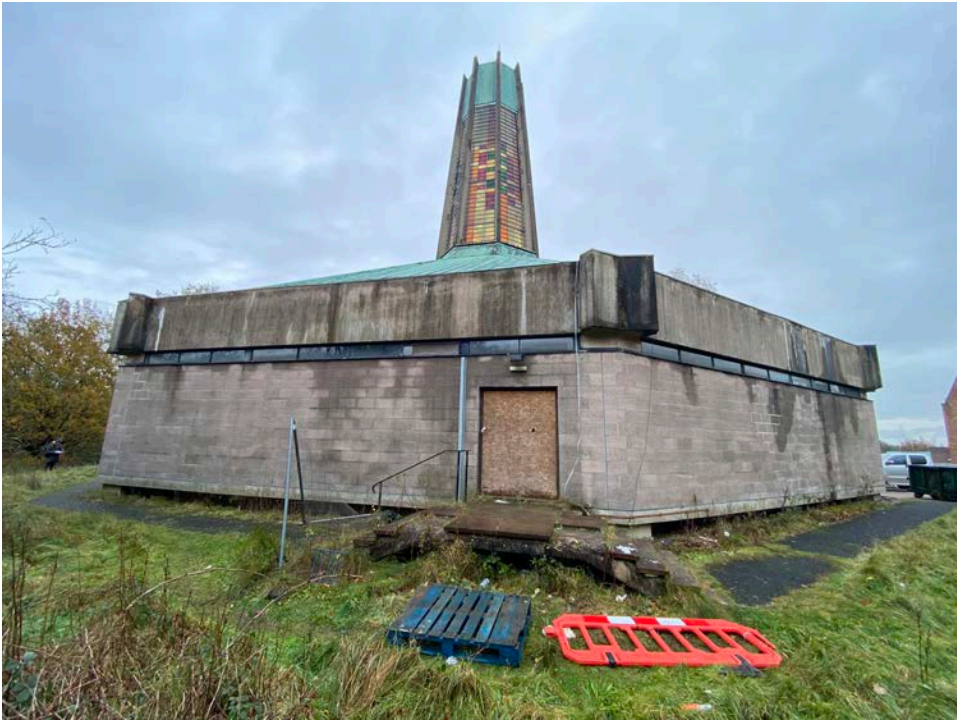
REAR FACADE SHOWING AREAS OF DAMAGED CONCRETE

- Formation of a series of 20mm diameter holes in concrete frame externally to allow for testing / investigative works. Holes are to be made good following works using suitable waterproof concrete / repair mortar to match appearance of existing concrete.
- Localised removal of small area of damaged flashing to allow inspection and testing of concrete frame behind (2no. locations). Flashing to be carefully reinstated following works to prevent water ingress.
- Localised removal of small area of damaged flashing to allow inspection and testing of concrete frame behind. Flashing to be carefully reinstated following works to prevent water ingress.

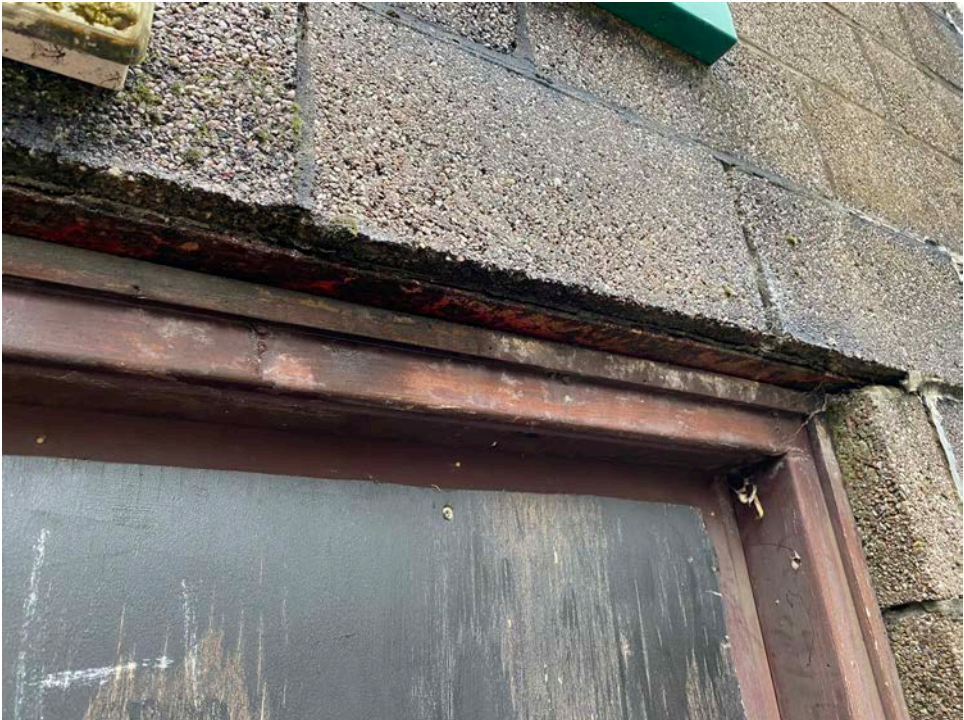
CORRODED LINTEL ABOVE MAIN ENTRANCE DOORS

- Careful removal of complete block from the wall above existing lintel to main entrance doors to allow investigation of poor condition lintel and surrounding wall. Blockwork is to be carefully reinstated following works and re-pointed using mortar to match original colour, texture and composition.

| Element | Proposal | Impact / Mitigation |
|---|---|---|
| External Concrete Blockwork Walls | Careful removal of complete block from the wall above existing lintel to main entrance doors to allow investigation of poor condition lintel and surrounding wall. Blockwork is to be carefully reinstated following works and re-pointed using mortar to match original colour, texture and composition. | Block to be removed in area currently in poor condition owing to water ingress in order to minimise impact on historic fabric. Work considered necessary to allow for the future repair of the historic building fabric and so is considered to have a NEUTRAL IMPACT. |

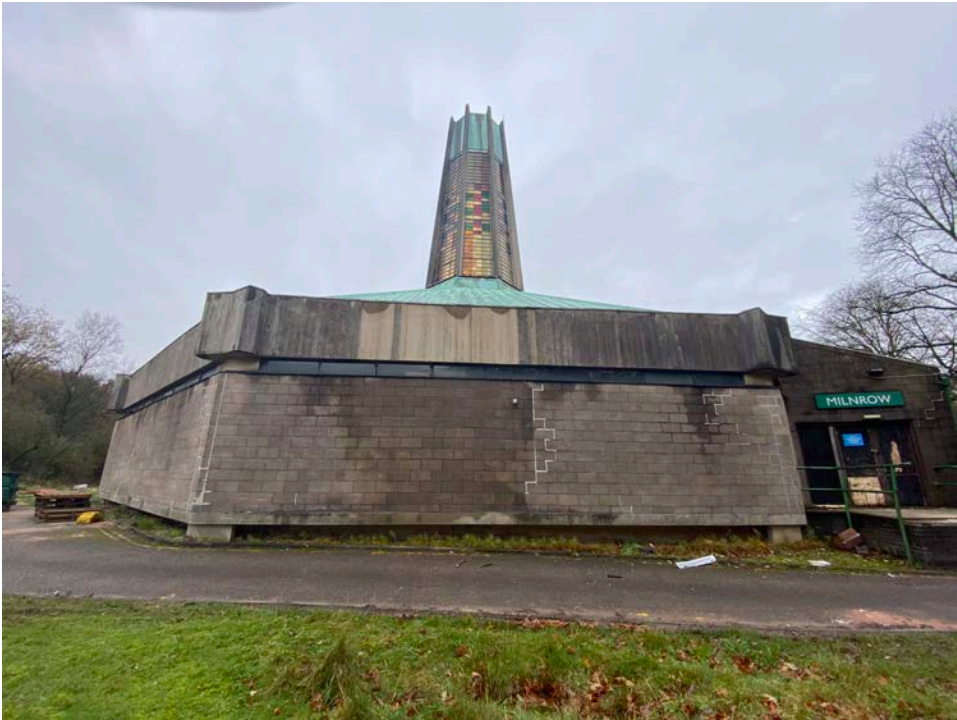
FACADE SHOWING AREAS OF STAINING AND LATER INAPPROPRIATE POINTING

- Careful removal of small area of original mortar to allow sampling to inform specification of matching mortar composition and colour for future re-pointing works. Area is to be re-pointed following works using mortar to match original colour, texture and composition.

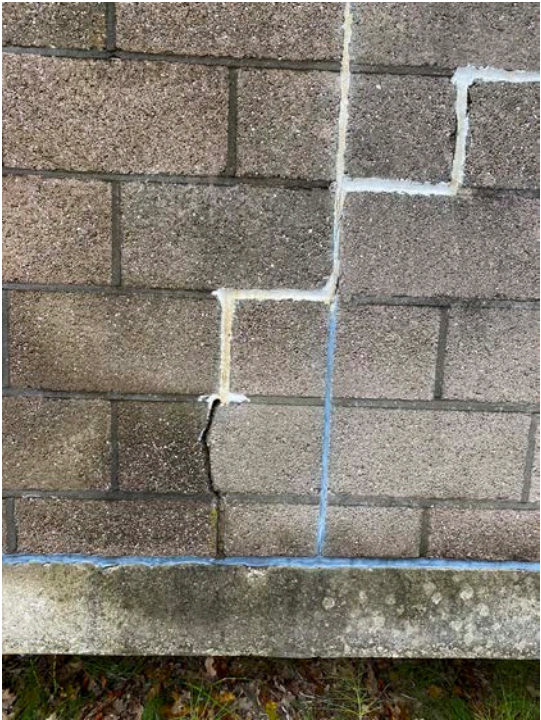
AREA OF INAPPROPRIATE POINTING

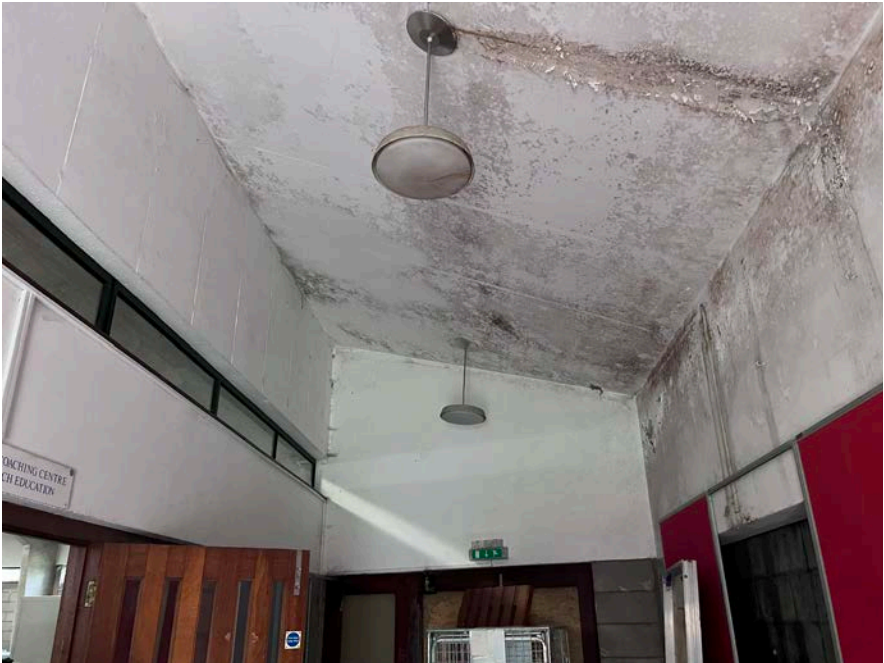
WATER DAMAGED CEILING TO NARTHEX

- Removal of water damaged ceiling to allow investigative works behind and to allow for drying out of historic building fabric

| Ceiling to Narthex | Removal of water damaged ceiling to allow investigative works behind and to allow for drying out of historic building fabric | Ceiling currently in poor condition and is considered to be of low significance. Work considered necessary to allow the future repair of the historic building fabric and is considered to have a NEUTRAL impact. |

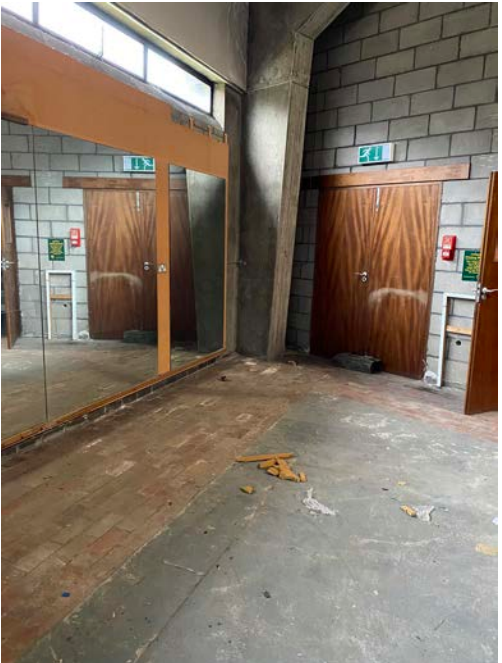
LOCATION FOR CORE HOLES THROUGH GF SLAB
