## Piling Risk Assessment

Proposed Commercial Development

Rhodes Business Park, Middleton

Document no.: STV6211-R04-Rev\_A

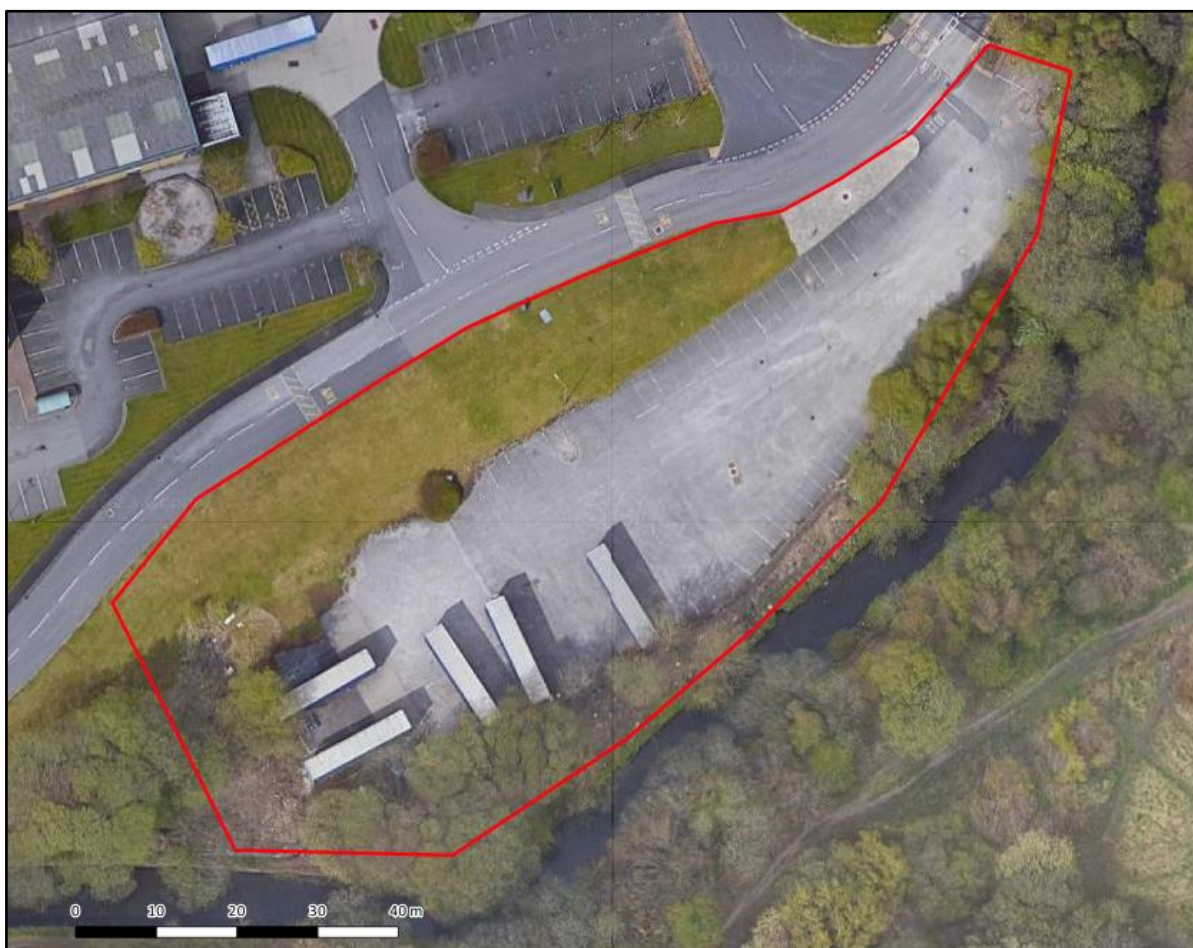
Figure 2-A: Aerial photograph and approximate site boundary

- 2.1.1 The site lies within Middleton, approximately 1.15km southwest of the town centre. The site is accessed from Silburn Way which lies adjacent to the site's north-western boundary.
- 2.1.2 The approximate postcode for the site is M24 4NE. The site currently comprises a lorry trailer parking area with surrounding soft landscaping, and an aerial site plan is presented below.
- 2.1.3 Commercial/light industrial units associated with the wider Rhodes Business Park are present beyond the northern and western boundaries of the site and include a natural stone supplier, a homeware store, and a boiler supplier. To the south and east is Alkrington Woods Nature Reserve beyond the River Irk, the channel of which forms the south-eastern boundary of the site.
