## Impact Statement

Project: Hopwood Hall,

| DOCUMENT TITLE | Design, Access and Heritage Impact Statement |

This Statement has been prepared by Seven Architecture on behalf of Rochdale Borough Council to support a listed building application for the fabric repairs relating to Hopwood Hall in Middleton. The Hall was historically an ancestral country home and is now redundant after becoming surplus to requirements by the training college that now surrounds it. The proposal looks to undertake emergency remedial fabric repairs to the roof, gutters, chimneys and elevations towards the south-east and south-west of the building, structural stabilisation works in the west wing while also creating welfare facilities within the building. This work is to be undertaken as a part of the ongoing restoration of the Hall. Phase 1 of the remedial works were concluded 2019/2020 by Buttress Architects and references to their Heritage Statement are made within this document.

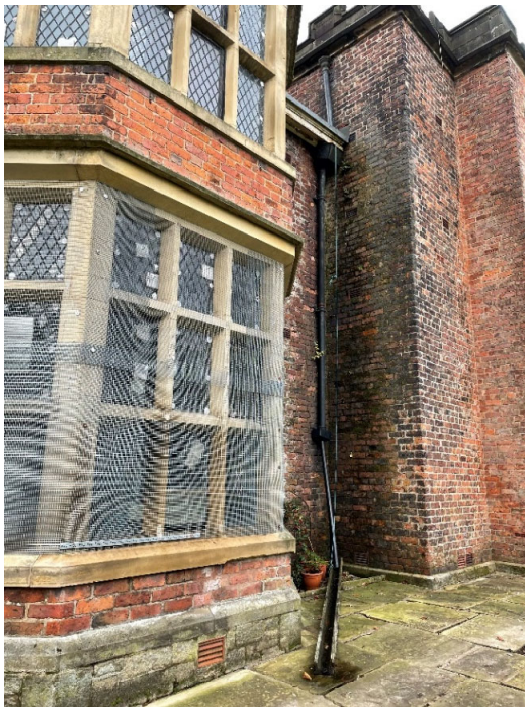
**Figure 02** Rainwater pipe failure affecting the brickwork to the south-east of the Hall.

Due to budget limitations not all the remedial works could be undertaken and as such some of the most historically important sections of the hall remain extremely vulnerable. Across the elevations there is widespread rainwater pipe failure including staining and algal growth to the external brickwork. Some areas of the brickwork have therefore deteriorated more than others due to water saturation. The inability to shed water effectively has led to the general decline of the structure. The lack of access to the roof has rendered maintenance troublesome and over time has also led to the deterioration of the elevations and chimney structures.

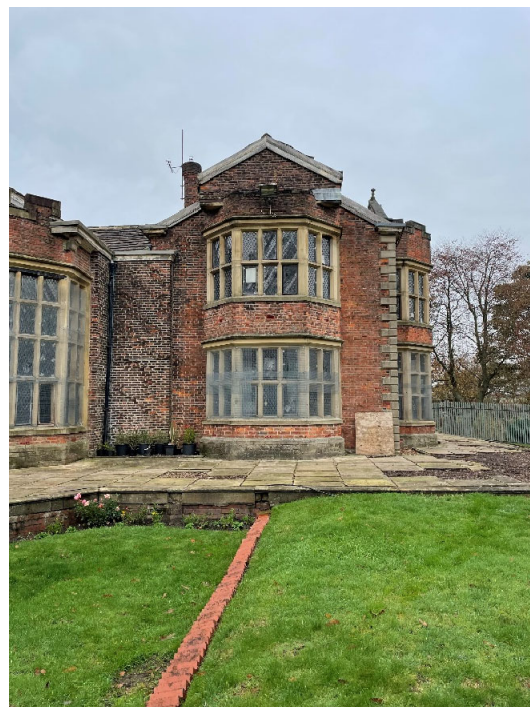
**Figure 03** Degradation to the roofs throughout.
