## Remediation Strategy

Proposed Commercial Development

Rhodes Business Park, Middleton

Document no.: STV6211-R03-Rev\_A

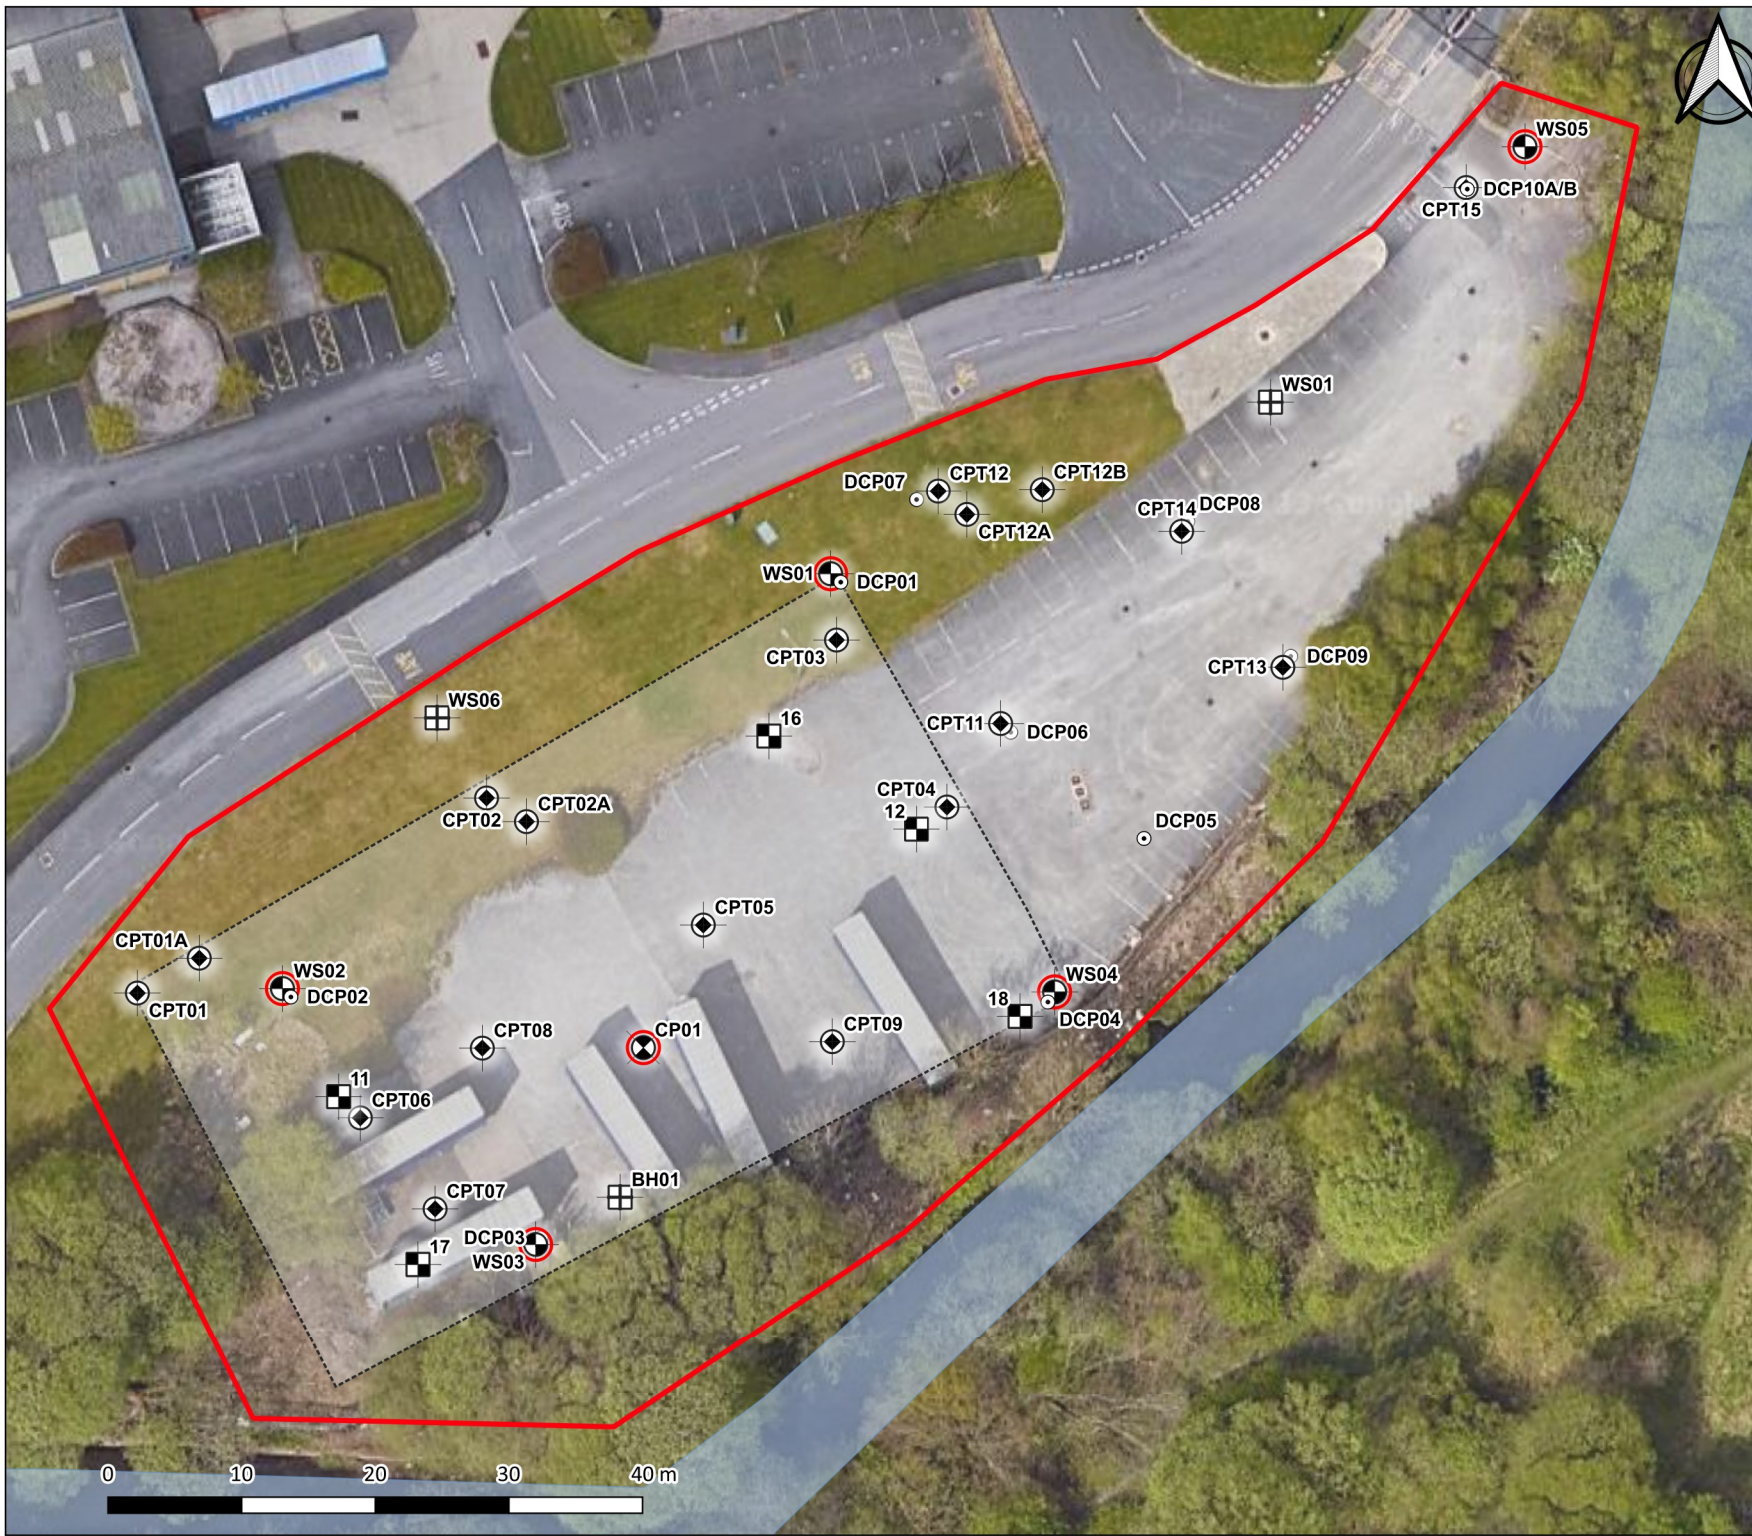
DRAWING No.  
STV6211-D01-A

TITLE  
Exploratory Hole Location Plan

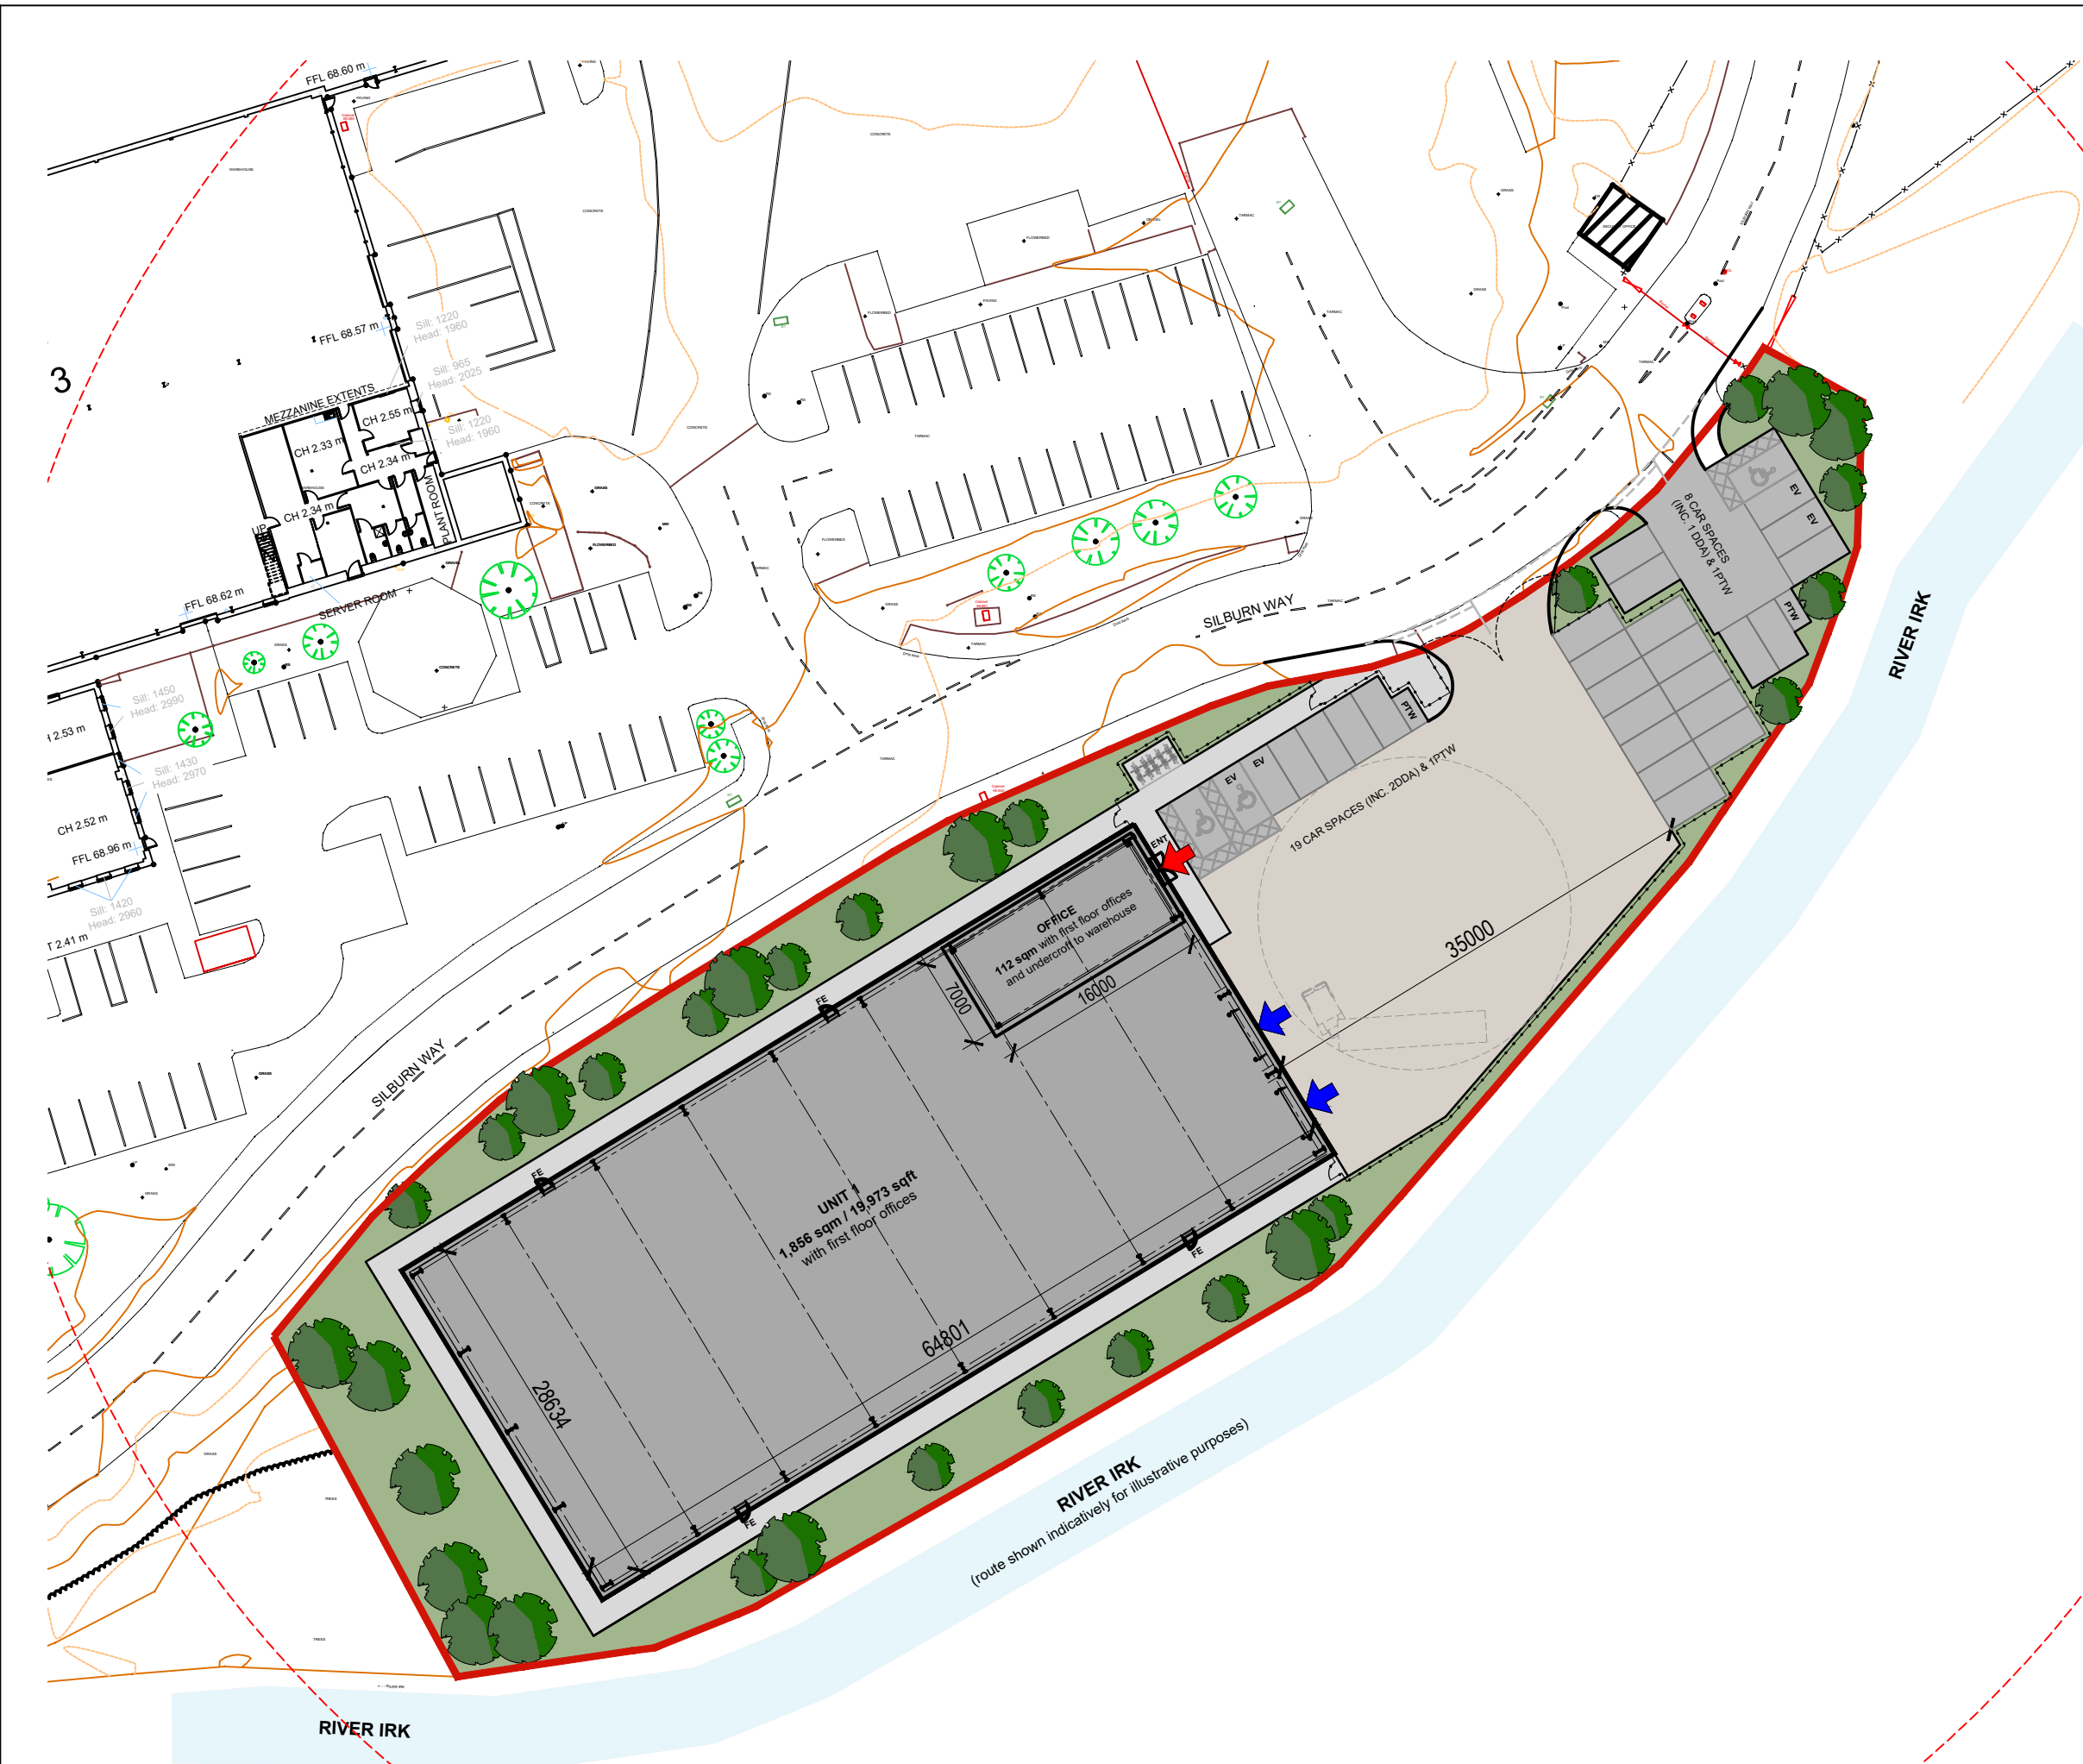
Red Line Boundary Area : 1.22 Acres / 0.4951 Hectares

Environmental Agency Information indicates the site is located within Flood Zone 3.

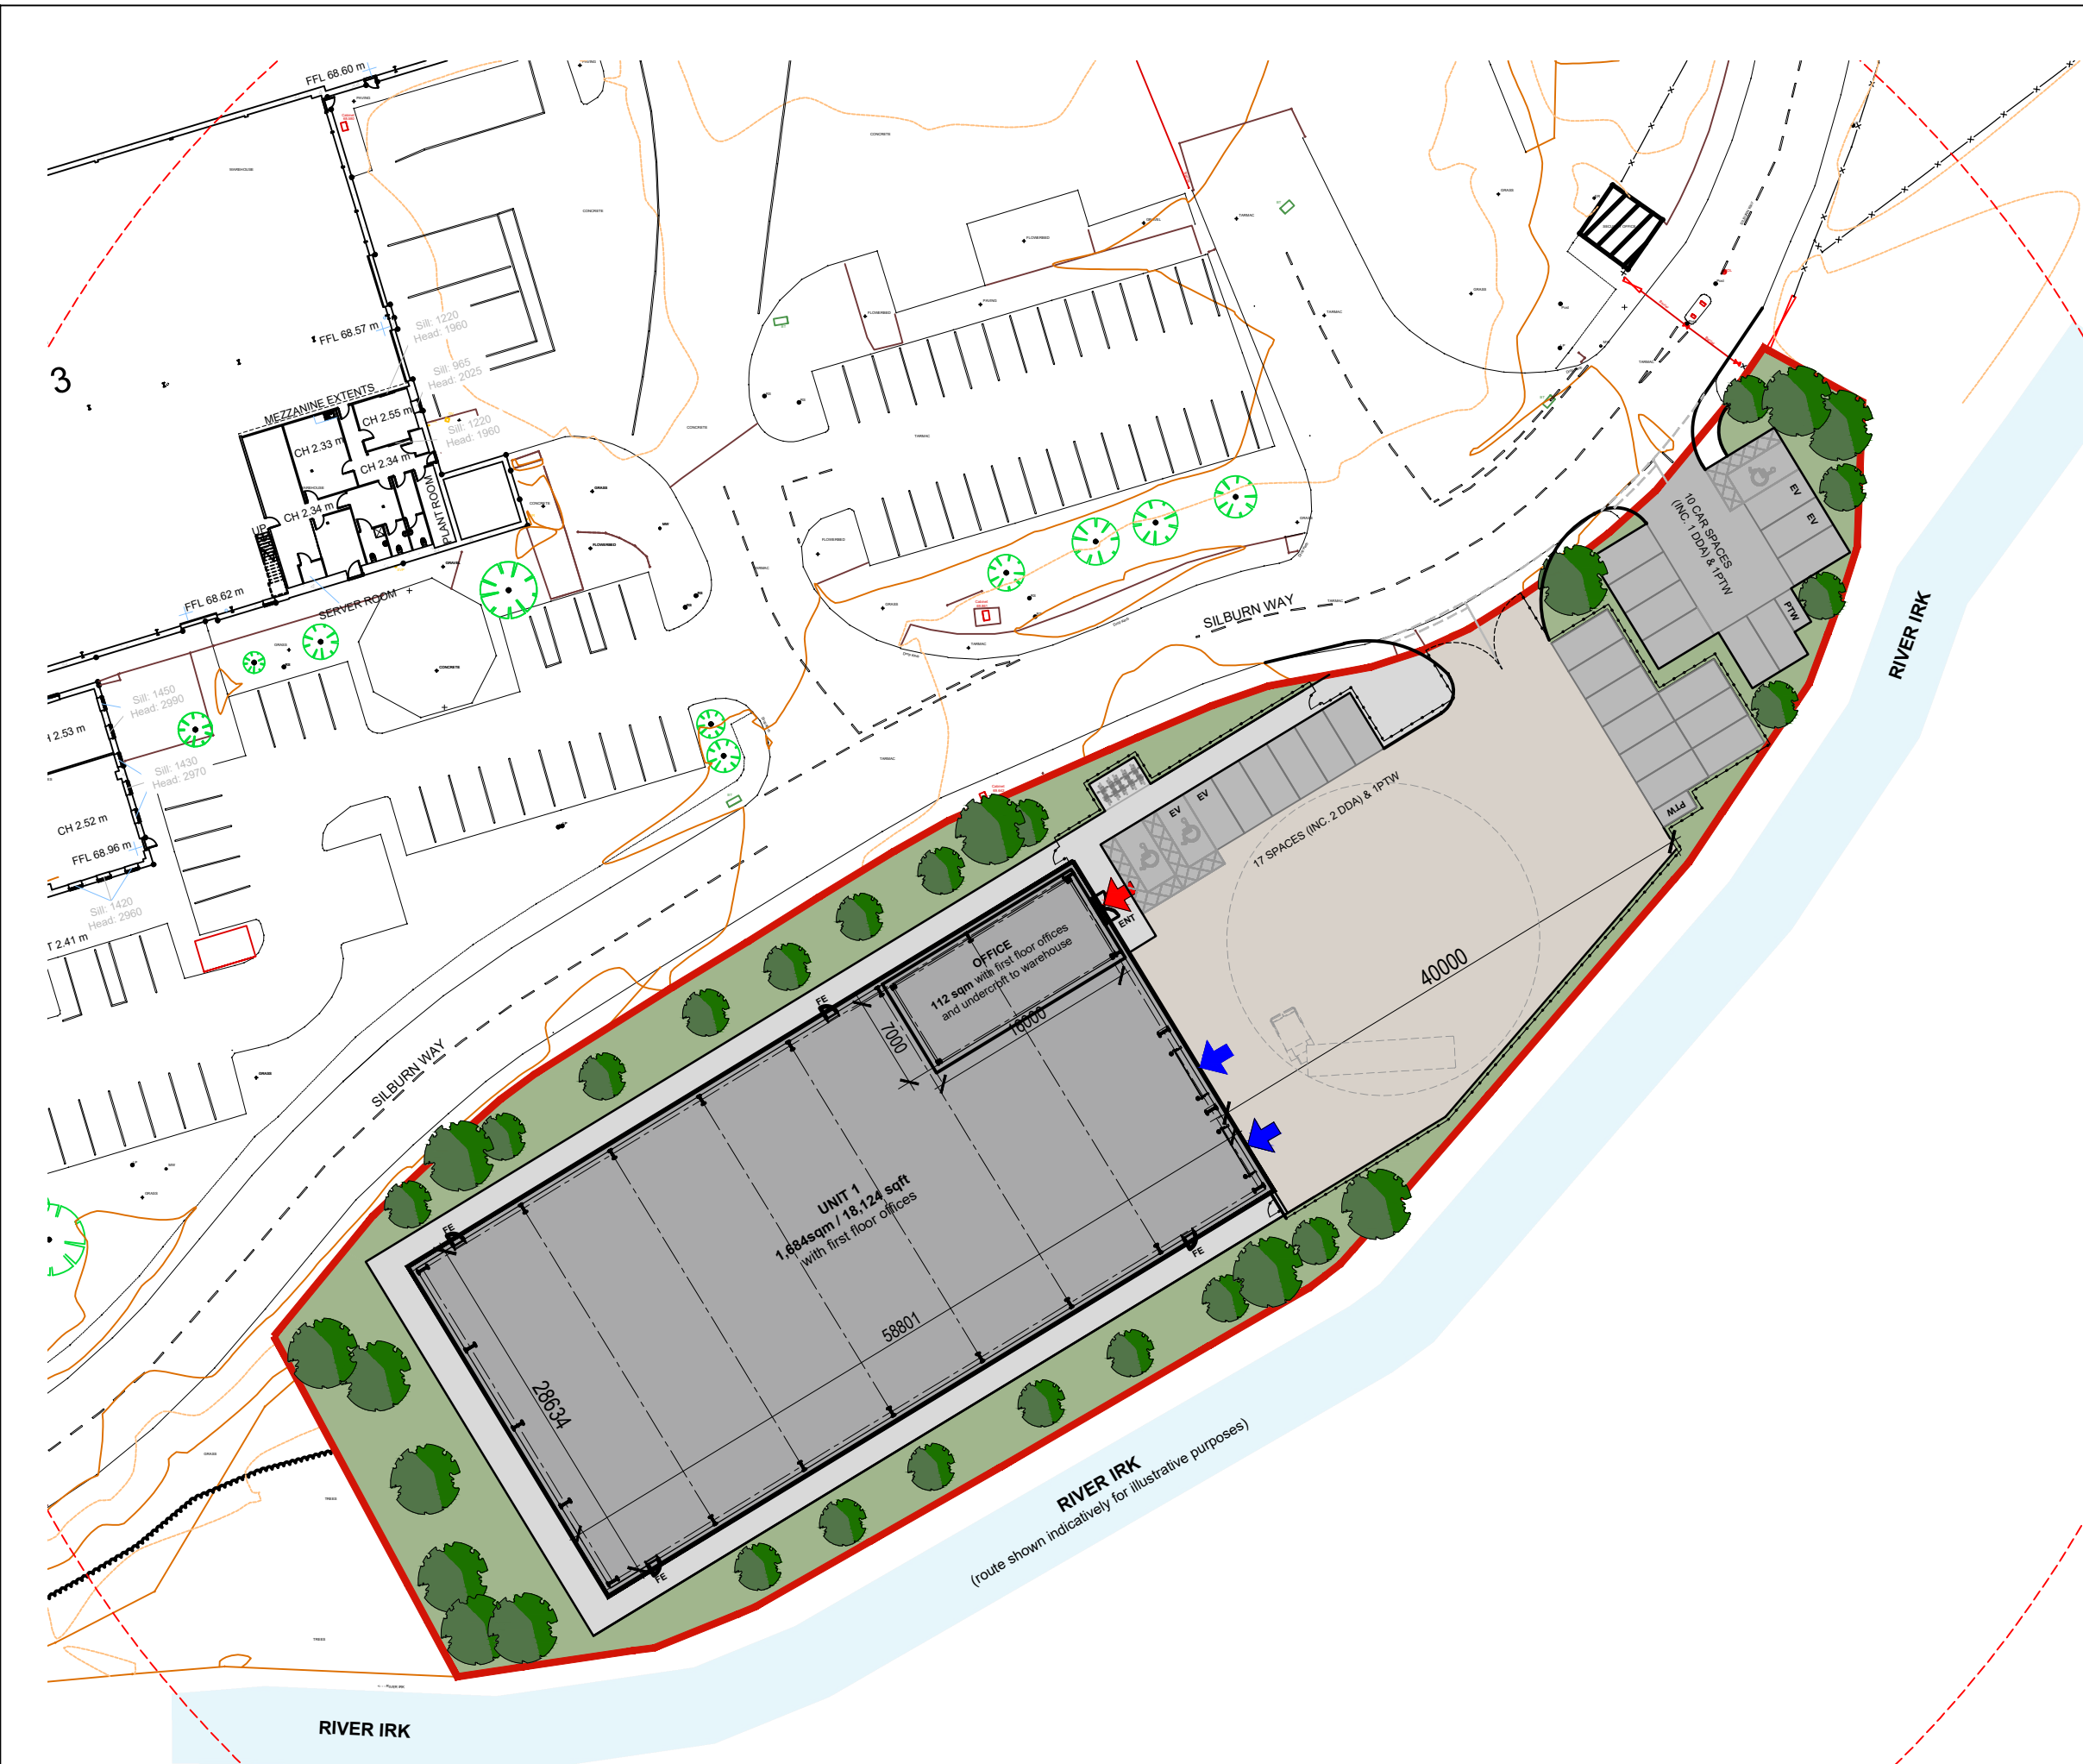
Red Line Boundary Area : 1.22 Acres / 0.4951 Hectares

Environmental Agency Information indicates the site is located within Flood Zone 3.
