# LITTLEBOROUGH FIRE STATION LITTLEBOROUGH

## DESK BASED COAL MINING RISK ASSESSMENT

Job Number: LKC 21 1310  
Date: July 2021  
Client: Bradshaw Gass & Hope LLP

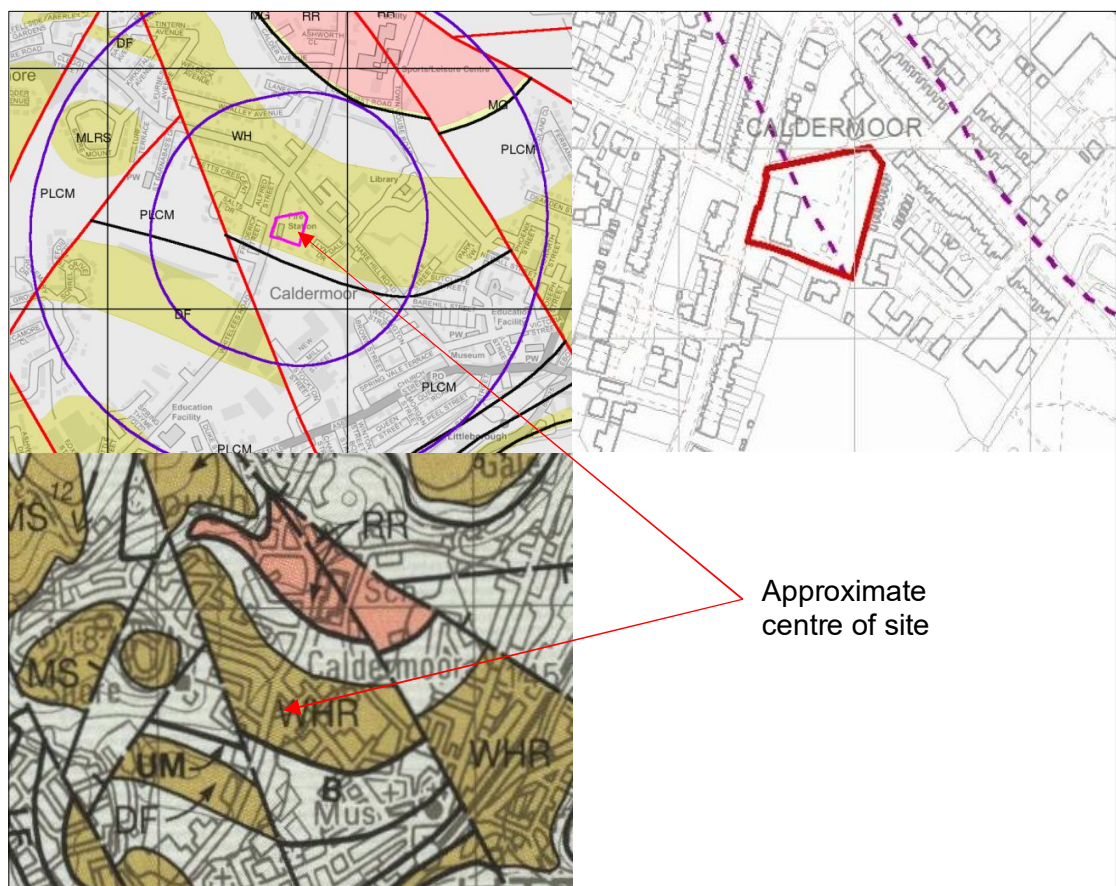
Extracts showing differences from geological mapping are shown on Plate 2-1.

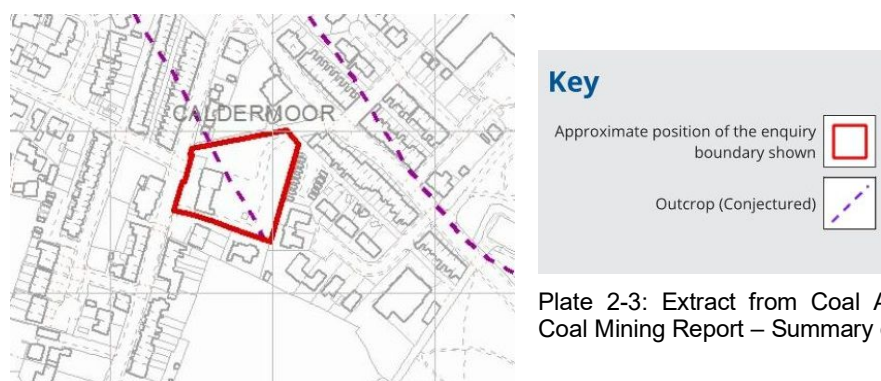
Plate 2-3: Extract from Coal Authority Consultants Coal Mining Report – Summary of Findings.

Plate 2-3 shows an extract of the plan provided with the Coal Authority Consultants Coal Mining Report.

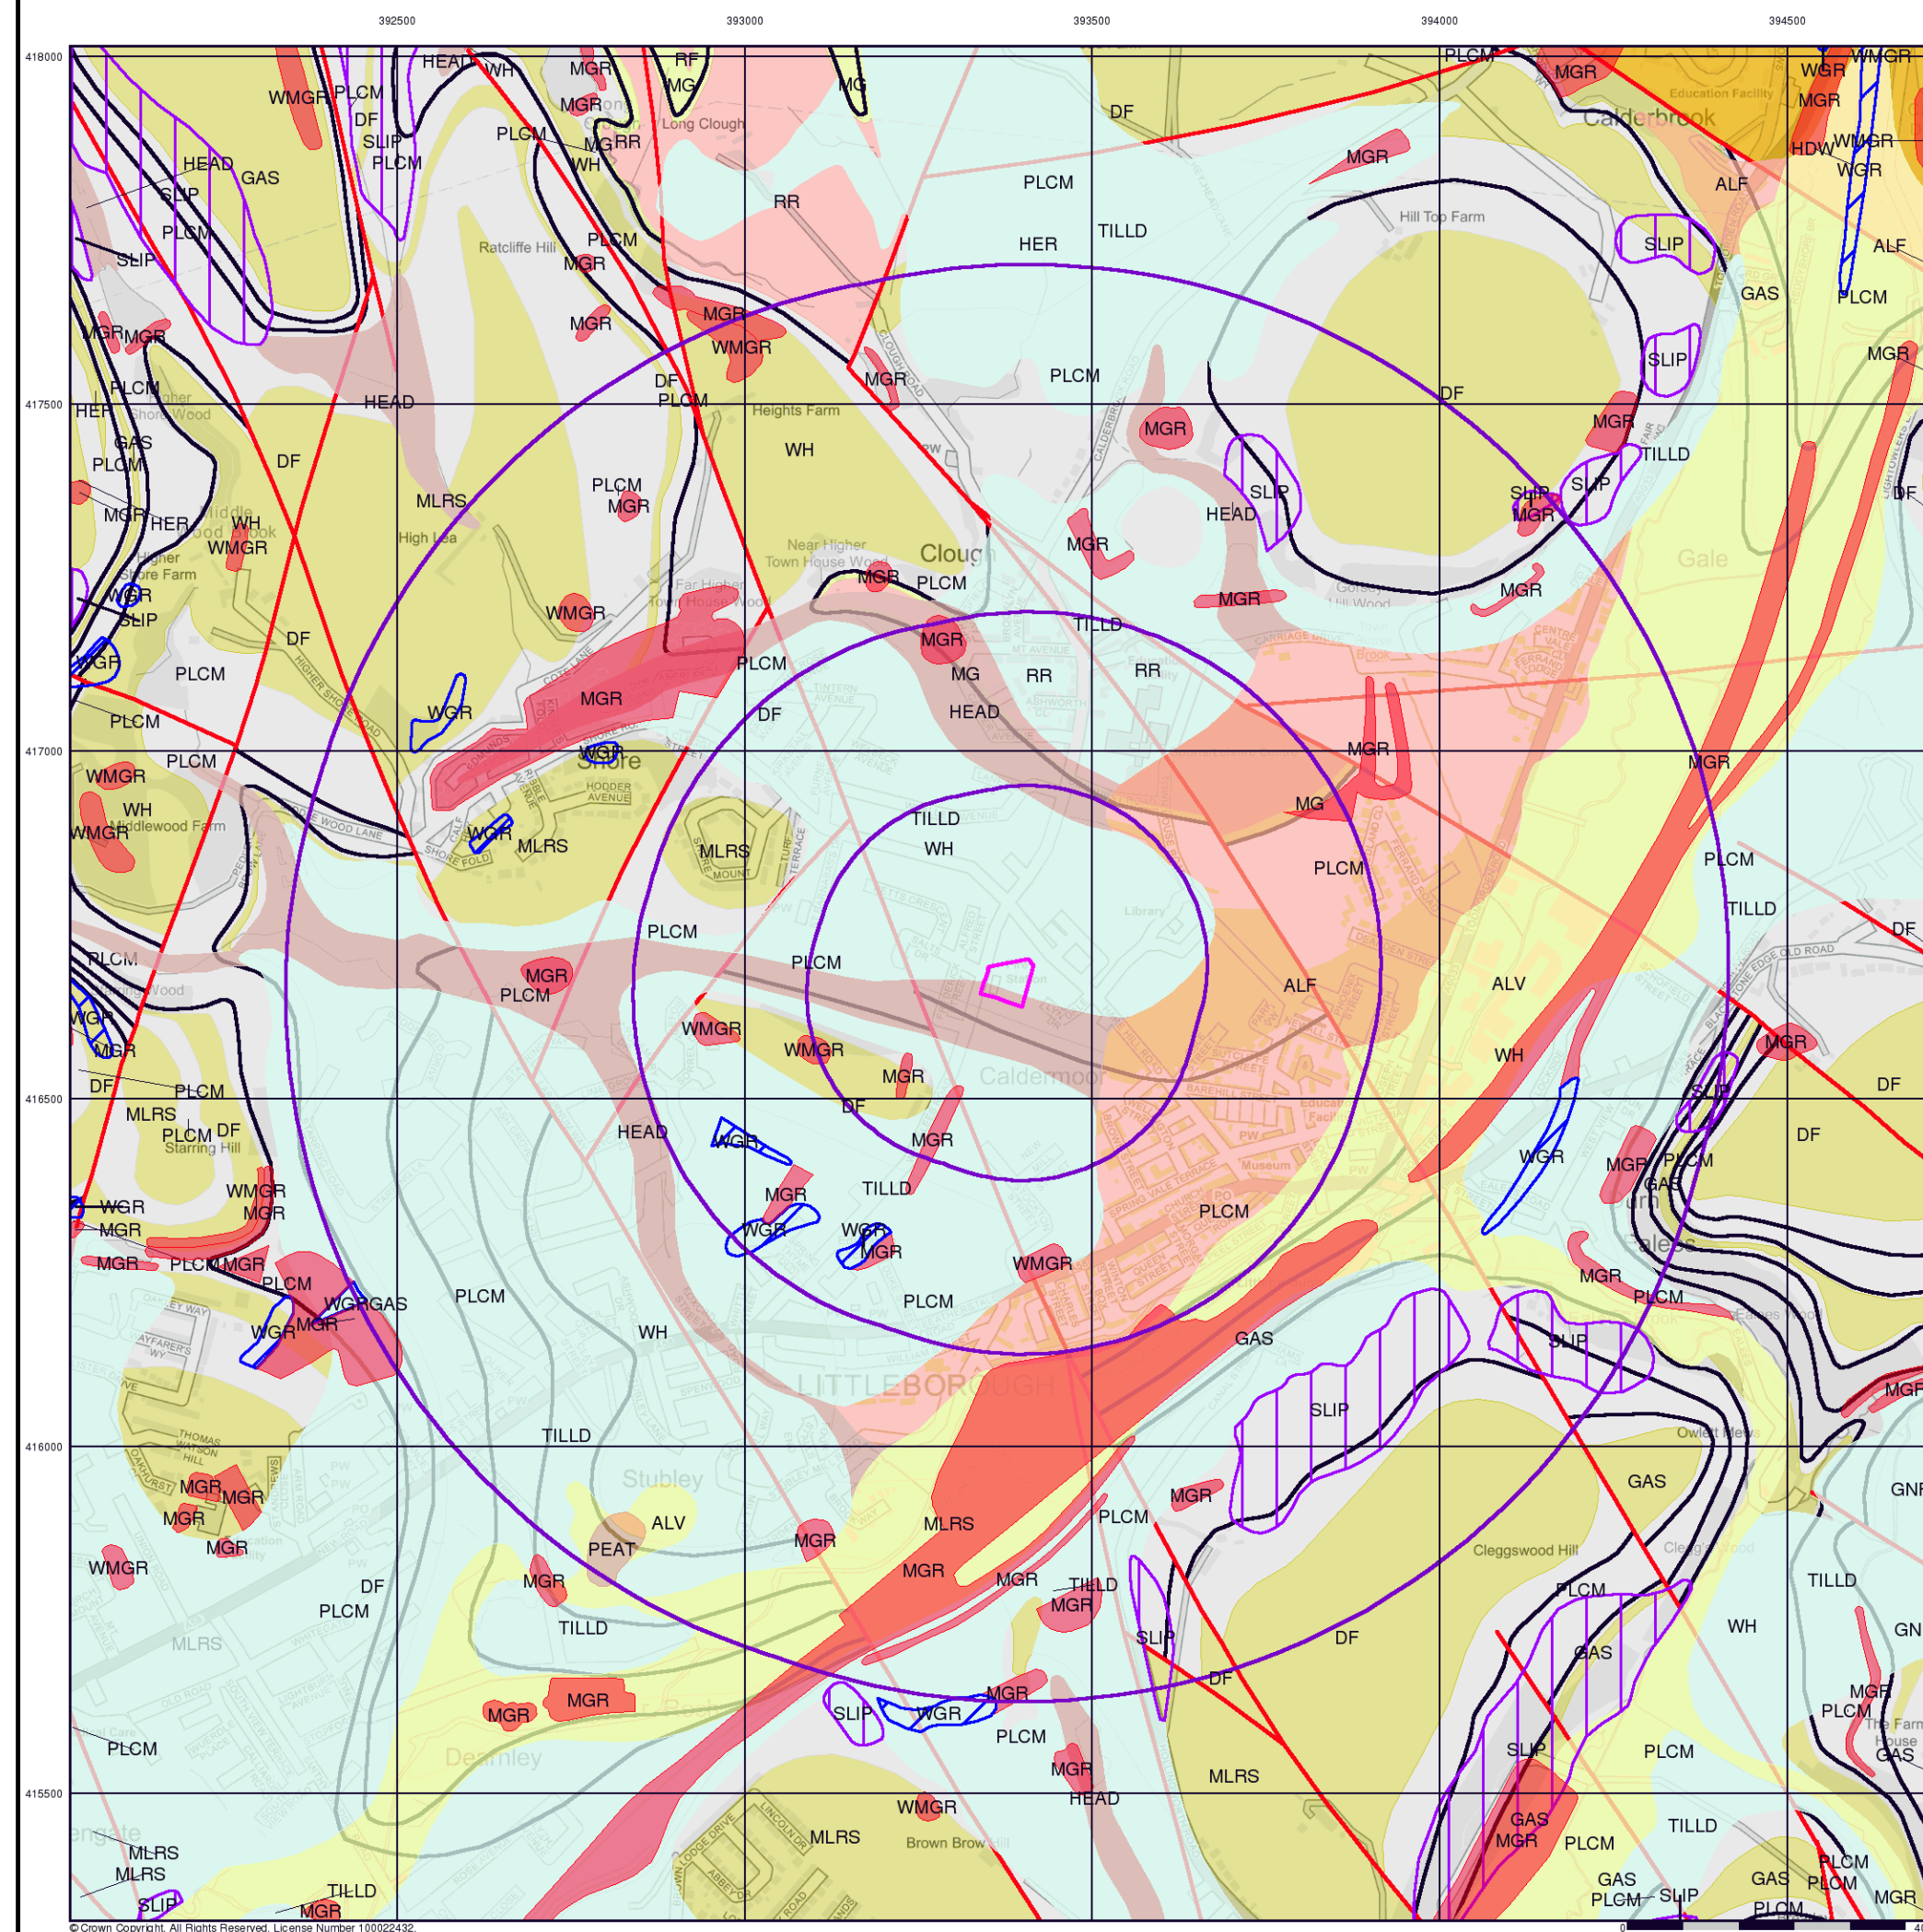
### Bedrock and Faults Map - Slice A

The BGS Faults and Rock Segments dataset includes geological faults and thin beds mapped as lines such as coal seams and mineral veins. These are not restricted by age and could relate to features of any of the 1:10,000 geology datasets.

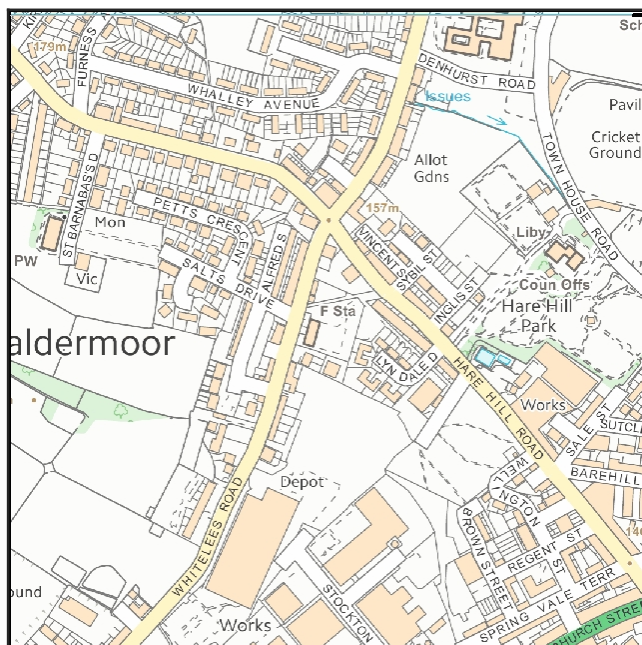
Approximate position of property
