## Remediation Strategy

Dobfield Road

Rochdale

**Report A5182/22/RMS**

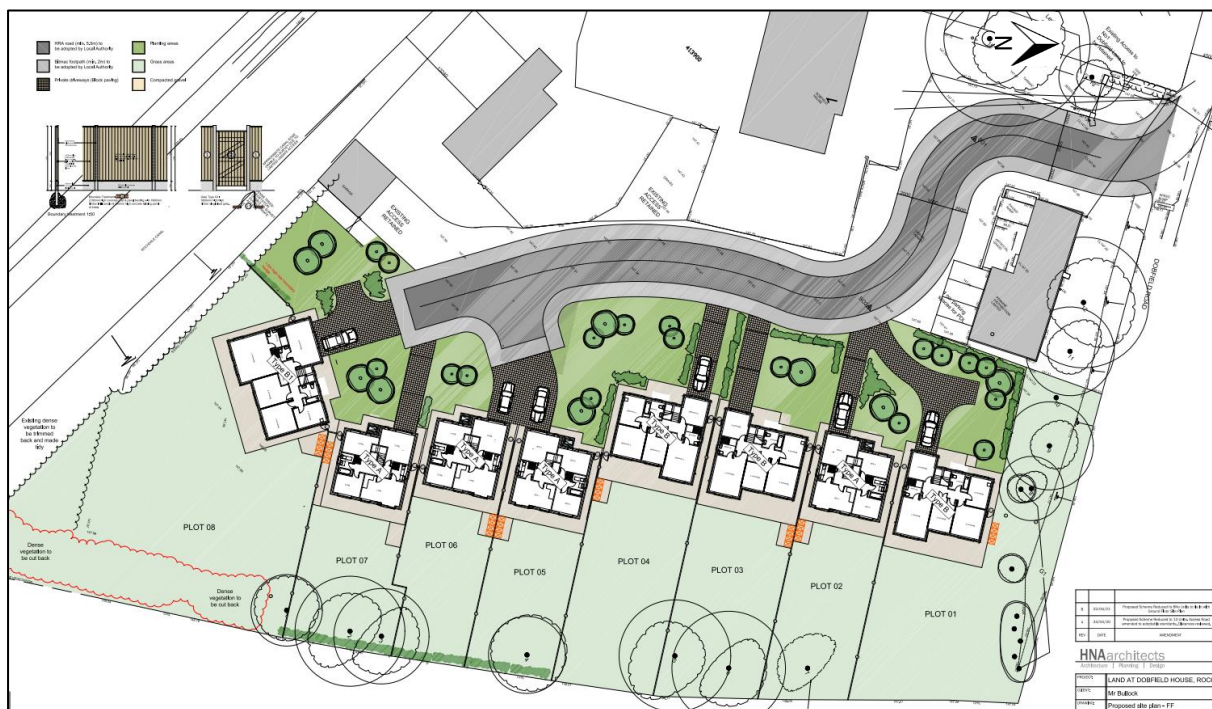
**Figure 1 Proposed Development Layout Plan**

Figure 1 below shows the proposed development layout plan.
