## **WORMS EYE**

## **RAMSDEN FARM, ROUNDTORN ROAD, MIDDLETON, M24 1FT – Phase 2**

### **COAL MINING RISK ASSESSMENT**

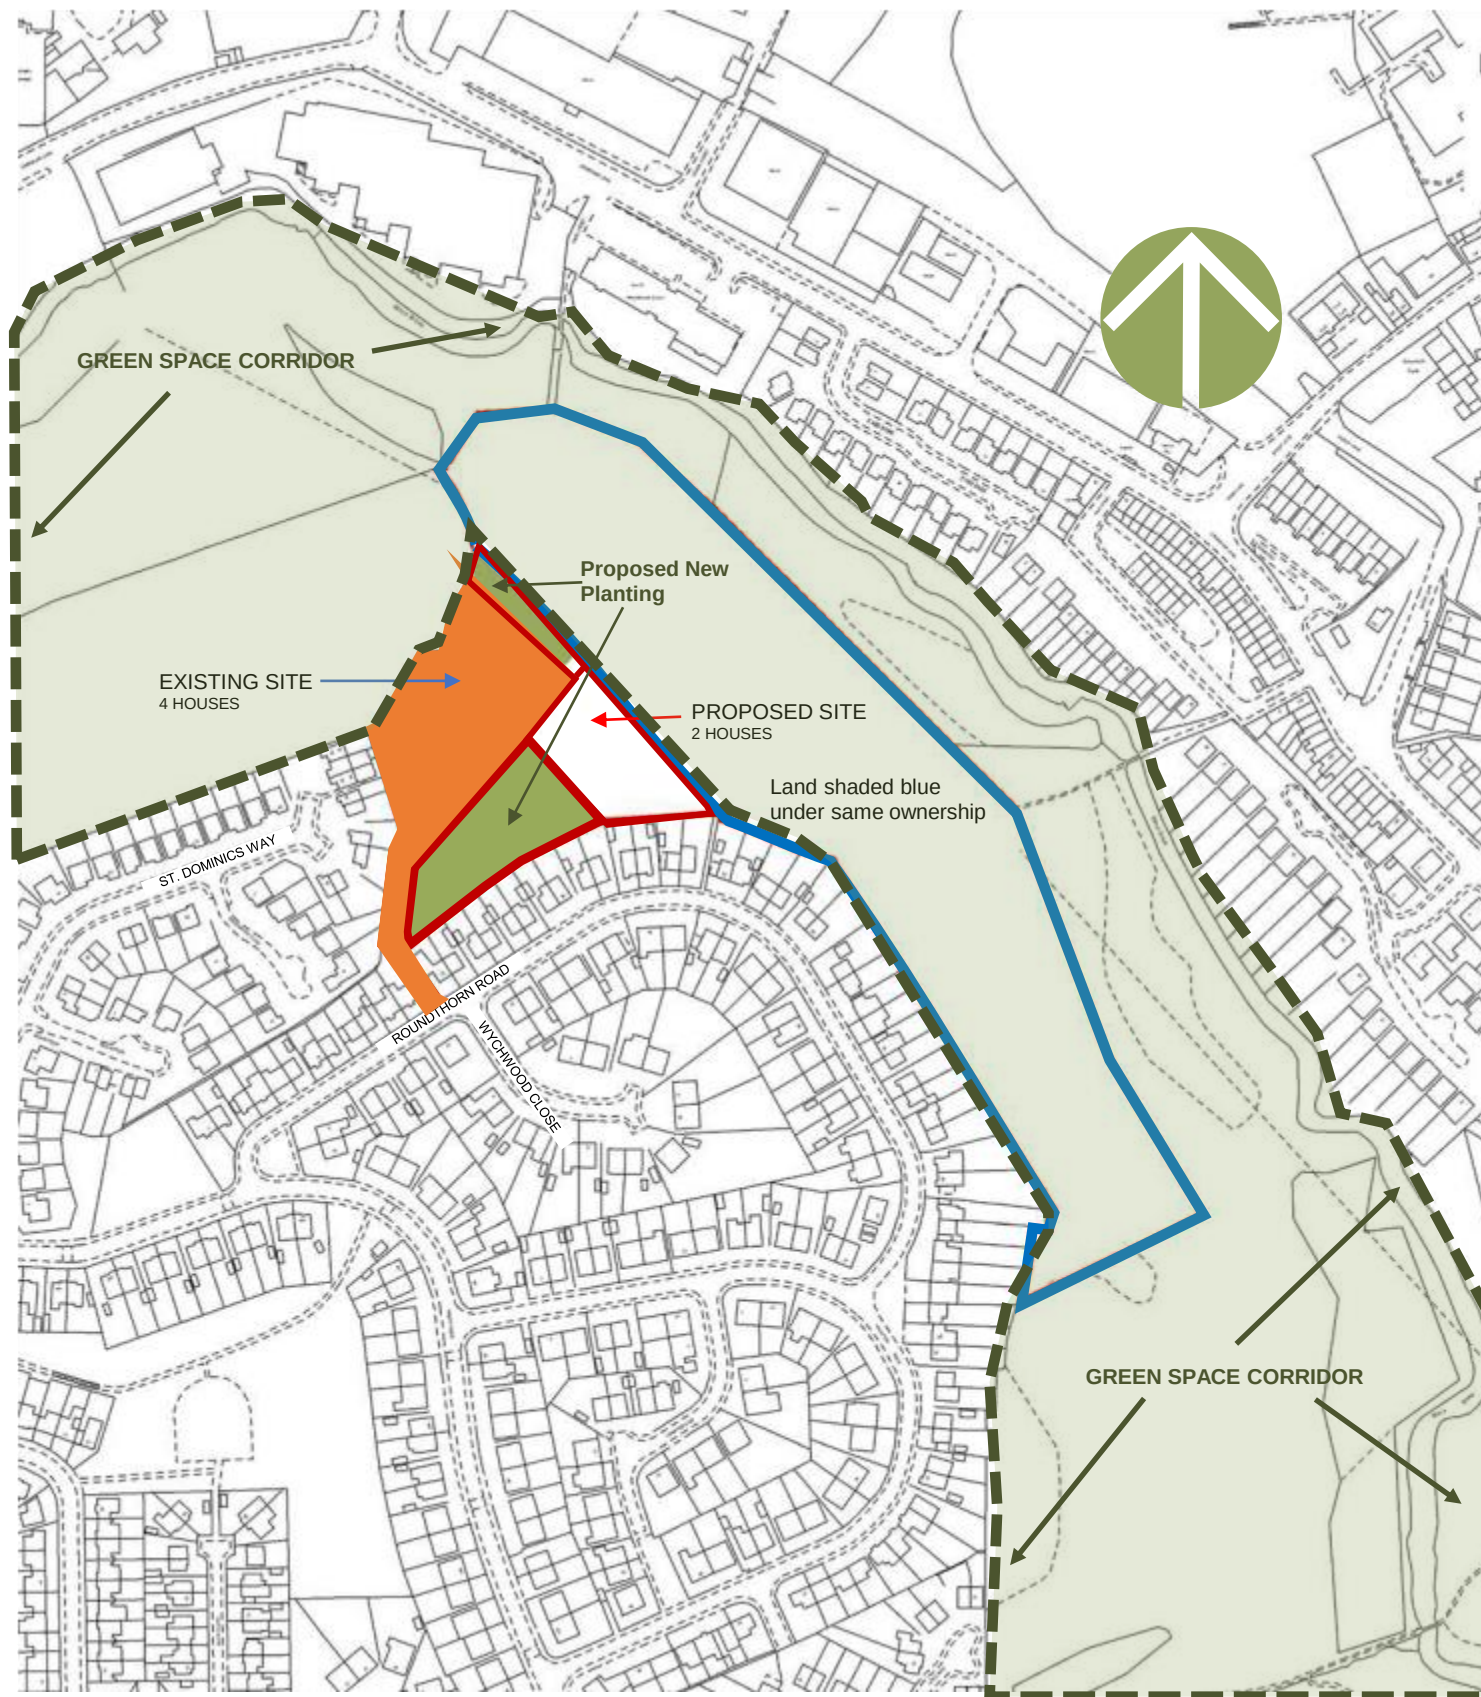
DWG REF: 6383\_Design Layout  
5/12

RAMSDEN FARM  
PROPOSED HOUSE TYPES PLOTS 5 & 6

It is proposed to build two detached houses with associated gardens, driveways and garages, at the northeast of the site. The middle and southwest of the site will be reserved for new planting.
