## **FOUL AND SURFACE WATER DRAINAGE STRATEGY**

**DEVELOPMENT AT  
FORMER SMITHYBRIDGE PUB,  
SMITHY BRIDGE, ROCHDALE**

**ARMSTRONG PROJECTS LTD**

**NW149/02r2b**

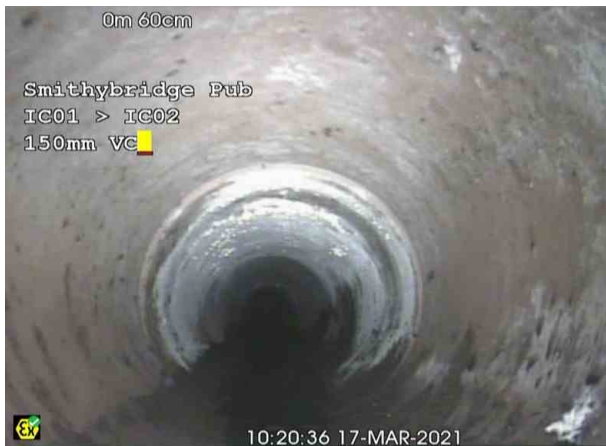
IC01X\_bffedaaf-4910-402c-99f7-d0e334cd5fe1\_20210326\_100658\_049.jpg, 00:00:01, 0.60 m  
General photograph taken at this point

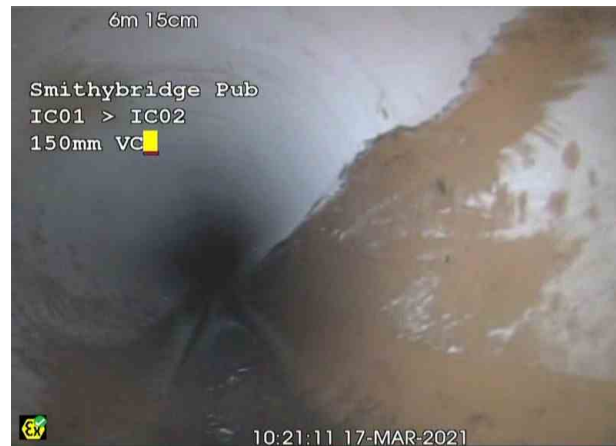
IC01X\_93491887-3c86-4817-9fa4-894a7640107e\_20210326\_101325\_149.jpg, 00:00:36, 6.15 m  
General photograph taken at this point

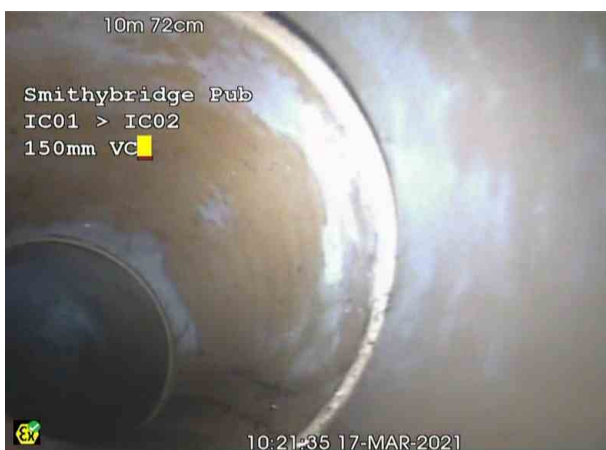
IC01X\_164e1793-c60e-4484-99d6-fb5d9f011dcc\_20210326\_101401\_637.jpg, 00:01:00, 10.72 m  
General photograph taken at this point

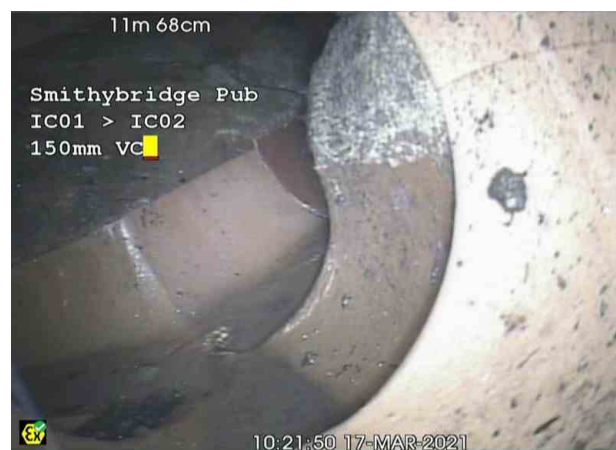
IC01X\_fae65e3b-d66d-42b9-bde6-6874127e1edd\_20210326\_101607\_541.jpg, 00:01:15, 11.68 m  
Finish node, inspection chamber, reference: IC02

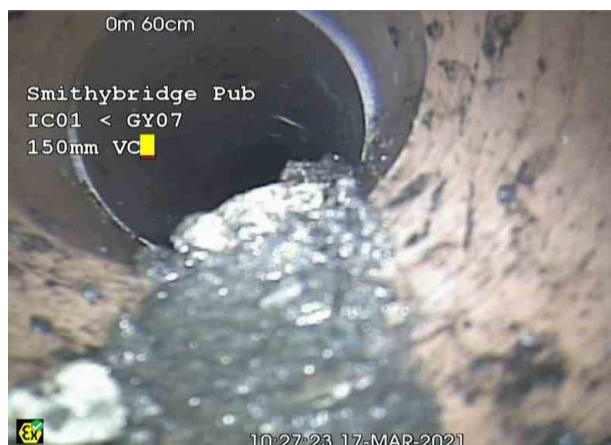
GY07X\_a197b9db-3f21-46a5-a057-83edfd12c2de\_20210326\_101803\_535.jpg, 00:00:00, 0.60 m  
General photograph taken at this point

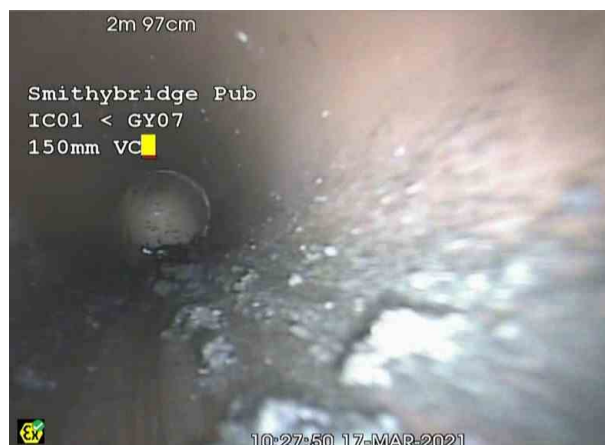
GY07X\_b9ff7f6a-d4ba-4225-bcaf-fecb5ef973ec\_20210326\_101926\_539.jpg, 00:00:28, 2.97 m  
General photograph taken at this point

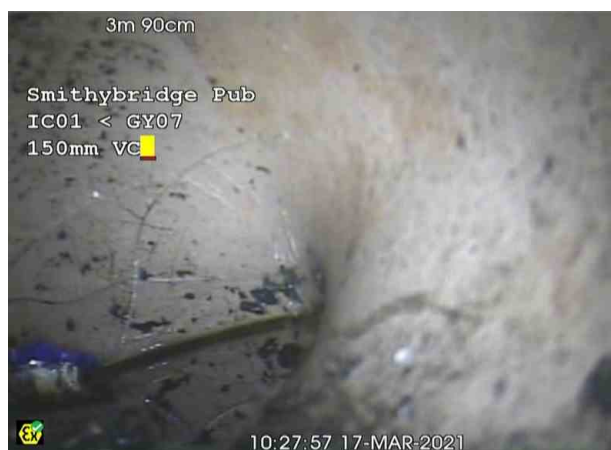
GY07X\_e3f78160-28ca-4f6f-a6d9-405d2d6ae78b\_20210326\_102037\_491.jpg, 00:00:34, 3.90 m  
Finish node, gully, reference: GY07

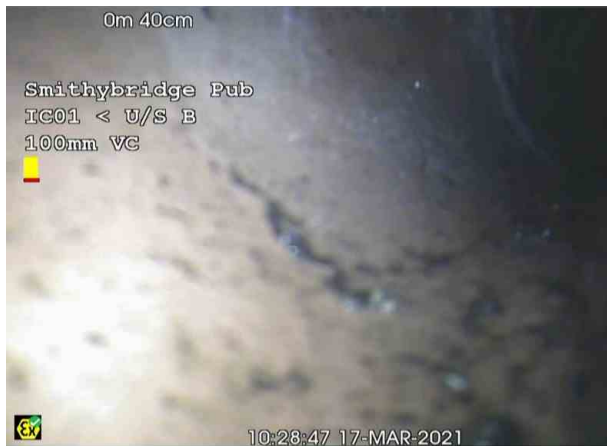
IC01 U\_S  
BX\_c4bf4e87-ed12-4168-8fc1-2ba682eca3b3\_20210326\_1027  
19\_989.jpg, 00:00:04, 0.40 m  
General photograph taken at this point

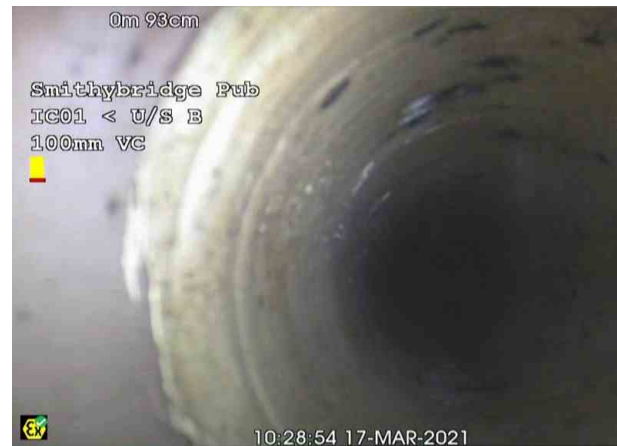
IC01 U\_S  
BX\_d01a7057-fa8b-4ee8-9392-acd33942c42b\_20210326\_103  
016\_752.jpg, 00:00:12, 0.93 m  
Point repair, localised lining from 12 o'clock to 12 o'clock, start

| Scale: 1:50 | Position [m] | Code | Observation | MPEG | Photo | Grade |
|---|---|---|---|---|---|---|
| | 0.93 | S01 | RPL Point repair, localised lining from 12 o'clock to 12 o'clock, start | 00:00:12 | IC01 U_S BX_d01a7057-fa8b-4 | |

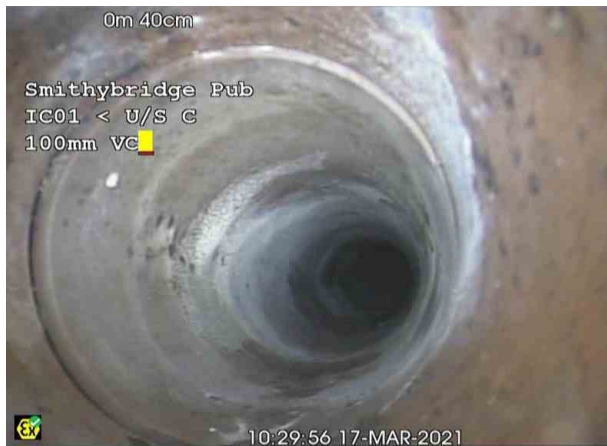
IC01 U\_S  
CX\_253f7ec9-8de0-4d41-86f0-ab6e9564c929\_20210326\_104  
622\_508.jpg, 00:00:00, 0.40 m  
General photograph taken at this point

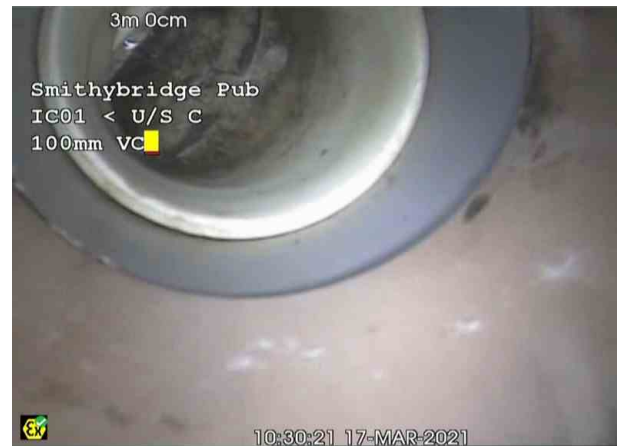
IC01 U\_S  
CX\_9a79e9b9-b9a3-42cf-b09a-94b395639466\_20210326\_104  
922\_040.jpg, 00:00:25, 3.00 m  
Finish node, other special chamber, reference: IC01 U/S C,  
Waste discharge point

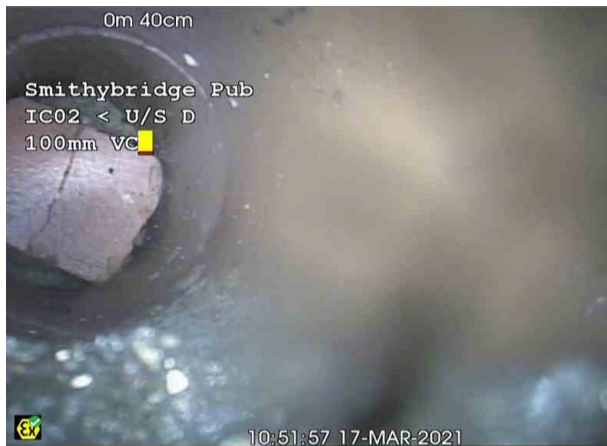
IC02 U\_S  
DX\_4d300f2d-fa71-47ca-85cc-0aafb8d3c54a\_20210326\_1050  
09\_927.jpg, 00:00:00, 0.40 m  
General photograph taken at this point

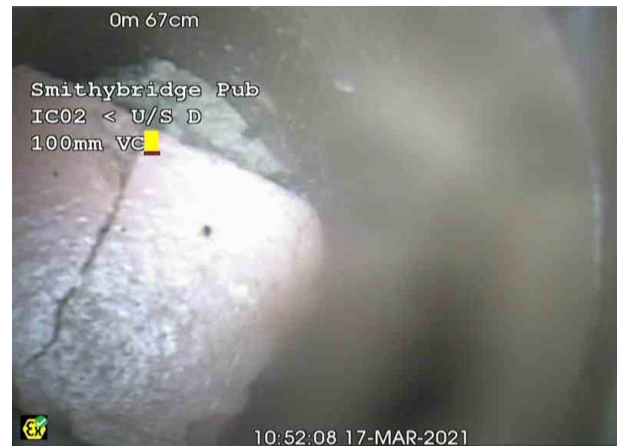
IC02 U\_S  
DX\_981bfd3d-3bfb-4873-b6a9-a4d86b7b5449\_20210326\_105  
043\_537.jpg, 00:00:10, 0.67 m  
Survey abandoned, Capped off Not in use

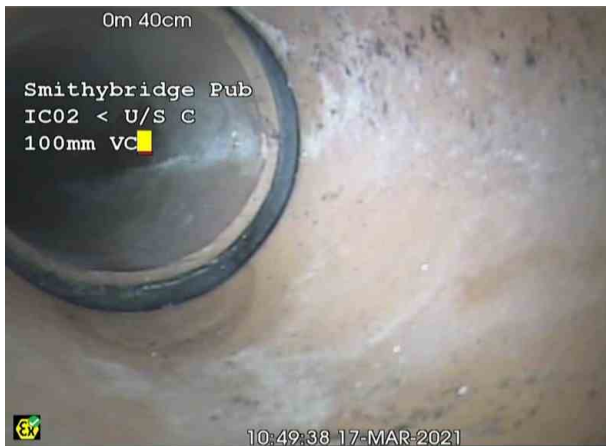
IC02 U\_S  
CX\_c05dca78-e744-4819-b1ed-a5d5036f9838\_20210326\_095  
130\_462.jpg, 00:00:00, 0.40 m  
General photograph taken at this point

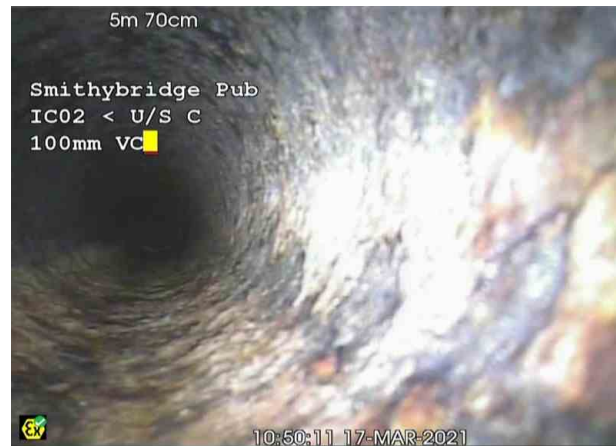
IC02 U\_S  
CX\_f40f73d4-74ac-47b8-8c70-8ca3797d4c23\_20210326\_0956  
17\_417.jpg, 00:00:34, 5.70 m  
General photograph taken at this point

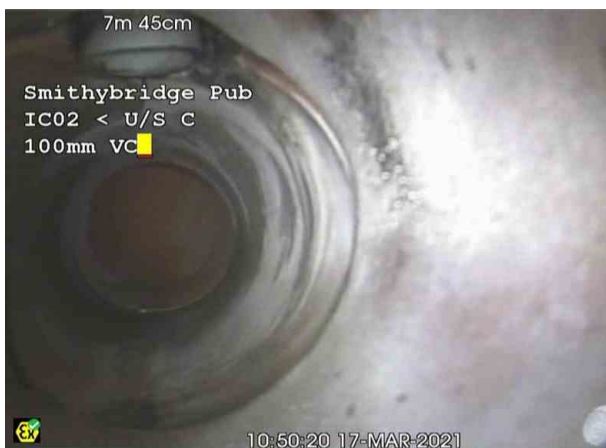
IC02 U\_S  
CX\_70b95ca6-0eb4-4064-962c-fb0f0544179a\_20210326\_095  
853\_176.jpg, 00:00:42, 7.45 m  
Connection other than junction at 12 o'clock, diameter: 25mm

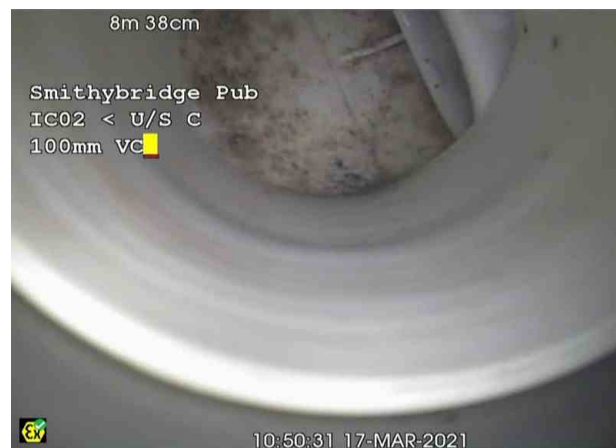
IC02 U\_S  
CX\_02fdb13b-785b-42cd-8000-b0512d5cf0cf\_20210326\_1001  
42\_734.jpg, 00:00:54, 8.38 m  
Finish node, other special chamber, reference: IC02 U/S C,  
Waste discharge point

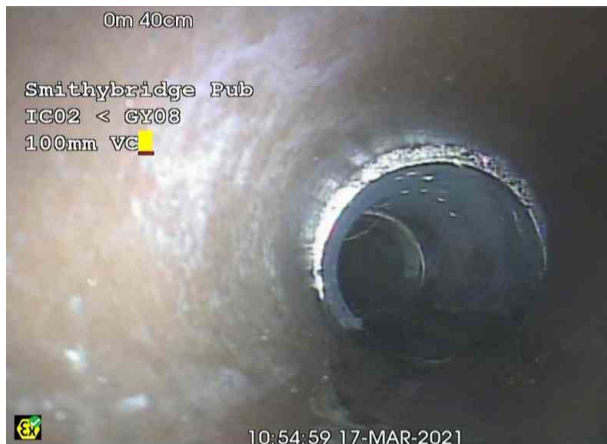
GY08X\_eb75e575-9715-4534-94f6-f420e8364a0b\_20210326\_105238\_660.jpg, 00:00:00, 0.40 m  
General photograph taken at this point

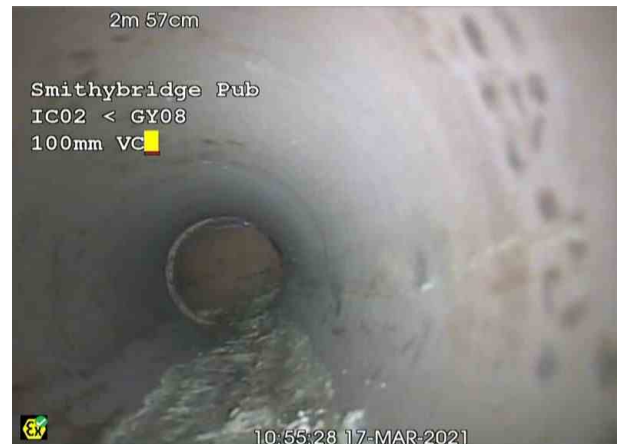
GY08X\_da1f80c1-b3d6-40e5-8a65-42b870347a63\_20210326\_110109\_422.jpg, 00:00:30, 2.57 m  
General photograph taken at this point

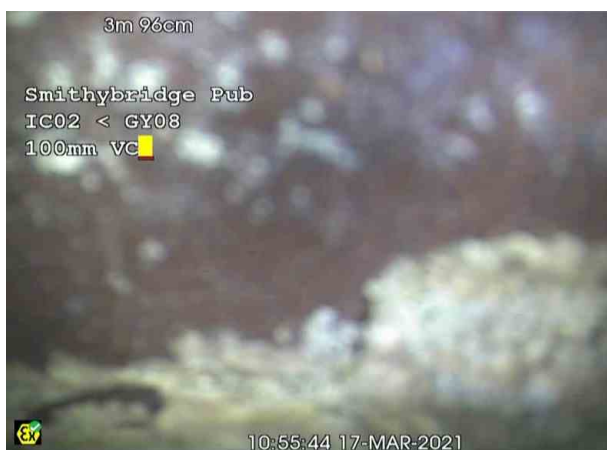
GY08X\_f3eb5e01-afb1-4d0c-9f89-7dd39f4ae273\_20210326\_110633\_738.jpg, 00:00:46, 3.96 m  
Finish node, gully, reference: GY08

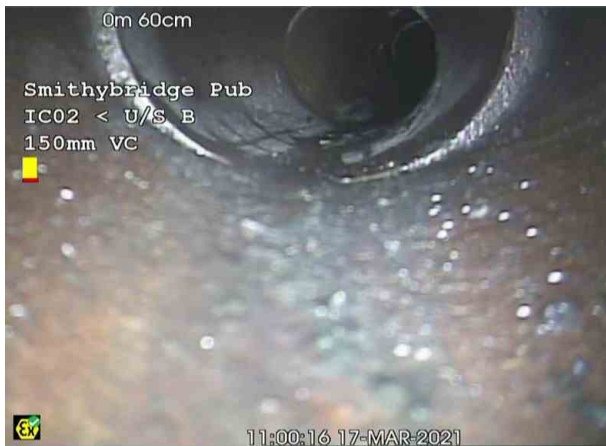
IC02 U\_S  
BX\_1c2a95b0-b665-4c5d-9fd2-bach2e39159b\_20210326\_110  
711\_484.jpg, 00:00:00, 0.60 m  
General photograph taken at this point

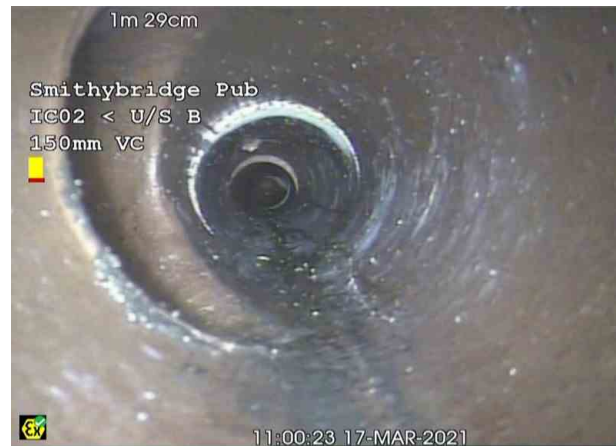
IC02 U\_S  
BX\_835b8aab-5741-41e1-9aac-735842a1afe5\_20210326\_110  
753\_842.jpg, 00:00:07, 1.29 m  
Junction at 8 o'clock, diameter: 150mm

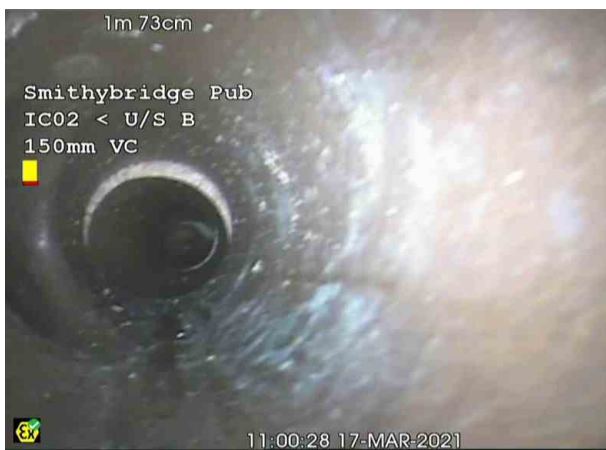
IC02 U\_S  
BX\_ff442f2-28d4-438b-82ea-4f5a3b9cefeb\_20210326\_11081  
1\_071.jpg, 00:00:13, 1.73 m  
Junction at 8 o'clock, diameter: 100mm

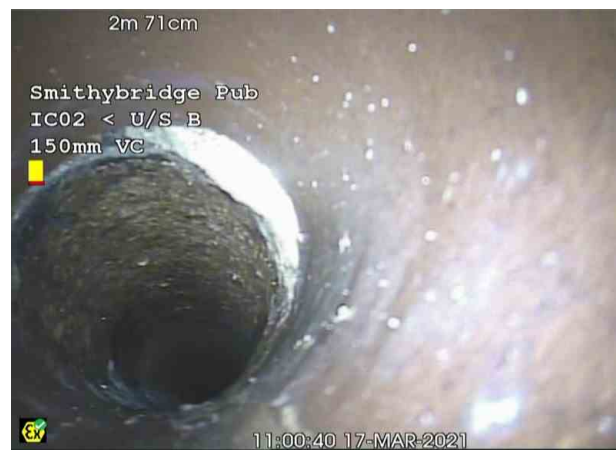
IC02 U\_S  
BX\_242ec4b5-9145-4bb9-b8d8-355af8a53835\_20210326\_110  
943\_193.jpg, 00:00:24, 2.71 m  
Pipe material changes to cast iron at this point

| Scale: | 1:67 | Position [m] | Code | Observation | MPEG | Photo | Grade |
|---|---|---|---|---|---|---|---|
| | | 2.71 | S02 | Surface damage, corrosion products from 12 o'clock to 12 o'clock, start | 00:00:24 | | |

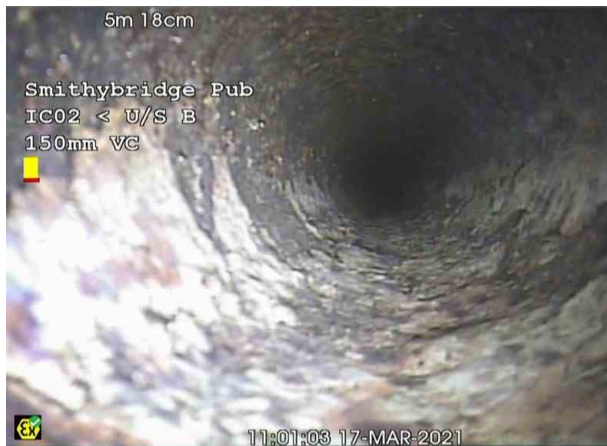
IC02 U\_S  
BX\_cdc80993-c9b6-4b3e-9047-55dade229b73\_20210326\_111  
015\_283.jpg, 00:00:47, 5.18 m  
General photograph taken at this point

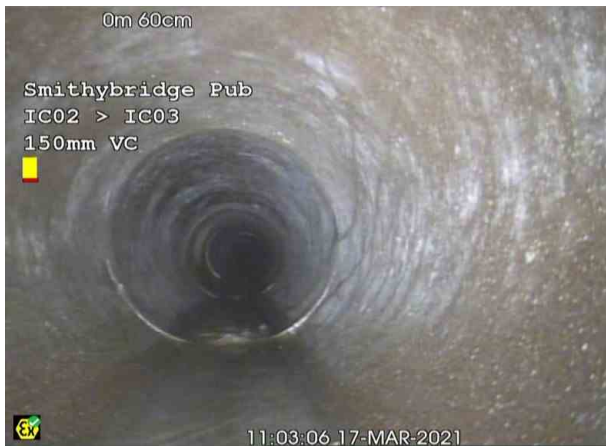
IC02X\_5b5218fa-4d9f-4e92-95a8-04225bfe15f4\_20210326\_112123\_386.jpg, 00:00:00, 0.60 m  
General photograph taken at this point

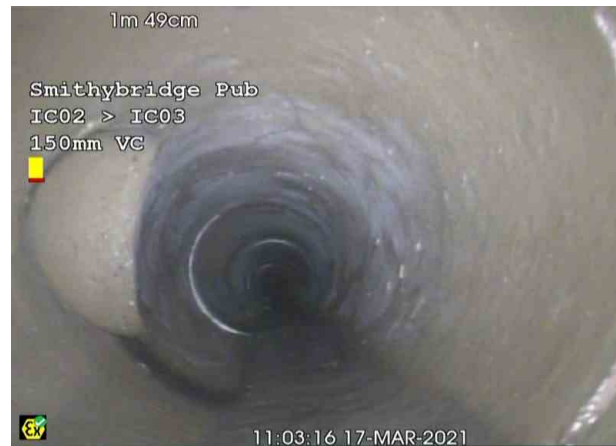
IC02X\_364c3182-ee9f-4bfb-a9cb-aff01ec17db7\_20210326\_112159\_505.jpg, 00:00:10, 1.49 m  
Junction at 10 o'clock, diameter: 100mm

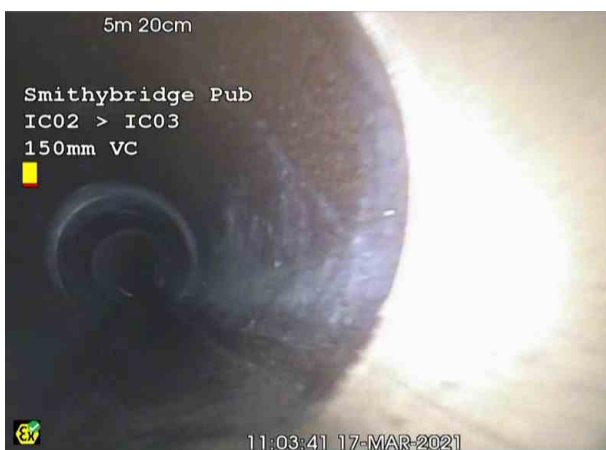
IC02X\_9606513a-df07-4c40-9211-803555284ada\_20210326\_112343\_543.jpg, 00:00:35, 5.20 m  
General photograph taken at this point

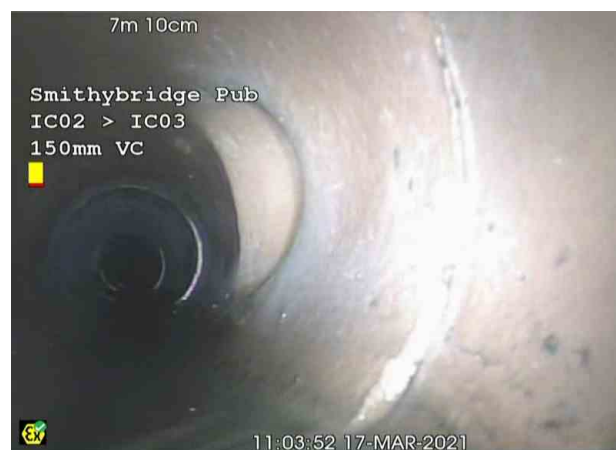
IC02X\_6c7172f1-f529-4103-9b40-56763bc648ec\_20210326\_112416\_943.jpg, 00:00:46, 7.10 m  
Junction at 2 o'clock, diameter: 100mm

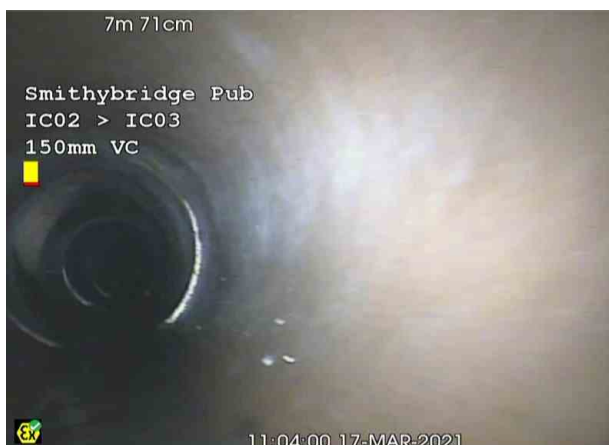
IC02X\_8ddd73b6-77aa-4340-bf19-cdd7b9f01124\_20210326\_1  
12447\_119.jpg, 00:00:54, 7.71 m  
Junction at 10 o'clock, diameter: 100mm

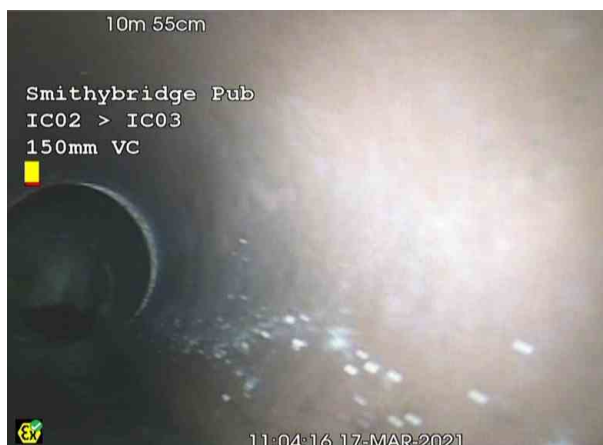
IC02X\_649e419c-124c-4f1e-8107-f98a7563e25f\_20210326\_1  
12551\_197.jpg, 00:01:10, 10.55 m  
General photograph taken at this point

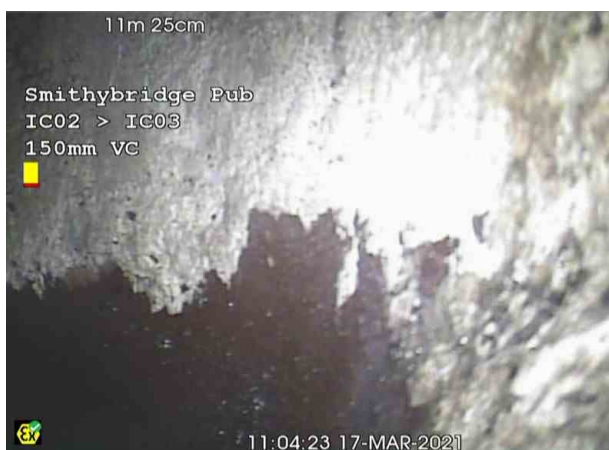
IC02X\_0d4c0fe4-c70e-42f3-b07d-fe43837d78ff\_20210326\_11  
2617\_823.jpg, 00:01:16, 11.25 m  
Finish node, inspection chamber, reference: IC03

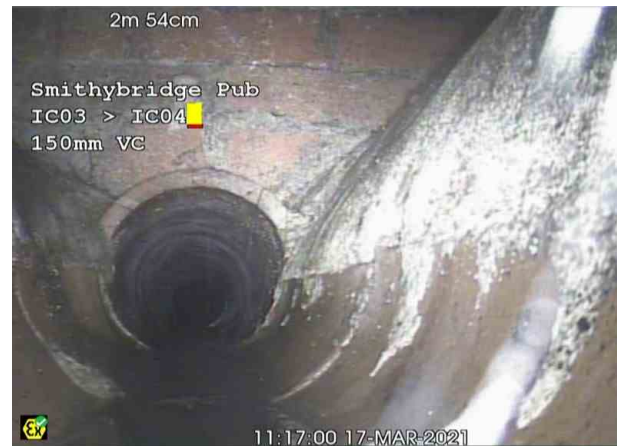
IC03X\_83f4e0ee-2fd8-4424-a37d-eea1e018da35\_20210326\_1  
12836\_659.jpg, 00:00:27, 2.54 m  
Finish node, inspection chamber, reference: IC04

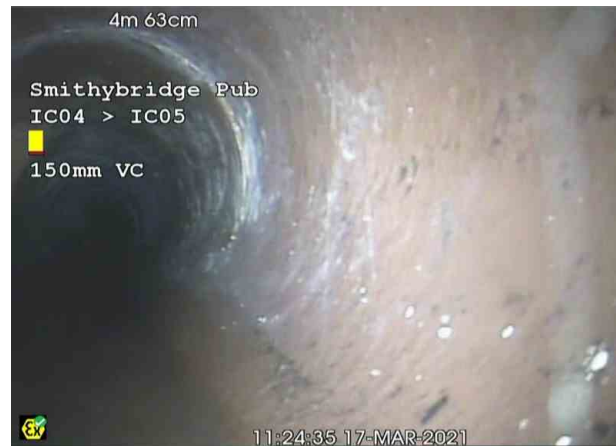
IC04X\_8cc0c8f9-5257-4923-83f0-b68e224434c7\_20210326\_1  
13209\_390.jpg, 00:00:42, 4.63 m  
Junction at 10 o'clock, diameter: 100mm

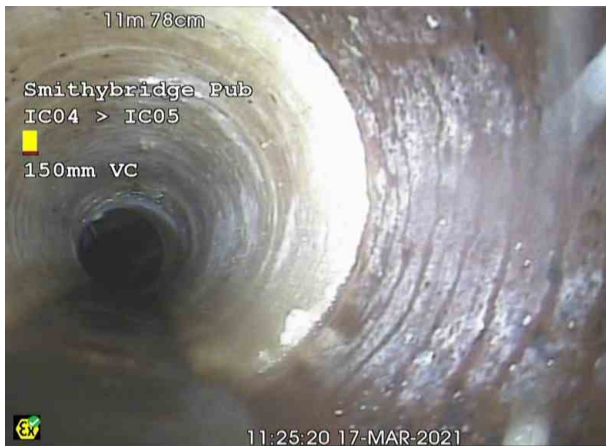
IC04X\_bb2fe570-7059-4250-9fdb-52abdbfb31b6\_20210326\_1  
13346\_864.jpg, 00:01:26, 11.78 m  
Surface damage, corrosion products from 12 o'clock to 12  
o'clock, start

| 11 | The Smithybridge Pub | 11.78 | IC04 | Downstream | IC05 | Surface damage, corrosion products from 12 o'clock to 12 o'clock, start | | |

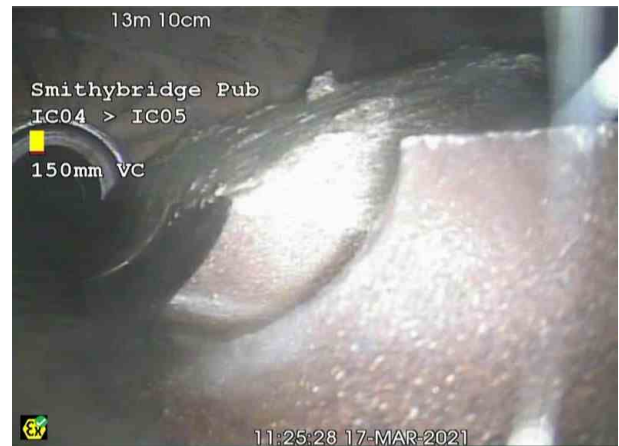
IC04X\_3caafd62-505b-45ff-9d04-3c207b800e15\_20210326\_1  
13409\_657.jpg, 00:01:35, 13.10 m  
Finish node, inspection chamber, reference: IC05

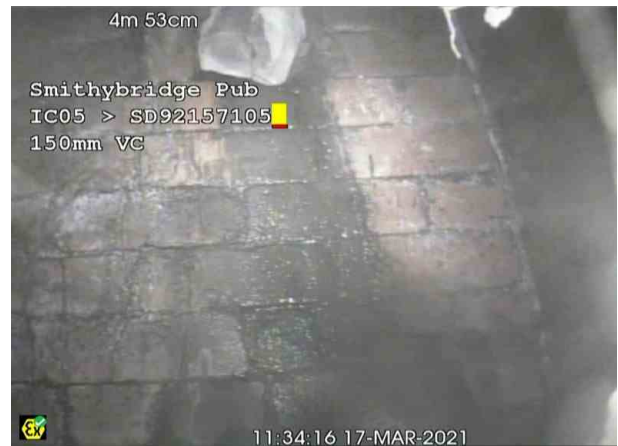
IC05X\_afd0d3a8-0ac6-4f6c-a802-72de62750eb2\_20210326\_1  
13913\_060.jpg, 00:01:12, 4.53 m  
Finish node, manhole, reference: SD92157104, UU Asset

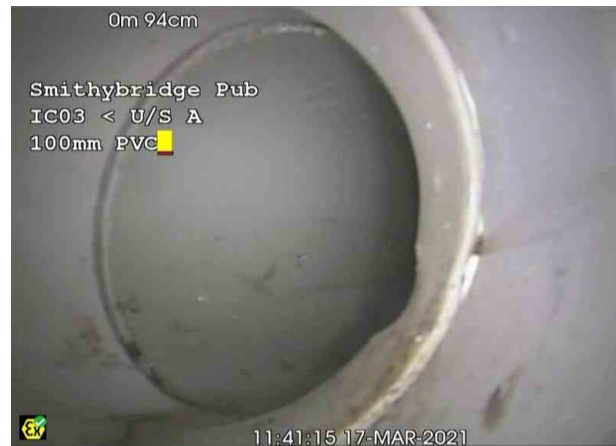
IC03 U\_S  
AX\_9e3a0a8c-97fe-463f-90c9-c8c96d97aafc\_20210326\_1150  
41\_713.jpg, 00:00:07, 0.94 m  
Line deviates right, Approx 90 degrees

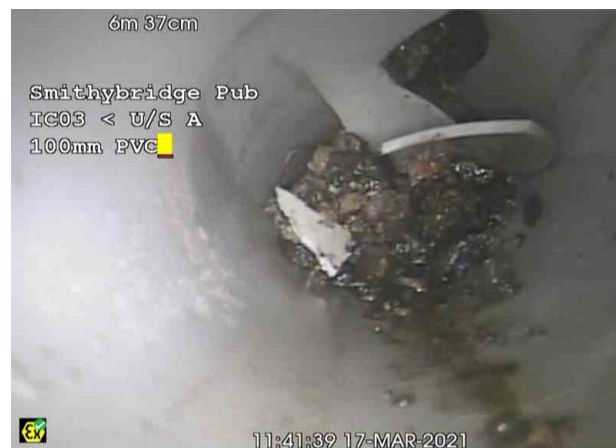
IC03 U\_S  
AX\_eedd93d8-598c-4417-91fb-52df387d14ff\_20210326\_1153  
22\_382.jpg, 00:00:31, 6.37 m  
Hole in drain or sewer from 12 o'clock to 3 o'clock

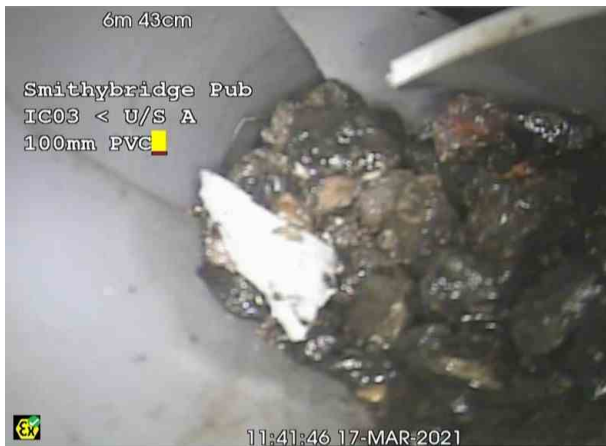
IC03 U\_S  
AX\_f84d163a-9015-4487-ac1b-01b63cef9926\_20210326\_1155  
17\_773.jpg, 00:00:39, 6.43 m  
Survey abandoned, Deformed pipe with 40% debris from hole

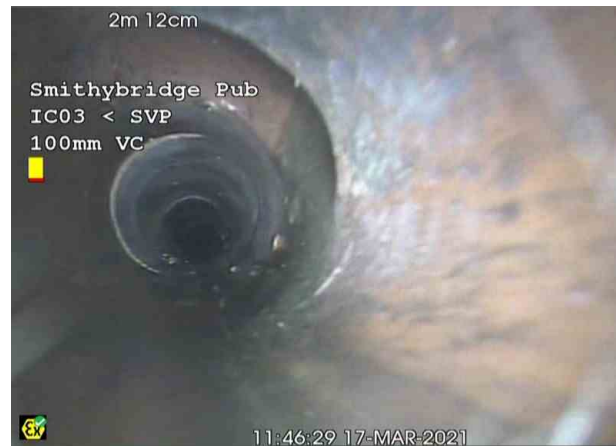
SVPX\_731bb806-4714-4449-ae77-cf0db3dc7702\_20210326\_120422\_045.jpg, 00:00:15, 2.12 m  
Junction at 2 o'clock, diameter: 100mm

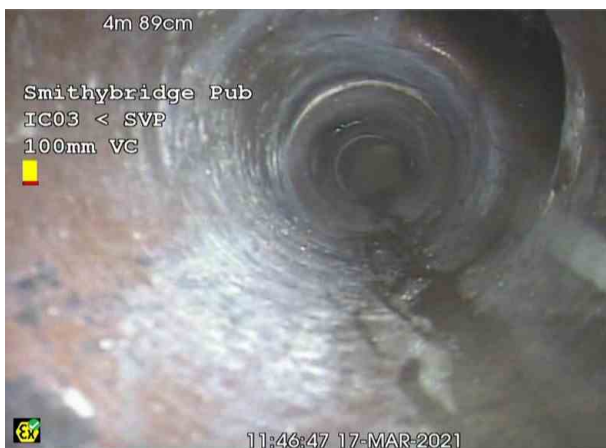
SVPX\_b0ebe08b-677f-423d-9e63-7cb37e57115c\_20210326\_120450\_924.jpg, 00:00:33, 4.89 m  
Junction at 2 o'clock, diameter: 100mm

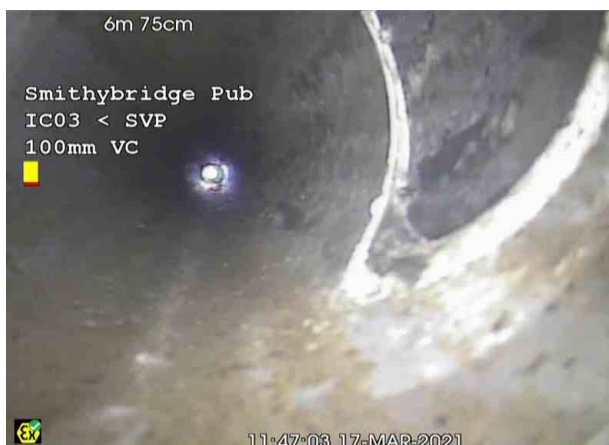
SVPX\_a135fa71-76ed-44a6-9f8c-06981d7863d6\_20210326\_1  
20620\_407.jpg, 00:00:49, 6.75 m  
Finish node, other special chamber, reference: SVP, Soil stack

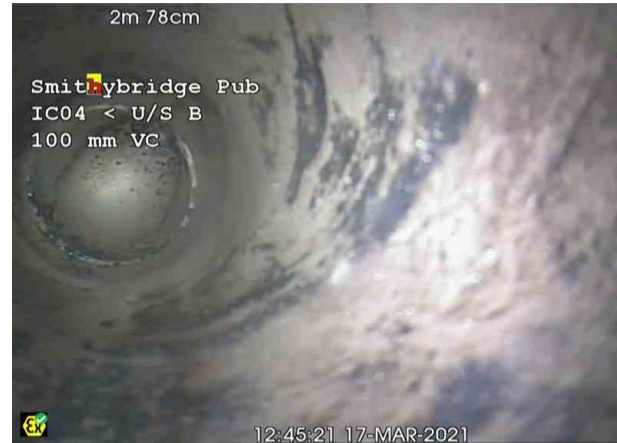
IC04 U\_S  
BX\_cbb955bb-b81c-472f-b187-6a448b6202c6\_20210326\_121  
153\_173.jpg, 00:00:37, 2.78 m  
Finish node, other special chamber, reference: IC04 U/S B,  
Node point from building

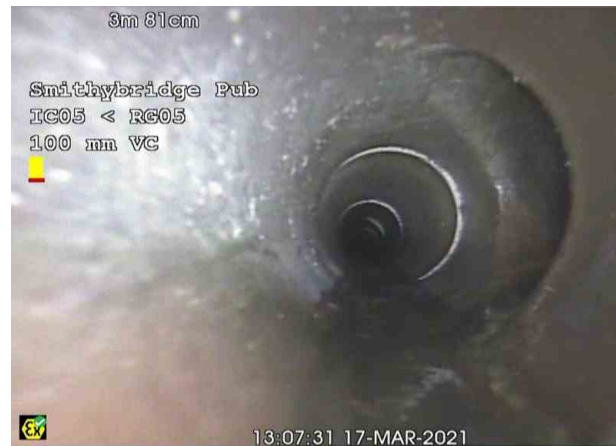
RG05X\_1d0c6782-b4f7-462f-9fe1-2de1d3ea2e99\_20210326\_121330\_977.jpg, 00:00:21, 3.81 m  
Junction at 3 o'clock, diameter: 100mm

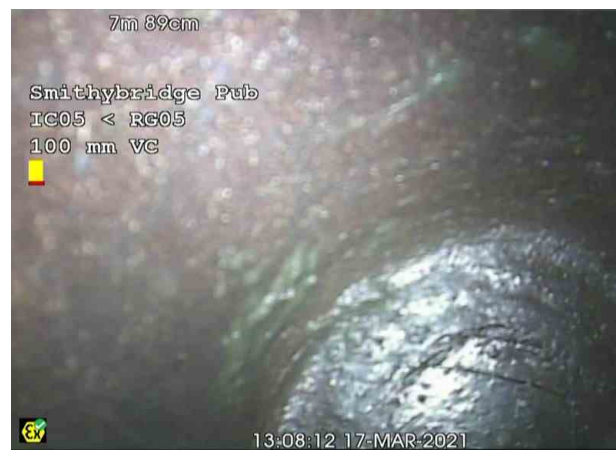
RG05X\_d87ac500-43ab-4f26-b197-79fe25f380a9\_20210326\_121708\_757.jpg, 00:01:03, 7.89 m  
Finish node, gully, reference: RG05

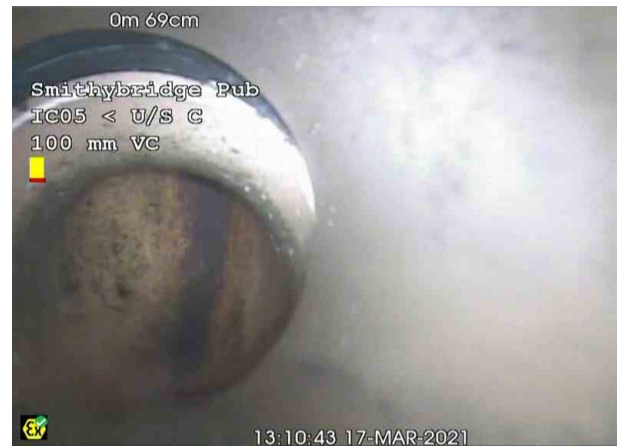
IC05 U\_S  
CX\_3d9348c4-45f9-4fe4-848a-202ea901d854\_20210326\_123  
358\_614.jpg, 00:00:05, 0.69 m  
Joint displaced, large, Band seal visible

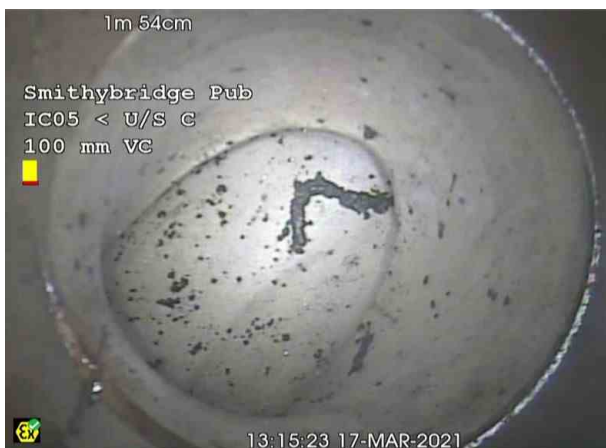
IC05 U\_S  
CX\_ffba0a50-97c4-4a54-96ec-78fb6d810f9b\_20210326\_1235  
33\_219.jpg, 00:01:59, 1.54 m  
Finish node, other special chamber, reference: IC05 U/S C,  
Waste discharge point

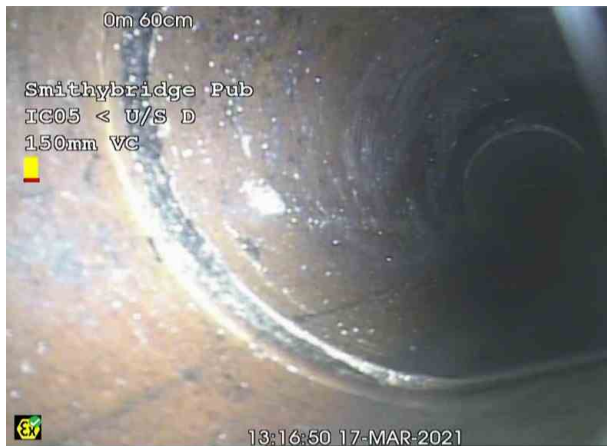
IC05 U\_S  
DX\_6970f791-91ba-4ddc-a457-c533055f833a\_20210326\_123  
724\_894.jpg, 00:00:00, 0.60 m  
General photograph taken at this point

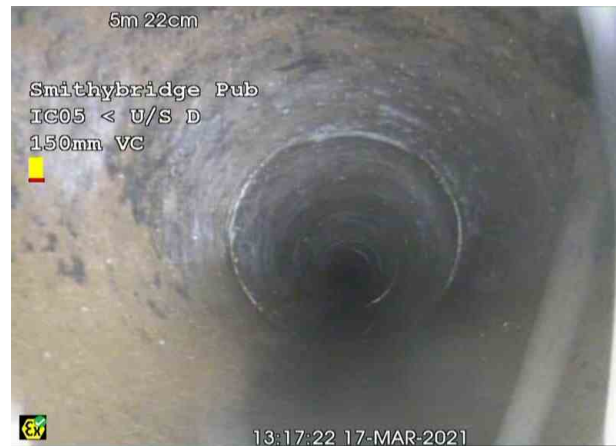
IC05 U\_S  
DX\_f4755a17-49c3-487d-bba8-0853d8dae6c0\_20210326\_123  
806\_342.jpg, 00:00:32, 5.22 m  
General photograph taken at this point

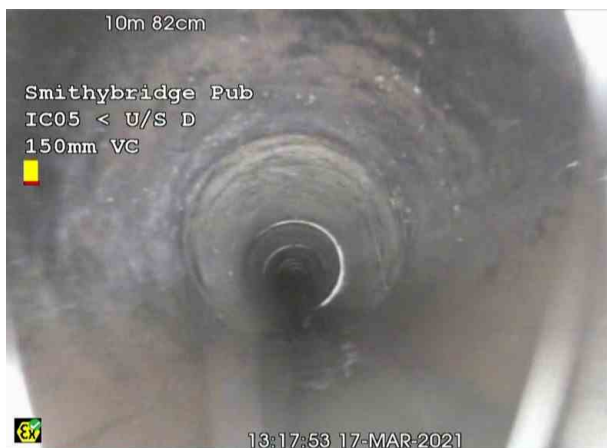
IC05 U\_S  
DX\_c32dc713-5af0-48bc-b8d8-bc4c29819c20\_20210326\_123  
855\_123.jpg, 00:01:02, 10.82 m  
General photograph taken at this point

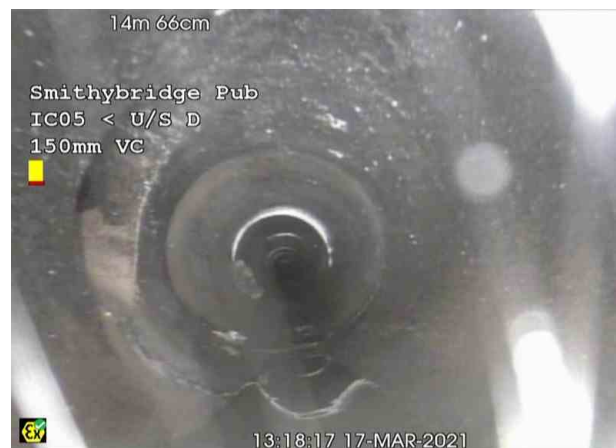
IC05 U\_S  
DX\_e578da2d-5c77-4bc2-861b-8a0ae9aaa63c\_20210326\_123  
935\_093.jpg, 00:01:27, 14.66 m  
Junction at 10 o'clock, diameter: 100mm

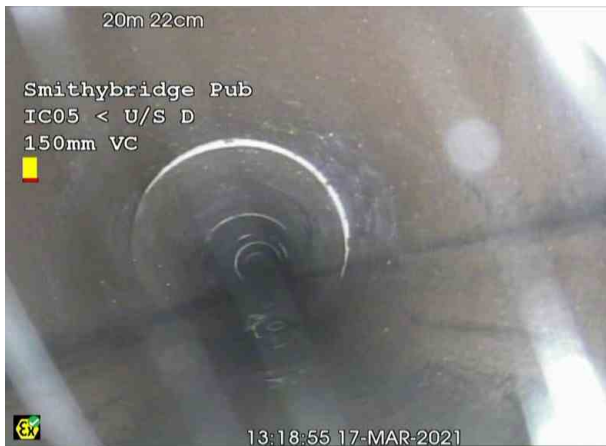
IC05 U\_S  
DX\_b5a6df72-6270-4107-8a6b-ff5aa99fc8b9\_20210326\_1242  
02\_465.jpg, 00:02:05, 20.22 m  
General photograph taken at this point

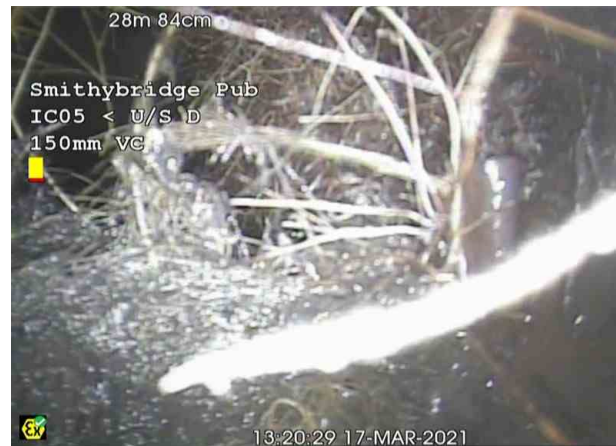
IC05 U\_S  
DX\_e148923e-c4e2-4c17-84b8-2d7ced156081\_20210326\_124  
425\_674.jpg, 00:03:39, 28.84 m  
Finish node, inspection chamber, reference: IC05 U/S D,  
Buried / Shown as IC05 on the screen

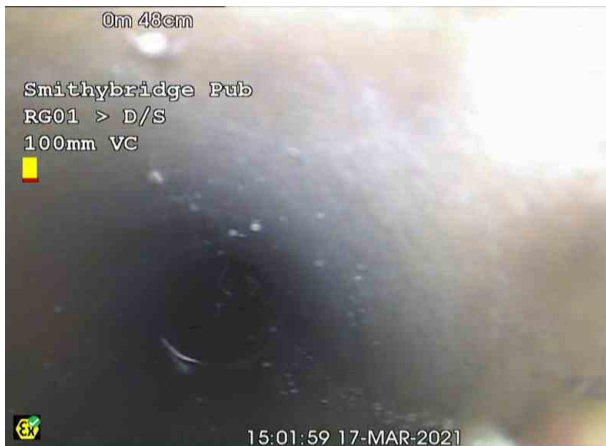
RG01X\_5afc0aa8-ecee-4f87-a7ea-91e11bec8a87\_20210326\_134538\_997.jpg, 00:00:20, 0.48 m  
General photograph taken at this point

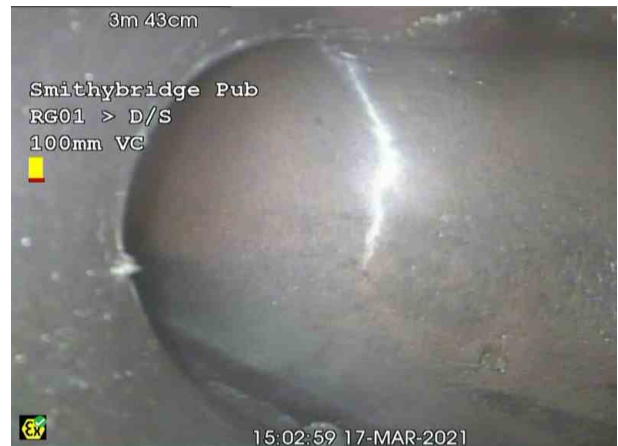
RG01X\_3fbc5cbf-7d72-4847-8a92-9fedb3a477a7\_20210326\_134713\_318.jpg, 00:01:21, 3.43 m  
Finish node, other special chamber, reference: RG01 D/S, T Junction

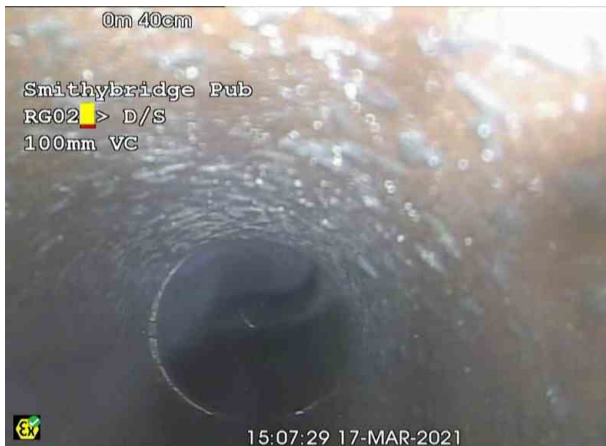
RG02X\_8273f697-a6e3-4520-94bf-ef4121f2d542\_20210326\_134756\_779.jpg, 00:00:00, 0.40 m  
General photograph taken at this point

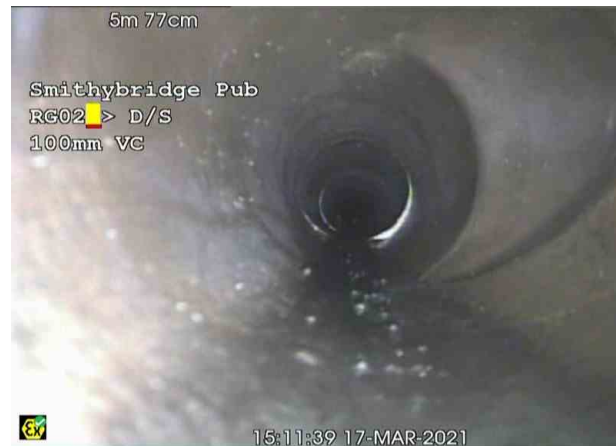
RG02X\_67cb7ecb-5983-4ab8-9259-0fe1dee003fe\_20210326\_135053\_042.jpg, 00:01:55, 5.77 m  
General photograph taken at this point

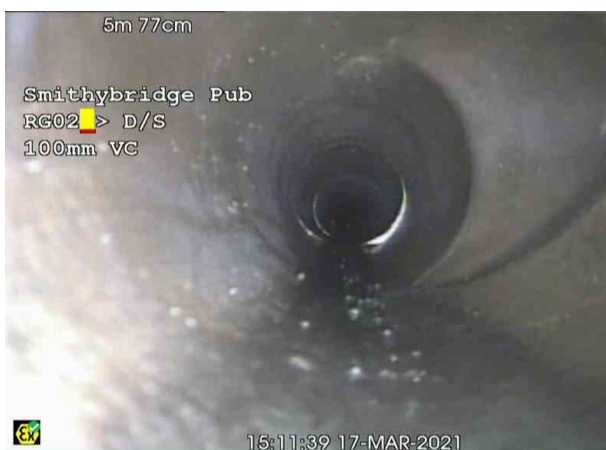
RG02X\_dc1e3951-a39f-495d-9086-abf775369a2a\_20210326\_135107\_487.jpg, 00:01:55, 5.77 m  
Junction at 2 o'clock, diameter: 100mm

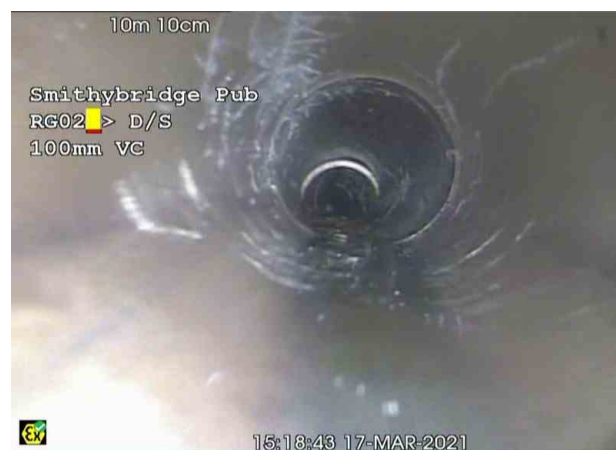
RG02X\_1181fd41-fee3-42f6-9025-08794d3551ea\_20210326\_135240\_208.jpg, 00:03:18, 10.10 m  
General photograph taken at this point

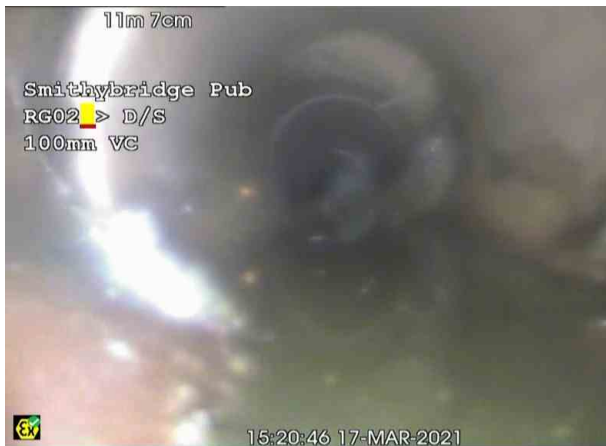
RG02X\_63dd7449-0cd9-4f5b-8a10-e60ffb3a7324\_20210326\_135601\_131.jpg, 00:05:22, 11.07 m  
Junction at 2 o'clock, diameter: 100mm

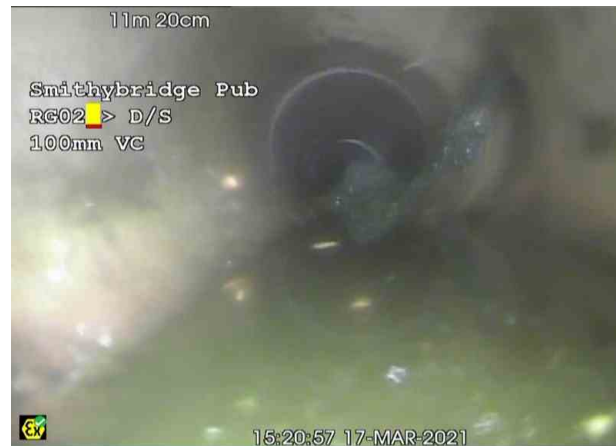
RG02X\_d90418a4-f563-4736-bd08-961766937f07\_20210326\_135910\_556.jpg, 00:05:33, 11.20 m  
Roots, tap, from junction

| Scale: | 1:109 | Position [m] | Code | Observation | MPEG | Photo | Grade |
|---|---|---|---|---|---|---|---|
| | 15.07 | REM | General remark: Attempting to clear the lens after going through roots from connection | 00:08:43 | | | |

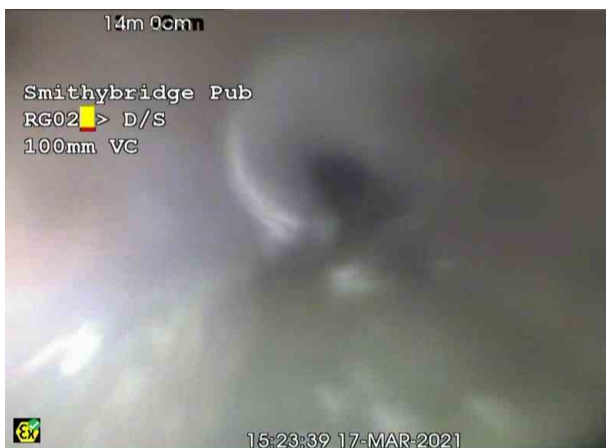
RG02X\_c0266c47-0fa4-4d91-83d9-57a424ca9848\_20210326\_140522\_007.jpg, 00:09:23, 18.44 m  
Junction at 10 o'clock, diameter: 100mm

| Scale: | 1:109 | Position [m] | Code | Observation | MPEG | Photo | Grade |
|---|---|---|---|---|---|---|---|
| | 18.44 | JN | Junction at 10 o'clock, diameter: 100mm | 00:09:23 | RG02X_c0<br>266c47-0f<br>a4-4d91-8 | | |

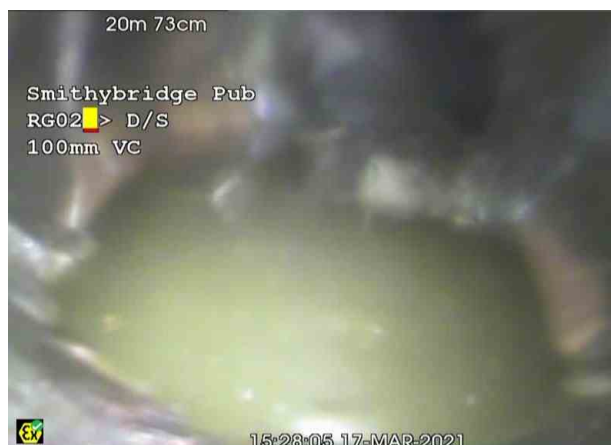
RG02X\_0b5727fb-a089-4d19-99b9-6f168c8d709e\_20210326\_140820\_000.jpg, 00:11:59, 20.73 m  
Finish node, inspection chamber, reference: IC06, Shown as RG02 D/S on the screen / IC06 is buried

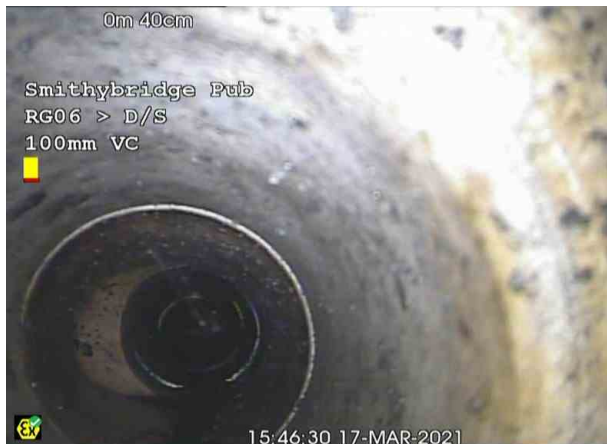
RG06X\_bb364ba2-3dda-46a0-ab46-7abdd55dfc16\_20210326\_141029\_695.jpg, 00:00:01, 0.40 m  
General photograph taken at this point

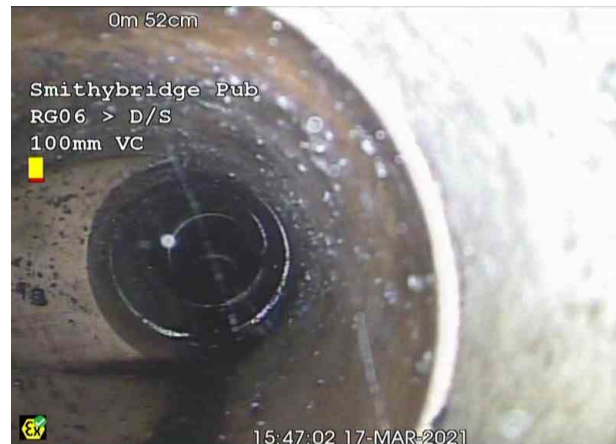
RG06X\_3700d764-5051-4fc4-9839-647e2de48980\_20210326\_141104\_473.jpg, 00:00:33, 0.52 m  
Junction at 9 o'clock, diameter: 100mm

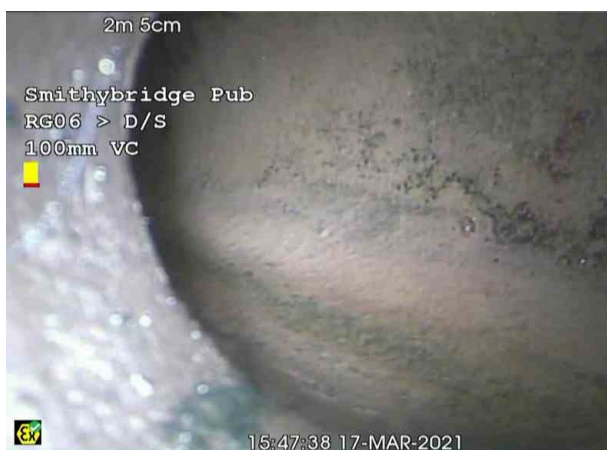
RG06X\_436b3aa2-f32a-4cce-894b-458d5eec30bc\_20210326\_141307\_109.jpg, 00:01:09, 2.05 m  
Finish node, other special chamber, reference: RG06 D/S, T Junction

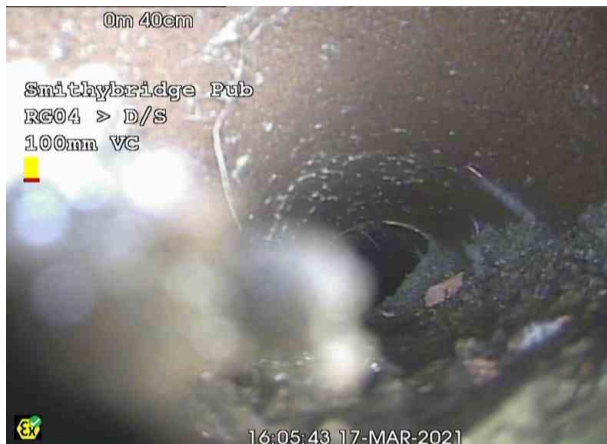
RG04X\_9d073a66-c6ac-4ab6-94a3-9da814fe5b1d\_20210326\_141408\_892.jpg, 00:00:02, 0.40 m  
General photograph taken at this point

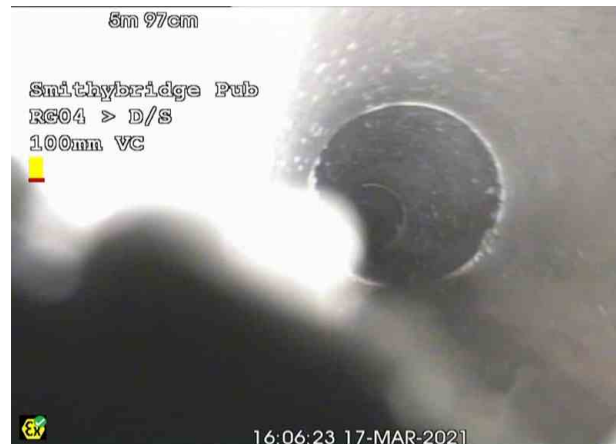
RG04X\_9efa3488-8d11-486f-b1ba-503ec1890e95\_20210326\_141623\_289.jpg, 00:00:42, 5.97 m  
General photograph taken at this point

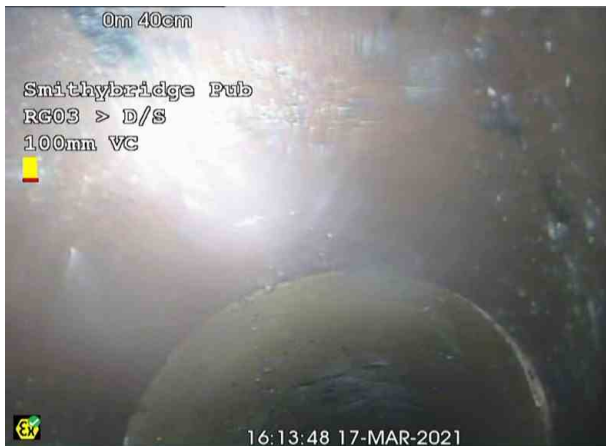
RG03X\_72e3ce49-ea7f-40dc-aa71-564052f5ebe3\_20210326\_141724\_628.jpg, 00:00:00, 0.40 m  
General photograph taken at this point

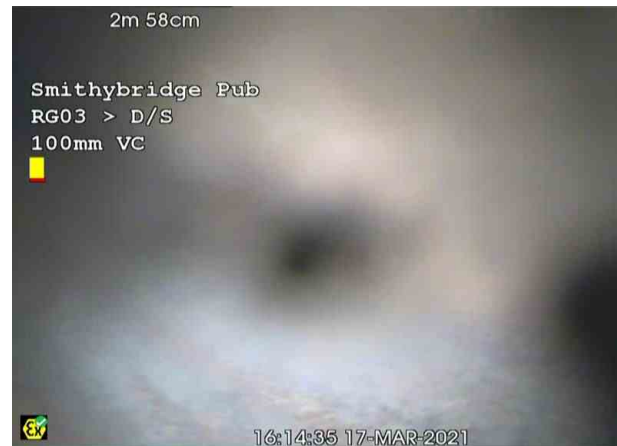
RG03X\_11130214-9649-436d-94f8-bf45aaf29857\_20210326\_141811\_497.jpg, 00:00:47, 2.58 m  
Finish node, other special chamber, reference: RG03 D/S, T Junction
