# HERITAGE STATEMENT

| PROJECT TITLE | St Mary's C of E School |
| DOCUMENT TITLE | Heritage Statement |

This Statement has been prepared by Seven Architecture on behalf of Rochdale Borough Council to support a listed building application for the fabric repairs relating to St Mary's CofE Primary School in Rochdale. The school is currently open to the public and used as a primary school however remedial works to the roof have been identified as key to the continued use of the building.

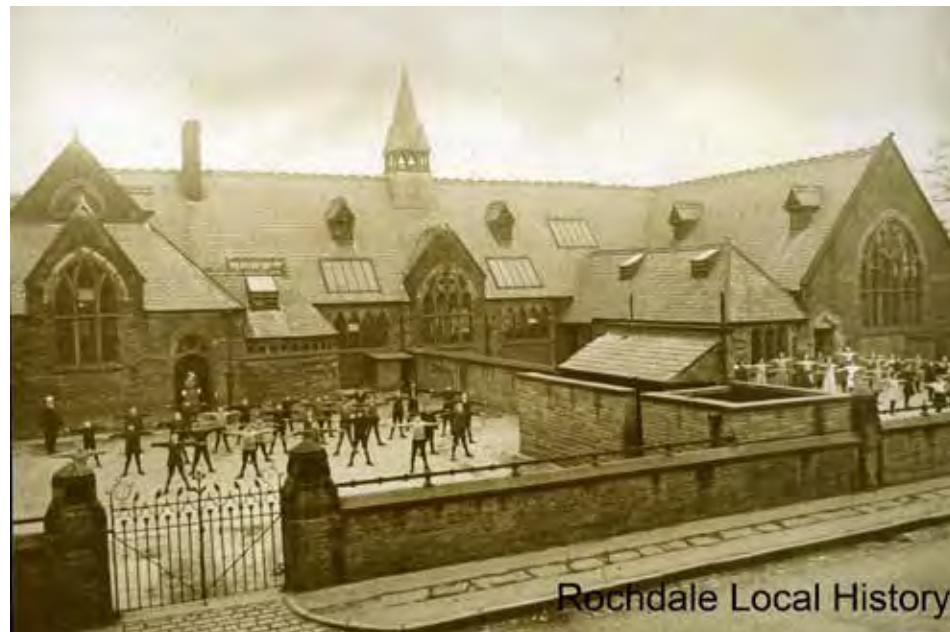
Figure 11  
Local photo of St Marys C of E School.  
Anon.

Since the 1989 map there seems to have been little change the external plans of the school, church and vicarage. The school retains its original plan with a small extension to the west elevation. The playground retains its historic separation which originally would have separated the boys and girls, indicated in the undated photograph below.

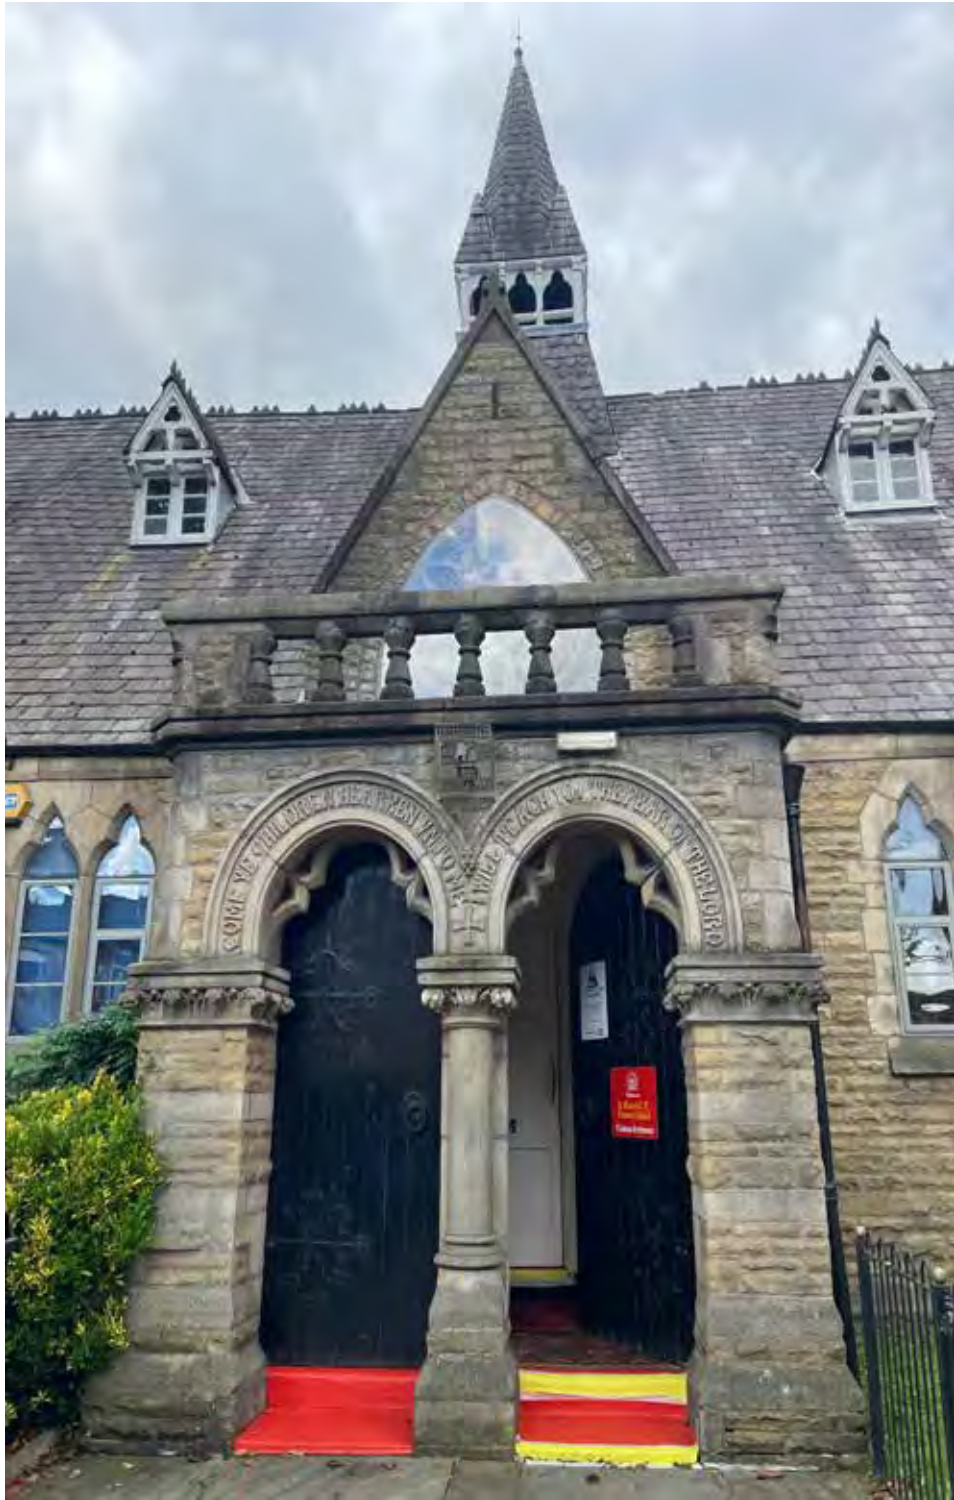
1 View of the south elevation.
