## Phase 1 Geoenvironmental Desk Study & Ground Stability Risk Assessment for Rochdale Corner Plot, Maclure Street, Rochdale, OL11 1DN

**Project No: NX570**

**Rochdale**  
Development  
Agency

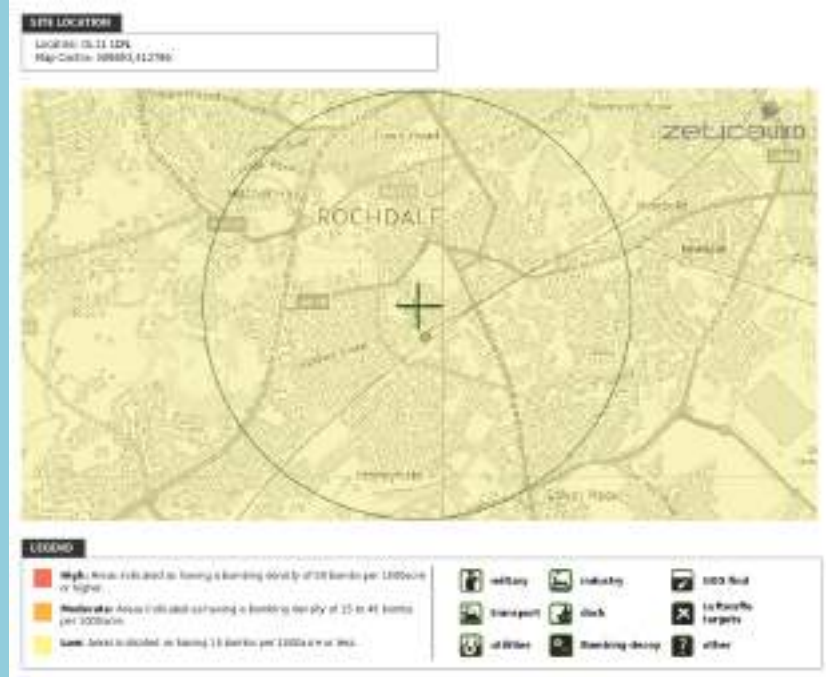
The regional unexploded bomb risk map from Zetica indicates that the site is in an area at low risk from possible Unexploded Ordnance (UXO) resulting from the Second World War. (Zetica, 2020).
