## CRIME IMPACT STATEMENT

**Demolition of existing unit B and G and erection of a B2/B8 warehouse unit with ancillary B1(a) office space including ancillary office, parking and servicing areas, associated works and infrastructure**

**AT Birch Business Park, Whittle Lane, Heywood**

**FOR: Yeagate Ltd**

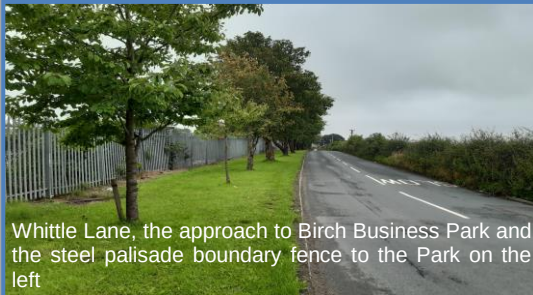
Whittle Lane, the approach to Birch Business Park and the steel palisade boundary fence to the Park on the left

- 3.3.1 The gatehouse should be retained and continue to be staffed 24/7.
- 3.3.2 The existing perimeter fencing and vehicle entrance barriers should be retained. The security qualities of the palisade fence should be reviewed from time to time in order to ensure it continues to provide a secure boundary. Some sections of fencing that have been damaged tree growth. If not addressed the fencing may be breached and the overall security of the business park compromised.

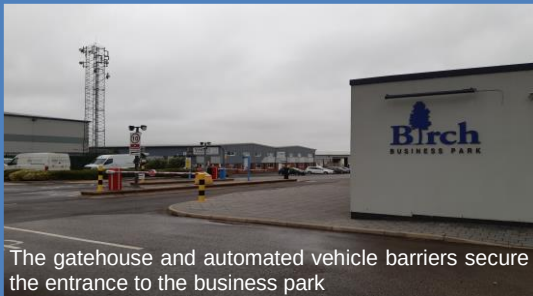
The gatehouse and automated vehicle barriers secure the entrance to the business park

- there is only a single point of entry into Birch Business Park with automated vehicle barriers and a manned gatehouse at the entrance;
- Whittle Lane is not heavily trafficked and being isolated from built-up, residential areas, pedestrian usage is particularly low. Therefore, the number of passers-by, who may have criminal intentions, wishing to exploit any weaknesses in the security of business park or cause criminal damage to property, is less than it would be on a more heavily trafficked street in a built-up neighbourhood;

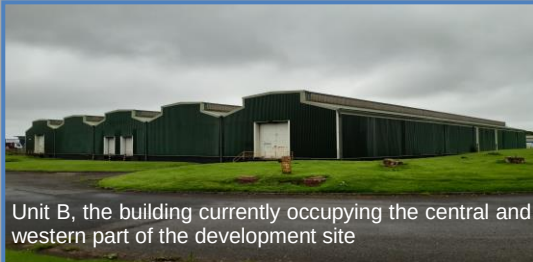
Unit B, the building currently occupying the central and western part of the development site

The development site itself is situated on the southern edge of the business park on land currently occupied by Unit B and Unit G and associated service areas and peripheral landscaping. Unit B is a large, multi-tenanted building, which occupies the central and western parts of the site. Parts of the building appear unoccupied. There are service shutters and personnel doors on the eastern elevation of Unit B, which open onto a narrow service yard, and loading docks on the western elevation. The land north of the building is currently used for open storage of steel work and aggregates. Parking appears to be limited to space within the service yard. One of the business park circulation roads encircles the building. Unit G comprises two buildings, both much smaller than Unit B, both in height and floor area, as well as portacabins, all of which are located at the eastern edge of the development site. Parts of the land immediately surrounding the buildings are used for open storage and parking. The southern and eastern sides of the site are enclosed with steel palisade fencing. A grassed embankment separates the eastern edge of the development site from land at a lower level on the business park, which has recently been redeveloped and is now occupied by Unit D, a new, 6,795.1m<sup>2</sup> building, with consent for B2/B8 use with ancillary B1 office accommodation, and awaits occupation.

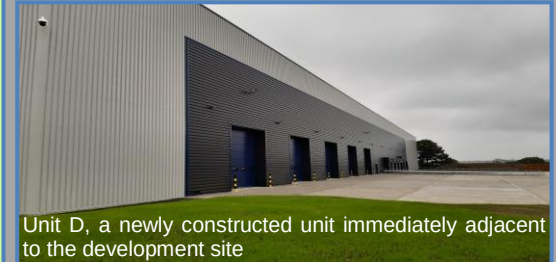
Unit D, a newly constructed unit immediately adjacent to the development site
