## **Remediation Statement & Validation Proposal Sheets**

**Project Reference: 21-763**

**Site: Proposed Residential Development – Land at Hollin Bank,  
Hollingworth Road, Littleborough**

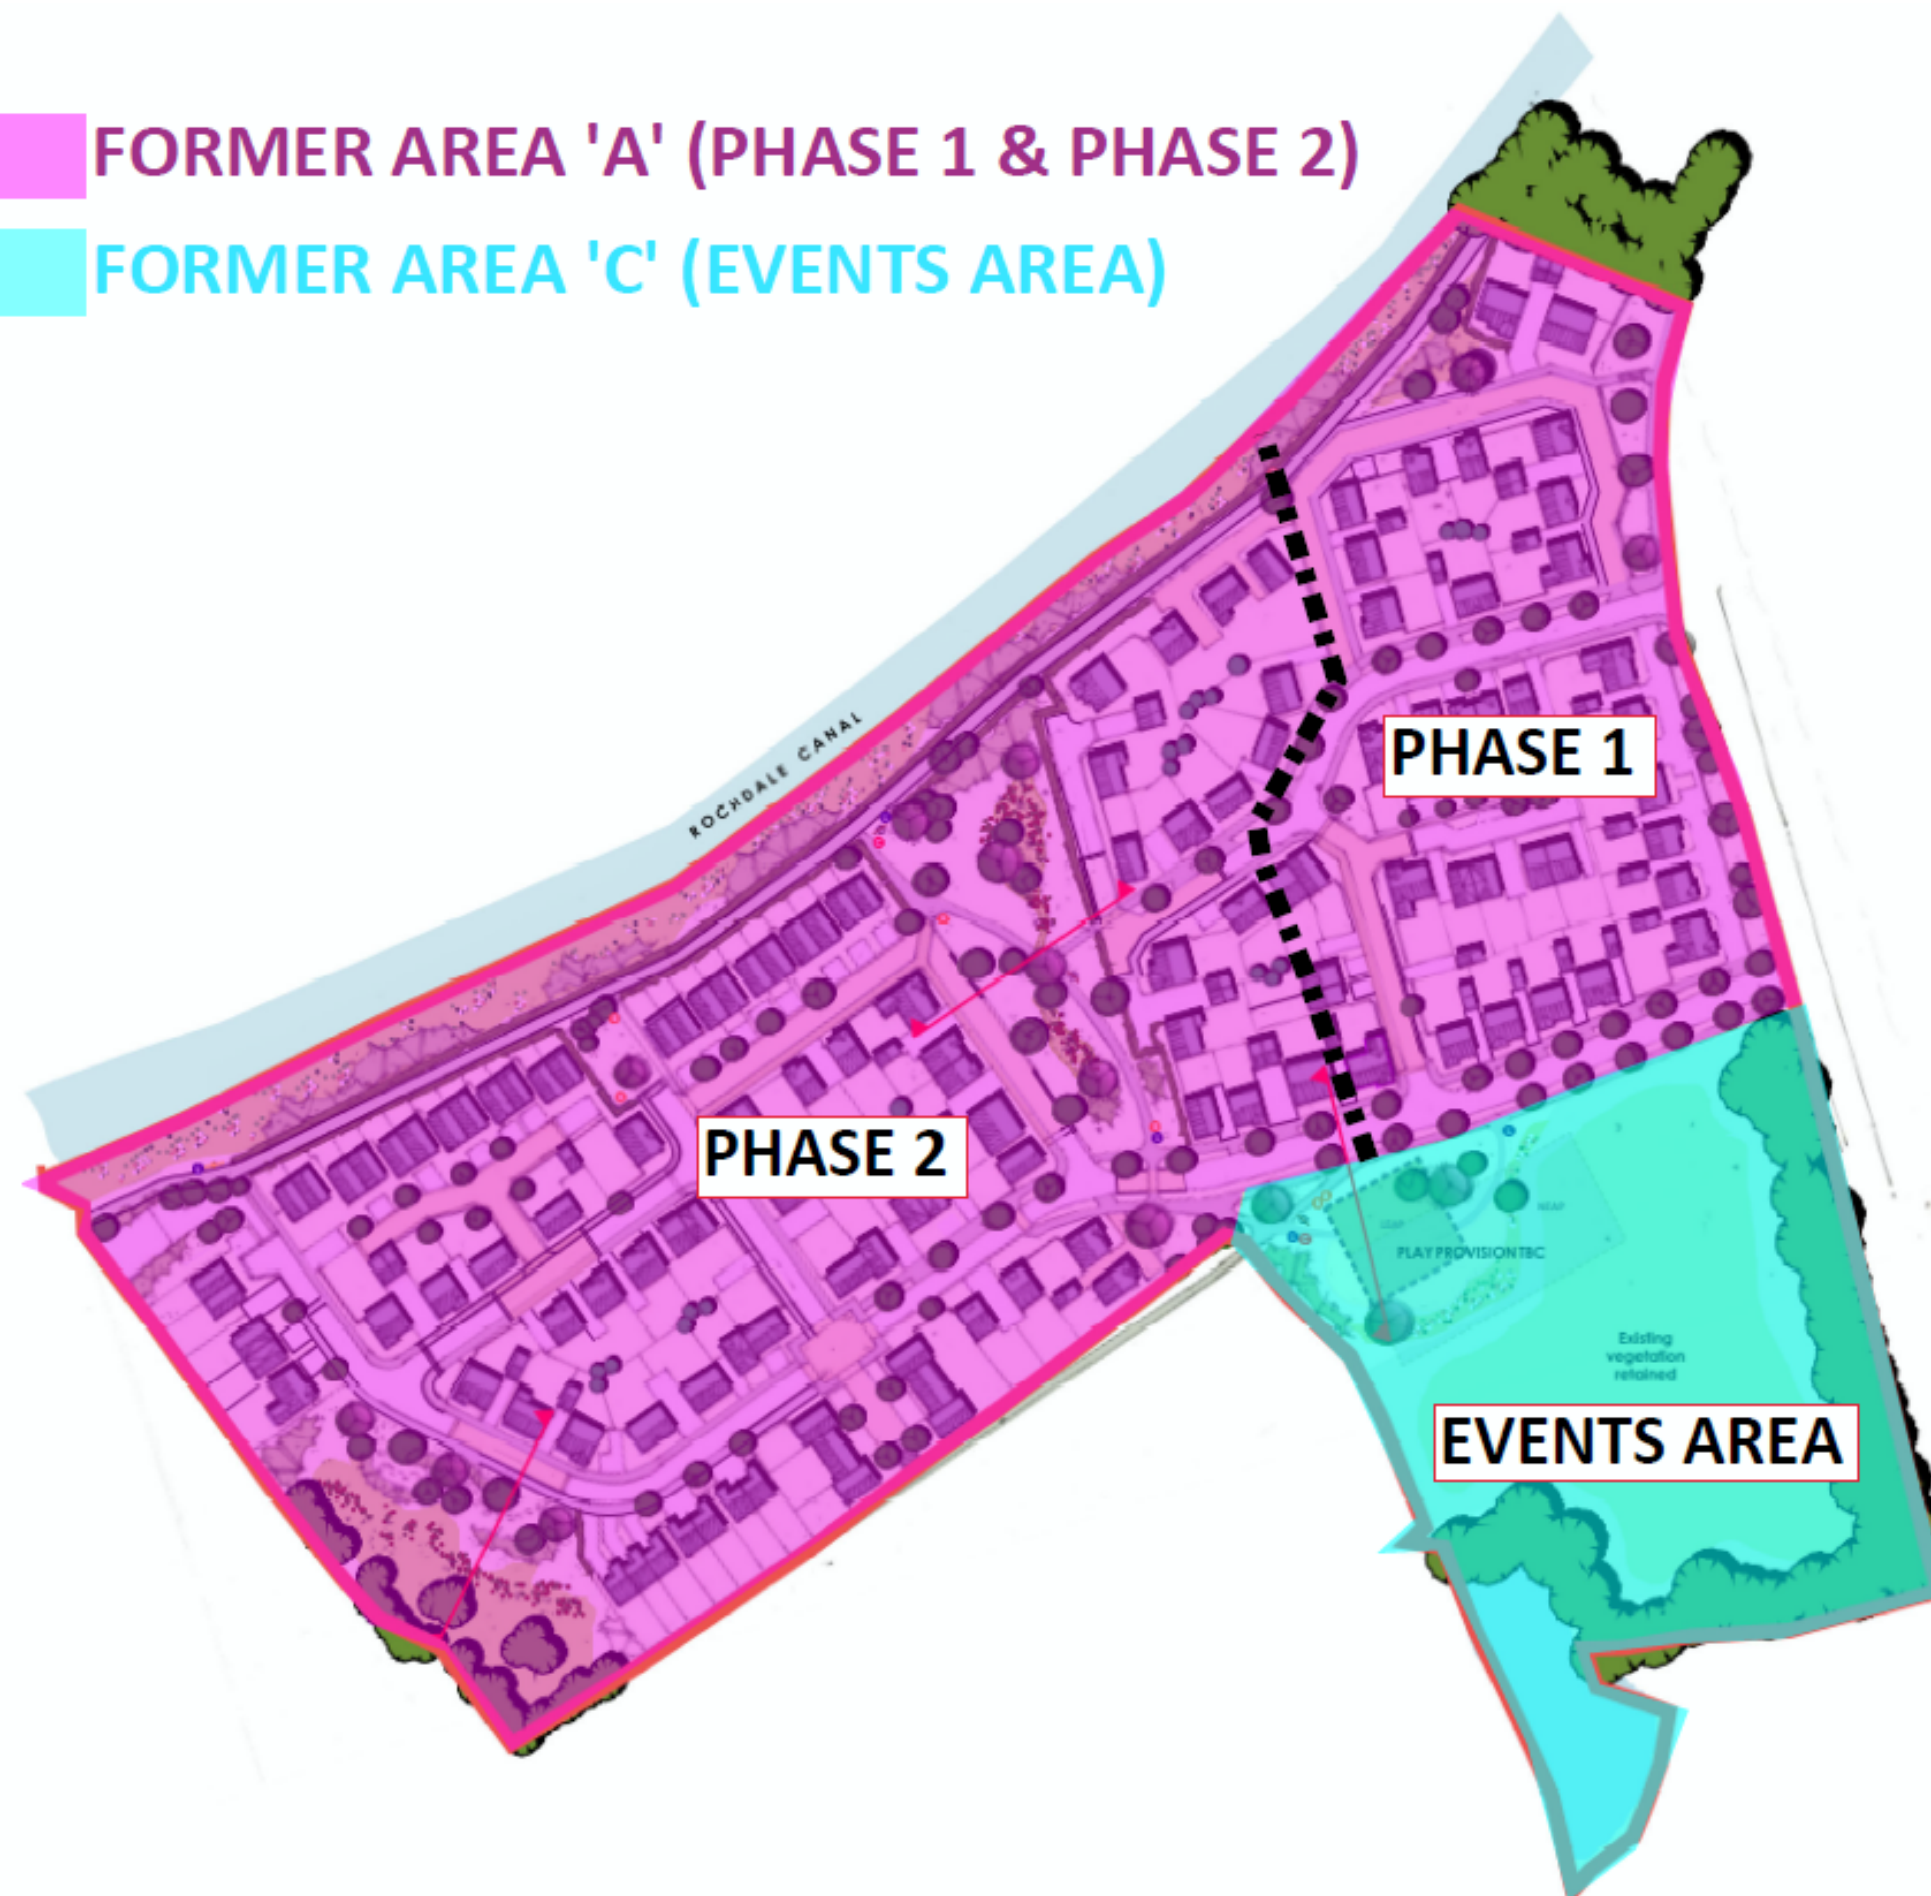
- FORMER AREA 'A' (PHASE 1 & PHASE 2)**
- FORMER AREA 'C' (EVENTS AREA)**

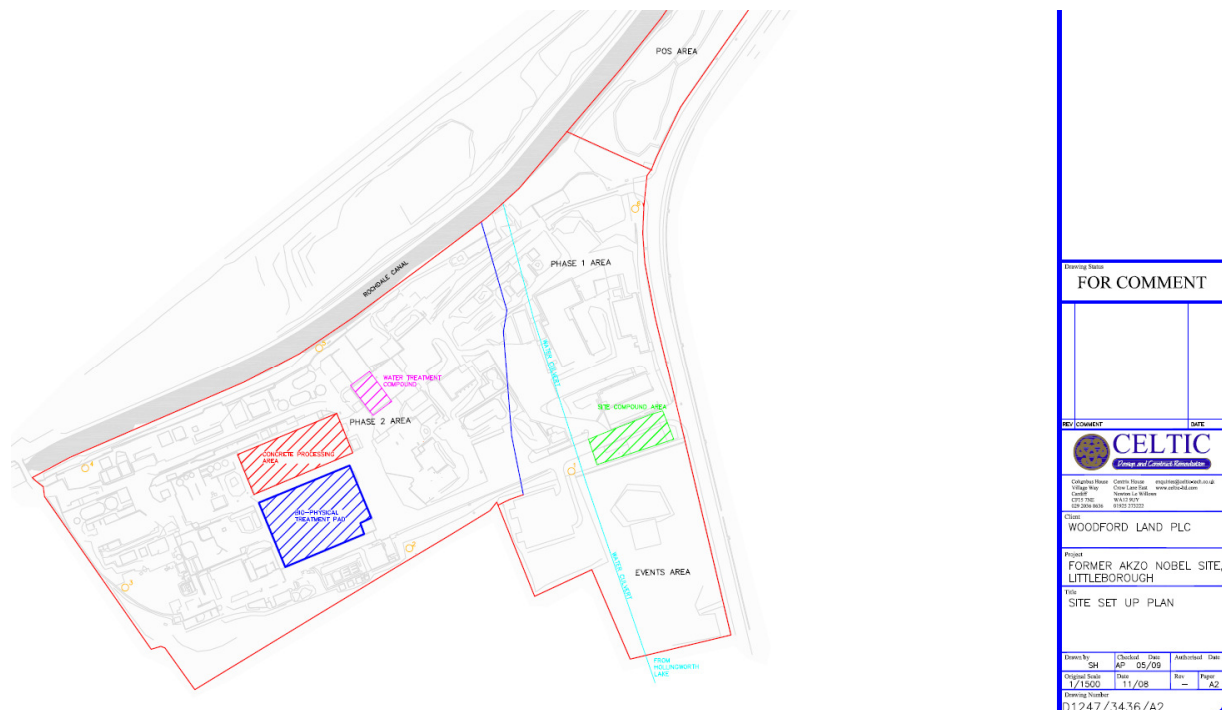
CELTIC's Site Set Up Plan included in their March 2009 report notes the area of the site proposed for housing west of the culvert is titled 'Phase 2' whilst the area east of the culvert and south of the proposed residential area is 'Phase 1':

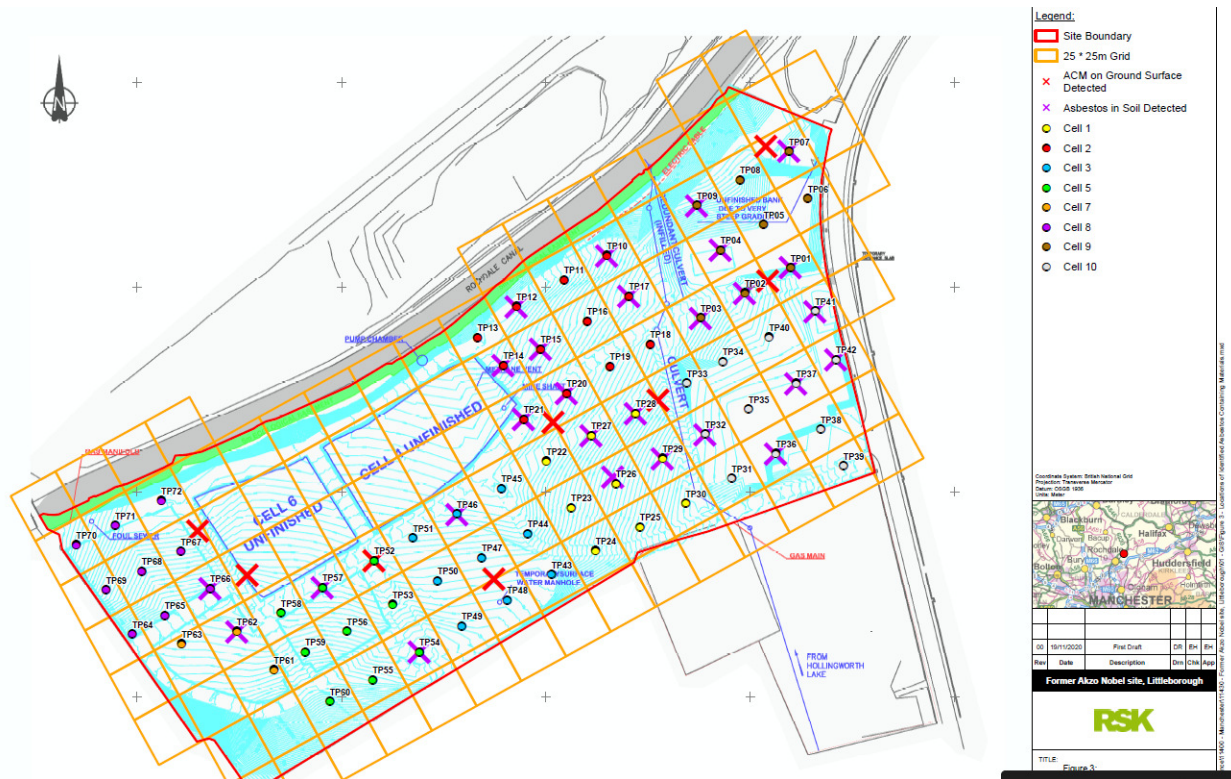
This investigation included a walkover by an asbestos consultant to identify suspected ACM, and sampling and analysis of 8 bulk bags and 55 samples taken between site surface and 0.3 m. The hard to dig layer comprised sandy cobbles of concrete and brick with fragments of wood, plastic and rebar, and was found up to 0.2 to 0.6 m thick. Three locations found a geotextile below the layer and in seven locations, the layer appeared more cohesive. The report notes the hard to dig layer was absent in selected pits. Concrete obstructions were also noted in five holes.

Visible ACM was noted in four surface locations, and 27 of 55 samples recorded up to 0.019%. Of the 8 bulk bags, 4 contained ACM.

The report concludes the material is ingrained with asbestos, and that mitigation measures are required during future disturbance of the ground including notifying future works to the HSE and 'employing the specialisms of a licensed asbestos contractor to manage such future works appropriately'. Air monitoring around the site's perimeter may also be required during drier times of the year. The hard to dig layer could be considered 'hazardous waste' if removed from site in its current state. If it remains in place, it should be capped with 600 mm of clean cover and a visible marker layer. Where services are to be installed, the surrounding soils should also be 'clean'.
