## Hydrogeological Review & Groundwater Piling Assessment

Hollingworth Road, Littleborough

Vistry Partnerships Yorkshire

## Hollingworth Road, Littleborough – Hydrogeological Review and Groundwater Piling Assessment

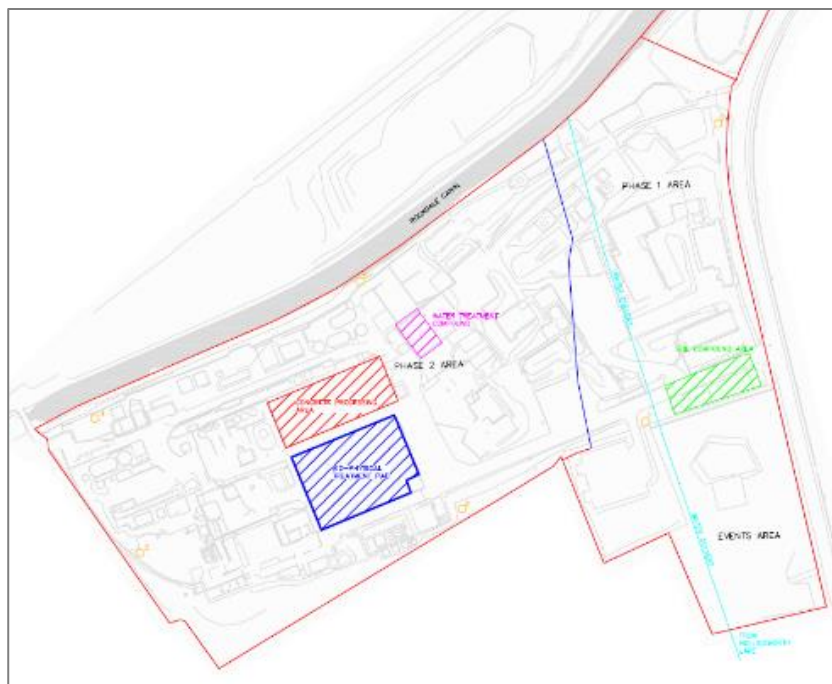
Woodford Remediation completed remedial works on the site in 2008. The remediation works were carried out for a commercial end-use in the eastern third of the site, and a residential end-use in the western two thirds, referenced Phase 1 and 2 respectively on the plan below.

The remedial works included the removal of relict foundations (including piles) to a depth of 2.0 m below remediation level. The upper 2.0 m of ground below remediation level was also turned over to inspect for signs of impacted ground; the turnover was typically terminated where natural ground was encountered within the upper 2.0 m. Ground levels were left low in localised sections of the site due to a shortfall of material.

A hard to dig layer, comprising crushed and screened demolition arisings, was placed at the surface across much of the development platform (the site was split into ten 'cells', and the hard to dig layer was installed in eight of these).
